## ACCESSORIES & EQUIPMENT

### Floor Coverings and Headlinings - Canyon, Colorado

## HEADLINING TRIM PANEL REPLACEMENT (CREW CAB)

## HEADLINING TRIM PANEL REPLACEMENT (EXTENDED CAB)

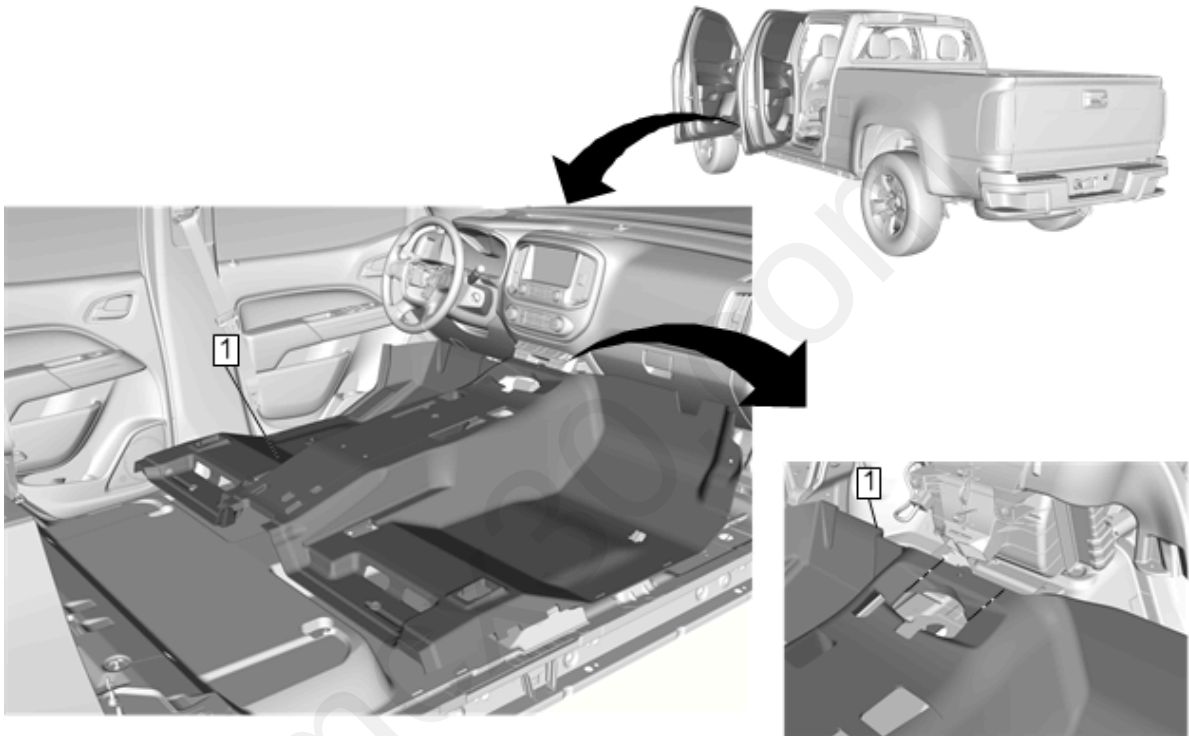
**Fig. 1: Front Floor Panel Carpet**  
Courtesy of GENERAL MOTORS COMPANY

| Callout | Component Name |
|---|---|
| 1 | Front Floor Panel Carpet<br><br><b>Procedure</b><br><br>1. Using an appropriate cutting tool, carefully cut the carpet at the front center to remove.<br>2. Tuck the carpet under the front floor console and heating, ventilation, and air conditioning (HVAC) unit when replacing. |

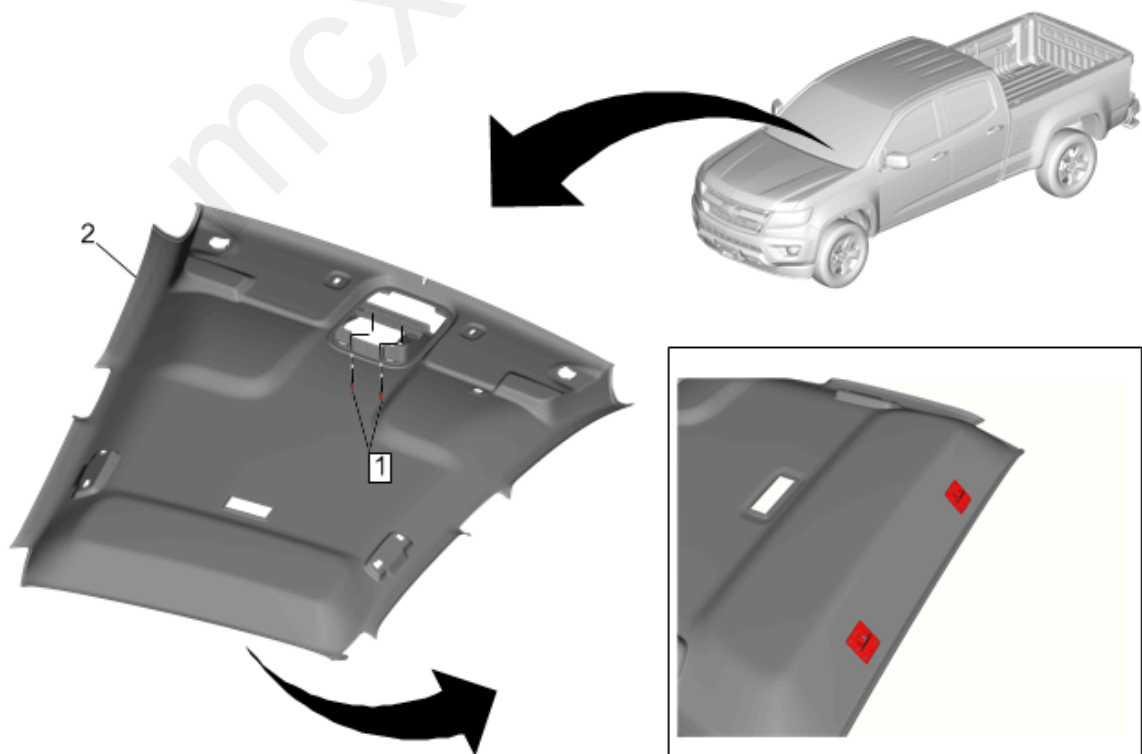
Headliner Trim Panel Assembly  
Courtesy of GENERAL MOTORS COMPANY

13. Disconnect the headliner trim panel assembly (2) electrical connectors.
14. Remove the two screws (1) from the front portion of the headliner at the roof console backing plate.
15. There are two retainers at the rear underside of the headliner, if necessary remove.
16. Remove the windshield. Refer to [Windshield Replacement](#) .
17. With the aid of an assistant, remove the headliner trim panel assembly (2) from the vehicle through the front windshield.
18. If transferring or replacing the wiring harness. Refer to [Headliner Harness Replacement](#).

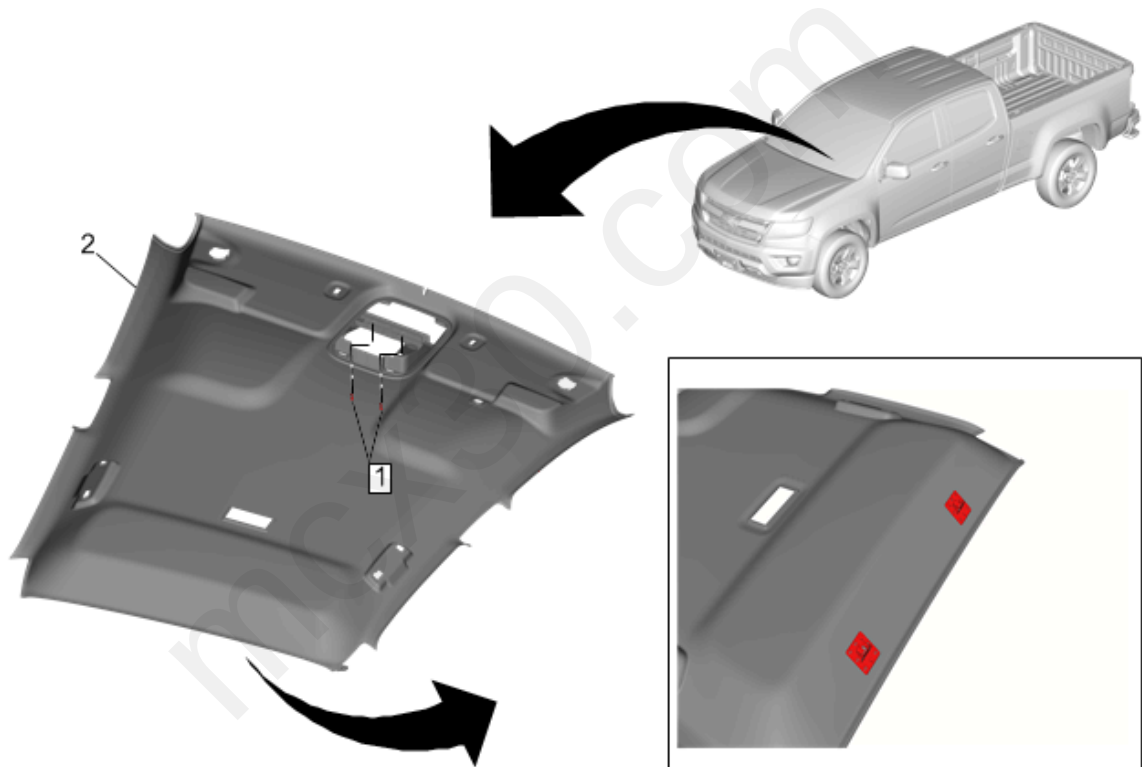
**Fig. 15: Headliner Trim Panel Assembly**  
Courtesy of GENERAL MOTORS COMPANY

1. With the aid of an assistant, position the headliner trim panel assembly (2) into the vehicle through the front windshield.
2. Engage the two retainers at the rear underside of the headliner.
3. Install the two screws (1) to the front portion of the headliner at the roof console backing plate.
4. Connect the electrical connectors and secure.
5. If replacing the headliner assembly, transfer all necessary components.
6. If transferring or replacing the wiring harness. Refer to [Headliner Harness Replacement](#).
7. Tape any unused connectors to the headliner with a high adhesive tape.
8. Install the windshield. Refer to [Windshield Replacement](#) .

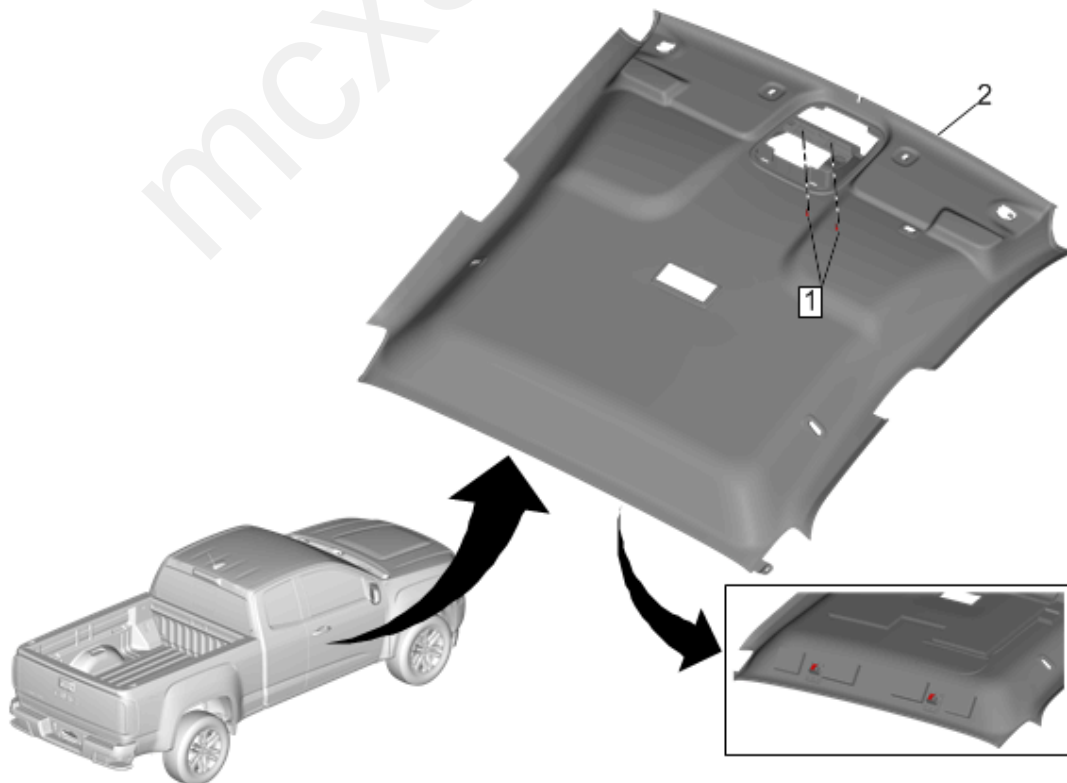
**Headliner Trim Panel Assembly And Fasteners**  
Courtesy of GENERAL MOTORS COMPANY

13. Disconnect the electrical connectors.
14. Remove the fasteners from the front portion of the headliner at the roof console backing plate.
15. There are two retainers at the rear underside of the headliner, if necessary remove.
16. With the aid of an assistant, remove the headliner trim panel assembly (2) from the vehicle through the passenger side door opening.
17. If transferring or replacing the wiring harness. Refer to [Headliner Harness Replacement](#)

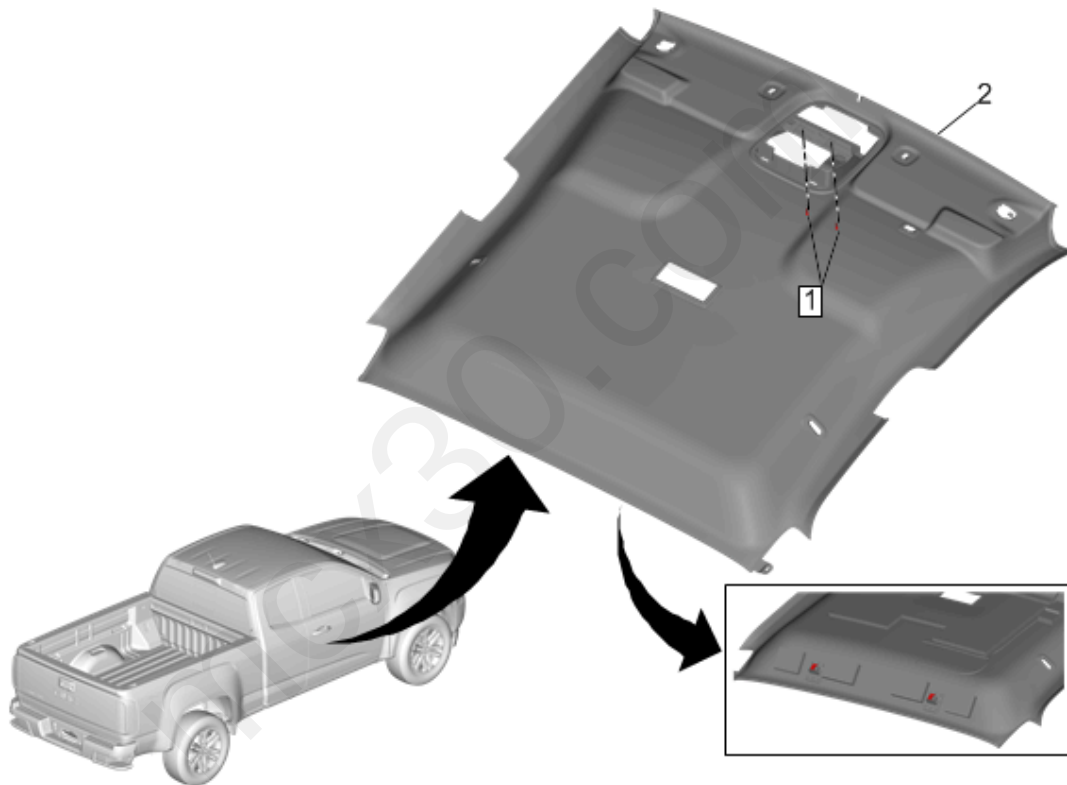
**Fig. 39: Headliner Trim Panel Assembly And Fasteners**  
Courtesy of GENERAL MOTORS COMPANY

1. With the aid of an assistant, position the headliner trim panel assembly (2) into the vehicle through the passenger side door opening.
2. Engage the two retainers at the rear underside of the headliner.
3. Install the fasteners to the front portion of the headliner at the roof console backing plate.
4. Connect the electrical connectors.
5. If replacing the headliner assembly (1), transfer all necessary components.
6. If transferring or replacing the wiring harness. Refer to [Headliner Harness Replacement](#)
7. Tape any unused connectors to the headlining with a high adhesive tape.

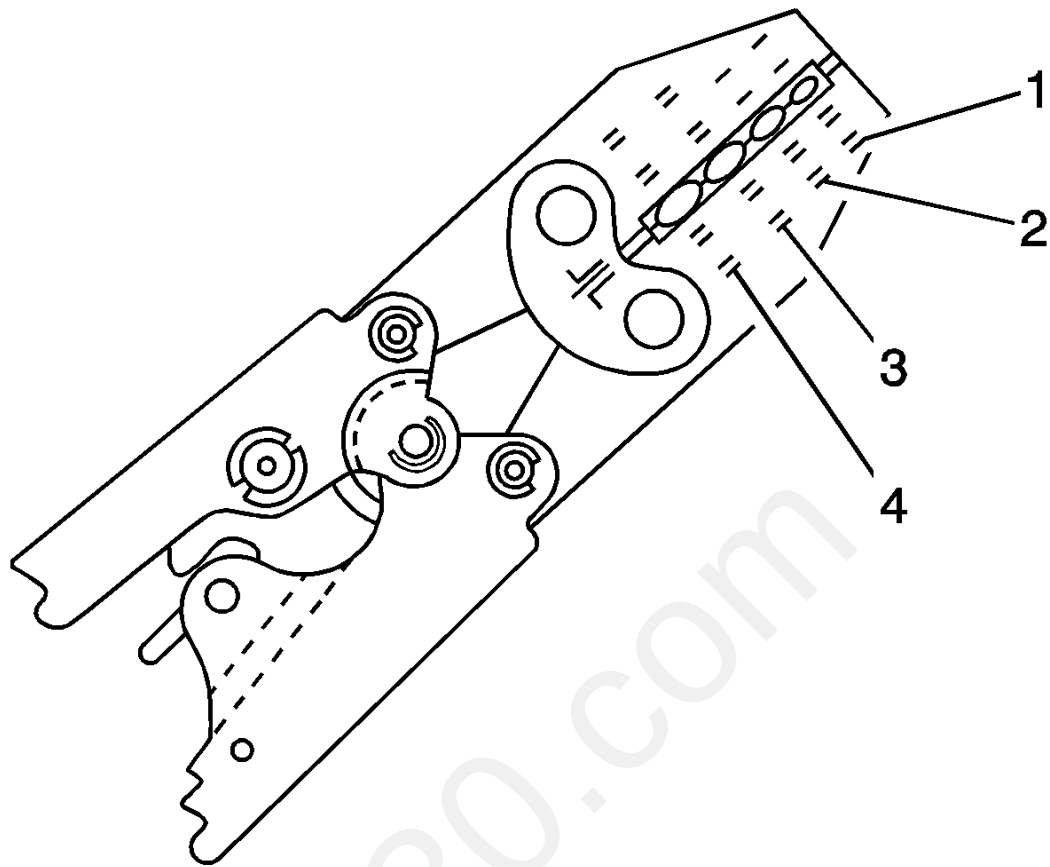
**Fig. 51: Crimping Tool**

6. The **EL-38125-10** splice sleeve crimping tool has four crimp nests. The largest crimp nest (4) is used for crimping 10 and 12 gauge wires. The second largest crimp nest (3) is used for crimping 14 and 16 gauge wires. The third largest crimp nest (2) is used for crimping 18 and 20 gauge wires. The smallest crimp nest (1) is used for crimping 22 to 26 gauge wires. The crimp nests are referenced in the table (farther above) under the crimp tool nest color.

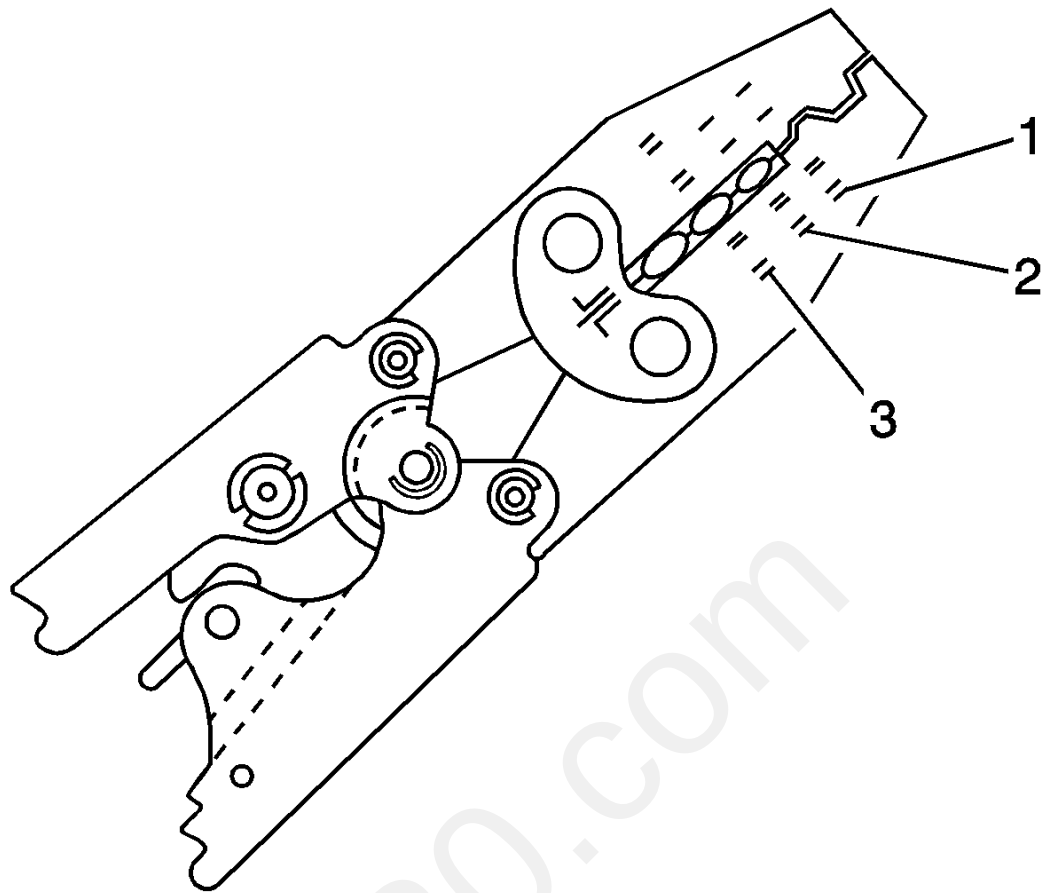
**Fig. 52: Splice Crimp Tool Nests**

8. Use the splice sleeve crimp tool in order to position the DuraSeal splice sleeve in the proper color nest of the splice sleeve crimp tool. For the four crimp nest tool, use the three largest crimp nests to crimp the splice sleeves. For the three crimp nest tool, use all three crimp nests to crimp the splice sleeves. Use the four and three crimp tool diagrams (above) and the table (farther above) to match the splice sleeve with the correct crimp nest. The crimp tool diagram callout numbers match the numbers in the table (under crimp tool nest color).

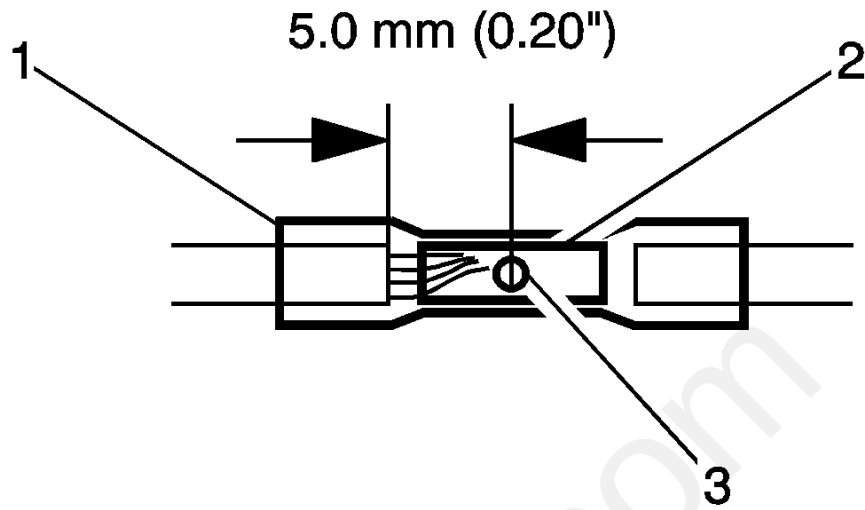
**Fig. 53: Duraseal Splice Sleeve**

10. Insert the wire into the splice sleeve barrel until the wire hits the barrel stop. Refer to **Folded-Over Wire Repair** for splicing wires of 0.35 mm or less (22, 24, 26 gauge sizes) and for splicing wires of different gauges.
11. Tightly close the handles of the crimp tool until the crimper handles open when released.

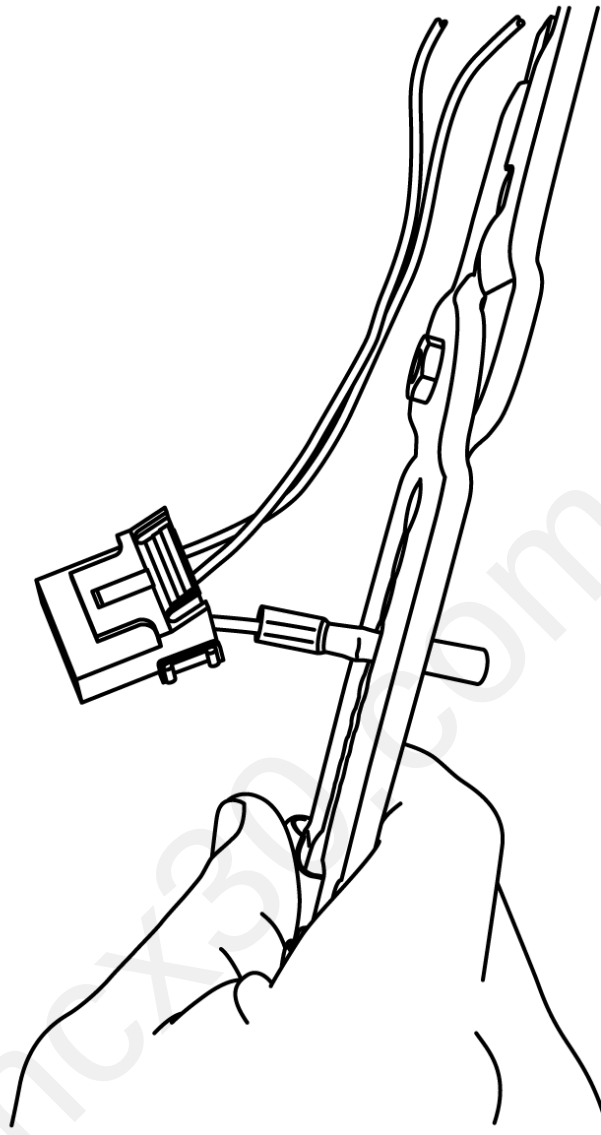
**Fig. 56: Tightly Close Handles Of Crimp Tool**  
Courtesy of GENERAL MOTORS COMPANY

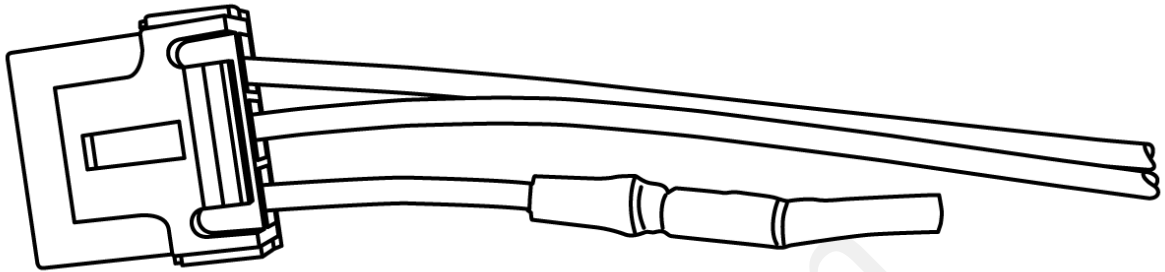
3. Using the heat torch, apply heat to the crimped area of the barrel.

**Fig. 57: Applying Heat To Crimped Area Of Barrel**  
**Courtesy of GENERAL MOTORS COMPANY**

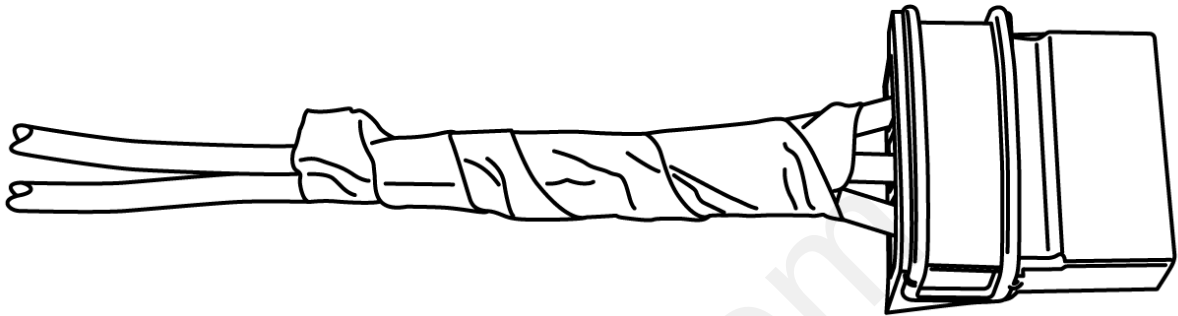
**Fig. 58: Taping Extra Terminated Leads Back Into Harness**  
Courtesy of GENERAL MOTORS COMPANY
