## 2010 ACCESSORIES & EQUIPMENT

### Collision Repair - Equinox & Terrain

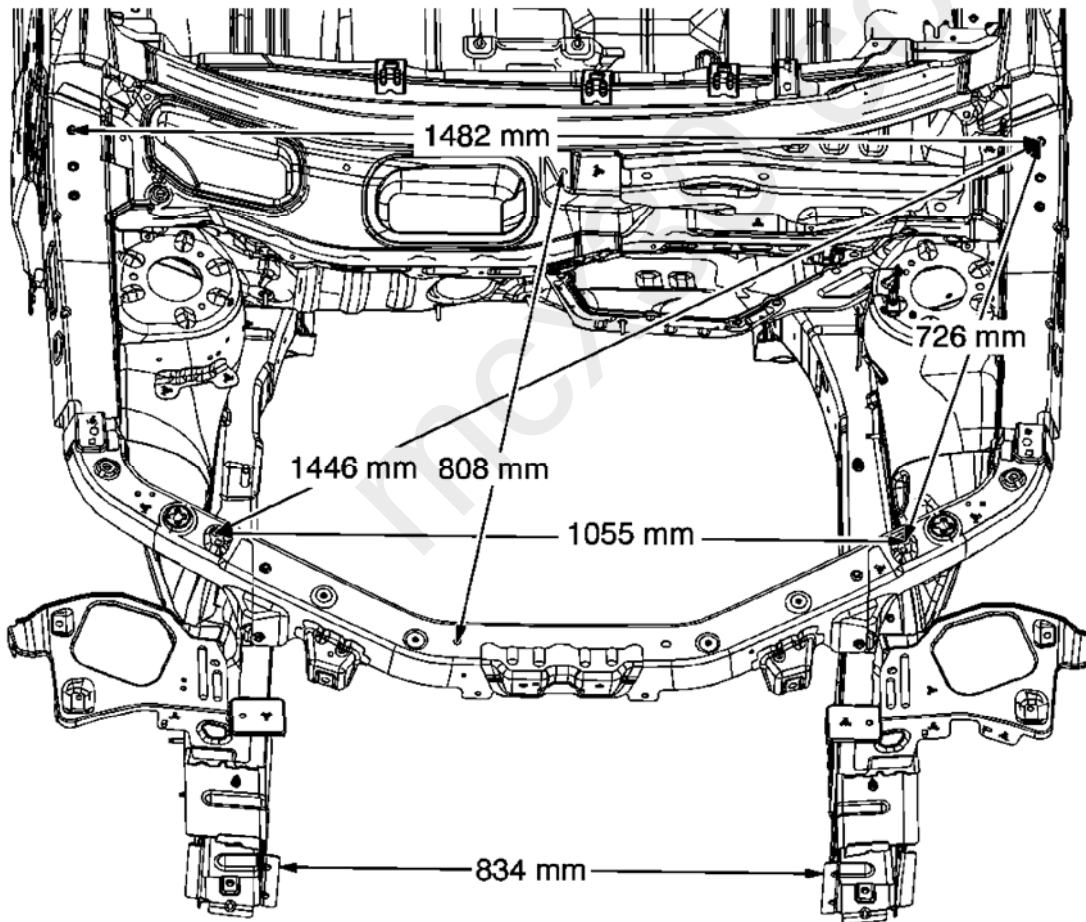
Point-to-Point Measurements are for reference only. All measurements are given in millimeters. Use these measurements for diagnosis and estimating. Point-to-Point measurements are duplicated with tram bar pointers set at equal lengths. All die marks, holes, slots and fasteners are measured to the center. All dimensions are symmetrical unless otherwise specified.

**Fig. 1: Under Hood Opening Dimensions**  
Courtesy of GENERAL MOTORS CORP.

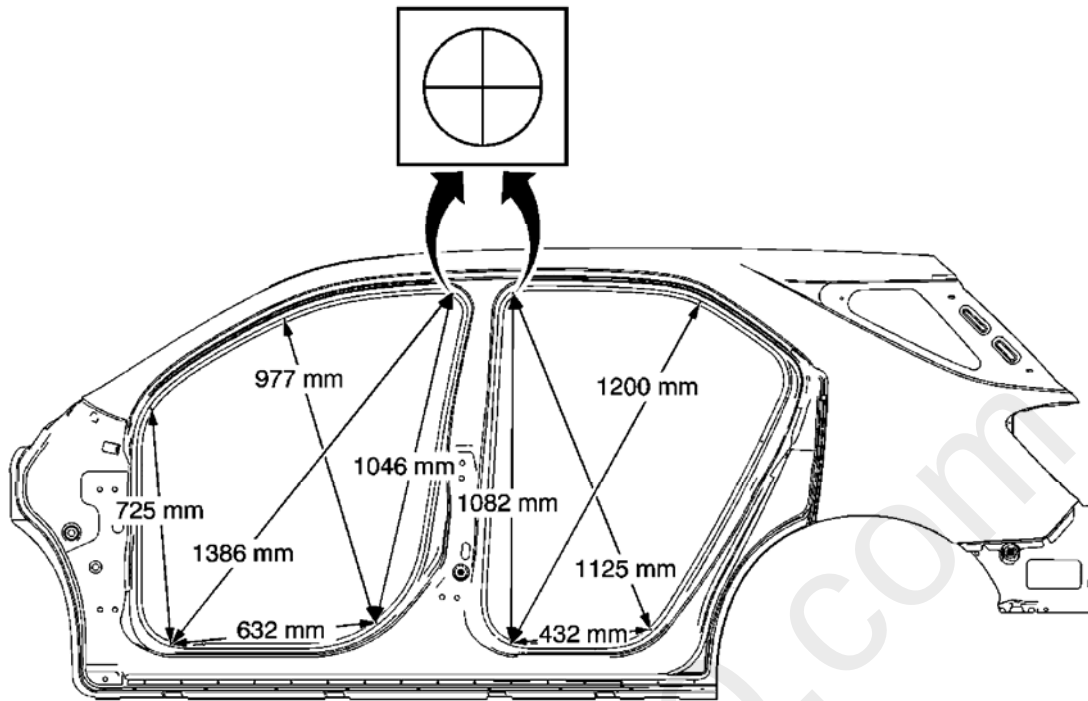
**Fig. 2: Body Side Opening Dimensions (Equinox)**  
Courtesy of GENERAL MOTORS CORP.

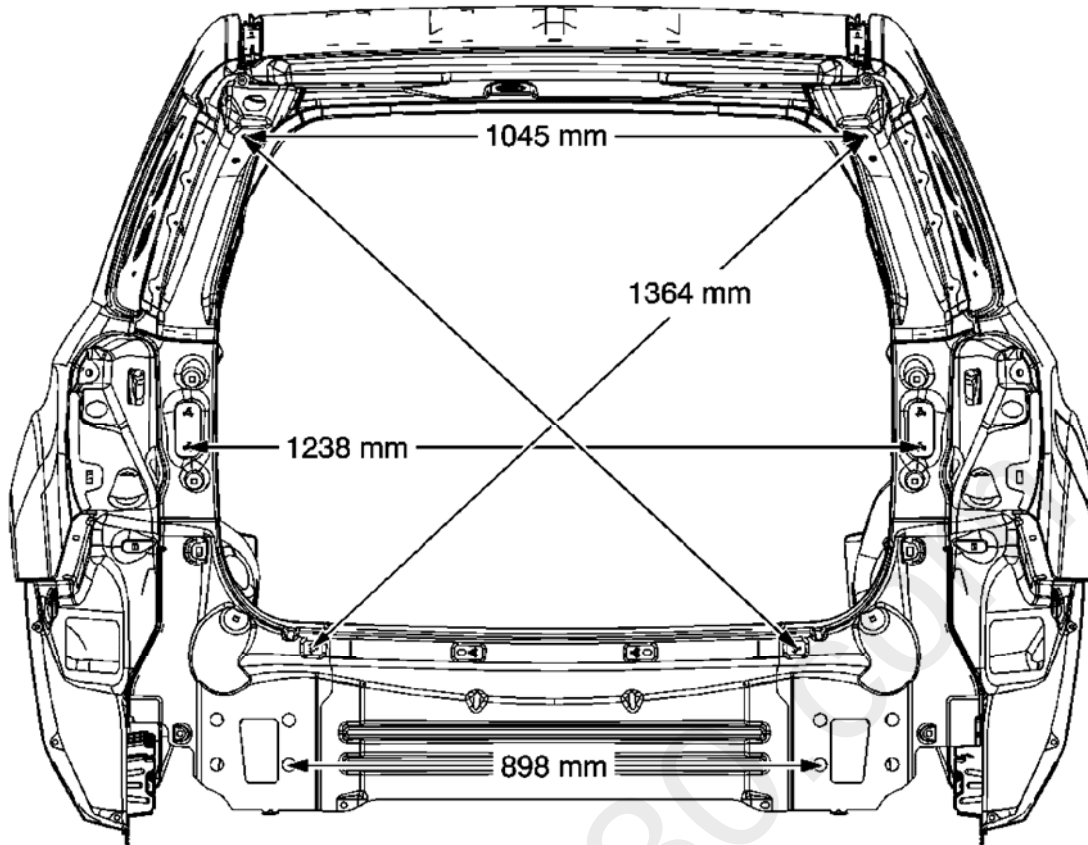
**Fig. 3: Rear Body Dimensions**  
Courtesy of GENERAL MOTORS CORP.

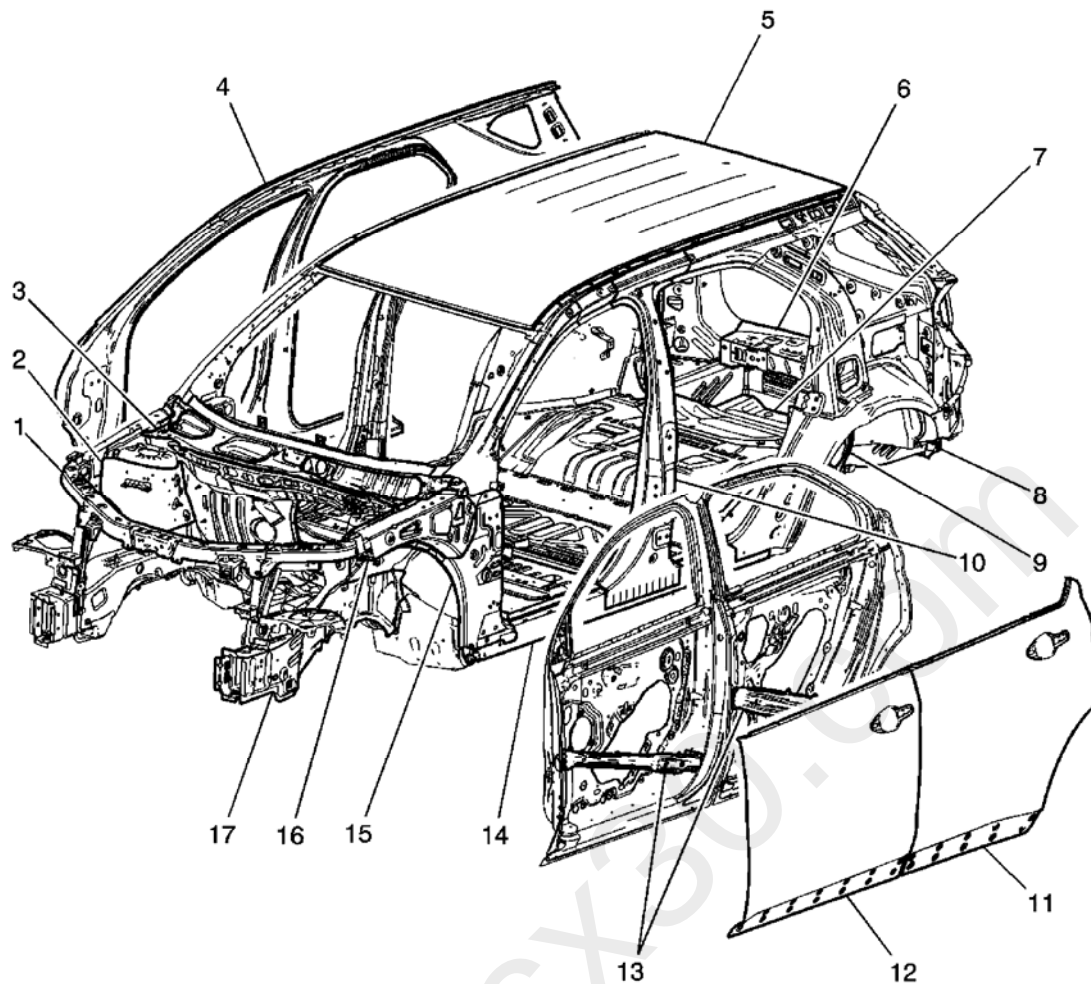
**Fig. 4: Structure Identification**  
 Courtesy of GENERAL MOTORS CORP.

| Number | Description | Materials | Procedure |
|---|---|---|---|
| 1 | Radiator Support Assembly | <u>Mild Steel</u> | <u>Front End Upper Tie Bar Replacement</u> |
| 2 | Front Wheelhouse Assembly | <u>Mild Steel</u> | <u>Front Wheelhouse Panel Replacement</u> |
| 3 | Plenum Upper | <u>Mild Steel</u> | <u>Plenum Upper Panel Replacement</u> |
| 4 | Body Side Outer | <ul style="list-style-type: none"> <li>Body Side Outer</li> </ul> <u>Mild Steel</u> <ul style="list-style-type: none"> <li>A-Pillar and Roof Rail Reinf's <u>Dual Phase Steel</u></li> </ul> | <ul style="list-style-type: none"> <li><u>Center Pillar Outer Panel Reinforcement Replacement</u></li> <li><u>Quarter Outer Panel Sectioning</u></li> </ul> |

| 5 | Roof Outer Panel | <u>Mild Steel</u> | <u>Roof Outer Panel Replacement</u> |
| 6 | Rear End Panel | <u>Mild Steel</u> | <u>Body Rear End Panel Replacement</u> |
| 7 | Rear Floor Panel | <u>Mild Steel</u> | <u>Rear Floor Panel Replacement</u> |
| 8 | Rear Rail Assembly | <u>Mild Steel</u> | <ul style="list-style-type: none"> <li>• <u>Rear Rail Replacement</u></li> <li>• <u>Rail Replacement - Rear Section</u></li> </ul> |
| 9 | Rear Wheelhouse | <u>Mild Steel</u> | <u>Rear Inner Wheelhouse Replacement</u> |
| 10 | Center Pillar | <ul style="list-style-type: none"> <li>• Reinf - C/Plr Otr, Reinf - C/Plr Inr Lwr, Reinf - C/Plr Ctr</li> </ul> <u>Mild Steel</u> <ul style="list-style-type: none"> <li>• C/Plr Inr, Reinf - C/Plr Inr, Reinf - C/Plr Otr Up</li> </ul> <u>Dual Phase Steel</u> | <u>Center Pillar Outer Panel Reinforcement Replacement</u> |
| 11 | Rear Side Door | <u>Mild Steel</u> | <u>Rear Side Door Outer Panel Replacement</u> |
| 12 | Front Side Door | <u>Mild Steel</u> | <u>Front Side Door Outer Panel Replacement</u> |
| 14 | Rocker Panel | <u>Ultra High Strength Steel</u> | <u>Rocker Inner Panel Reinforcement Replacement</u> |
| 15 | Front Panel | <u>Mild Steel</u> | <ul style="list-style-type: none"> <li>• <u>Front Inner Hinge Pillar Body Replacement</u></li> <li>• <u>Front Hinge Pillar Body Sectioning</u></li> </ul> |
| 16 | Upper Rail | <u>Mild Steel</u> | <u>Front Compartment Upper Side Rail Replacement</u> |
| 17 | Front Rail Assembly | <u>Mild Steel</u> | <ul style="list-style-type: none"> <li>• <u>Front Compartment Front Rail Replacement</u></li> <li>• <u>Front Compartment Inner Side Rail Replacement</u></li> <li>• <u>Underbody Outer Front Side Rail Replacement</u></li> </ul> |

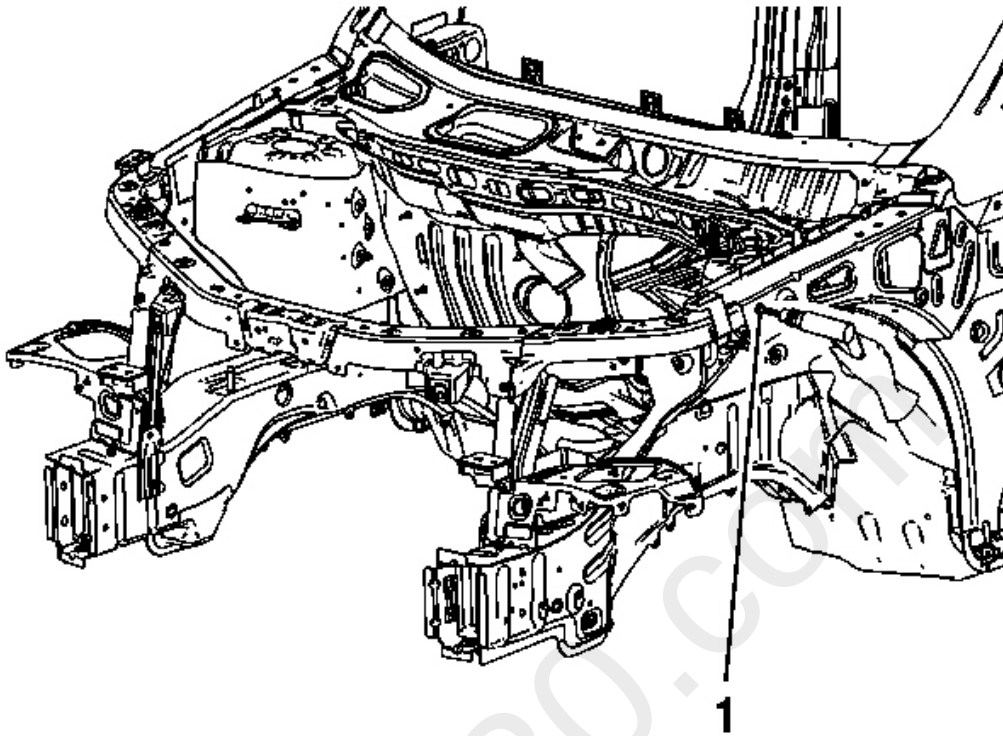
**Fig. 5: Locating Factory Welds**  
Courtesy of GENERAL MOTORS CORP.

**NOTE:** Do not damage any inner panels or reinforcements. Record the number and location of the original welds for installation of the service part.

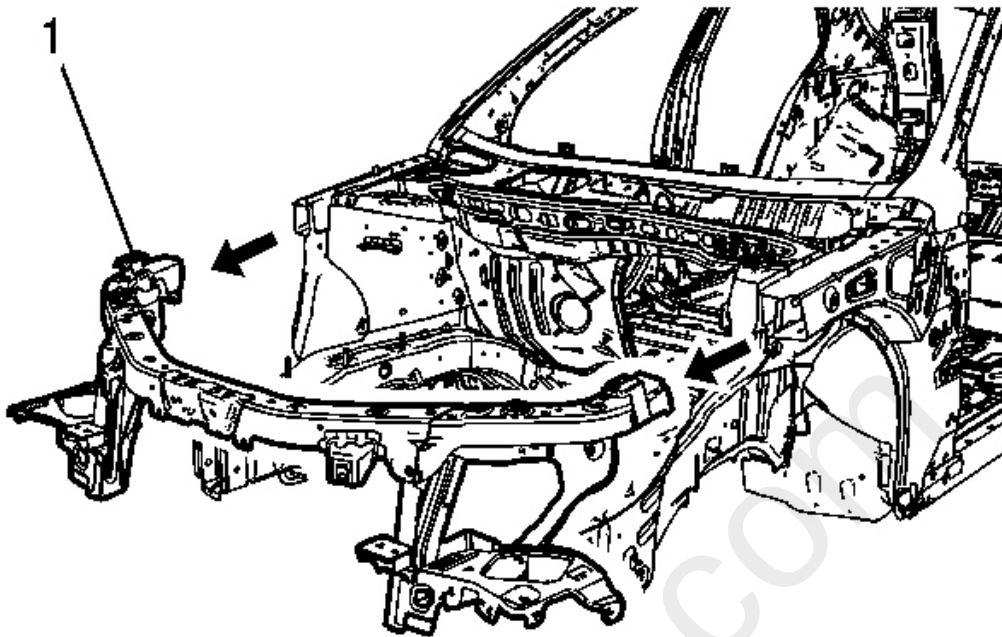
**Fig. 6: Damaged Tie Bar Assembly**  
**Courtesy of GENERAL MOTORS CORP.**

7. Remove the damaged tie bar assembly (1).

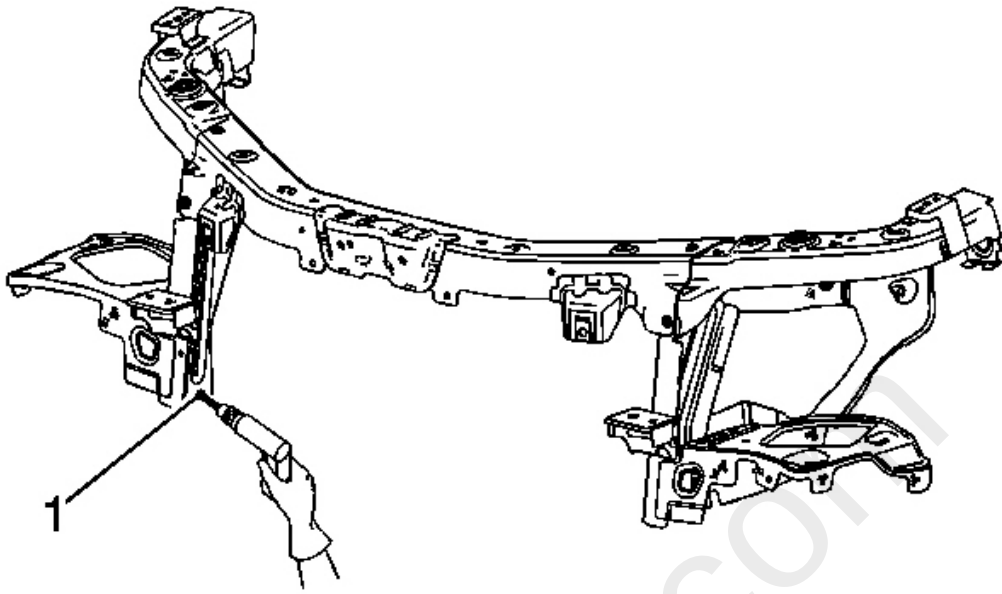
**Fig. 7: Drilling Plug Welds**

**NOTE:** If the location of the original plug welds cannot be determined or structural weld- thru adhesive was present, space plug weld holes every 40 mm (1 1/2 in) apart.

1. Drill 8 mm (5/16 in) plug weld holes in the service part as necessary in the locations noted from the original panel (1).
2. Prepare all mating surfaces as necessary.
3. Apply GM-approved Weld-Thru Coating or equivalent to all mating surfaces. Refer to **Anti-Corrosion Treatment and Repair** .

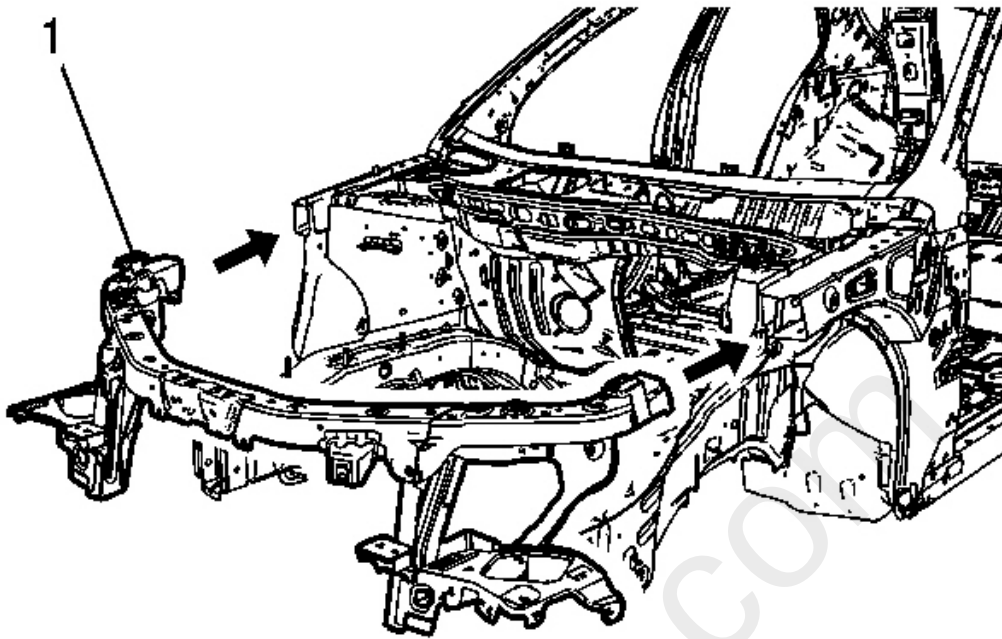
**Fig. 8: Positioning Tie Bar Assembly**  
**Courtesy of GENERAL MOTORS CORP.**

4. Position the tie bar assembly to the vehicle using 3-dimensional measuring equipment (1). Clamp the tie bar assembly into place.

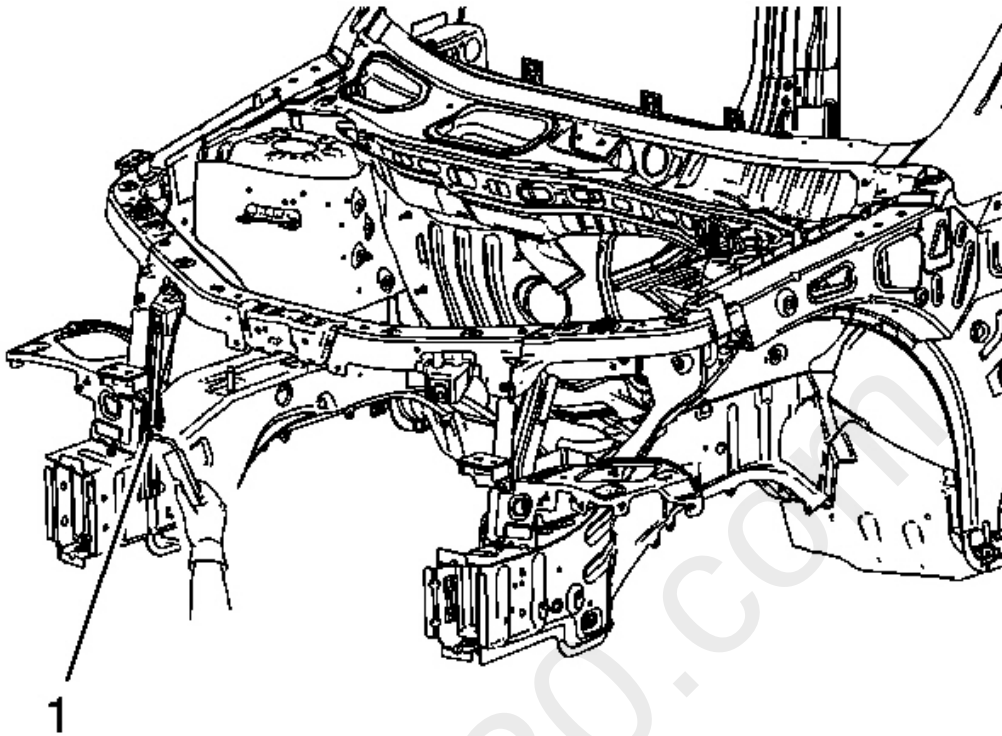
**Fig. 9: Plug Welding**  
Courtesy of GENERAL MOTORS CORP.

5. Plug weld accordingly (1).
6. Clean and prepare all welded surfaces.
7. Apply the sealers and anti-corrosion materials to the repair area, as necessary. Refer to **Anti-Corrosion Treatment and Repair** .
8. Paint the repair area. Refer to **Basecoat/Clearcoat Paint Systems** .
9. Install all related panels and components.
10. Connect the negative battery cable. Refer to **Battery Negative Cable Disconnection and Connection** .
11. Enable the SIR system. Refer to **SIR Disabling and Enabling** .

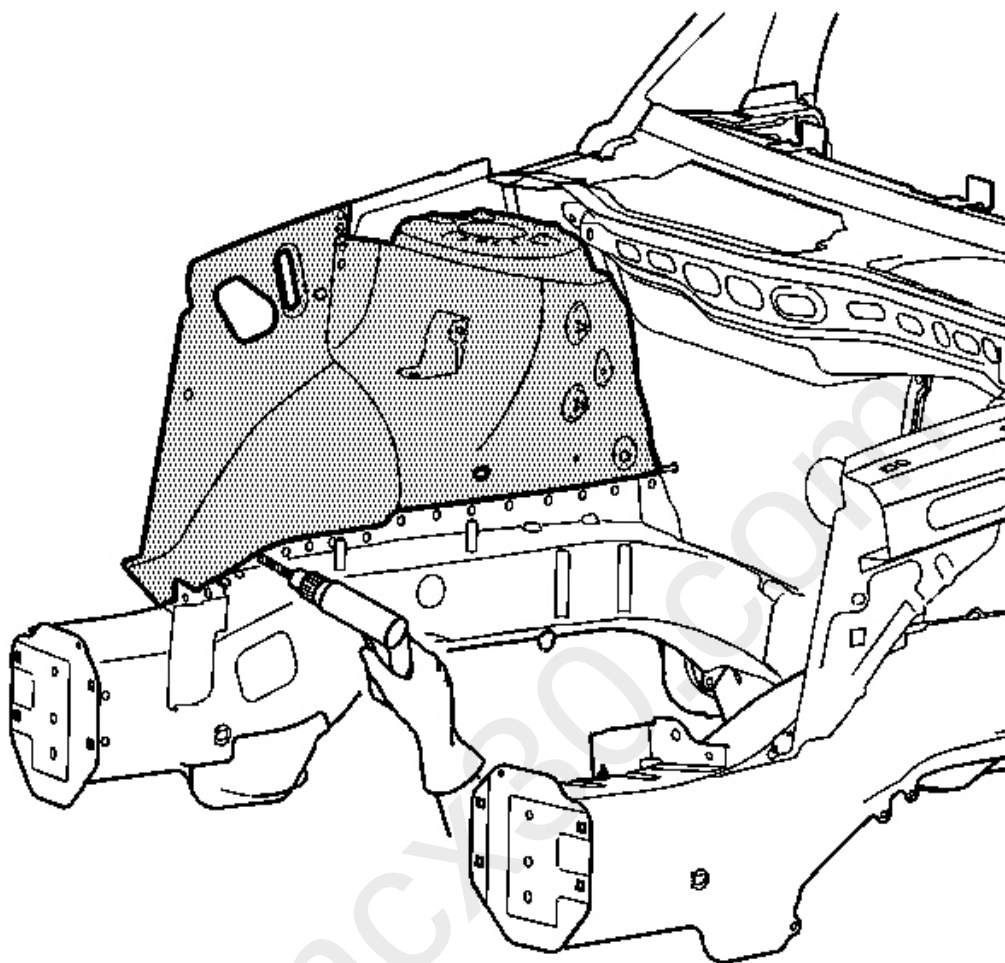
**Fig. 12: Drilling Out Factory Welds On Front Wheelhouse**  
Courtesy of GENERAL MOTORS CORP.

**NOTE:**        **Do not damage any inner panels or reinforcements.**

7. Locate and drill out all factory welds. Note the number and location of the welds for installation of the front wheelhouse.

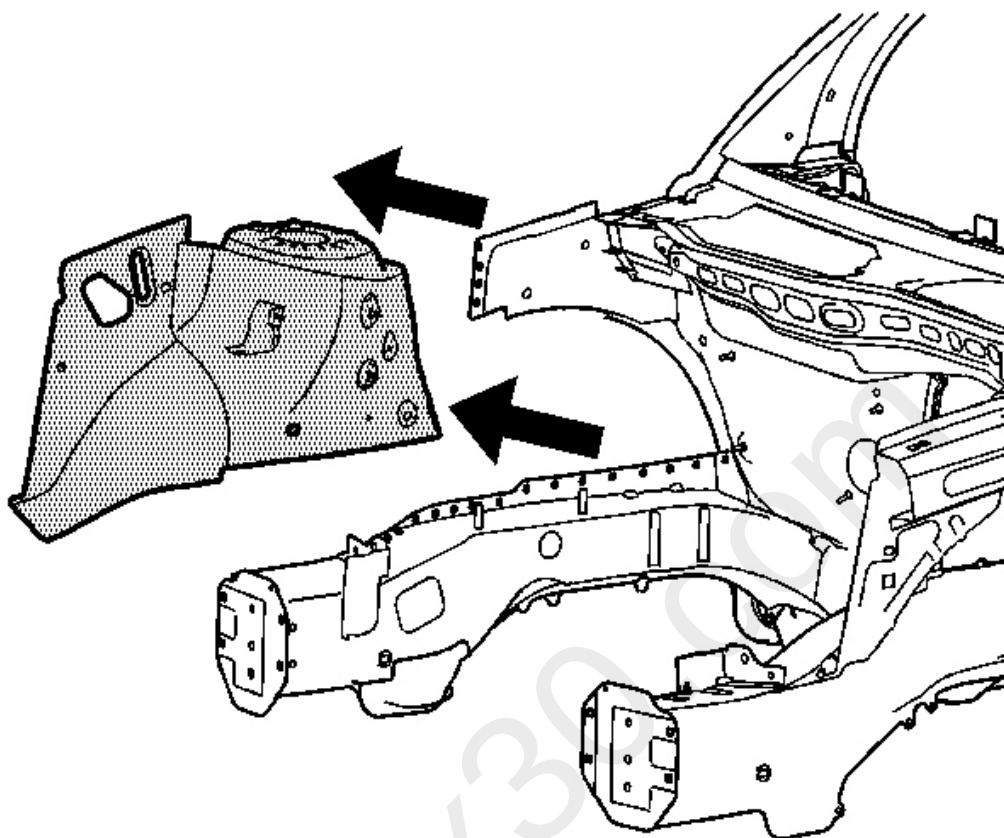
**Fig. 13: View Of Front Wheelhouse**  
**Courtesy of GENERAL MOTORS CORP.**

8. Remove the damaged front wheelhouse.

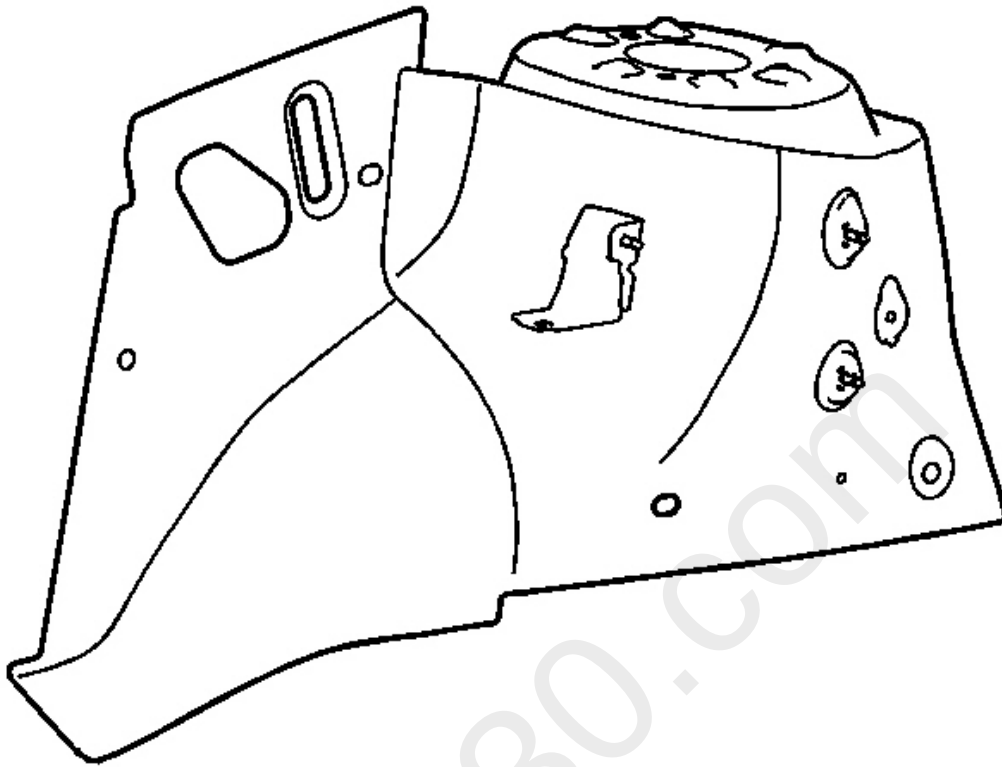
**Fig. 14: View Of Front Wheelhouse**  
Courtesy of GENERAL MOTORS CORP.

**NOTE:** If the location of the original plug weld holes can not be determined, space the plug weld holes every 40 mm (1 1/2 in) apart. Some panels may have structural weld-thru adhesive. It is necessary to replace the weld-thru adhesive with an additional spot weld between each factory spot weld.

1. Drill 8 mm (5/16 in) plug weld holes in the service part as necessary in the locations noted from the original panel.
2. Prepare all mating surfaces as necessary.
3. Apply GM-approved Weld-Thru Coating or equivalent to all mating surfaces. Refer to **Anti-Corrosion Treatment and Repair** .

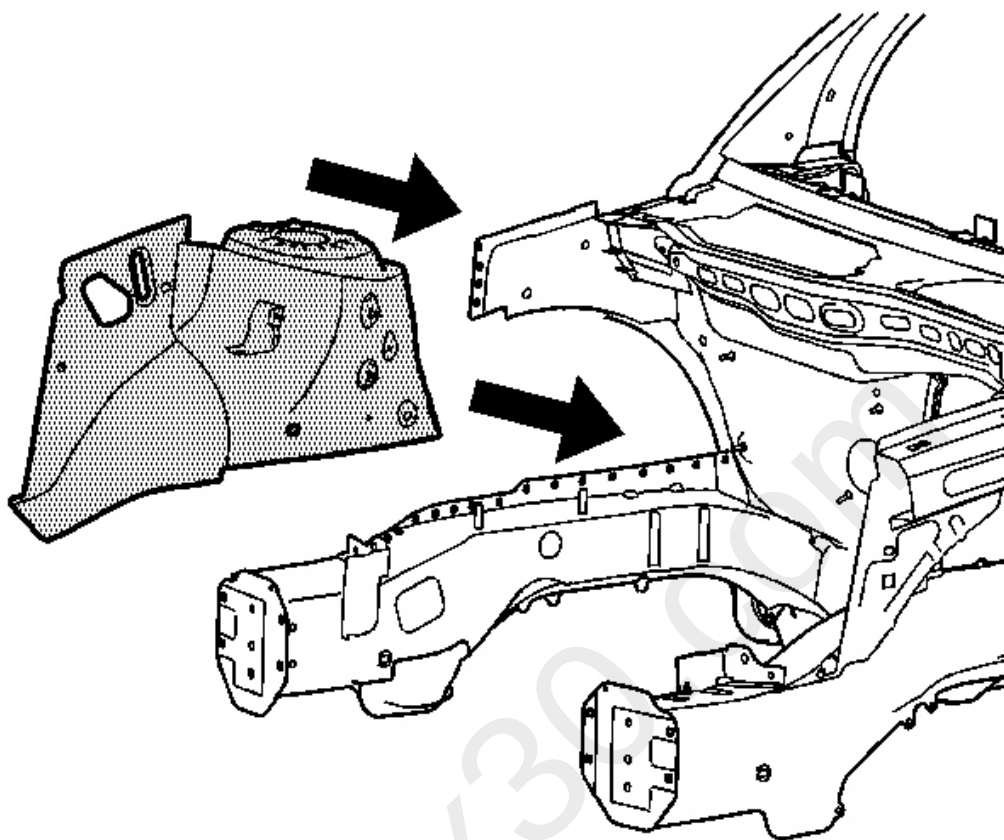
**Fig. 15: View Of Front Wheelhouse**  
**Courtesy of GENERAL MOTORS CORP.**

4. Position the front wheelhouse to the vehicle using 3-dimensional measuring equipment. Clamp the front wheelhouse into place.

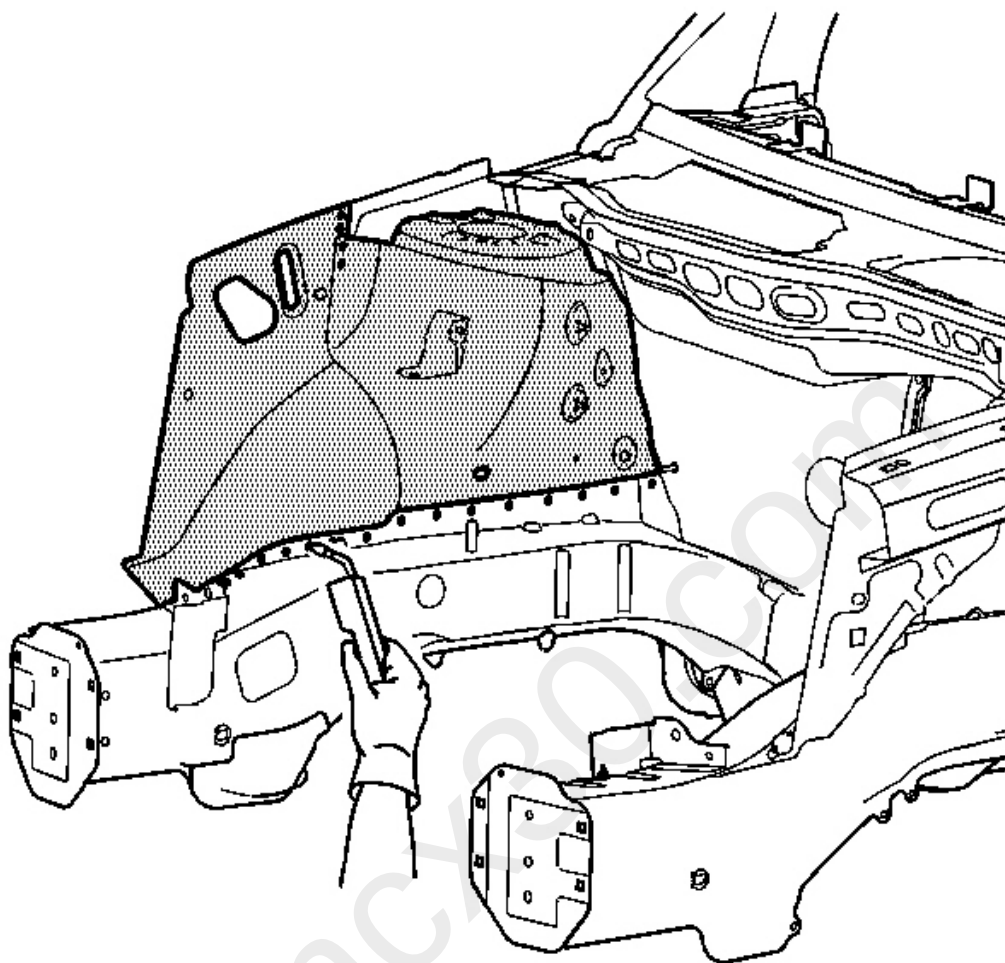
**Fig. 16: Plug Welding Front Wheelhouse**  
Courtesy of GENERAL MOTORS CORP.

5. Plug weld accordingly.

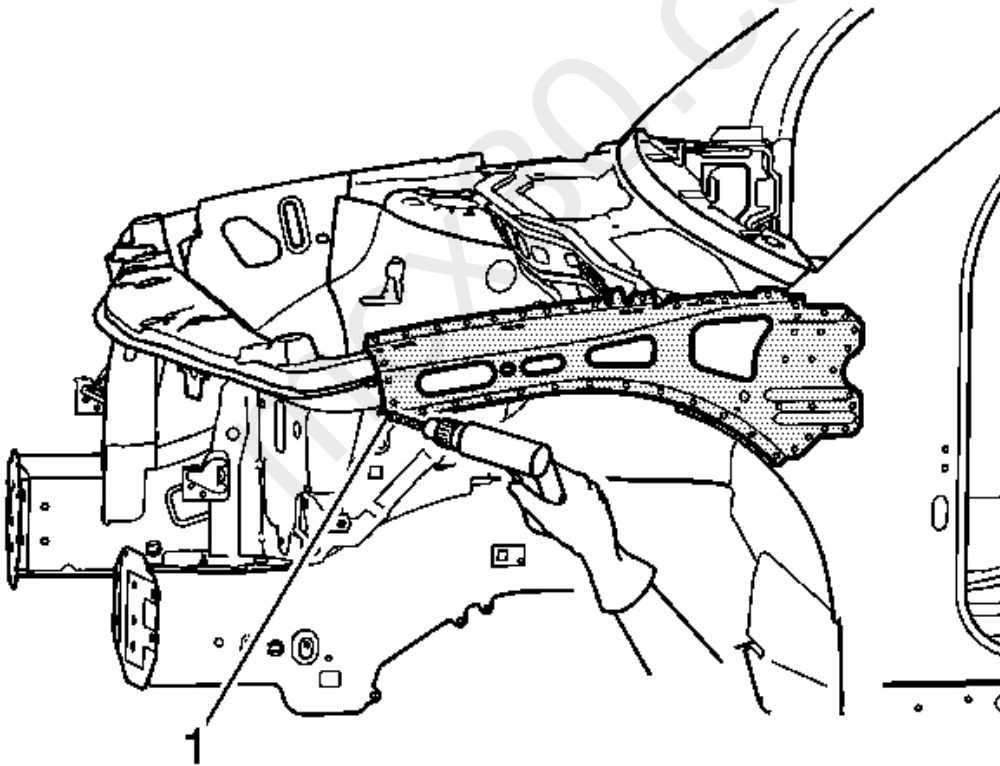
**Fig. 18: Drilling Out Factory Welds**  
Courtesy of GENERAL MOTORS CORP.

**NOTE:** Do not damage any inner panels or reinforcements. Record the number and location of the original welds for installation of the service part.

6. Locate and drill out all factory welds (1).

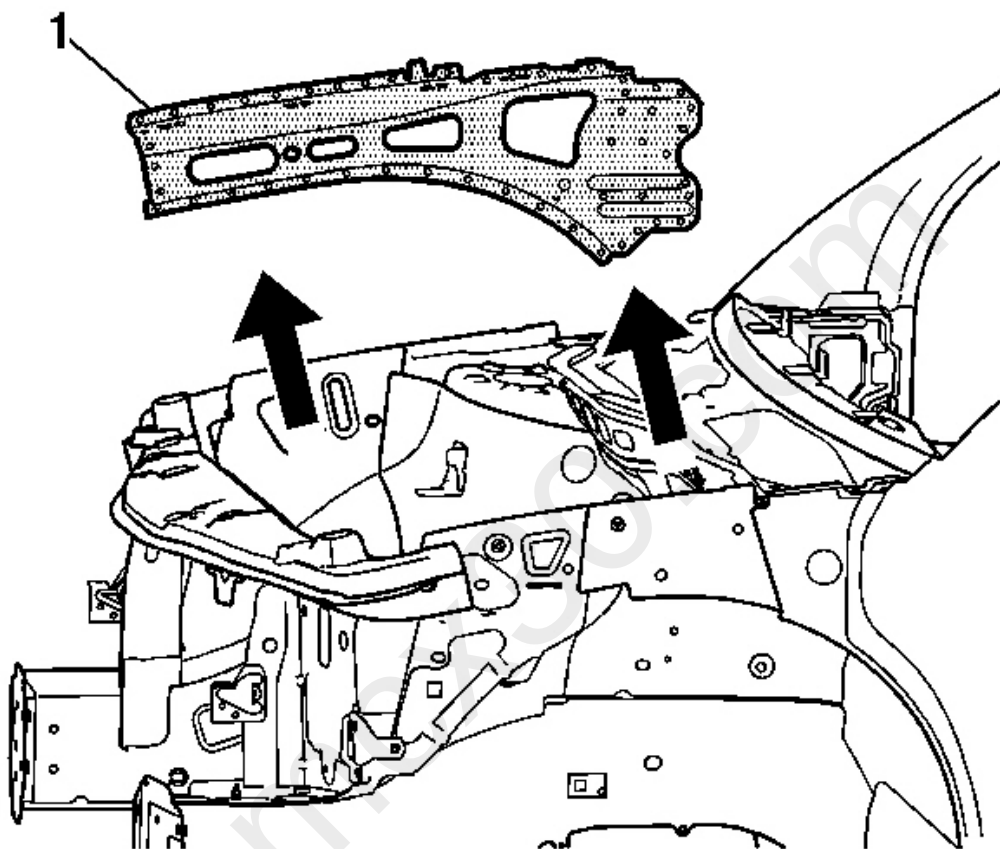
**Fig. 19: Removing Damaged Front Upper Outer Rail**  
Courtesy of GENERAL MOTORS CORP.

7. Remove the damaged front upper outer rail (1).

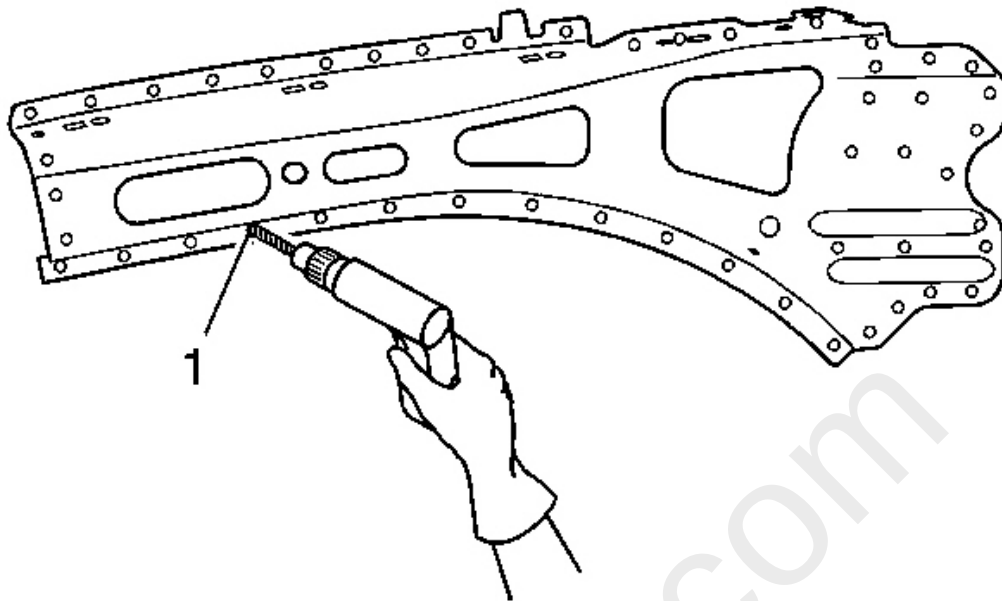
**Fig. 20: Drilling Plug Weld Holes**

1. Drill 8 mm (5/16 in) plug weld holes in the service part as necessary in the locations noted from the original panel (1).
2. Prepare all mating surfaces as necessary.
3. Apply GM-approved Weld-Thru Coating or equivalent to all mating surfaces. Refer to **Anti-Corrosion Treatment and Repair** .

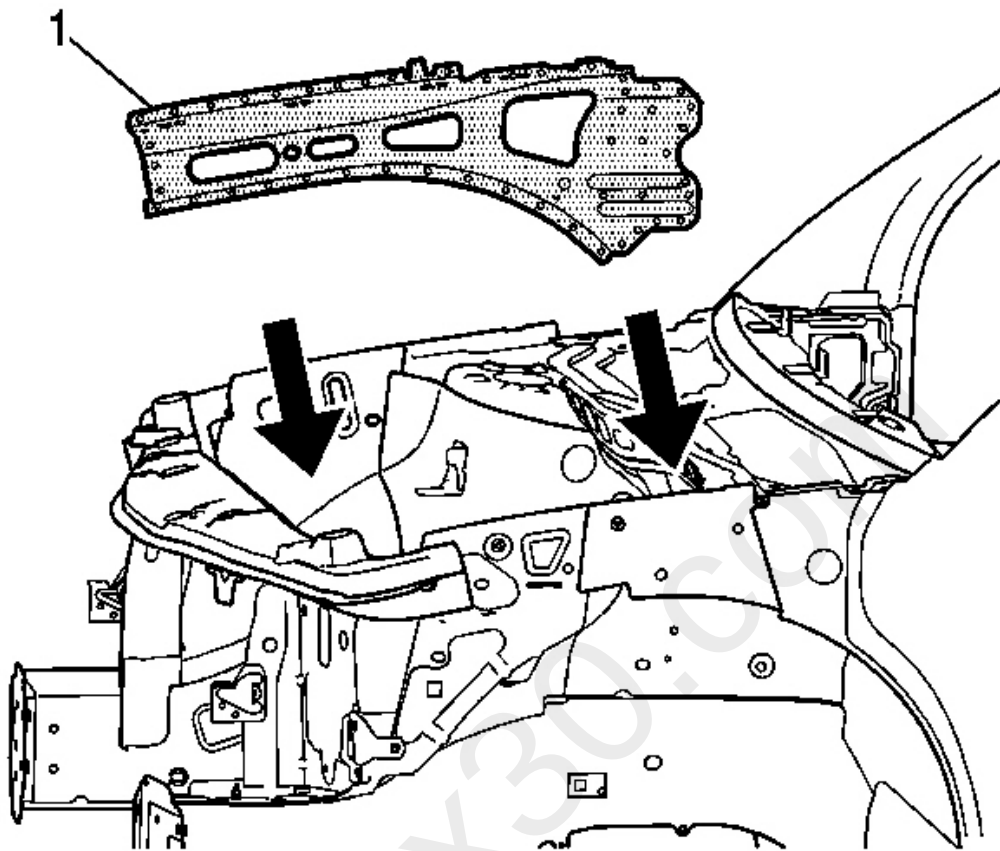
**Fig. 21: Positioning Front Upper Outer Rail**  
**Courtesy of GENERAL MOTORS CORP.**

4. Position the front upper outer rail to the vehicle using 3-dimensional measuring equipment (1). Clamp the front upper outer rail into place.

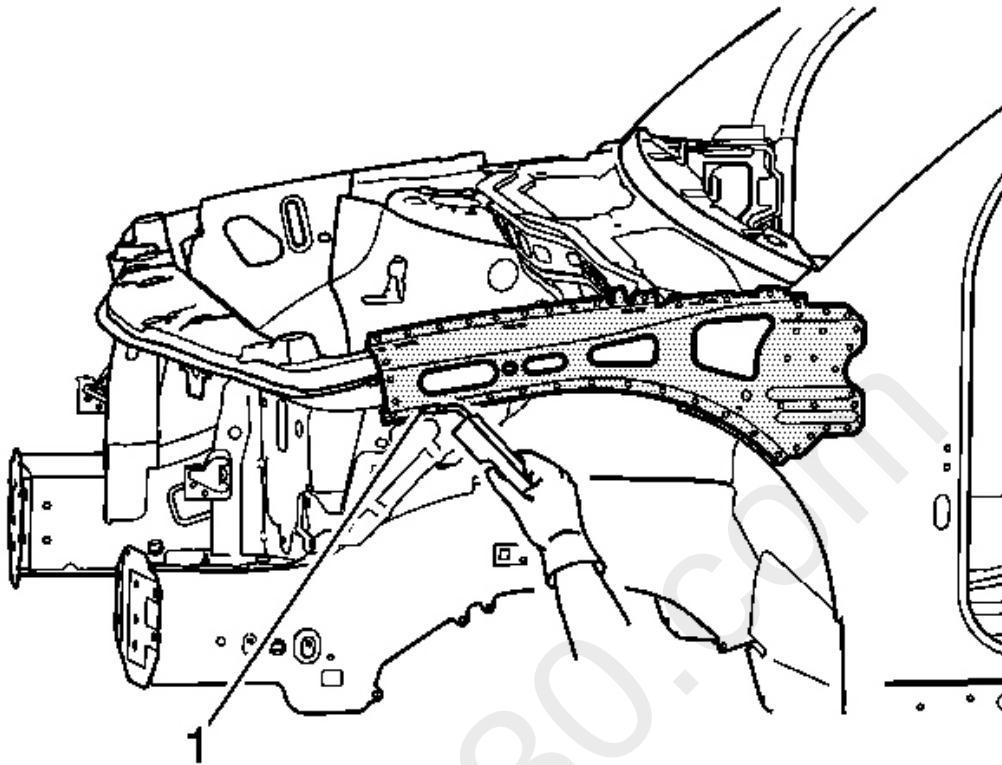
**Fig. 22: Plug Welding**  
**Courtesy of GENERAL MOTORS CORP.**

5. Plug weld accordingly (1).
6. Clean and prepare all welded surfaces.
7. Apply the sealers and anti-corrosion materials to the repair area, as necessary. Refer to **Anti-Corrosion Treatment and Repair** .
8. Paint the repair area. Refer to **Basecoat/Clearcoat Paint Systems** .
9. Install all related panels and components.
10. Connect the negative battery cable. Refer to **Battery Negative Cable Disconnection and Connection** .
11. Enable the SIR system. Refer to **SIR Disabling and Enabling** .

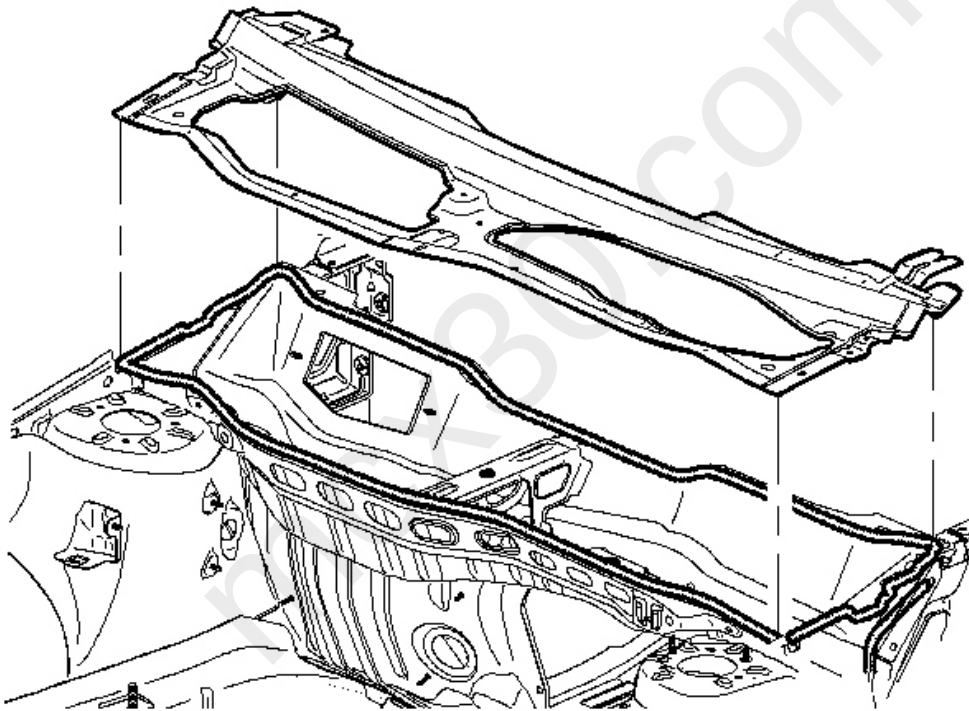
**Fig. 24: View of Plenum Upper Panel**  
Courtesy of GENERAL MOTORS CORP.

**NOTE:** If the location of the original plug weld holes can not be determined, space the plug weld holes every 40 mm (1 1/2 in) apart.

**Some panels may have structural weld-thru adhesive. It is necessary to replace the weld-thru adhesive with an additional spot weld between each factory spot weld.**

1. Drill 8 mm (5/16 in) plug weld holes in the service part as necessary in the locations noted from the original panel.
2. Prepare all mating surfaces as necessary.

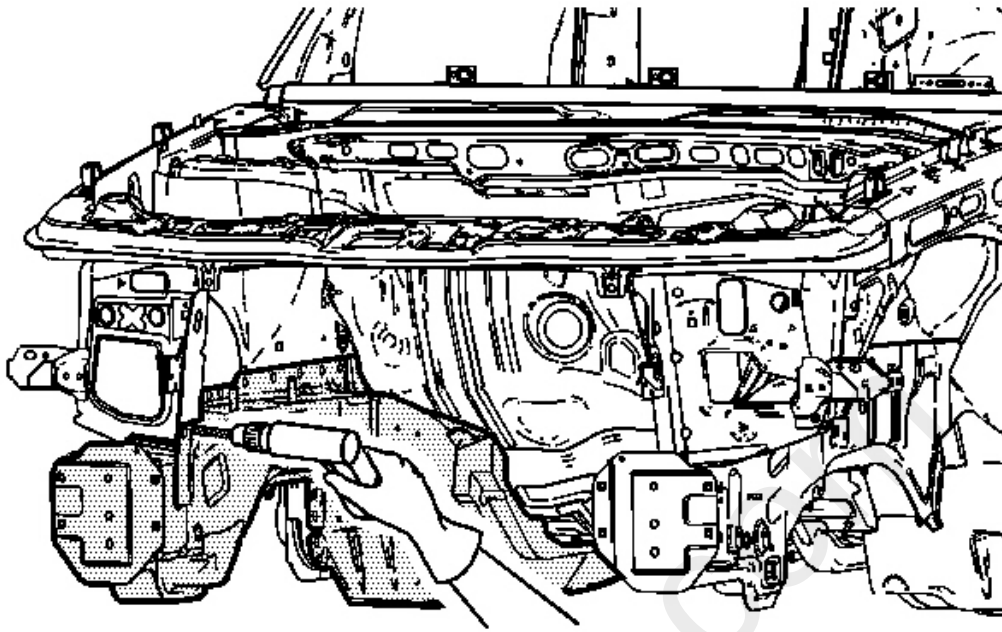
**Fig. 25: Drilling Out Factory Welds On Front Lower Rail**  
Courtesy of GENERAL MOTORS CORP.

6. Locate and drill out all factory welds. Note the number and location of the welds for installation of the front lower rail.

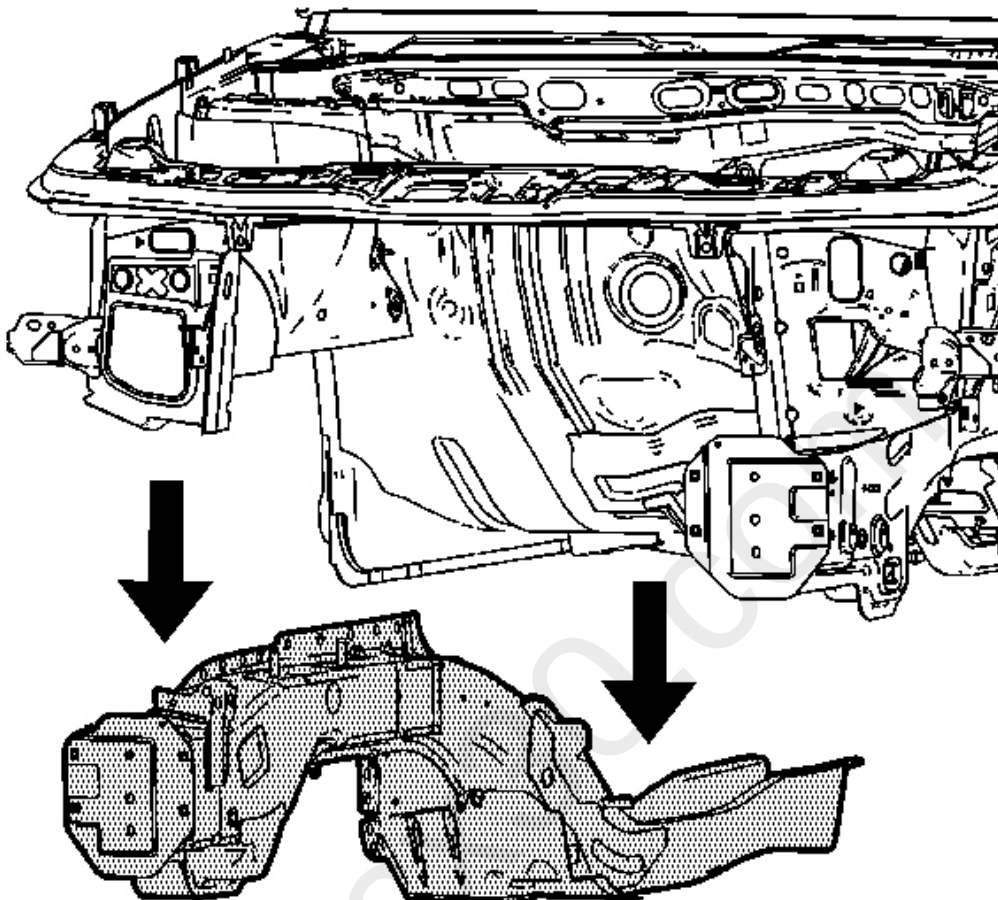
**Fig. 26: View Of Front Lower Rail**  
Courtesy of GENERAL MOTORS CORP.

7. Remove the damaged front lower rail.

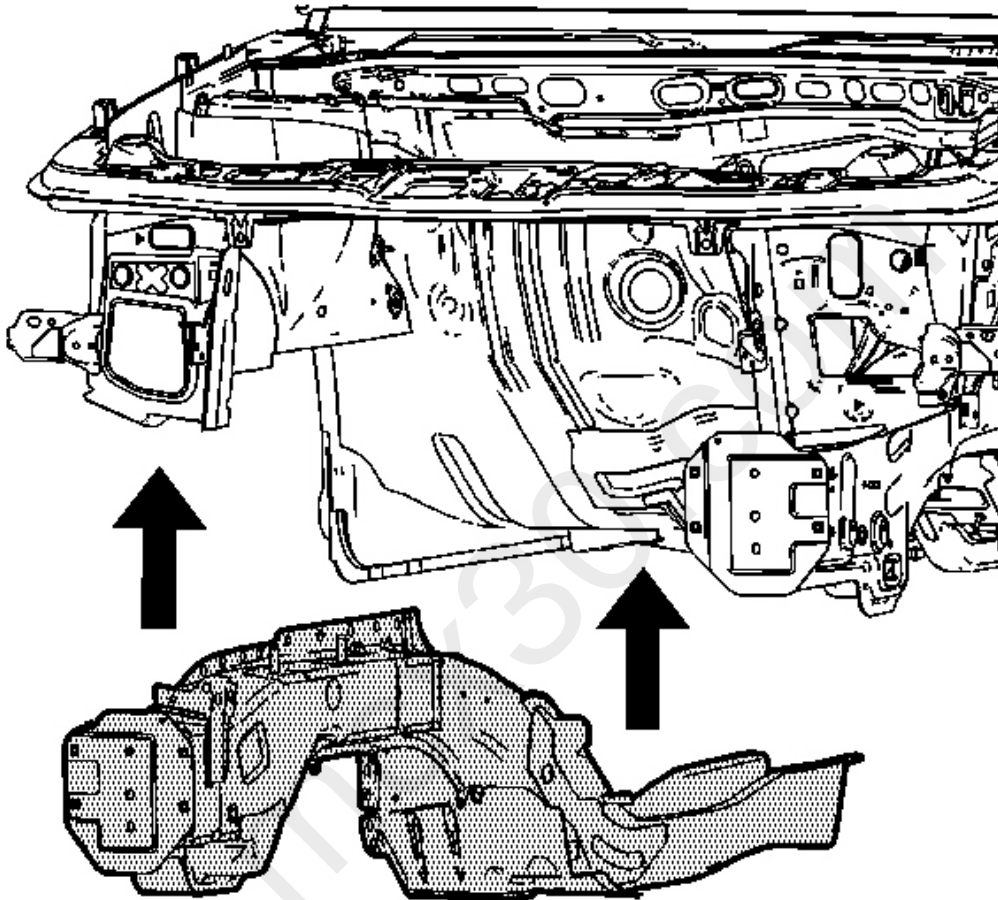
**Fig. 27: Identifying Front Lower Rail**  
**Courtesy of GENERAL MOTORS CORP.**

4. Position the front lower rail to the vehicle using 3-dimensional measuring equipment. Clamp the front lower rail into place.

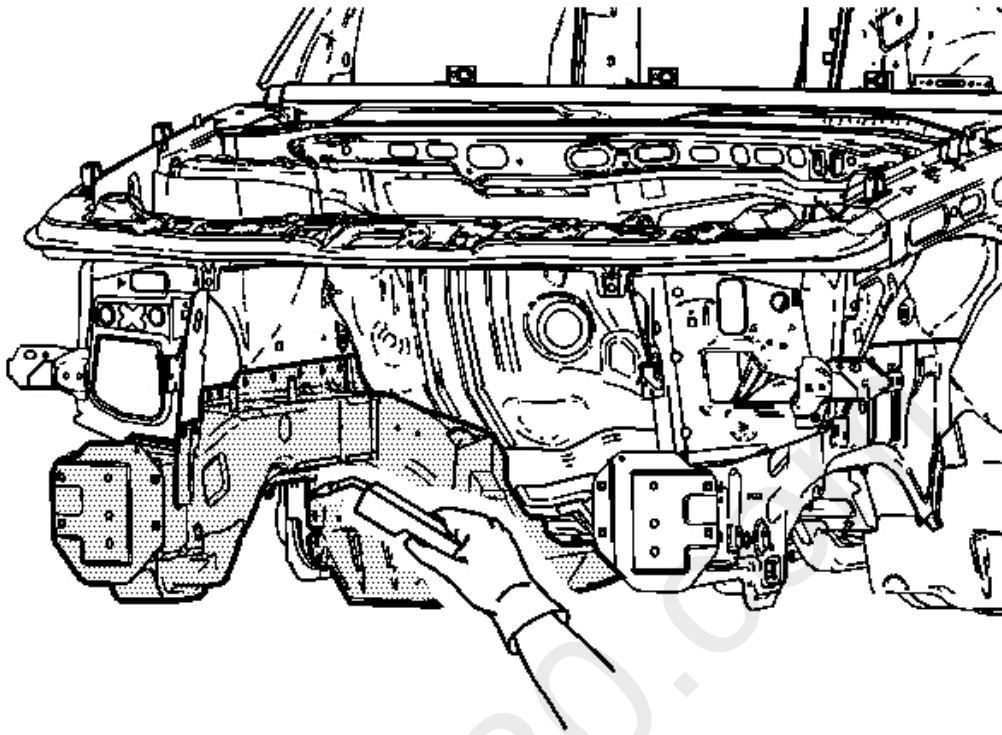
**Fig. 28: Plug Welding Front Lower Rail**  
Courtesy of GENERAL MOTORS CORP.

5. Plug weld accordingly.
6. Clean and prepare all welded surfaces.
7. Apply the sealers and anti-corrosion materials to the repair area, as necessary. Refer to **Anti-Corrosion Treatment and Repair** .
8. Paint the repair area. Refer to **Basecoat/Clearcoat Paint Systems** .
9. Install all related panels and components.
10. Connect the negative battery cable. Refer to **Battery Negative Cable Disconnection and Connection** .
11. Enable the SIR system. Refer to **SIR Disabling and Enabling** .

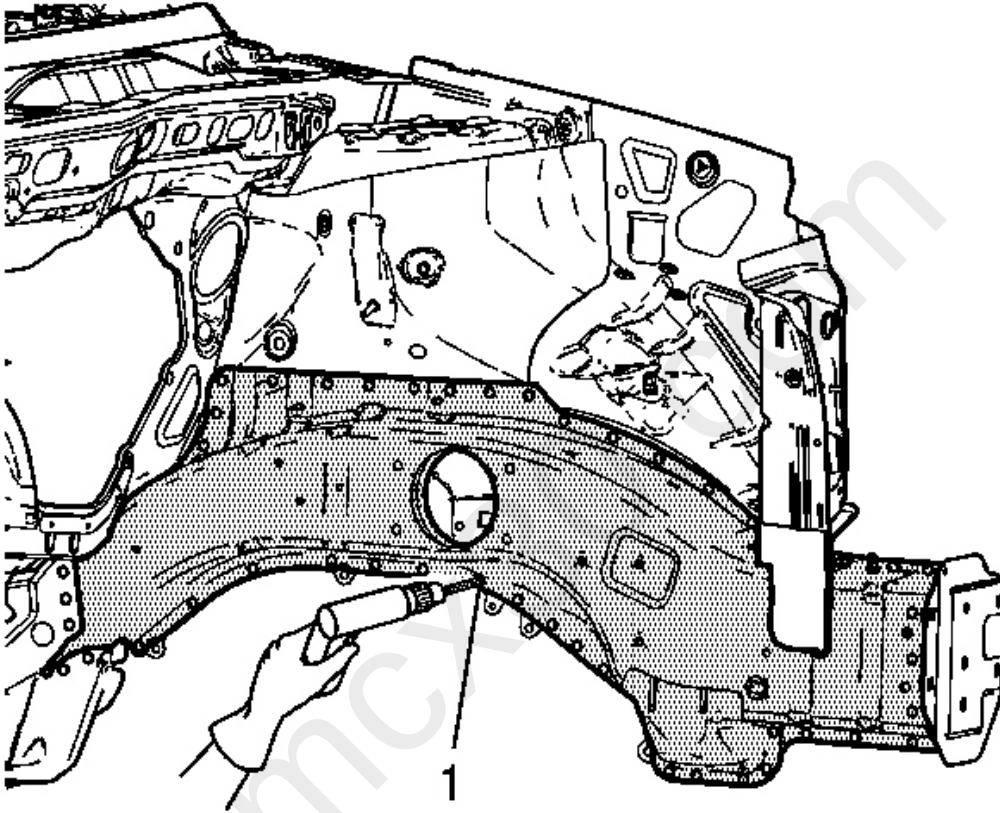
**Fig. 30: Drilling Out Factory Welds**  
Courtesy of GENERAL MOTORS CORP.

**NOTE:** Do not damage any inner panels or reinforcements. Record the number and location of the original welds for installation of the service part.

6. Locate and drill out all factory welds (1).
7. Remove the rear engine cradle mount.
8. Separate the front and rear sections of the tower rail. Care must be taken not to damage the inner side plate.
