## 2010 ACCESSORIES & EQUIPMENT

### Collision Repair - Equinox & Terrain

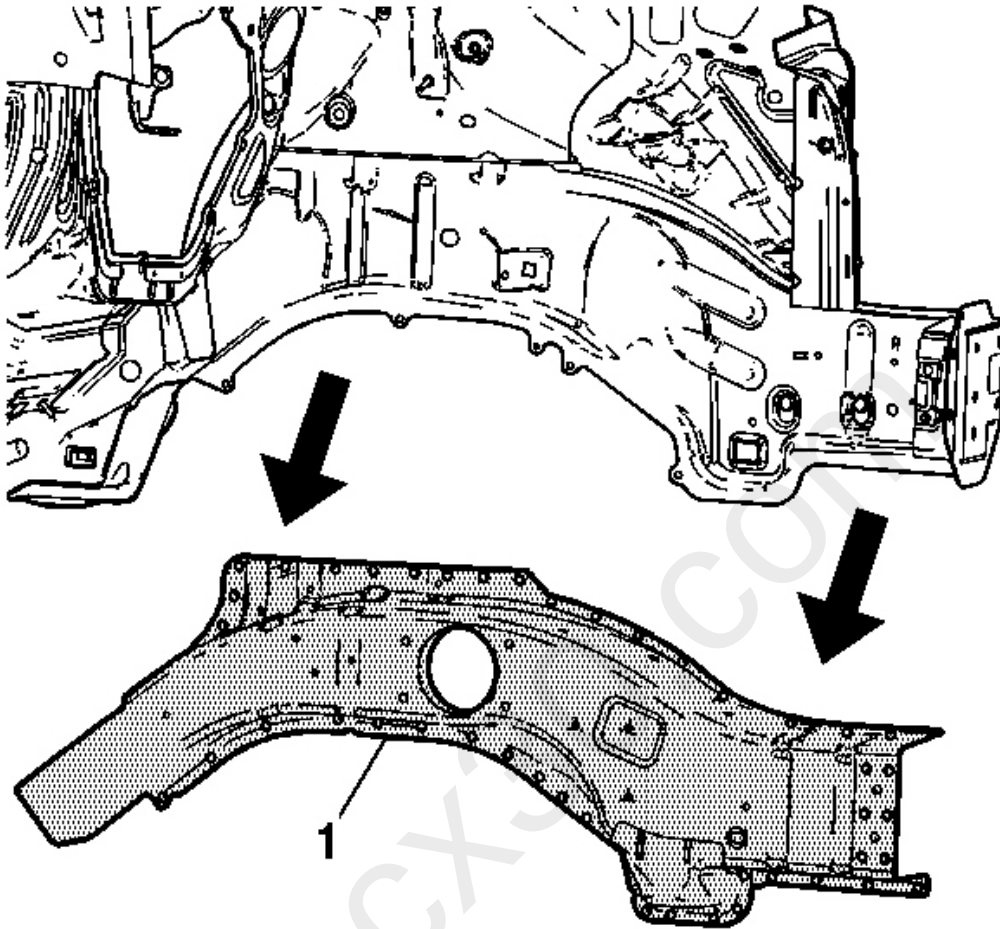
**Fig. 31: Identifying Front Lower Inner Rail - Front Half**  
Courtesy of GENERAL MOTORS CORP.

9. Remove the damaged front lower inner rail - front half (1).

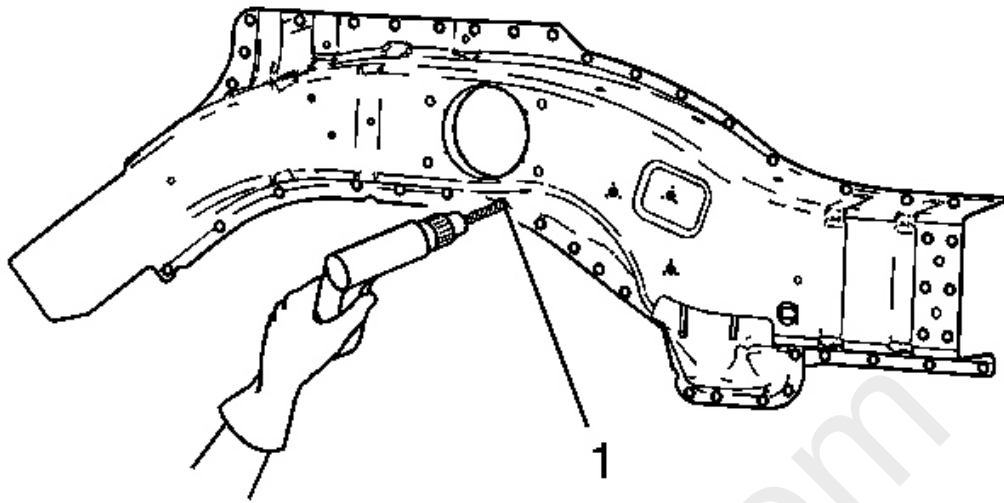
**Fig. 32: Drilling Plug Weld Holes**  
Courtesy of GENERAL MOTORS CORP.

**NOTE:** If the location of the original plug welds cannot be determined or structural weld- thru adhesive was present, space plug weld holes every 40 mm (1 1/2 in) apart.

1. Drill 8 mm (5/16 in) plug weld holes in the service part as necessary in the locations noted from the original panel (1).
2. Prepare all mating surfaces as necessary.
3. Apply GM-approved Weld-Thru Coating or equivalent to all mating surfaces. Refer to **Anti-Corrosion Treatment and Repair** .

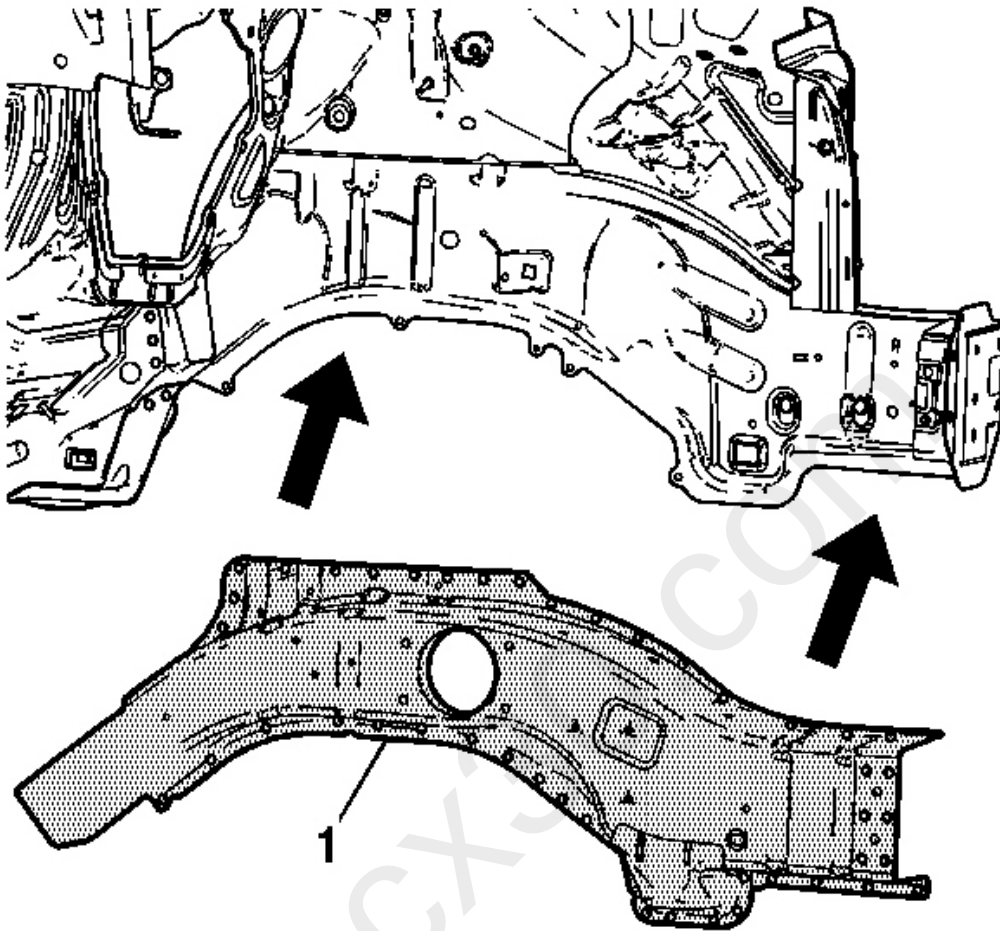
**Fig. 33: Positioning Front Lower Inner Rail - Front Half**  
Courtesy of GENERAL MOTORS CORP.

4. Position the front lower inner rail - front half to the vehicle using 3-dimensional measuring equipment (1). Clamp the front lower inner rail - front half into place.

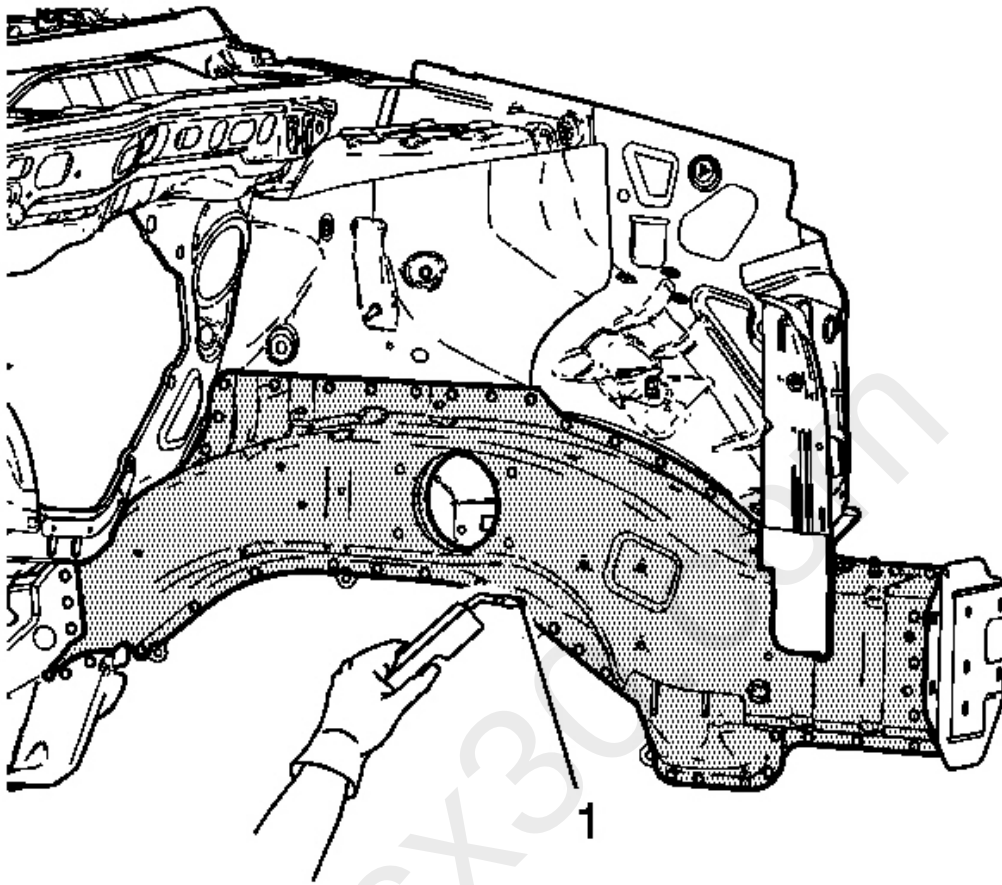
**Fig. 34: Plug Welding**  
Courtesy of GENERAL MOTORS CORP.

5. Plug weld accordingly (1).
6. Install the rear engine cradle mount.
7. Clean and prepare all welded surfaces.
8. Apply the sealers and anti-corrosion materials to the repair area, as necessary. Refer to **Anti-Corrosion Treatment and Repair** .
9. Paint the repair area. Refer to **Basecoat/Clearcoat Paint Systems** .
10. Install all related panels and components.
11. Connect the negative battery cable. Refer to **Battery Negative Cable Disconnection and Connection** .
12. Enable the SIR system. Refer to **SIR Disabling and Enabling** .

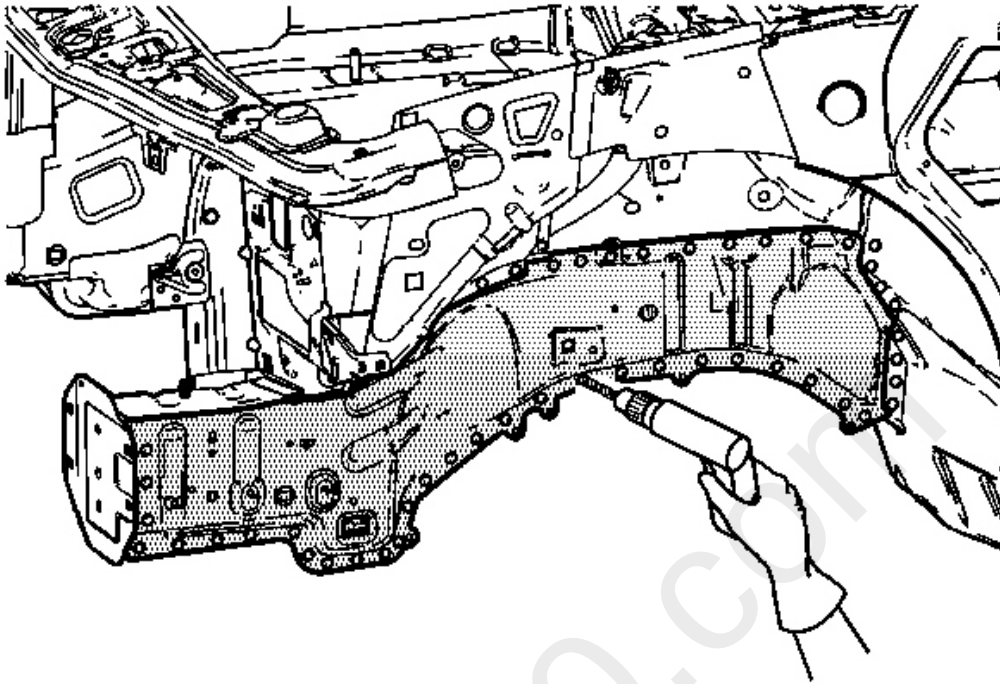
**Fig. 36: Drilling Out Factory Welds On Front Lower Outer Rail**  
Courtesy of GENERAL MOTORS CORP.

**NOTE:** Do not damage any inner panels or reinforcements.

6. Locate and drill out all factory welds. Note the number and location of the welds for installation of the front lower outer rail.
7. Remove the rear engine cradle mount.

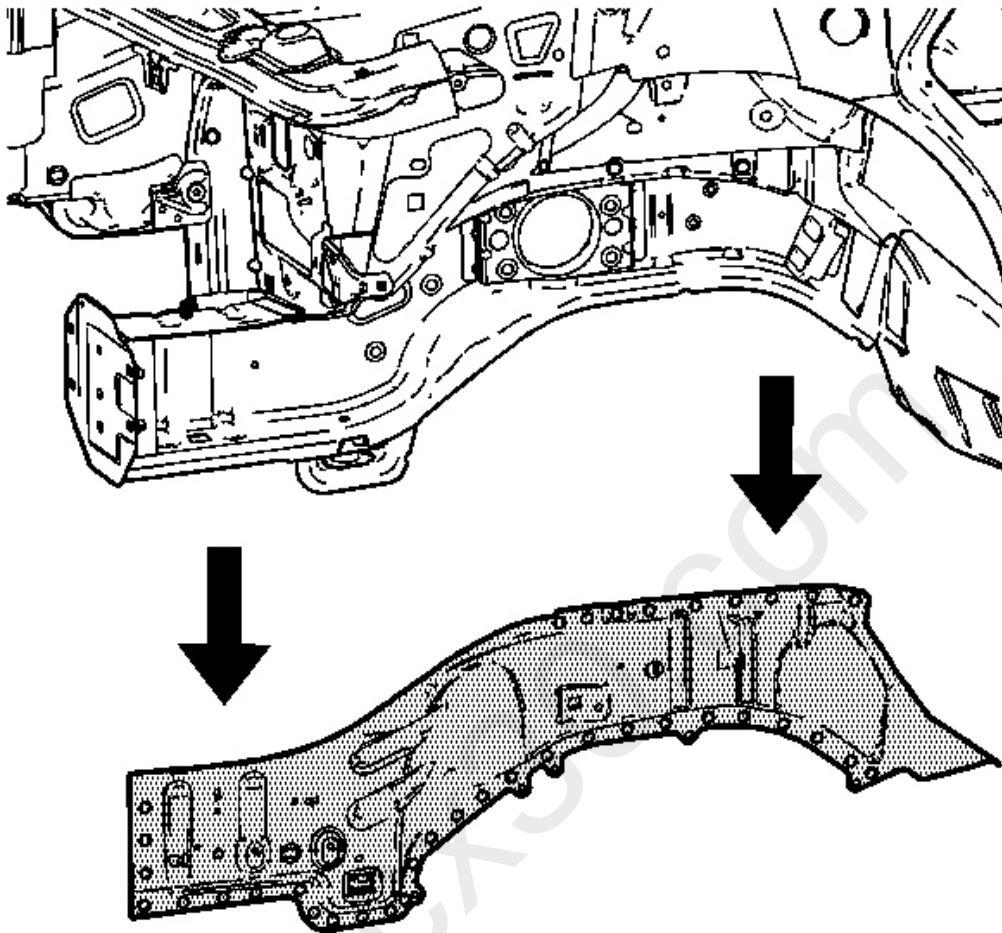
**Fig. 37: View Of Front Lower Outer Rail**  
Courtesy of GENERAL MOTORS CORP.

8. Remove the damaged front lower outer rail.

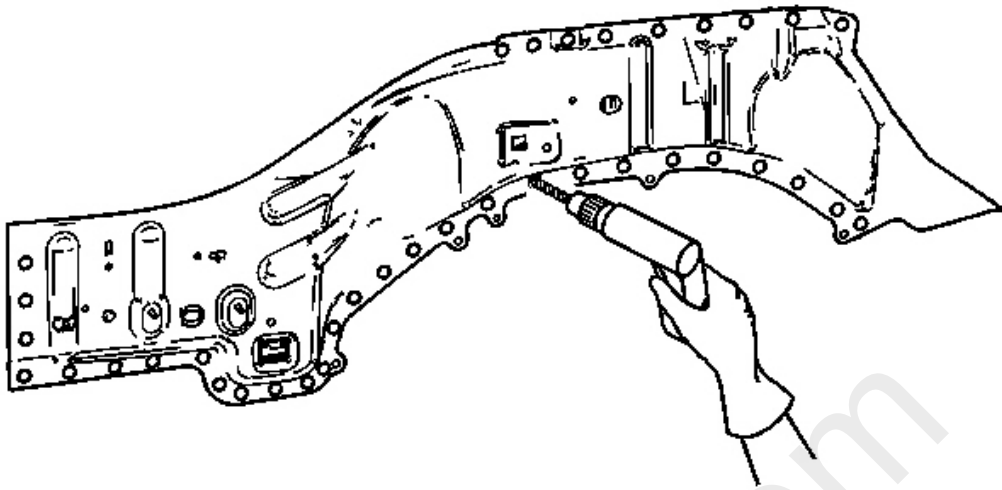
**Fig. 38: Drilling Plug Weld Holes On Front Lower Outer Rail**  
Courtesy of GENERAL MOTORS CORP.

**NOTE:** If the location of the original plug weld holes can not be determined, space the plug weld holes every 40 mm (1 1/2 in) apart.  
Some panels may have structural weld-thru adhesive. It is necessary to replace the weld-thru adhesive with an additional spot weld between each factory spot weld.

1. Drill 8 mm (5/16 in) plug weld holes in the service part as necessary in the locations noted from the original panel.
2. Prepare all mating surfaces as necessary.
3. Apply GM-approved Weld-Thru Coating or equivalent to all mating surfaces. Refer to **Anti-Corrosion Treatment and Repair** .

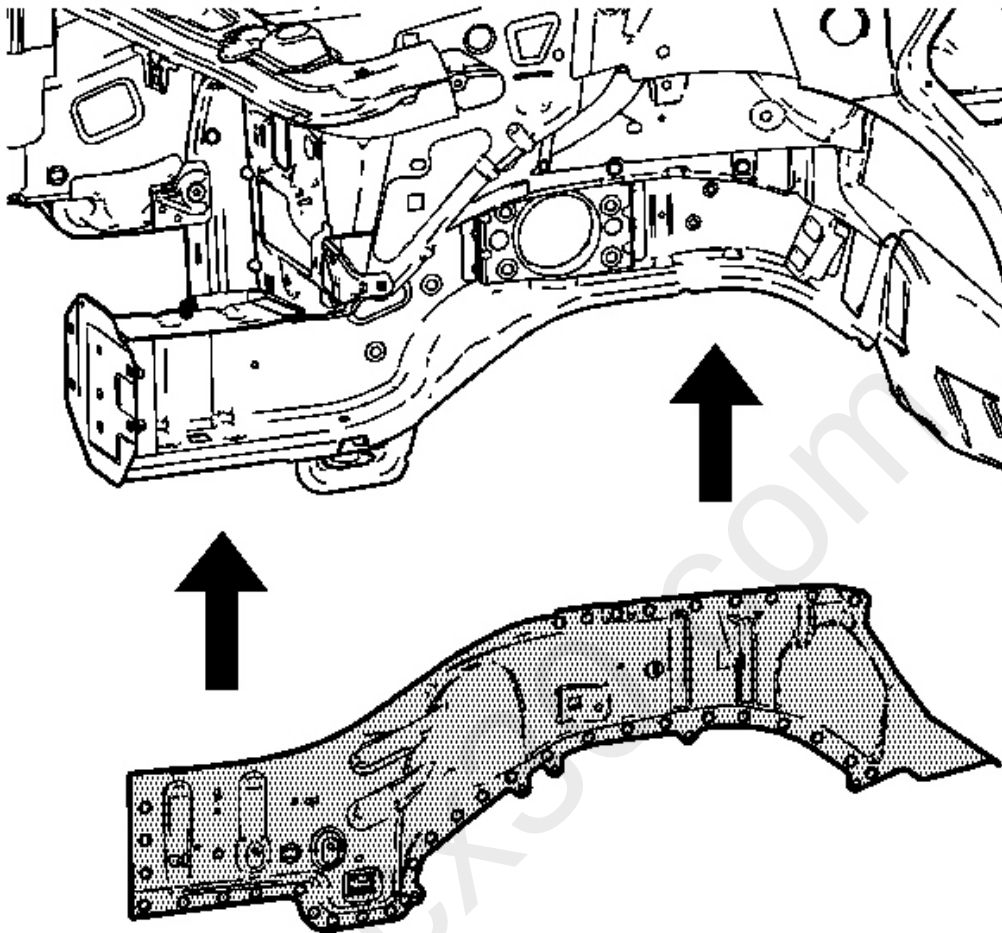
**Fig. 39: Locating Front Lower Outer Rail**  
Courtesy of GENERAL MOTORS CORP.

4. Position the front lower outer rail to the vehicle using 3-dimensional measuring equipment. Clamp the front lower outer rail into place.

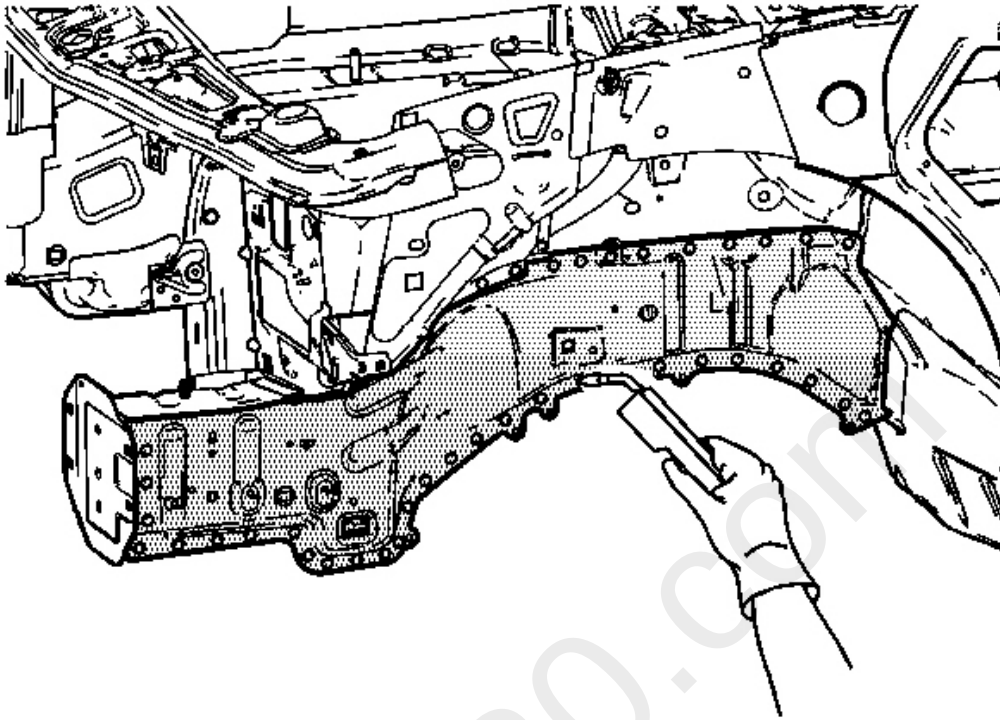
**Fig. 40: Plug Welding Front Lower Outer Rail**  
**Courtesy of GENERAL MOTORS CORP.**

5. Plug weld accordingly.
6. Install the rear engine cradle mount.
7. Clean and prepare all welded surfaces.
8. Apply the sealers and anti-corrosion materials to the repair area, as necessary. Refer to **Anti-Corrosion Treatment and Repair** .
9. Paint the repair area. Refer to **Basecoat/Clearcoat Paint Systems** .
10. Install all related panels and components.
11. Connect the negative battery cable. Refer to **Battery Negative Cable Disconnection and Connection** .
12. Enable the SIR system. Refer to **SIR Disabling and Enabling** .

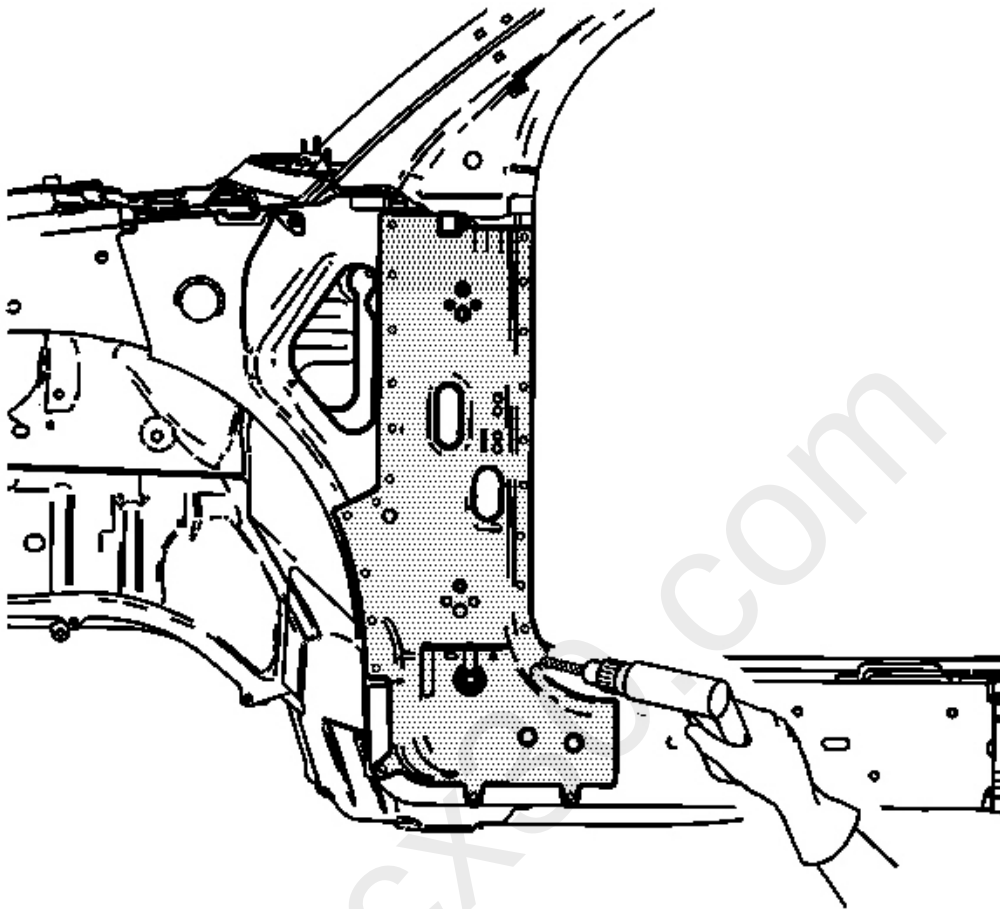
**Fig. 42: Drilling Out Factory Welds On Hinge Pillar Inner Reinforcement**  
Courtesy of GENERAL MOTORS CORP.

**NOTE:** Do not damage any inner panels or reinforcements.

7. Locate and drill out all factory welds. Note the number and location of the welds for installation of the hinge pillar inner reinforcement.

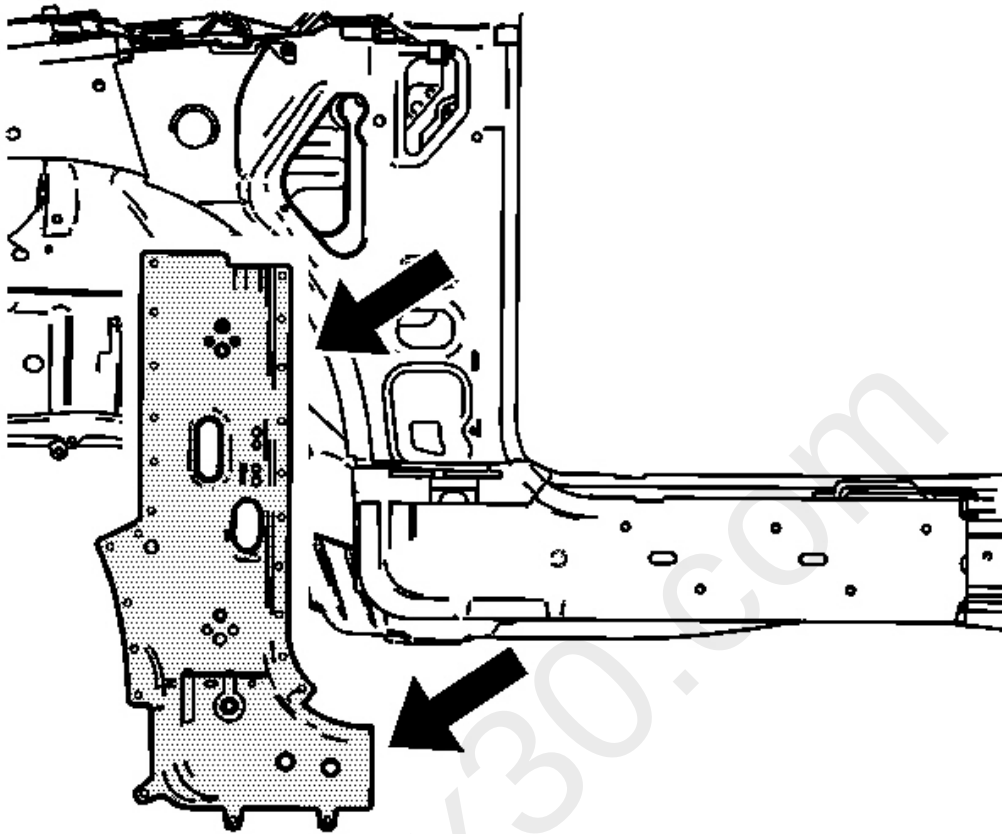
**Fig. 43: View Of Hinge Pillar Inner Reinforcement**  
Courtesy of GENERAL MOTORS CORP.

8. Remove the damaged hinge pillar inner reinforcement.

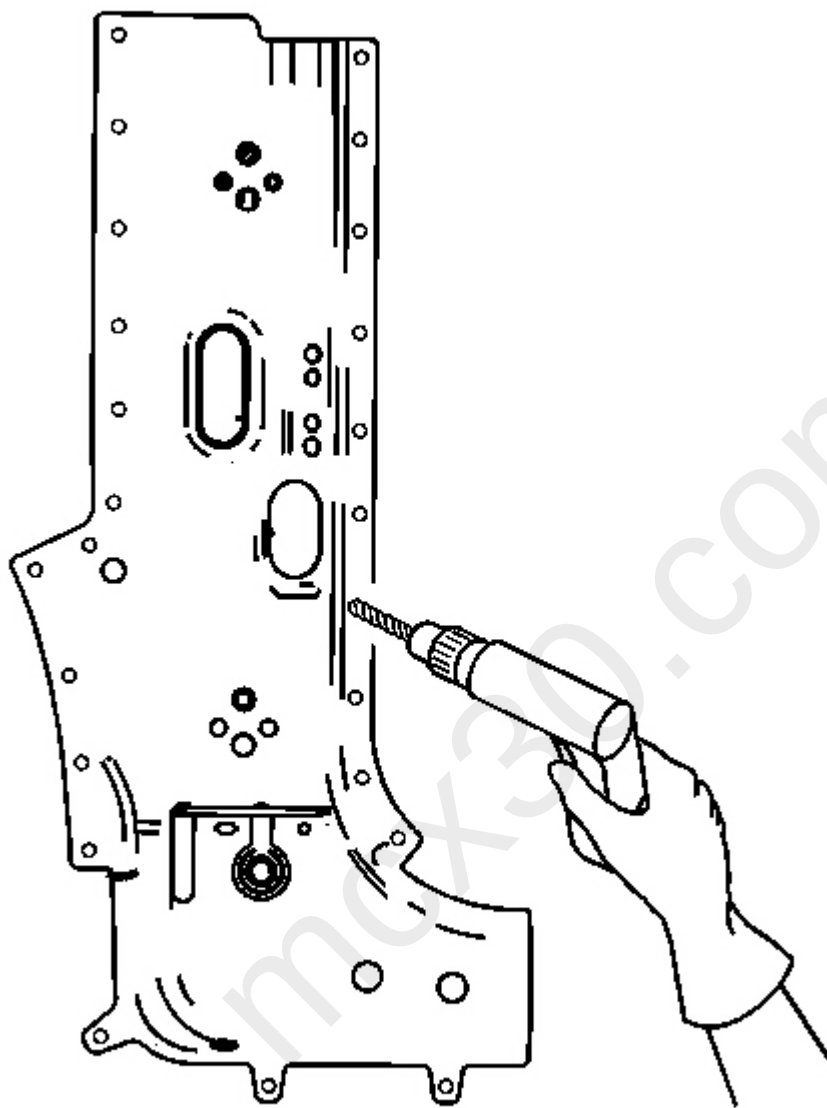
**Fig. 44: Drilling Out Plug Weld Holes On Hinge Pillar Inner Reinforcement**  
Courtesy of GENERAL MOTORS CORP.

**NOTE:** If the location of the original plug weld holes can not be determined, space the plug weld holes every 40 mm (1 1/2 in) apart.  
Some panels may have structural weld-thru adhesive. It is necessary to replace the weld-thru adhesive with an additional spot weld between each factory spot weld.

1. Drill 8 mm (5/16 in) plug weld holes in the service part as necessary in the locations noted from the original panel.
2. Prepare all mating surfaces as necessary.
3. Apply GM-approved Weld-Thru Coating or equivalent to all mating surfaces. Refer to **Anti-Corrosion Treatment and Repair** .

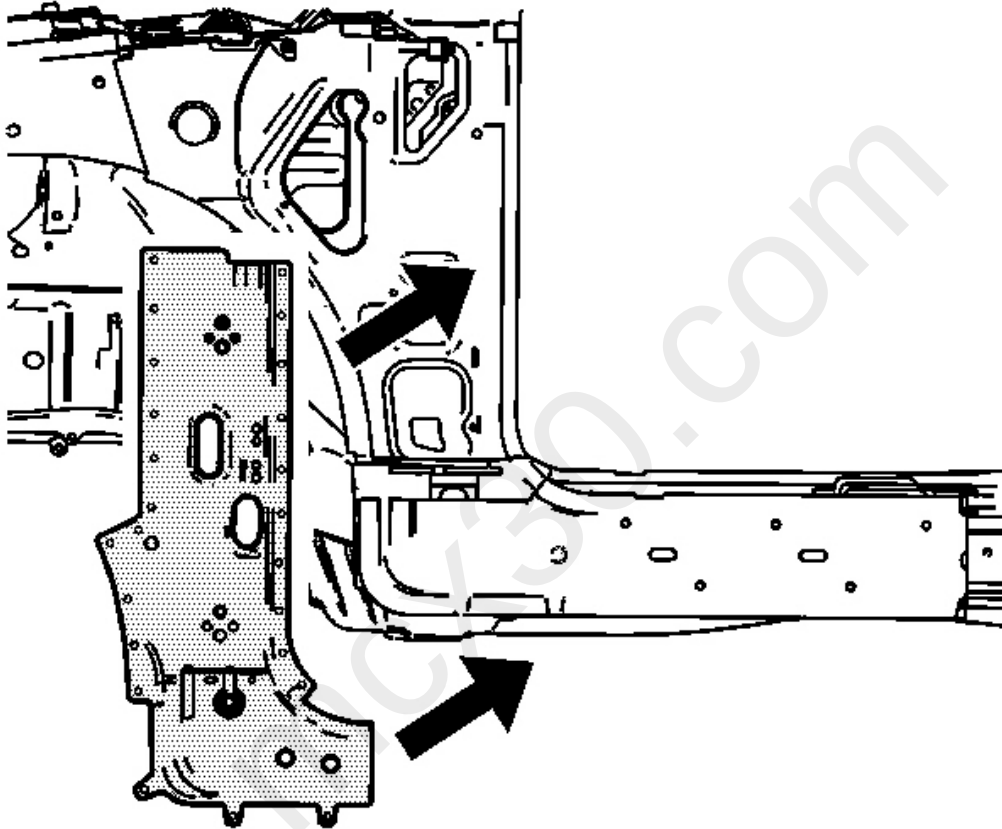
**Fig. 45: Positioning Hinge Pillar Inner Reinforcement**  
**Courtesy of GENERAL MOTORS CORP.**

4. Position the hinge pillar inner reinforcement to the vehicle using 3-dimensional measuring equipment. Clamp the hinge pillar inner reinforcement into place.

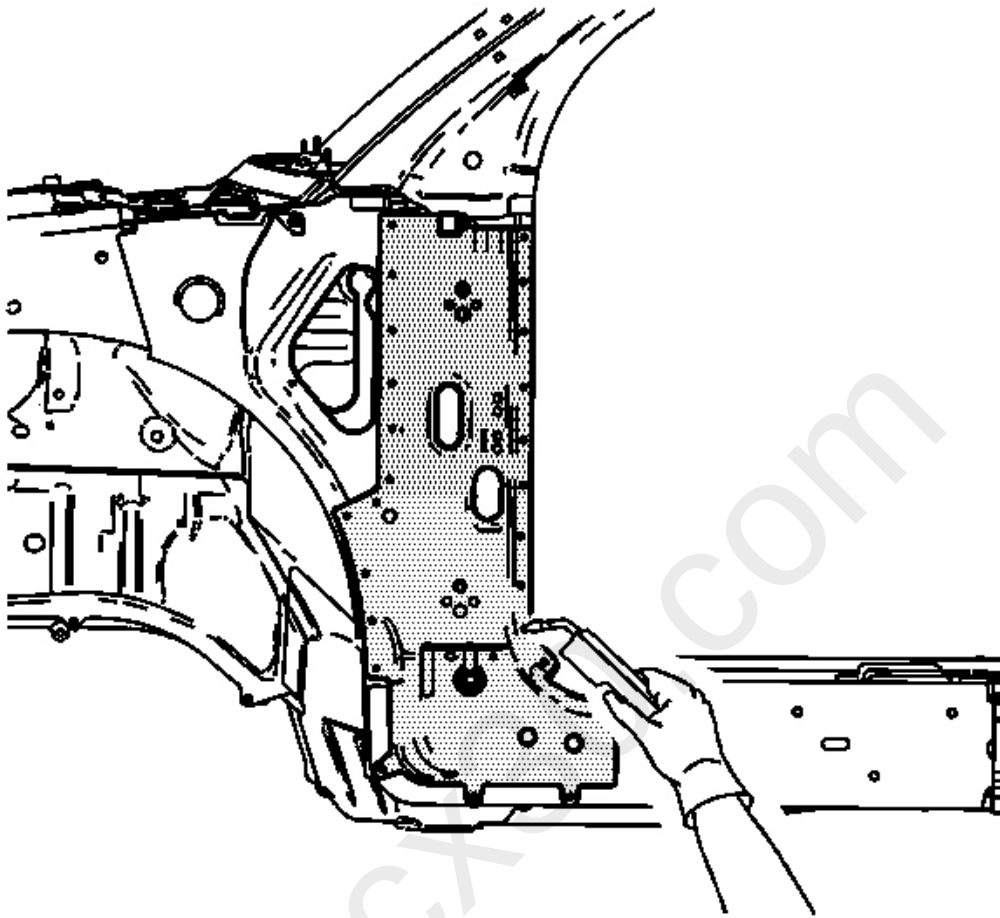
**Fig. 46: Plug Welding Hinge Pillar Inner Reinforcement**  
**Courtesy of GENERAL MOTORS CORP.**

5. Plug weld accordingly.
6. Clean and prepare all welded surfaces.
7. Install the new body side section.
8. Apply the sealers and anti-corrosion materials to the repair area, as necessary. Refer to **Anti-Corrosion Treatment and Repair** .
9. Paint the repair area. Refer to **Basecoat/Clearcoat Paint Systems** .
10. Install all related panels and components.
11. Connect the negative battery cable. Refer to **Battery Negative Cable Disconnection and Connection** .
12. Enable the SIR system. Refer to **SIR Disabling and Enabling** .

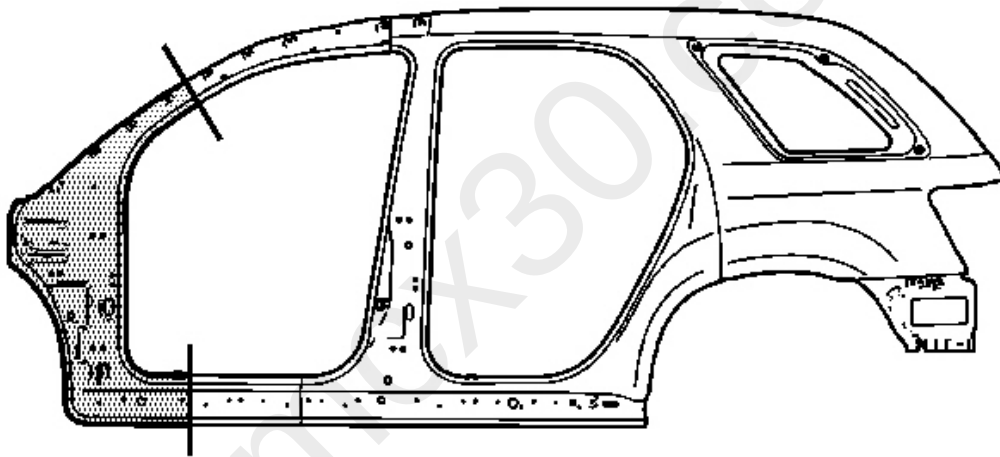
**NOTE:** Section in specified areas only. Sectioning outside of these areas may compromise the structural integrity of the vehicle. The door frame can be replaced at factory seams, but requires the removal of the windshield and the roof. The sectioning procedures have been developed as a more cost-effective alternative to complete replacement. The specific area to be sectioned is determined by the extent of the damage to the vehicle.

**Fig. 47: View Of Front Hinge Pillar Body Sectioning**  
Courtesy of GENERAL MOTORS CORP.

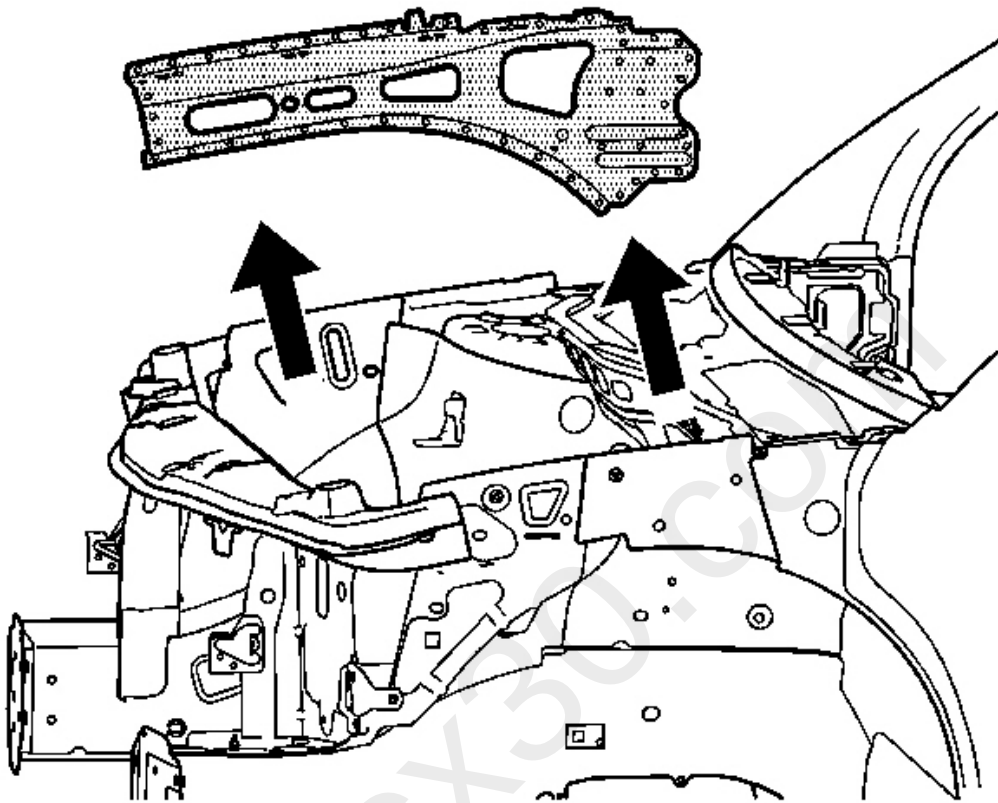
**Fig. 48: View Of Front Upper Outer Rail**  
Courtesy of GENERAL MOTORS CORP.

6. Drill spot welds and remove the front upper outer rail.

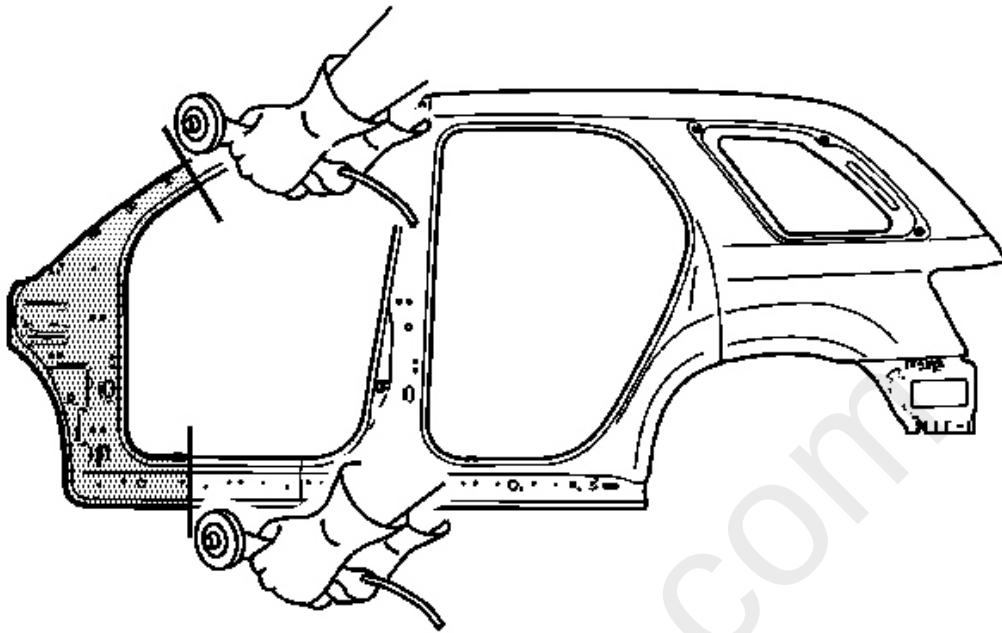
**Fig. 49: Cutting Front Hinge Pillar Body Sectioning Panel**  
Courtesy of GENERAL MOTORS CORP.

1. Cut the replacement windshield pillar section in corresponding locations to fit the original panel. The sectioning joint should be trimmed to allow 1 1/2 times the metal thickness at the sectioning joint.

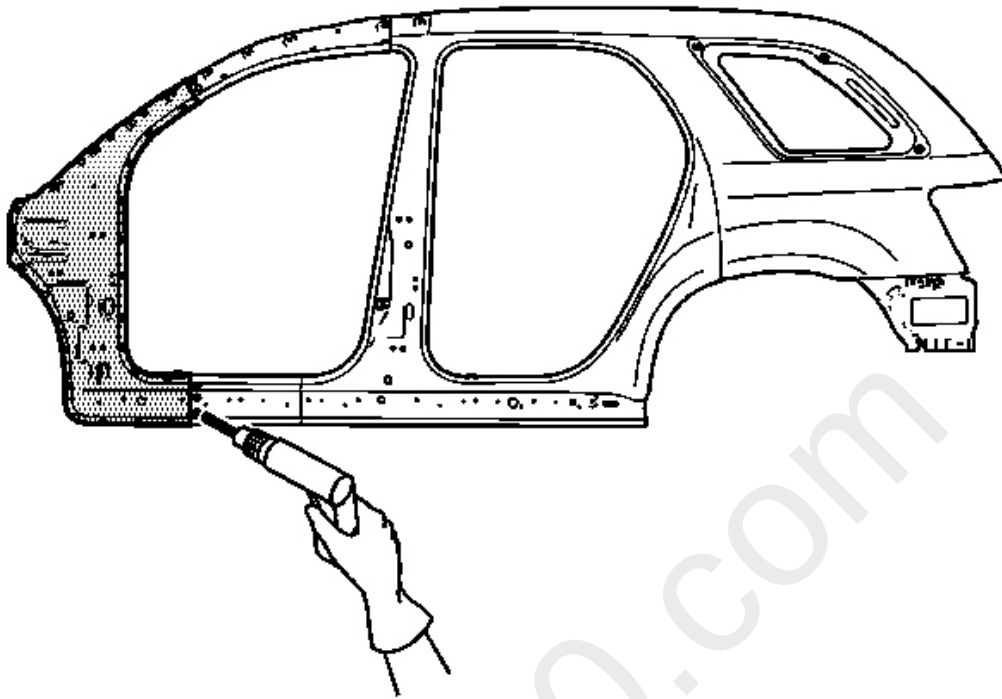
**Fig. 50: Drilling Out Factory Welds On Front Hinge Pillar Body**  
**Courtesy of GENERAL MOTORS CORP.**

8. Locate and drill out all factory welds. Note the number and location of the welds for installations of the service part.
9. Remove the damaged windshield pillar section.

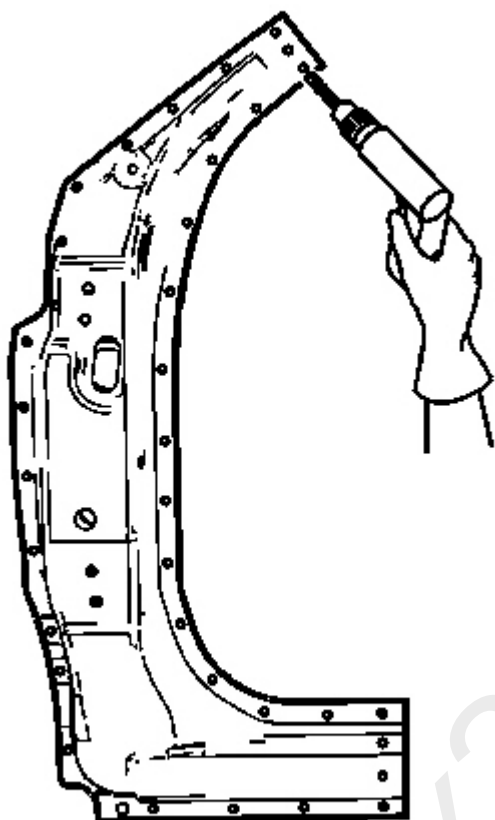
**Fig. 52: Drilling Windshield Frame Pillar Plug Weld Holes**  
Courtesy of GENERAL MOTORS CORP.

2. Create a 50 mm (2 in) backing plate (1) from the unused portion of the service part. Trim the backing plate as necessary to fit behind the sectioning joint where there is no reinforcement.
3. Drill 8 mm (5/16 in) plug weld holes along the sectioning cut on the remaining original part. Locate these holes 13 mm (1/2 in) from the edge and spaced 40 mm (1 1/2 in) apart.

4. Drill 8 mm (5/16 in) plug weld holes in the service part as necessary in the locations noted from the original panel and along the sectioning cut.
5. Prepare all mating surfaces, as necessary.
6. Apply GM-approved Weld-Thru Coating or equivalent to all mating surfaces. Refer to **Anti-Corrosion Treatment and Repair**.

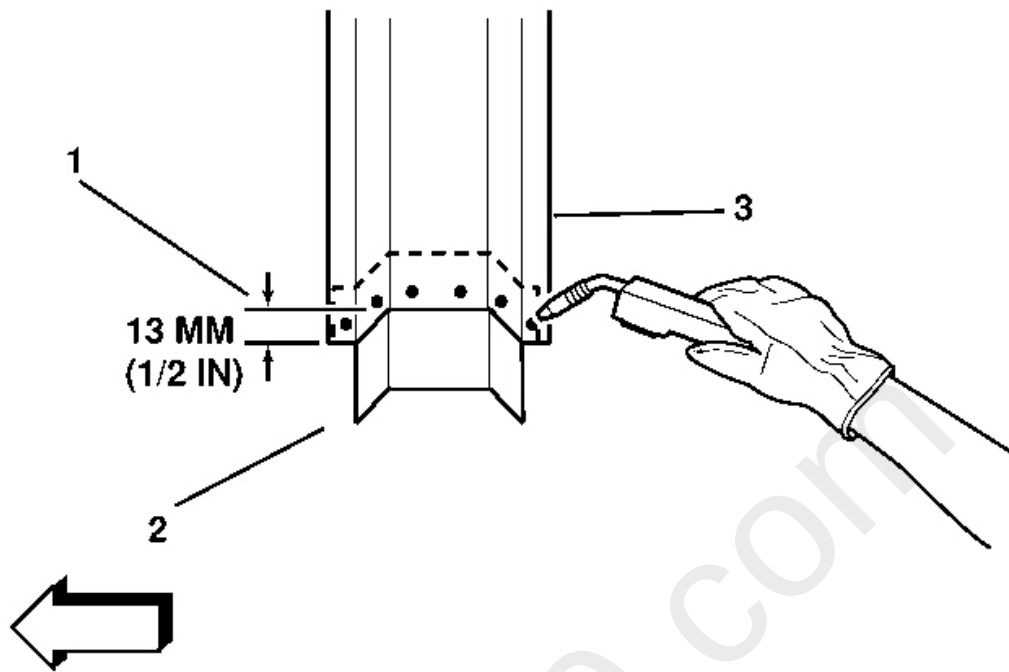
**Fig. 53: Plug Welding Backing Plate**  
**Courtesy of GENERAL MOTORS CORP.**

7. Fit the backing plate (2) halfway into the sectioning joint, clamp and plug weld to the vehicle.
8. Position the service part.

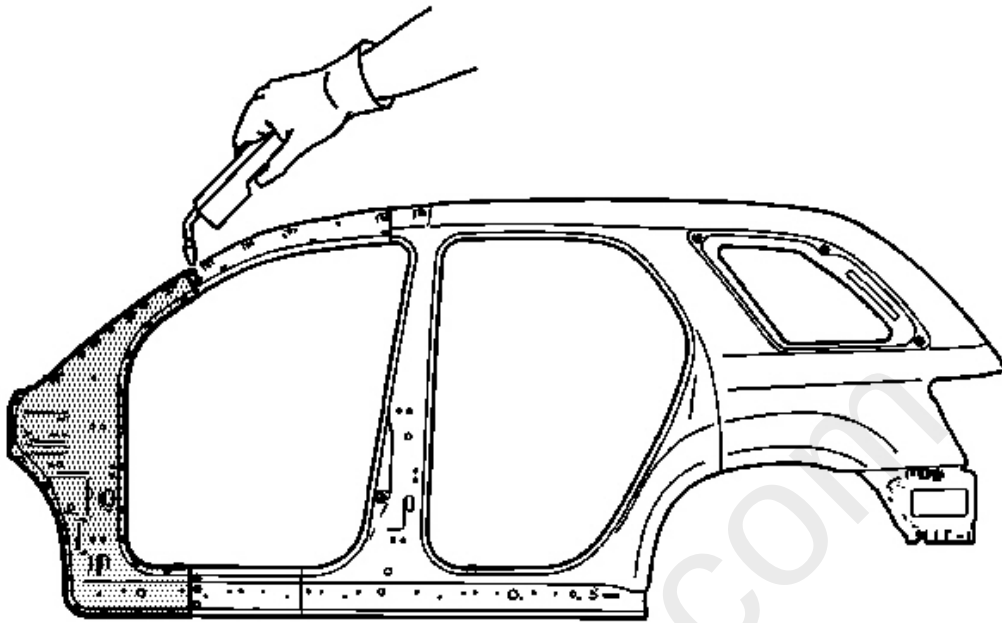
**Fig. 54: Plug Welding Front Hinge Pillar Body**  
Courtesy of GENERAL MOTORS CORP.

9. Plug weld accordingly.

**NOTE:** To create a solid weld with minimum heat distortion make 25 mm (1 in) stitch welds along the seam with 25 mm (1 in) gaps between. Then go back and complete the stitch weld.

10. Stitch weld the sectioning joint.
11. Clean and prepare all welded surfaces.

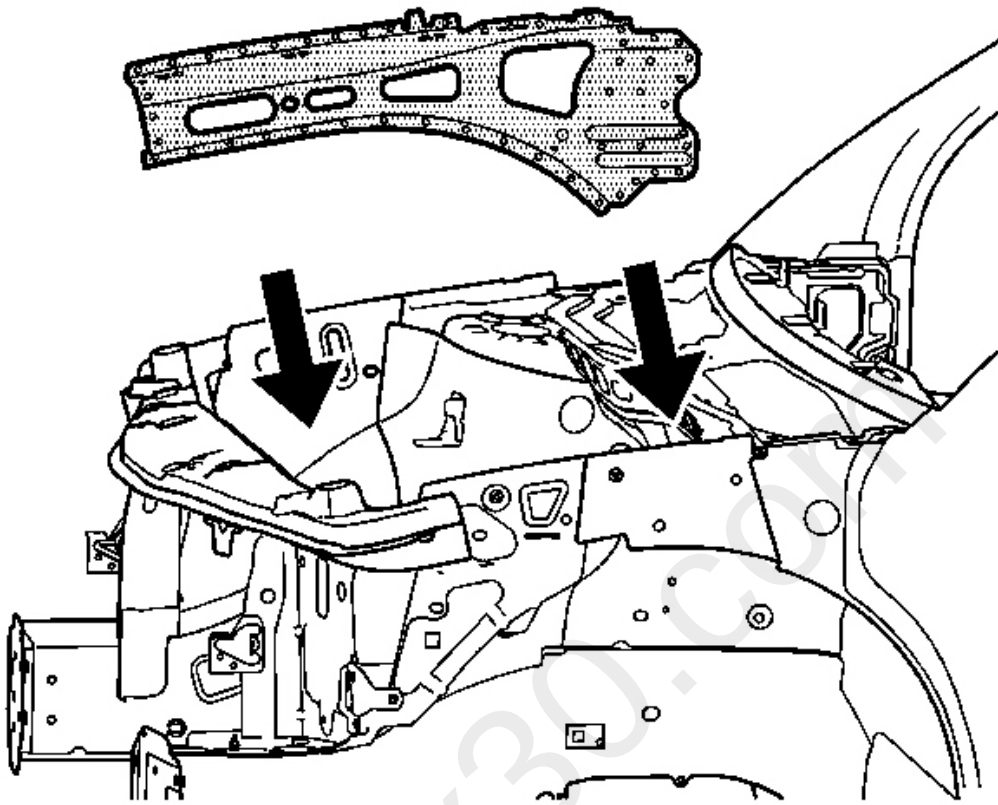
**Fig. 55: Identifying Front Upper Outer Rail**  
Courtesy of GENERAL MOTORS CORP.

12. Install the front upper outer rail.
13. Apply the sealers and anti-corrosion materials to the repair area, as necessary. Refer to **Anti-Corrosion Treatment and Repair** .
14. Paint the repair area. Refer to **Basecoat/Clearcoat Paint Systems** .
15. Install all related panels and components.
16. Connect the negative battery cable. Refer to **Battery Negative Cable Disconnection and Connection** .
17. Enable the SIR system. Refer to **SIR Disabling and Enabling** .

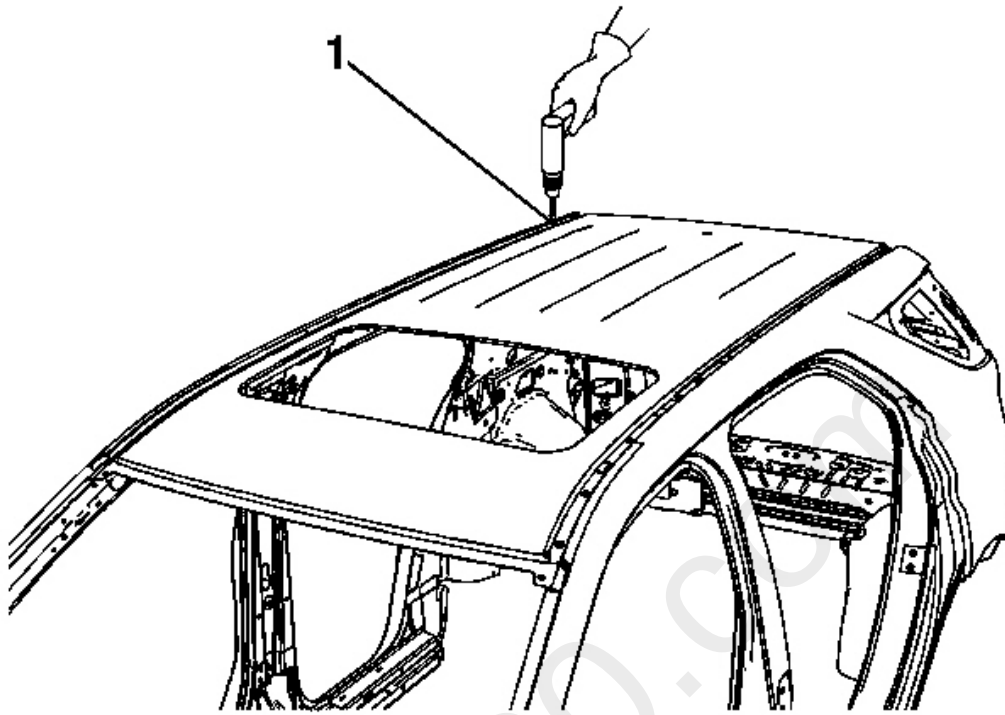
**Fig. 56: Drilling Out Roof Factory Welds**  
Courtesy of GENERAL MOTORS CORP.

8. Locate and drill out all factory welds (1).

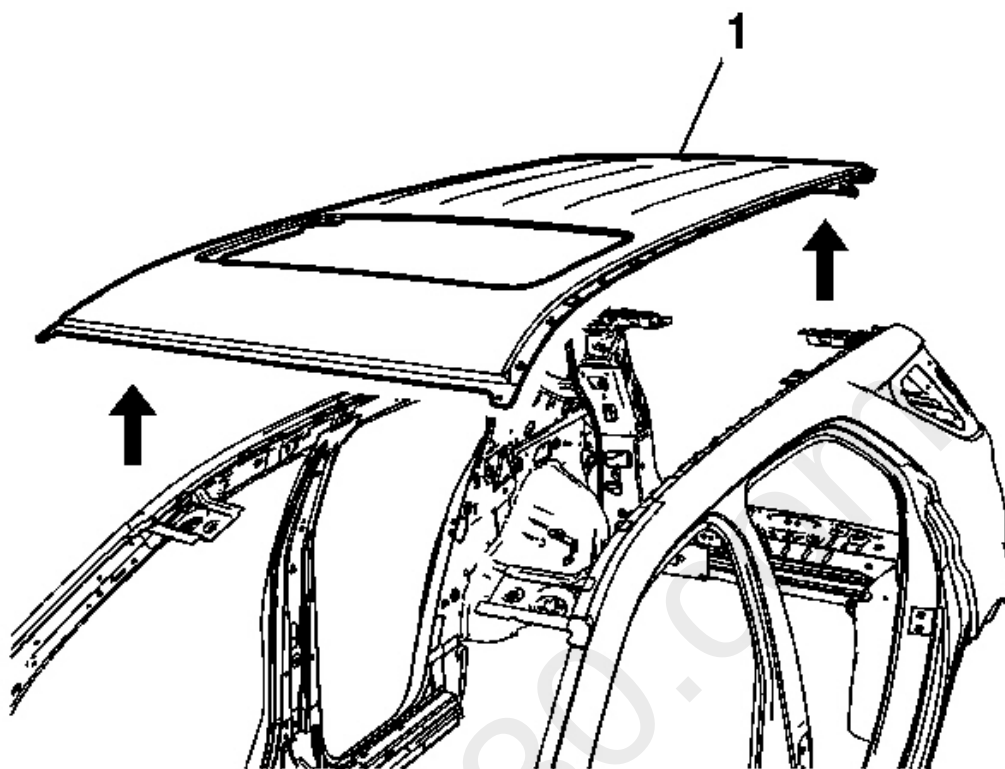
**Fig. 57: Identifying Roof Panel**  
Courtesy of GENERAL MOTORS CORP.

9. With the aid of an assistant, remove the roof panel (1).

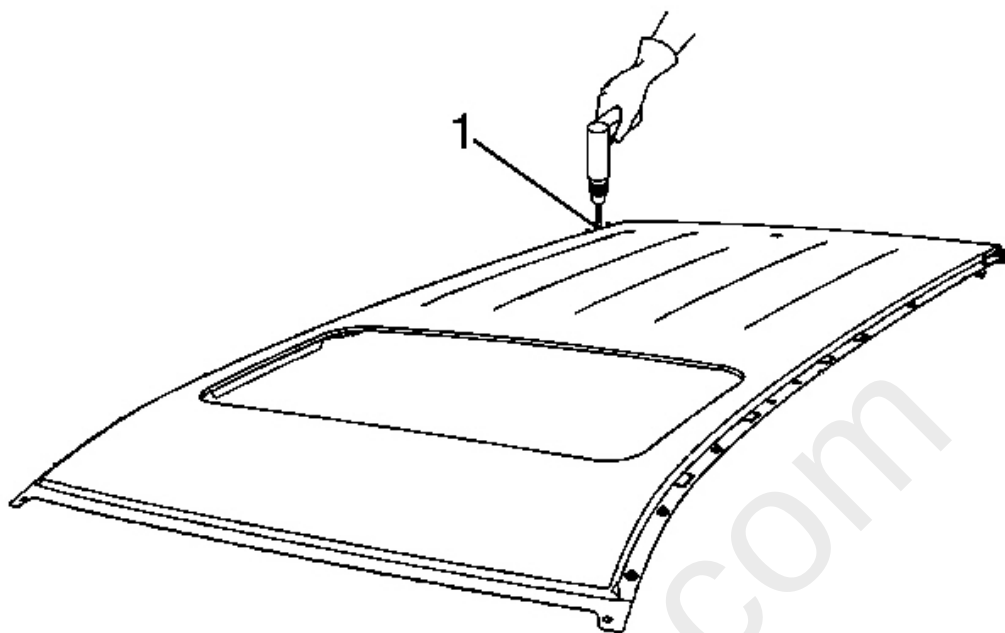
**Fig. 58: Drilling Roof Plug Weld Holes**  
**Courtesy of GENERAL MOTORS CORP.**

1. Drill 8 mm (5/16 in) plug weld holes as necessary in locations noted from the original panel (1).

**IMPORTANT:** If the location of the original plug weld holes can not be determined, or if structural weld-thru adhesive is present, space the plug weld holes every 40 mm (1 1/2 in) apart.

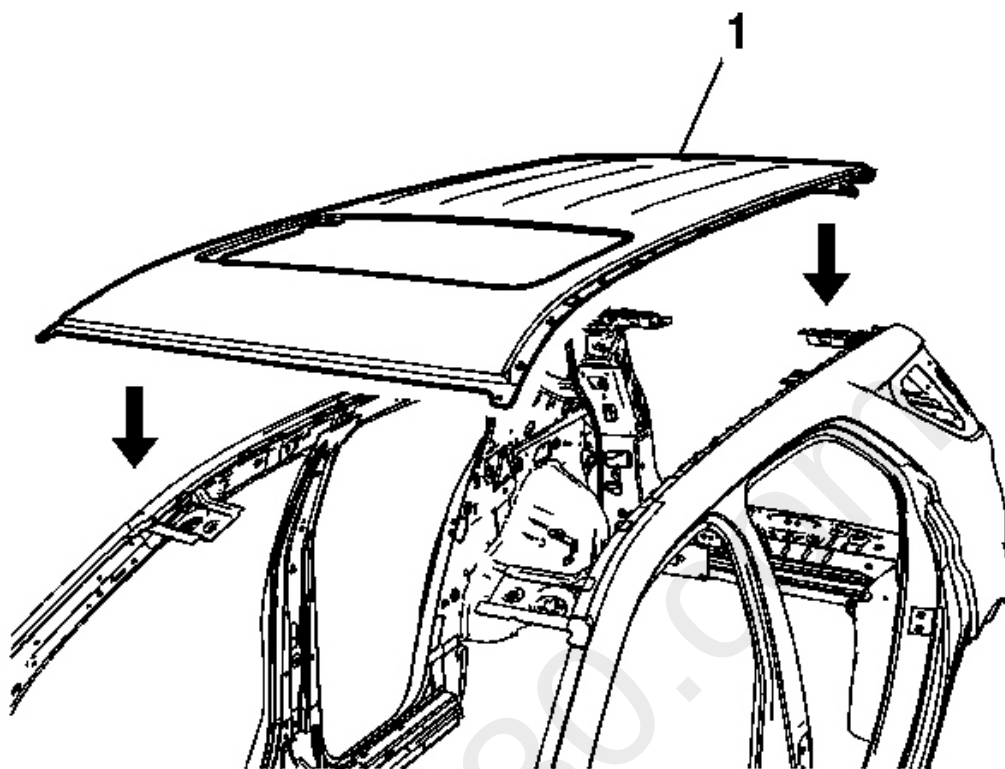
**Fig. 59: Positioning Roof Panel To Body**  
**Courtesy of GENERAL MOTORS CORP.**

4. With the aid of an assistant, position the roof panel to the body (1).

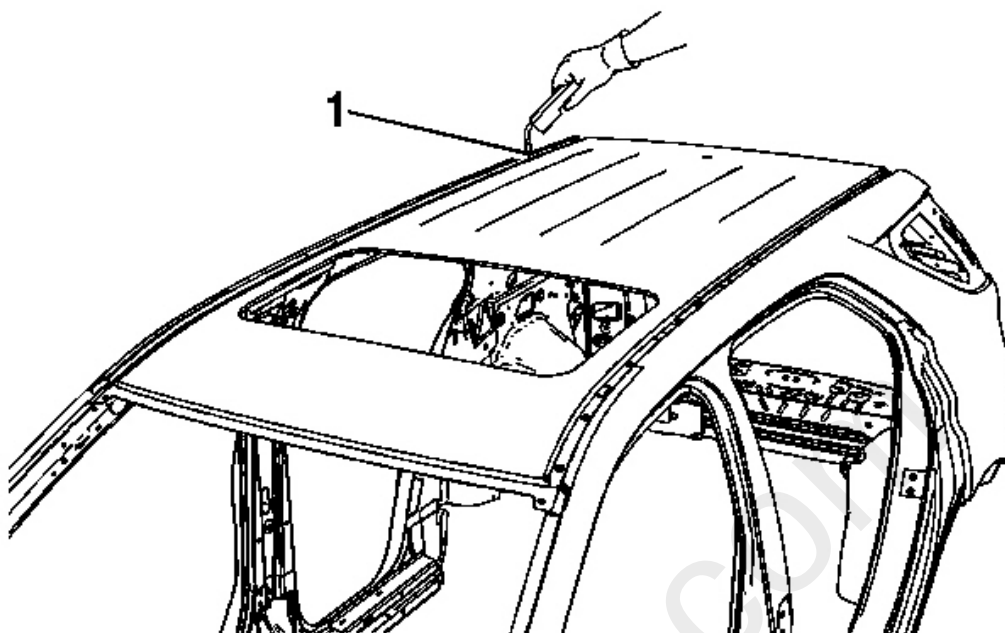
**Fig. 60: Plug Welding Roof**  
**Courtesy of GENERAL MOTORS CORP.**

5. Plug weld accordingly (1).
6. Clean and prepare all welded surfaces.
