## 2010 ACCESSORIES & EQUIPMENT

### Collision Repair - Equinox & Terrain

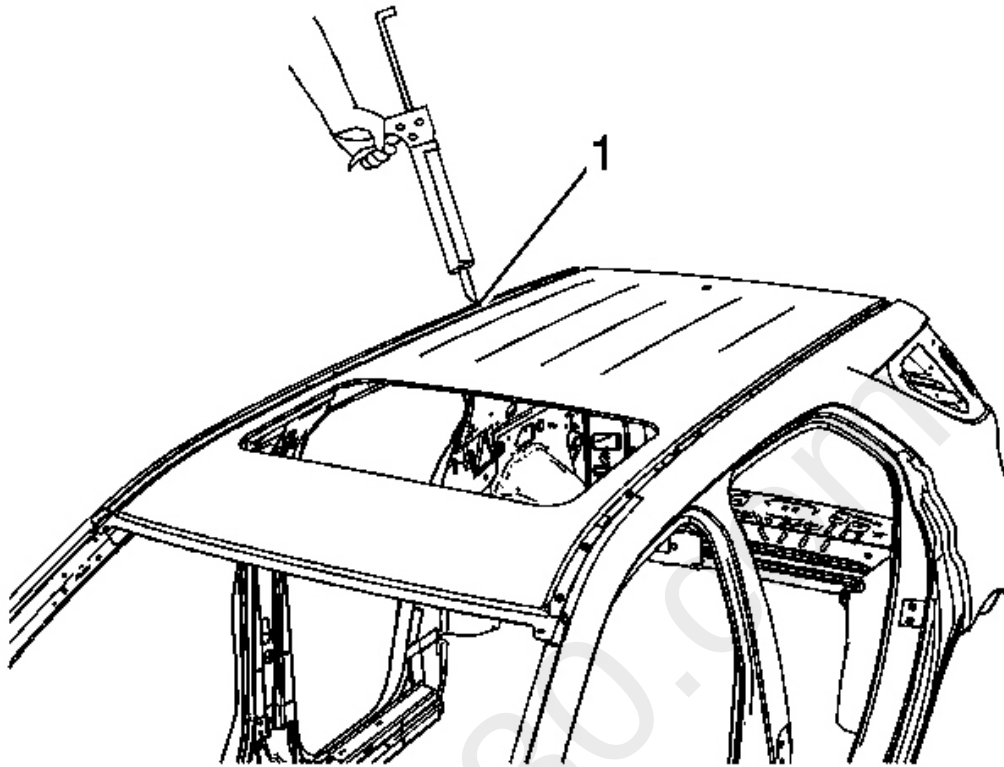
**Fig. 61: Applying Sealers**  
Courtesy of GENERAL MOTORS CORP.

7. Apply the sealers and anti-corrosion materials to the repair area, as necessary. Refer to **Anti-Corrosion Treatment and Repair** .
8. Paint the repair area. Refer to **Basecoat/Clearcoat Paint Systems** .
9. Install the windshield. Refer to **Windshield Replacement** .
10. Install the liftgate. Refer to **Liftgate Replacement** .
11. Install all related panels and components.
12. Connect the negative battery cable. Refer to **Battery Negative Cable Disconnection and Connection** .
13. Enable the SIR system. Refer to **SIR Disabling and Enabling** .

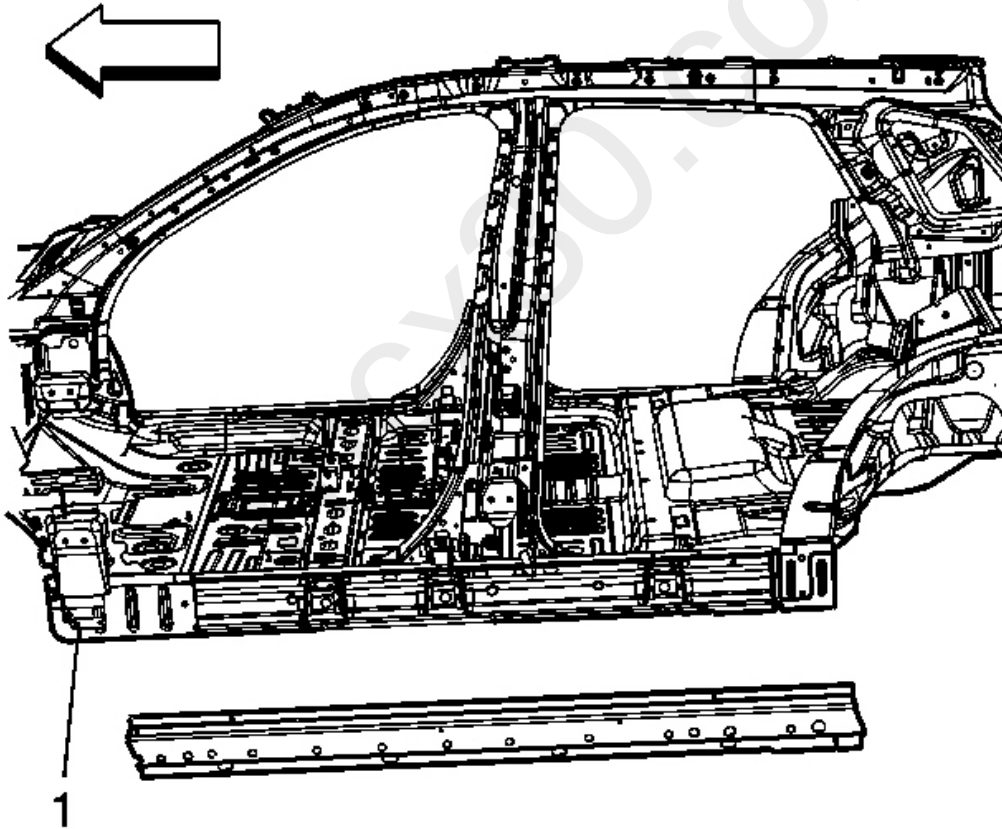
**Fig. 62: Locating Sealers & Anti-Corrosion Materials**  
Courtesy of GENERAL MOTORS CORP.

6. Note the location and remove the sealers and anti-corrosion materials from the repair area, as necessary (1). Refer to Anti-Corrosion Treatment and Repair.

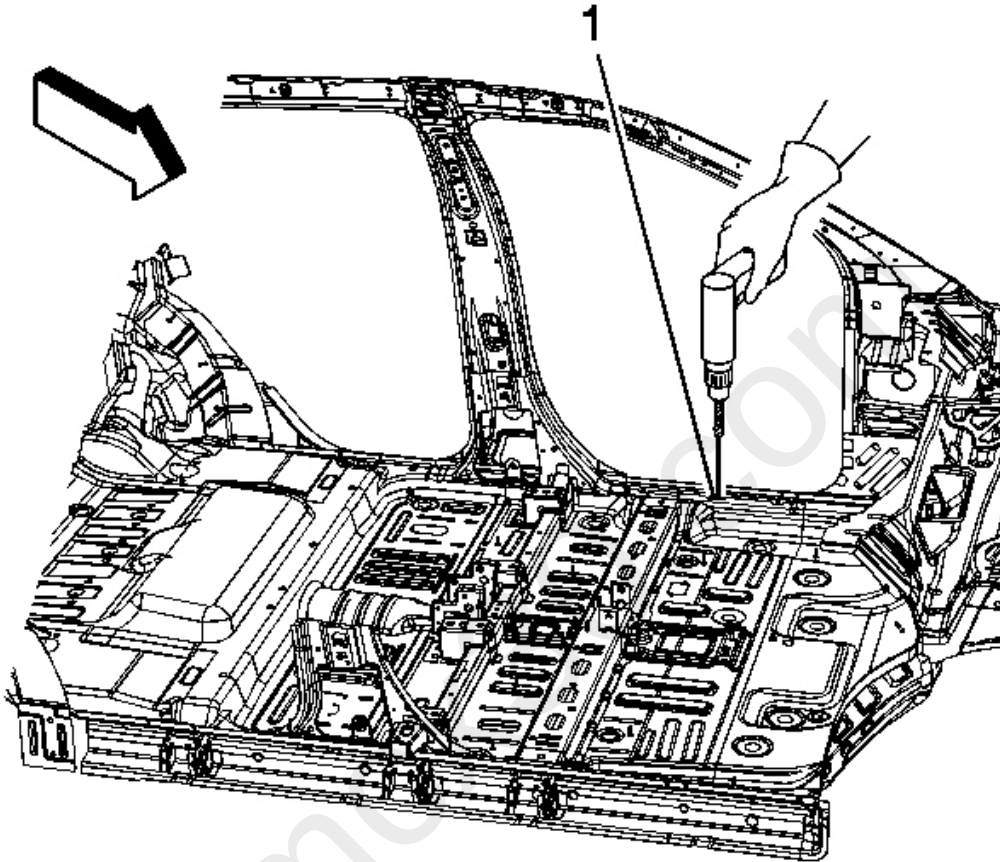
**Fig. 63: Drilling Out Factory Welds**  
Courtesy of GENERAL MOTORS CORP.

**NOTE:** The rocker inner panel is made of ultra high strength steel and should be replaced only at factory joints. Sectioning or straightening are not recommended. Refer to Ultra High Strength Steel.

7. Locate and drill out all factory welds (1).

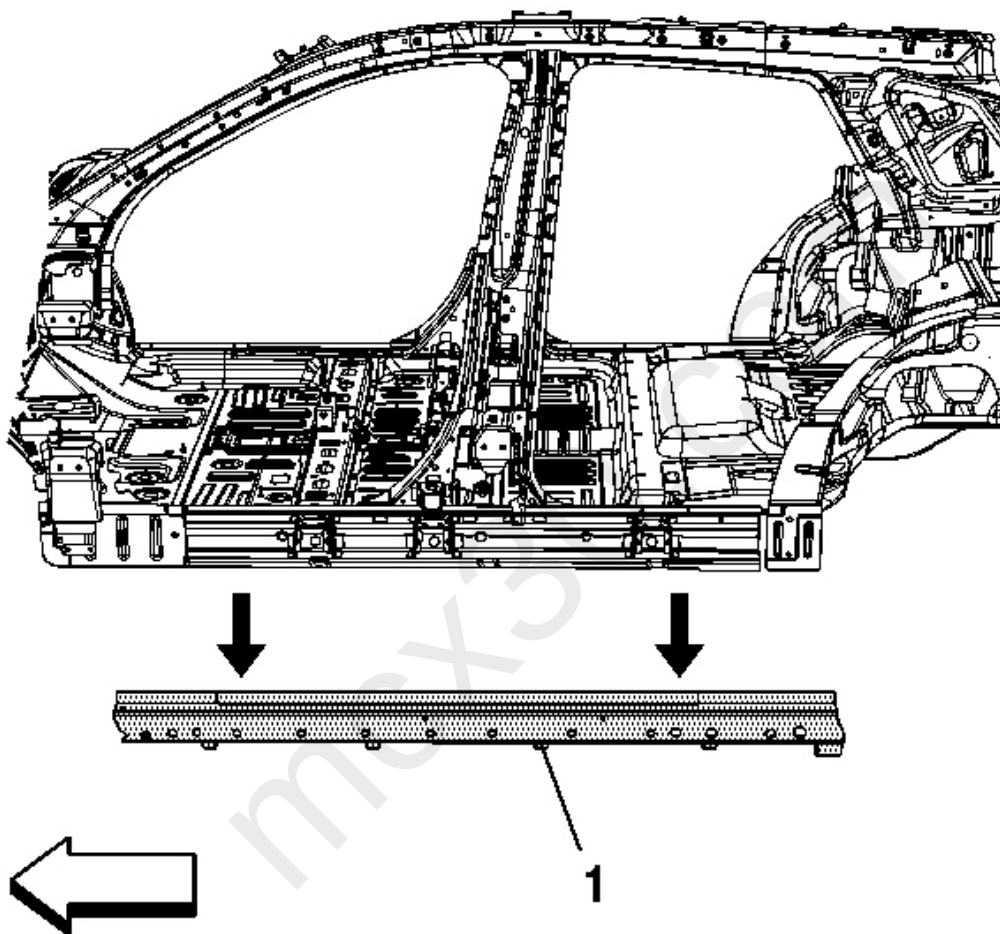
**Fig. 64: Removing Damaged Inner Rocker Panel**  
Courtesy of GENERAL MOTORS CORP.

8. Remove the damaged inner rocker panel (1).

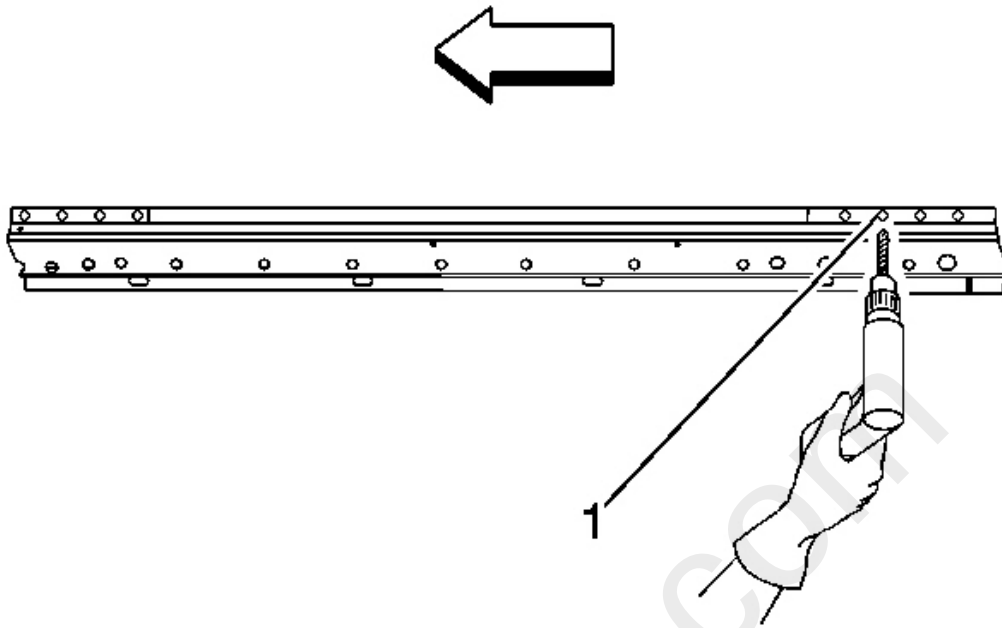
**Fig. 65: Drilling Plug Weld Holes**  
Courtesy of GENERAL MOTORS CORP.

**NOTE:** If the location of the original plug welds cannot be determined or structural weld thru adhesive was present, space plug weld holes every 40 mm (1 1/2 in) apart.

1. Drill 8 mm (5/16 in) plug weld holes in the service part as necessary (1), in the locations noted from the original panel.
2. Prepare all attachment surfaces as necessary.
3. Apply GM approved Weld-Thru Coating or equivalent to all mating surfaces. Refer to **Anti-Corrosion Treatment and Repair** .

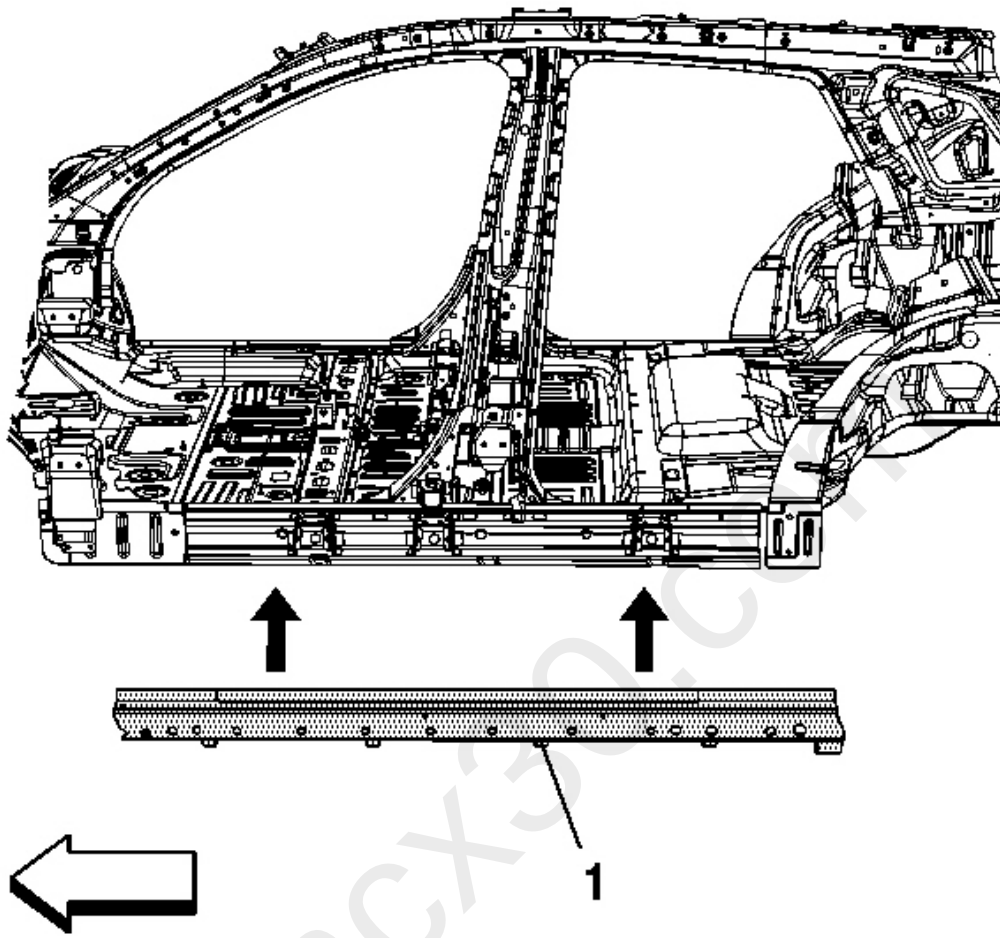
**Fig. 66: Positioning Inner Rocker Panel**  
Courtesy of GENERAL MOTORS CORP.

4. Position the inner rocker panel (1).
5. Clamp service parts in position.
6. Inspect the vehicle for proper dimensions using 3-dimensional equipment.

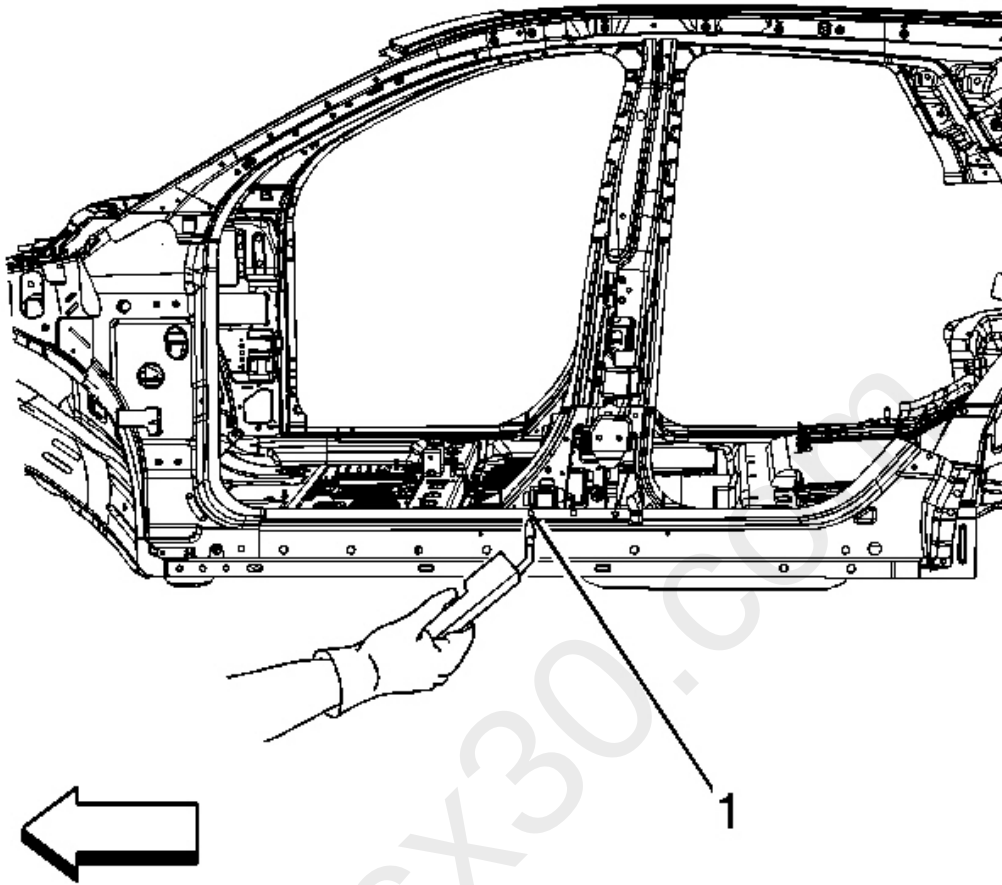
**Fig. 67: Plug Welding Inner Rocker Panel**  
**Courtesy of GENERAL MOTORS CORP.**

7. Plug weld accordingly (1).
8. Clean and prepare all welded surfaces.
9. Apply the sealers and anti-corrosion materials to the repair area, as necessary. Refer to **Anti-Corrosion Treatment and Repair** .
10. Paint the repair area. Refer to **Basecoat/Clearcoat Paint Systems** .
11. Install all related panels and components.
12. Connect the negative battery cable. Refer to **Battery Negative Cable Disconnection and Connection** .
13. Enable the SIR system. Refer to **SIR Disabling and Enabling** .

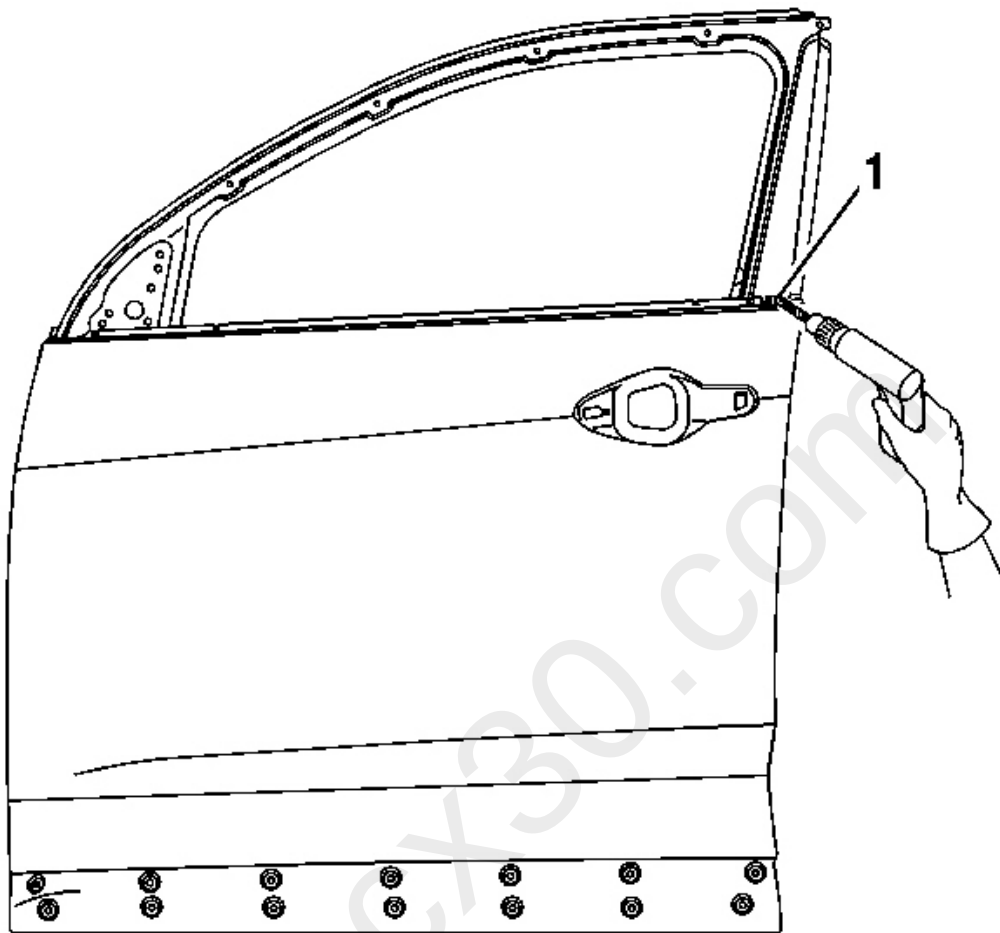
**Fig. 68: Drilling Out Factory Welds**  
Courtesy of GENERAL MOTORS CORP.

6. Locate and drill out all factory welds (1). Note the number and location of welds at the upper window frame and the mirror locations.

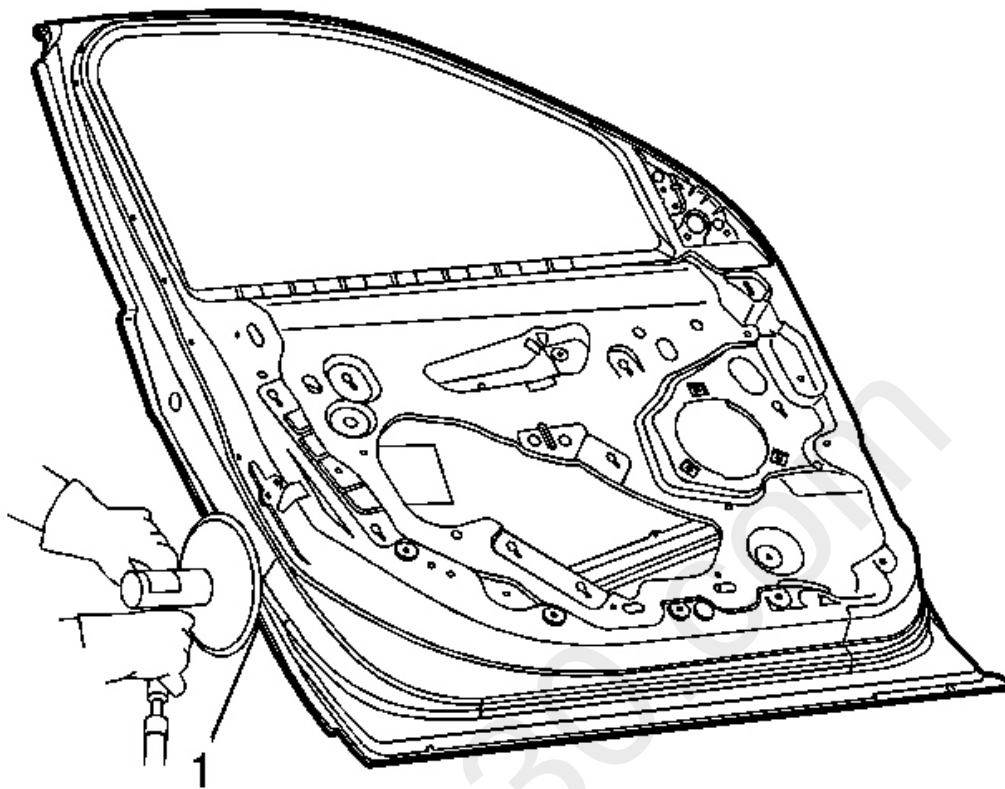
**Fig. 69: Grinding Edges Of Door Outer Panel**  
Courtesy of GENERAL MOTORS CORP.

7. Grind the edges of the door outer panel to separate the outer door panel from the door shell (1).

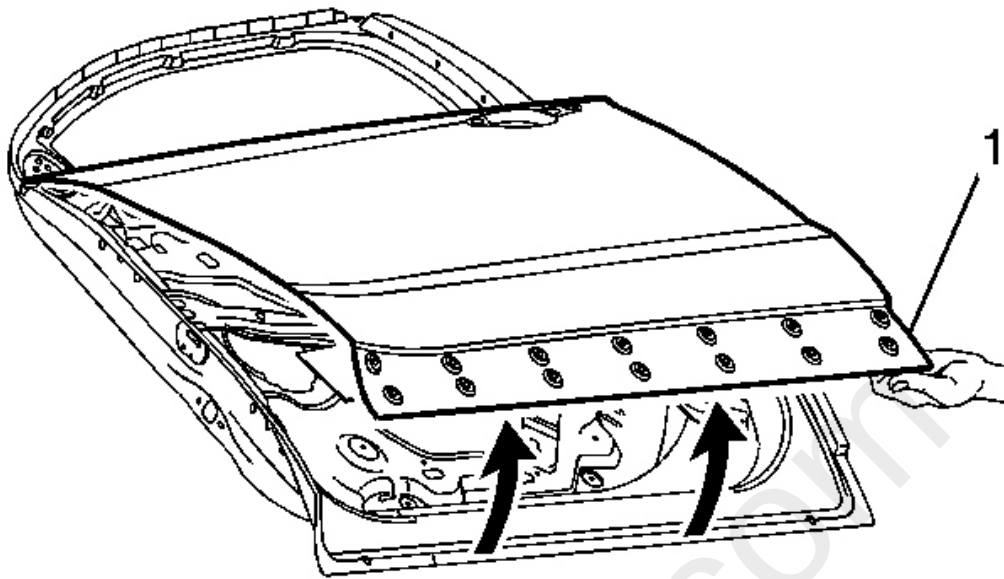
**Fig. 70: Removing Outer Door Panel**  
Courtesy of GENERAL MOTORS CORP.

**WARNING:** Inspection of the door guard beam for damage must be performed before replacement of the door outer panel. If damage to the door guard beam is found the door must be replaced. Failure to do so may compromise the structural integrity of the vehicle and may cause personal injury if the vehicle is involved in a collision.

8. Remove the outer door panel (1).
9. Remove the sealers and anti-corrosion materials from the repair area, as necessary. Refer to **Anti-Corrosion Treatment and Repair** .

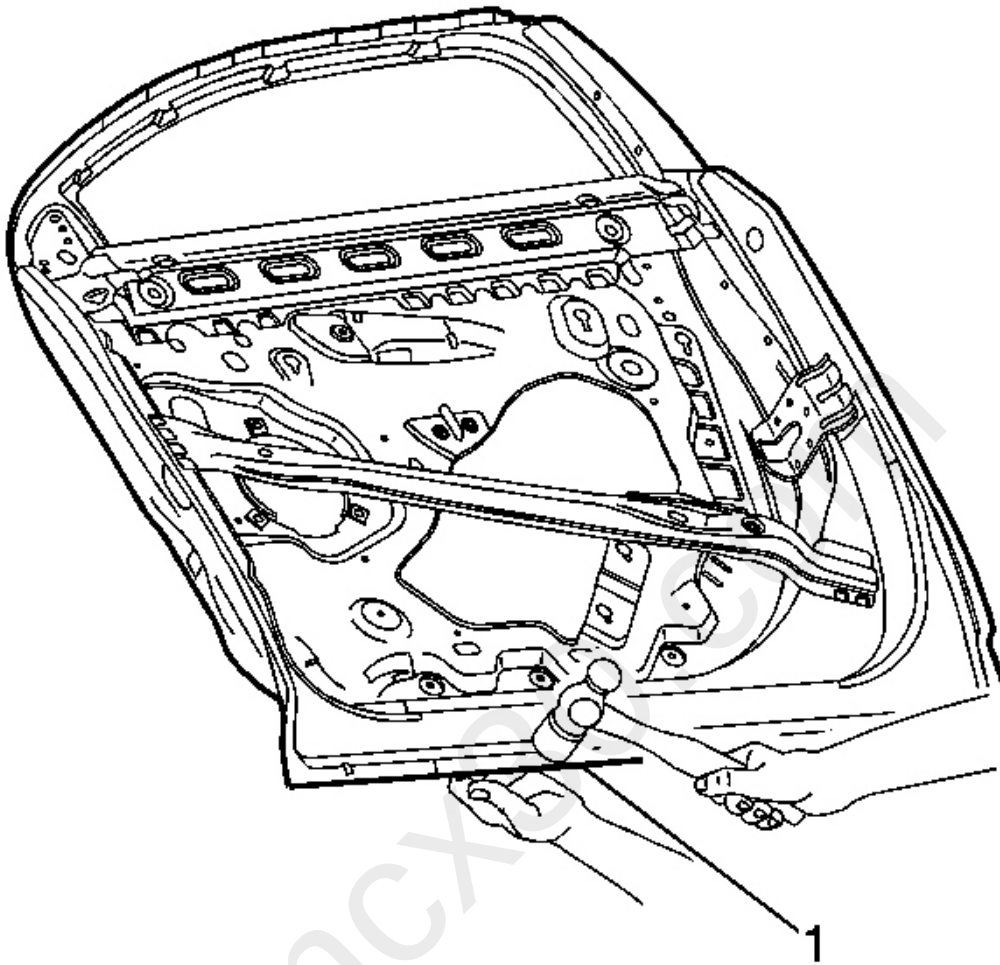
**Fig. 71: Straightening Edges Of Door Inner Panel**  
Courtesy of GENERAL MOTORS CORP.

10. Straighten the edges of the door inner panel (1).

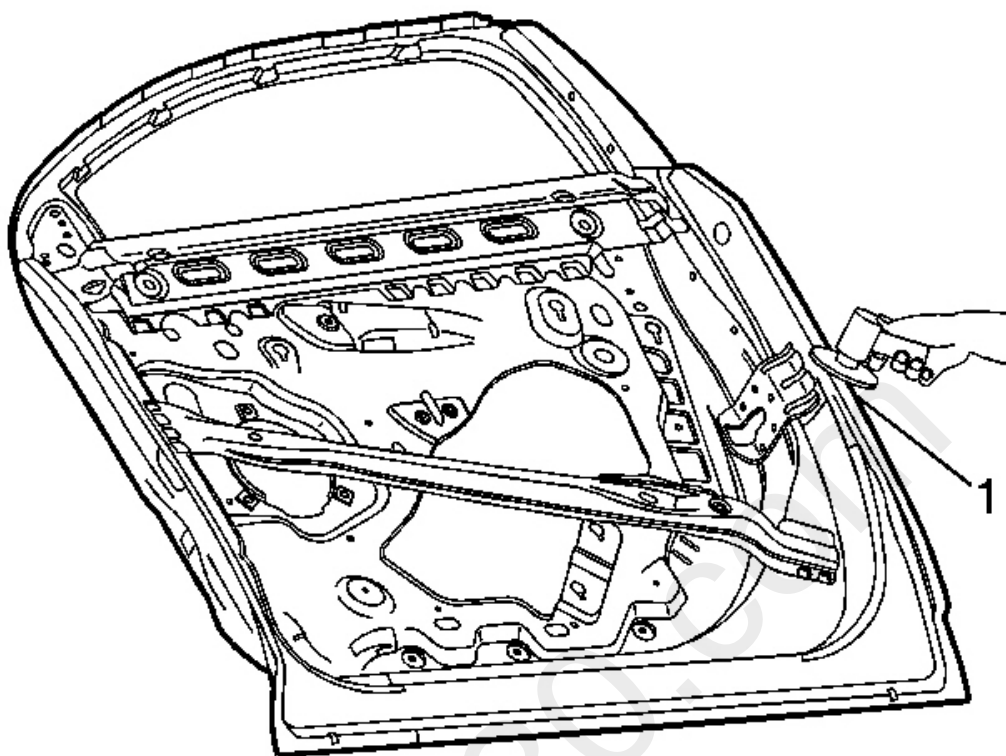
**Fig. 72: Grinding Surface Of Door Shell**  
**Courtesy of GENERAL MOTORS CORP.**

1. Using a grinding disk, grind the surface of the door shell, removing all adhesive (1). Mate the flanges to the outer panel.

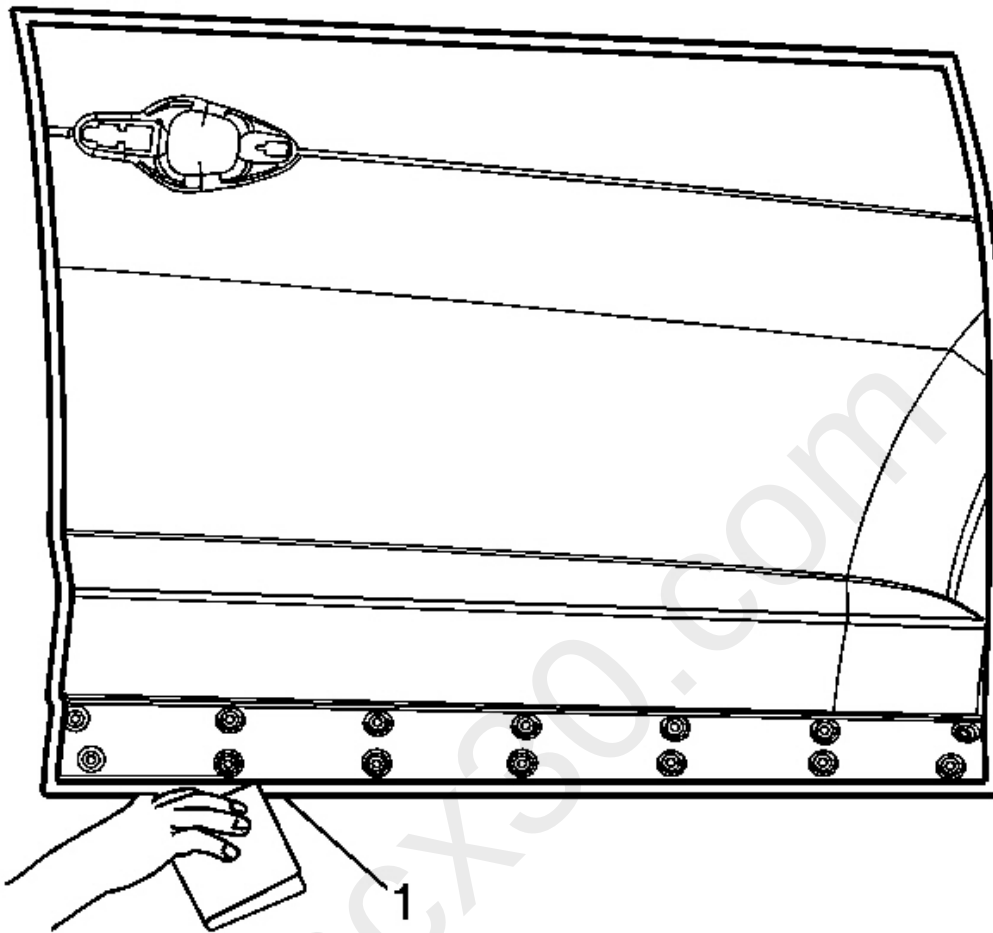
**Fig. 73: Scuffing Opposing Mating Surfaces Of Door Outer Panel**  
Courtesy of GENERAL MOTORS CORP.

2. Scuff the opposing mating surfaces of the door outer panel to remove the gloss of the E-Coat (1).

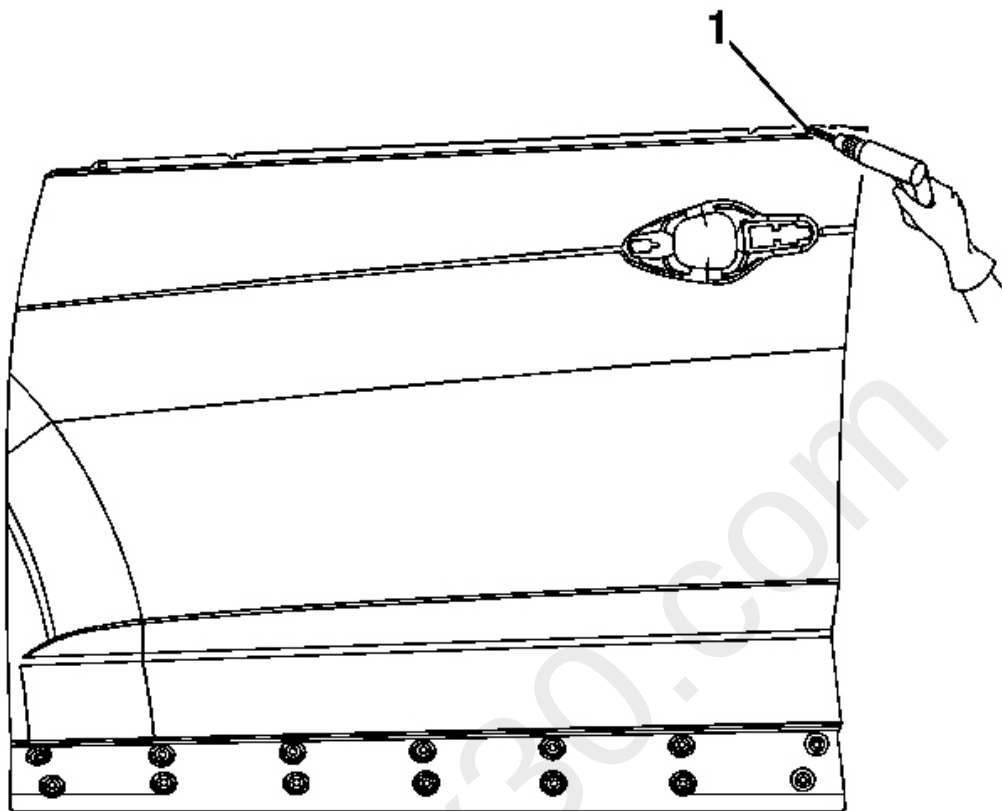
**Fig. 74: Drilling Plug Weld Holes**  
Courtesy of GENERAL MOTORS CORP.

**NOTE:** If the location of the original plug welds cannot be determined or structural weld- thru adhesive was present, space plug weld holes every 40 mm (1 1/2 in) apart.

3. Drill 8 mm (5/16 in) plug weld holes as necessary in the locations noted from the original panel (1).
4. Clean the mating surfaces.

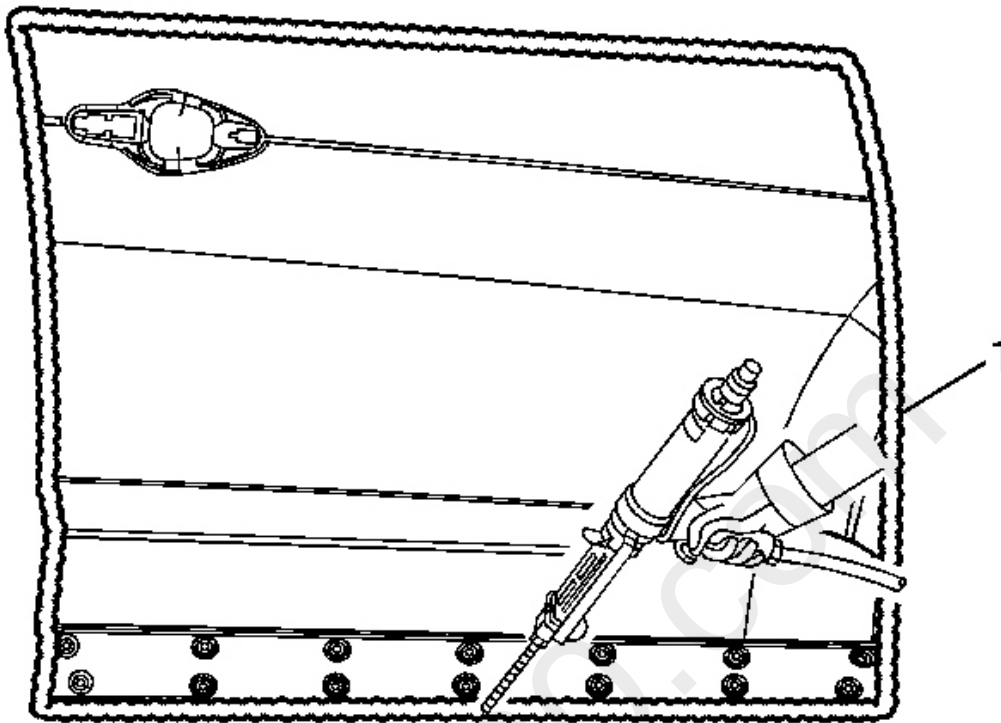
**Fig. 75: Applying Adhesive**  
Courtesy of GENERAL MOTORS CORP.

**NOTE:** The adhesive has a 40-50 minute working time. Do not allow the door to totally cure off the vehicle, as proper alignment of the door outer panel to the door shell will be difficult.

5. Apply a 3-6 mm (1/8-1/4 in) bead of metal panel bonding adhesive to both of the mating surfaces (1).
6. Using a small acid brush, spread a coat of adhesive to cover all the bare metal surfaces to ensure corrosion protection.

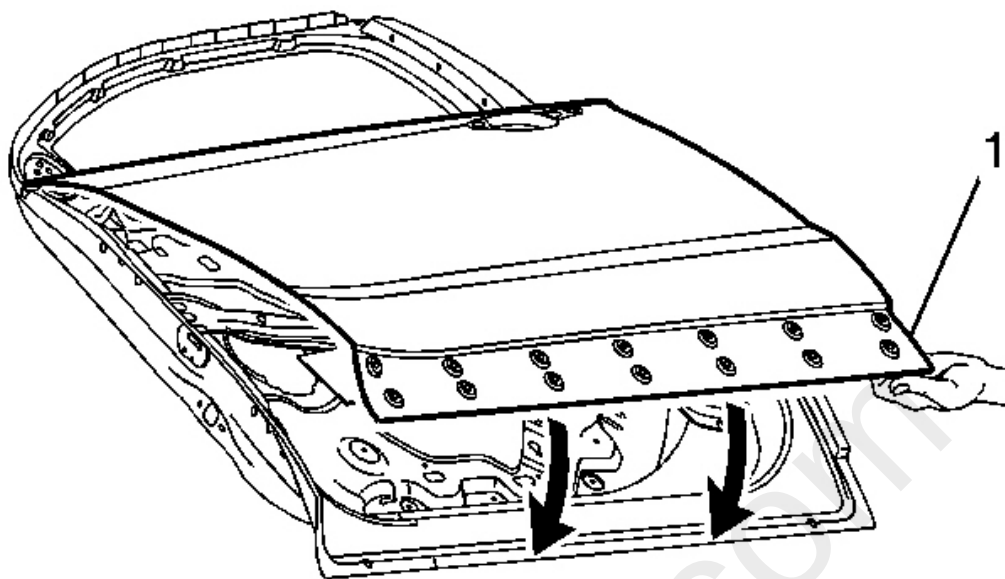
**Fig. 76: Installing Door Outer Panel To Door Shell**  
Courtesy of GENERAL MOTORS CORP.

7. Install the door outer panel to the door shell (1).

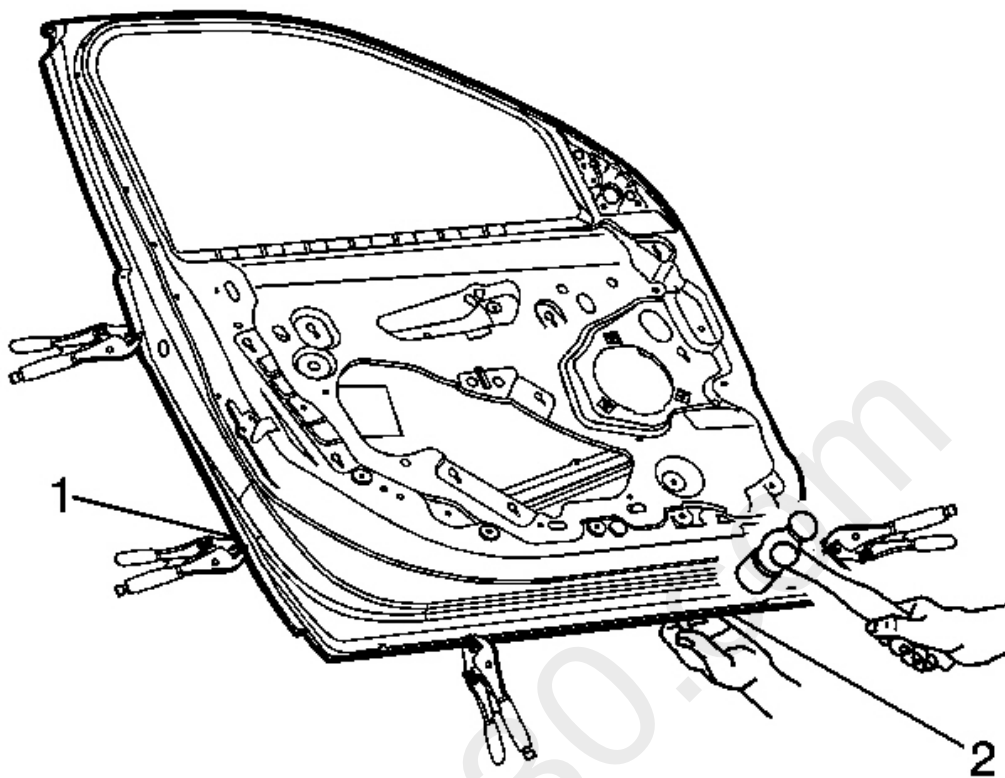
**Fig. 77: Re-Hemming Hem Flanges**  
Courtesy of GENERAL MOTORS CORP.

**NOTE:** Do NOT pull the panels apart after being joined together. Slide the panels against each other to realign the panels.

Continue to hammer in stages along the hem flanges.

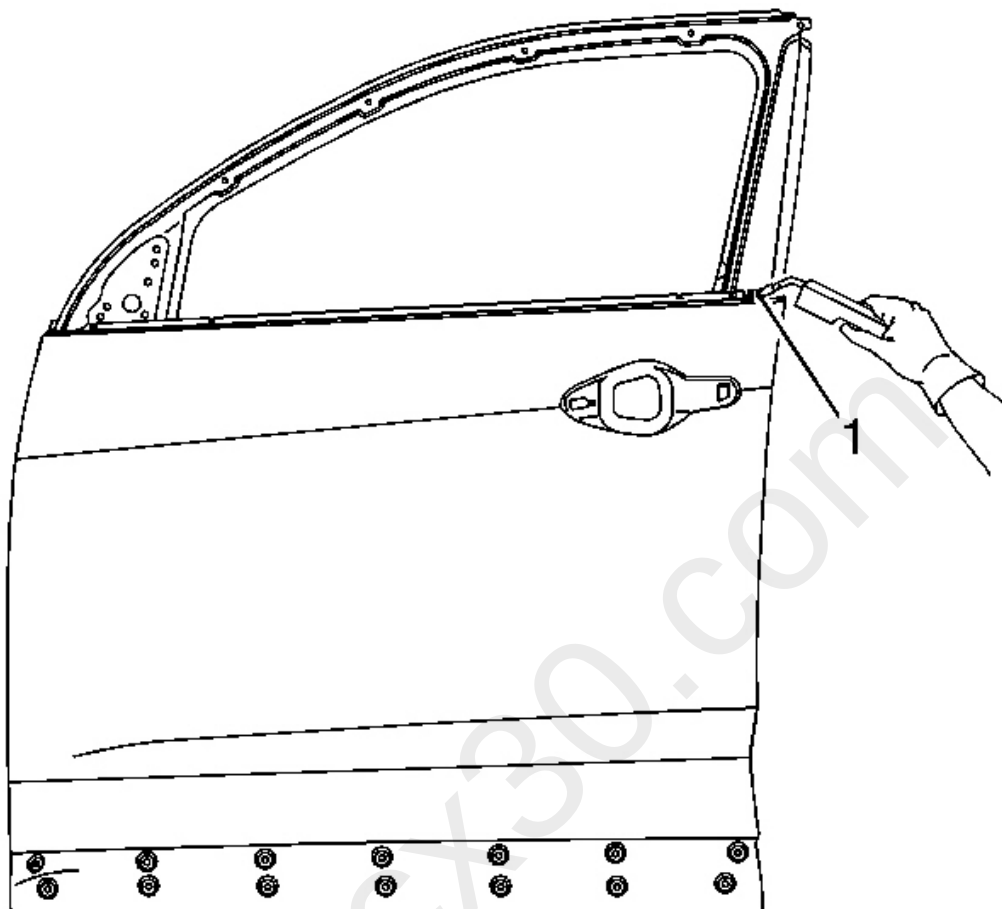
**Fig. 78: Welding Door Outer Panel To Door Frame**  
**Courtesy of GENERAL MOTORS CORP.**

12. Using metal-inert gas (MIG), weld the door outer panel to the door frame in the locations noted at the upper door frame (1).
13. Clean and prepare all welded surfaces.

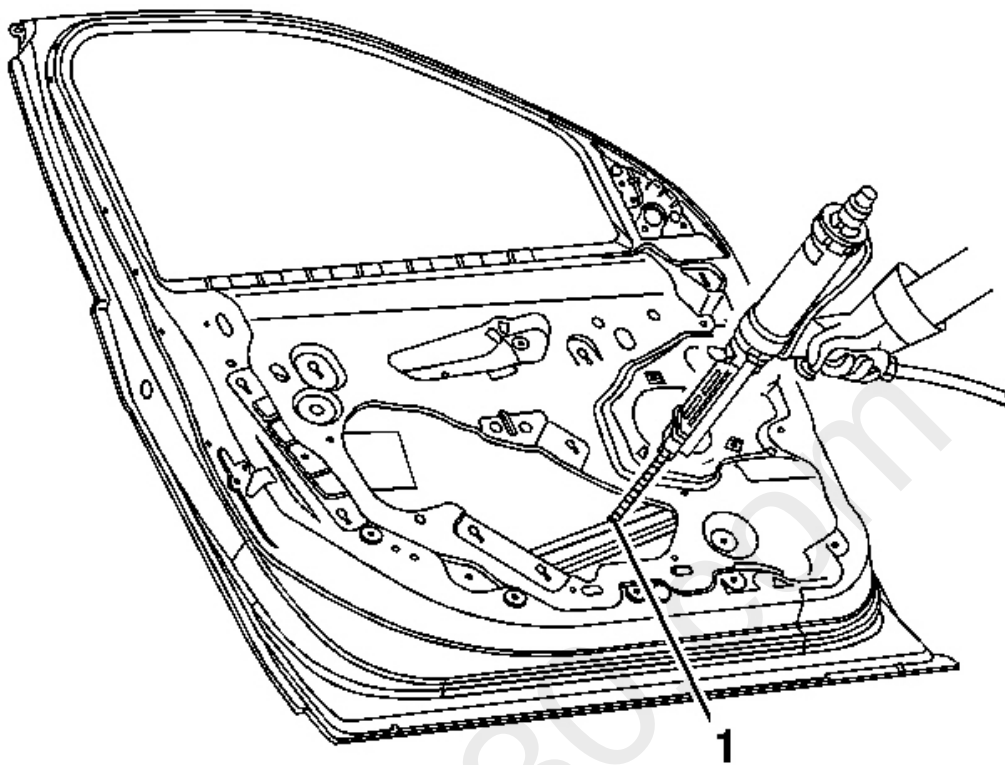
**Fig. 79: Applying Fusor**  
Courtesy of GENERAL MOTORS CORP.

14. Apply Fusor super flexible anti-flutter foam-fast set, Fusor P/N 121/124 or equivalent in 4-5 evenly spaced locations between the door outer panel and the impact beam (1).
15. Apply sealers and anti-corrosion materials to the repair area as necessary. Refer to **Anti-Corrosion Treatment and Repair** .
16. Paint the repaired area. Refer to **Basecoat/Clearcoat Paint Systems** .
17. Install the door assembly. Refer to **Front Side Door Replacement** .
18. Install all related panels and components.
19. Connect the negative battery cable. Refer to **Battery Negative Cable Disconnection and Connection** .
20. Enable the SIR system. Refer to **SIR Disabling and Enabling** .

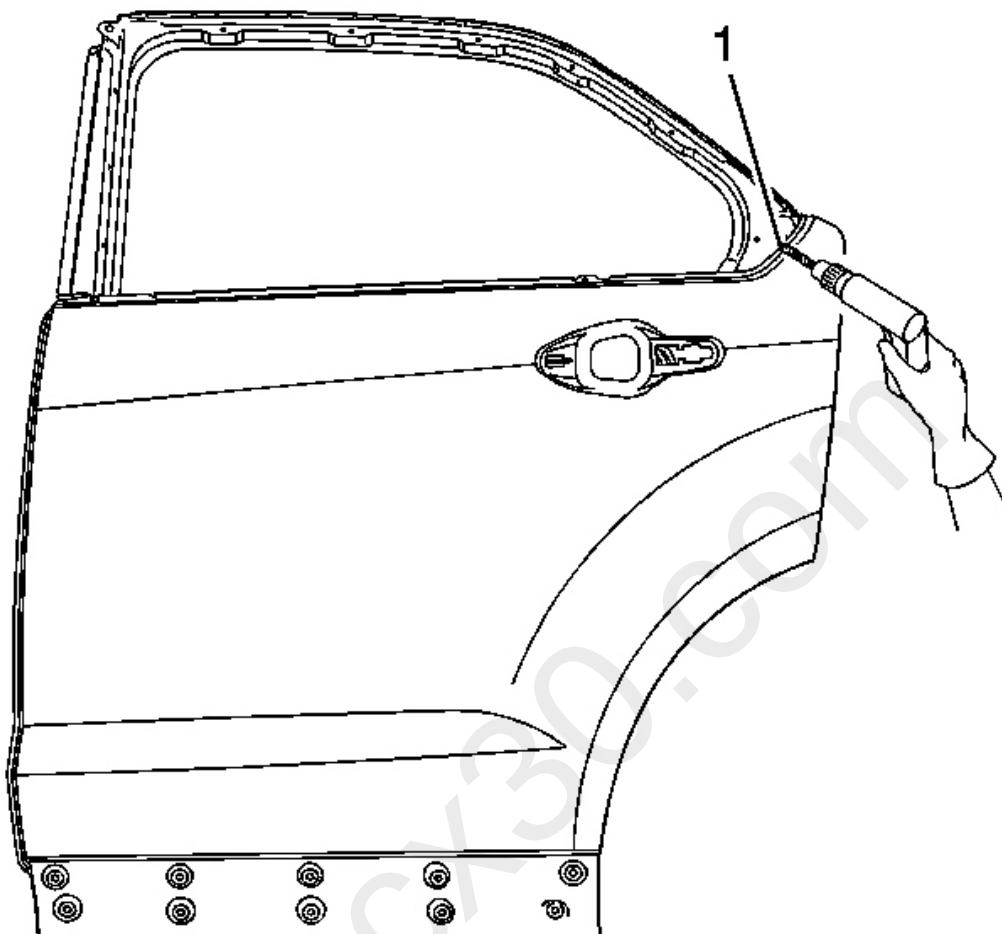
**Fig. 80: Drilling Out Factory Welds**  
**Courtesy of GENERAL MOTORS CORP.**

6. Locate and drill out all factory welds (1). Note the number and location of welds at the upper window.

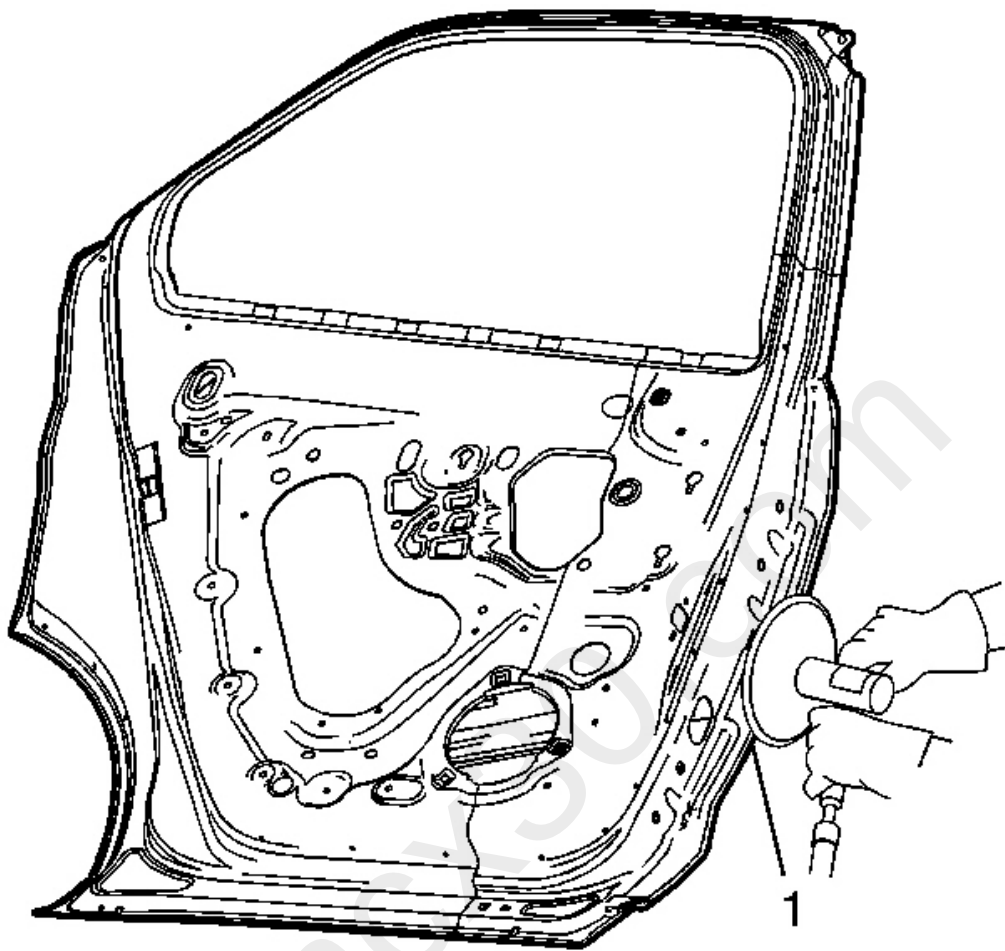
**Fig. 81: Grinding Edges Of Door Outer Panel**  
Courtesy of GENERAL MOTORS CORP.

7. Grind the edges of the door outer panel to separate the outer door panel from the door shell (1).

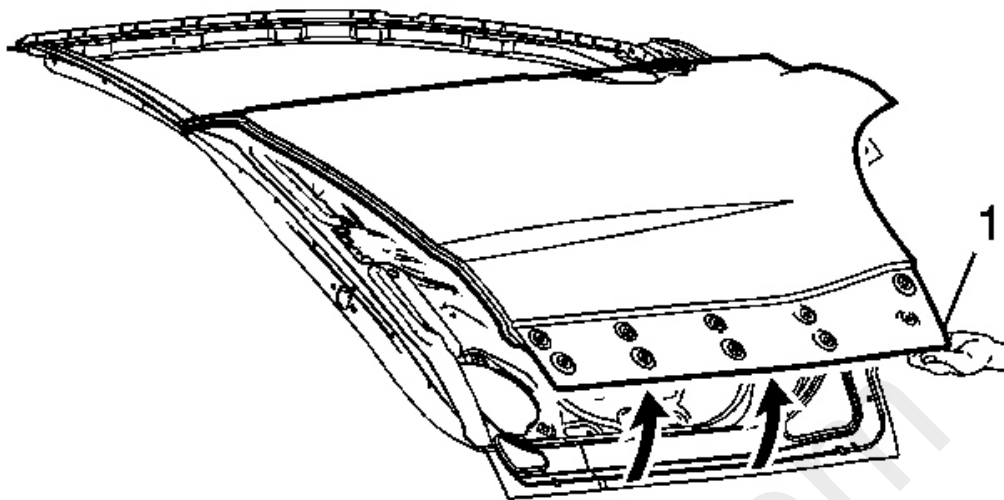
**Fig. 82: Removing Outer Door Panel**  
Courtesy of GENERAL MOTORS CORP.

**WARNING:** Inspection of the door guard beam for damage must be performed before replacement of the door outer panel. If damage to the door guard beam is found the door must be replaced. Failure to do so may compromise the structural integrity of the vehicle and may cause personal injury if the vehicle is involved in a collision.

8. Remove the outer door panel (1).
9. Remove the sealers and anti-corrosion materials from the repair area, as necessary. Refer to **Anti-Corrosion Treatment and Repair** .

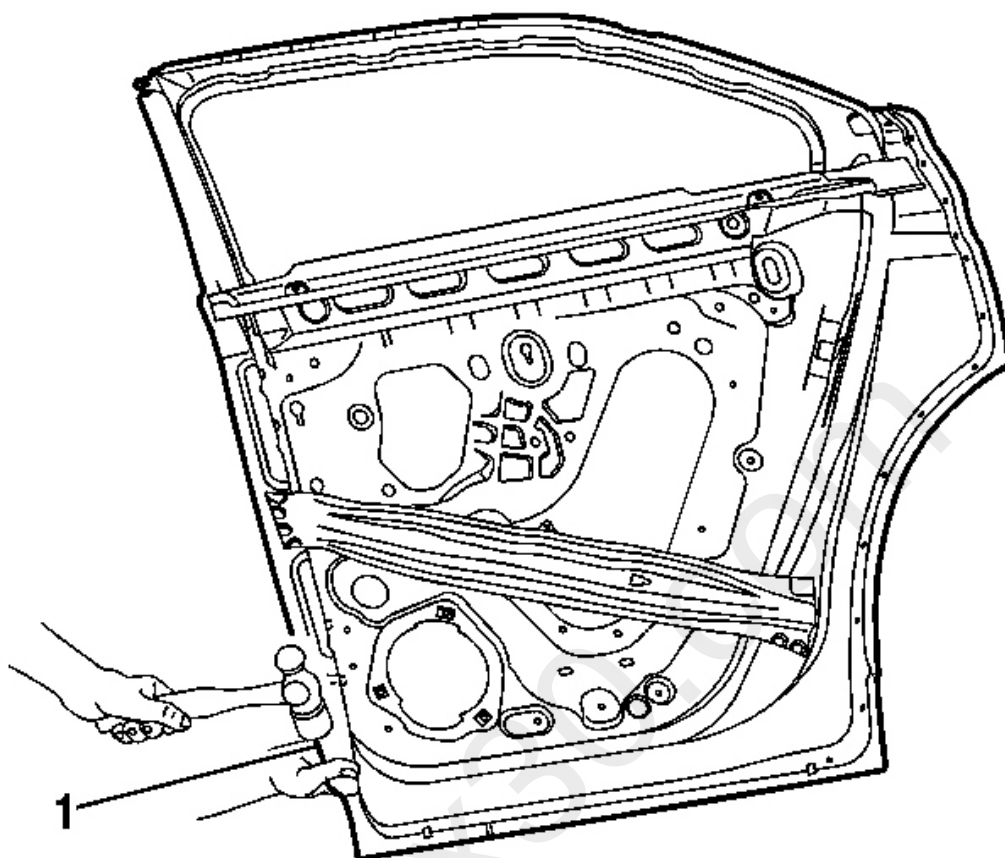
**Fig. 83: Straightening Edges Of Door Inner Panel**  
**Courtesy of GENERAL MOTORS CORP.**

10. Straighten the edges of the door inner panel (1).

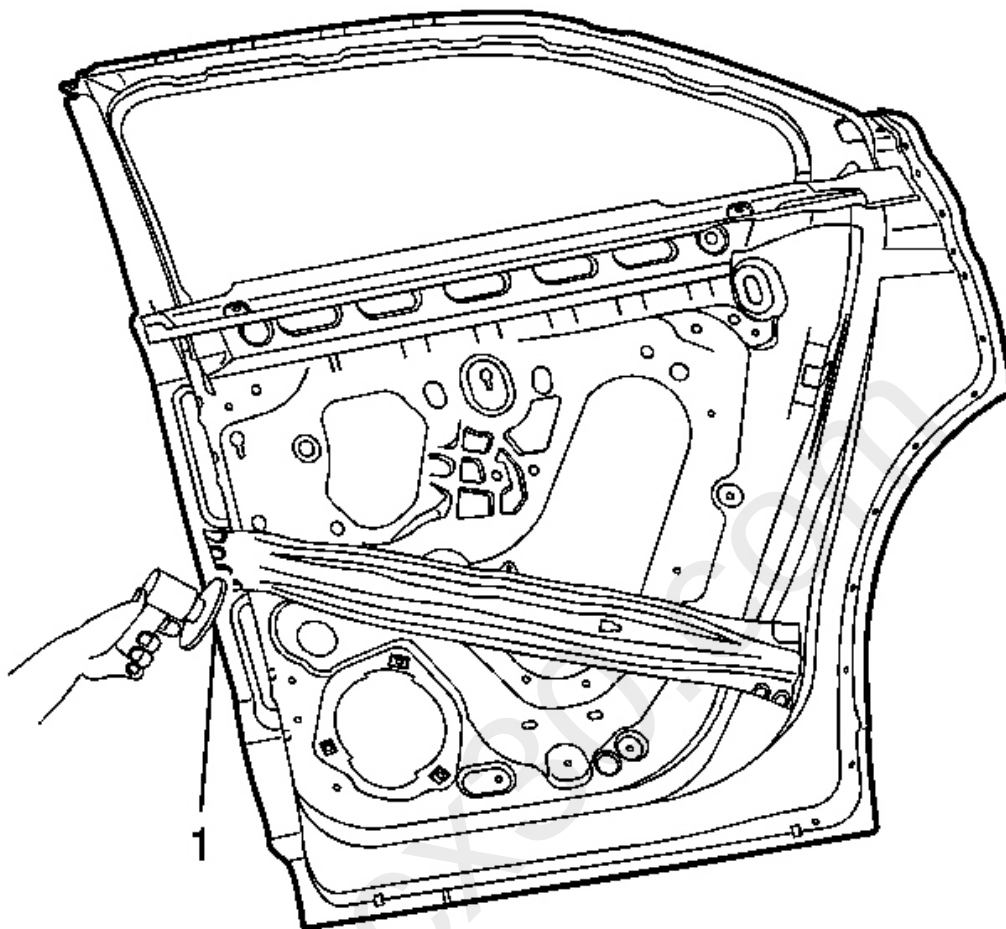
**Fig. 84: Grinding Surface Of Door Shell**  
**Courtesy of GENERAL MOTORS CORP.**

1. Using a grinding disk, grind the surface of the door shell, removing all adhesive (1). Mate the flanges to the outer panel.

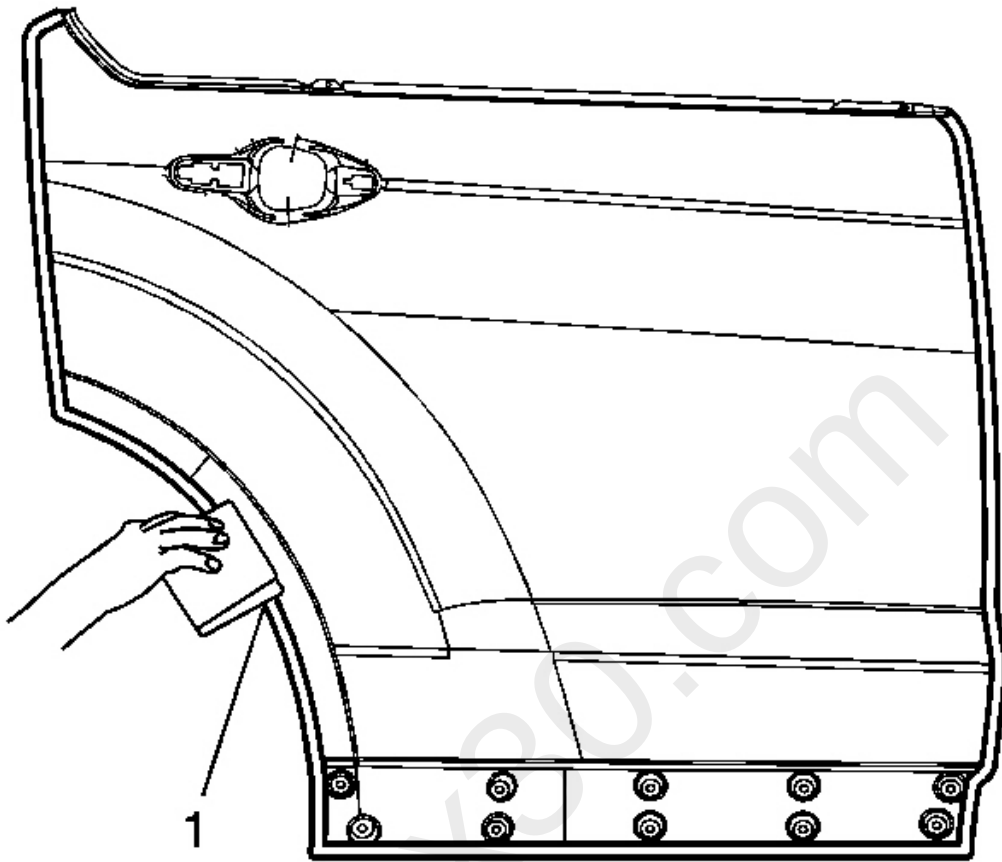
**Fig. 85: Scuffing Opposing Mating Surfaces**  
**Courtesy of GENERAL MOTORS CORP.**

2. Scuff the opposing mating surfaces of the door outer panel to remove the gloss of the E-Coat (1).
