## 2010 ACCESSORIES & EQUIPMENT

### Collision Repair - Equinox & Terrain

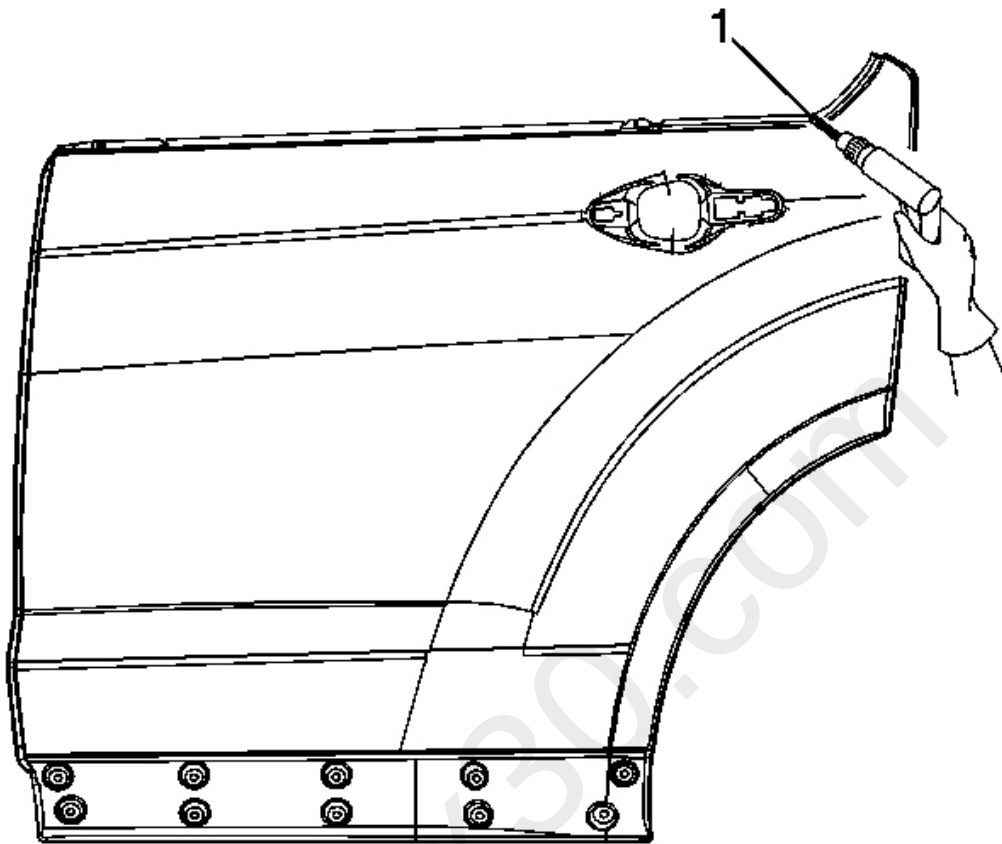
**Fig. 86: Drilling Plug Weld Holes**

**NOTE:** If the location of the original plug welds cannot be determined or structural weld- thru adhesive was present, space plug weld holes every 40 mm (1 1/2 in) apart.

3. Drill 8 mm (5/16 in) plug weld holes as necessary in the locations noted from the original panel (1).
4. Clean the mating surfaces.

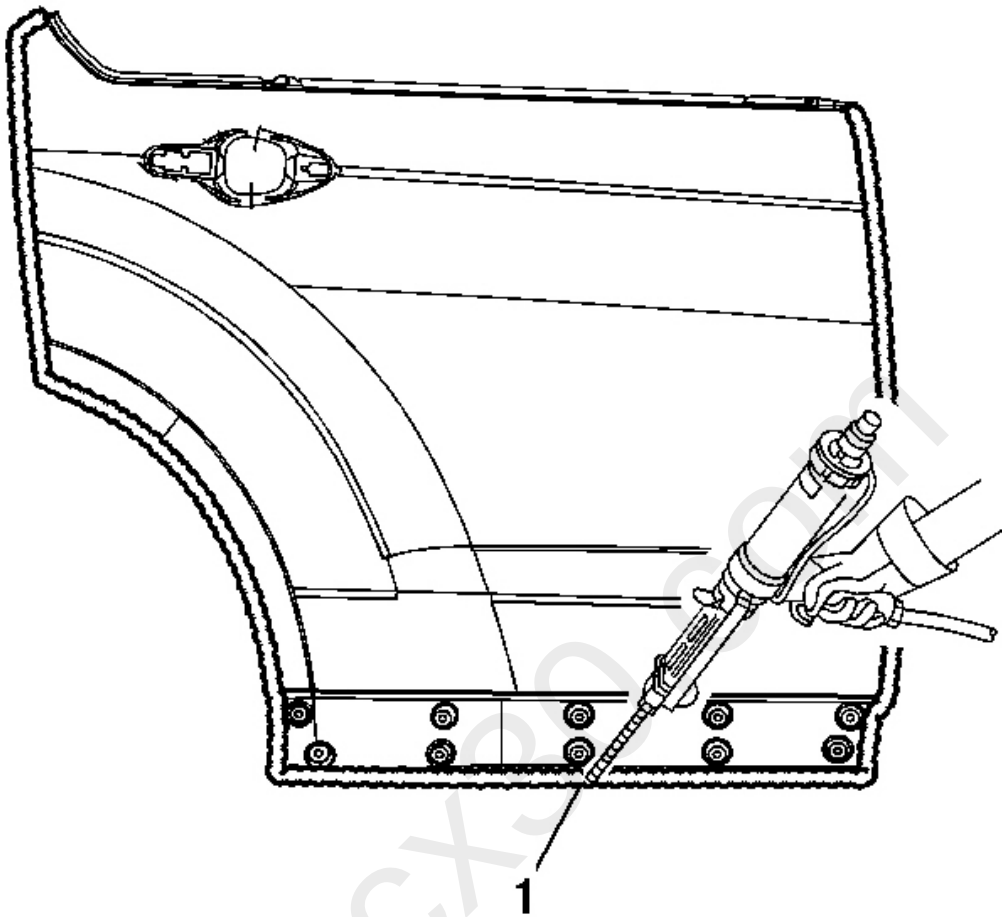
**Fig. 87: Applying Metal Panel Bonding Adhesive**  
Courtesy of GENERAL MOTORS CORP.

**NOTE:**        **The adhesive has a limited working time. Do not allow the door to totally cure off the vehicle, as proper alignment of the door outer panel to the door shell will be difficult.**

5. Apply a 3-6 mm (1/8-1/4 in) bead of metal panel bonding adhesive GM P/N 12378566/7 (Canadian P/N 88901674/5) or equivalent, to both of the mating surfaces (1).
6. Using a small acid brush, spread a coat of adhesive to cover all the bare metal surfaces to ensure corrosion protection.

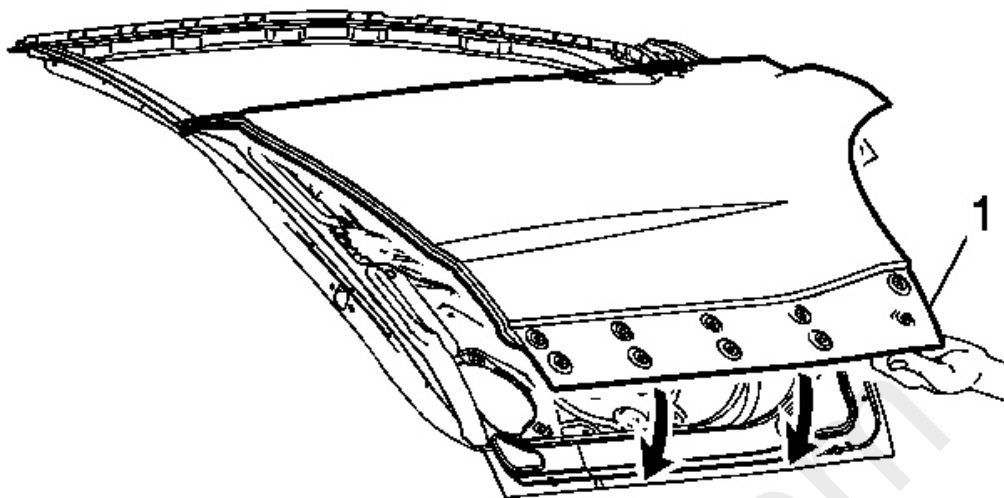
**Fig. 88: Installing Door Outer Panel To Door Shell**  
Courtesy of GENERAL MOTORS CORP.

7. Install the door outer panel to the door shell (1).

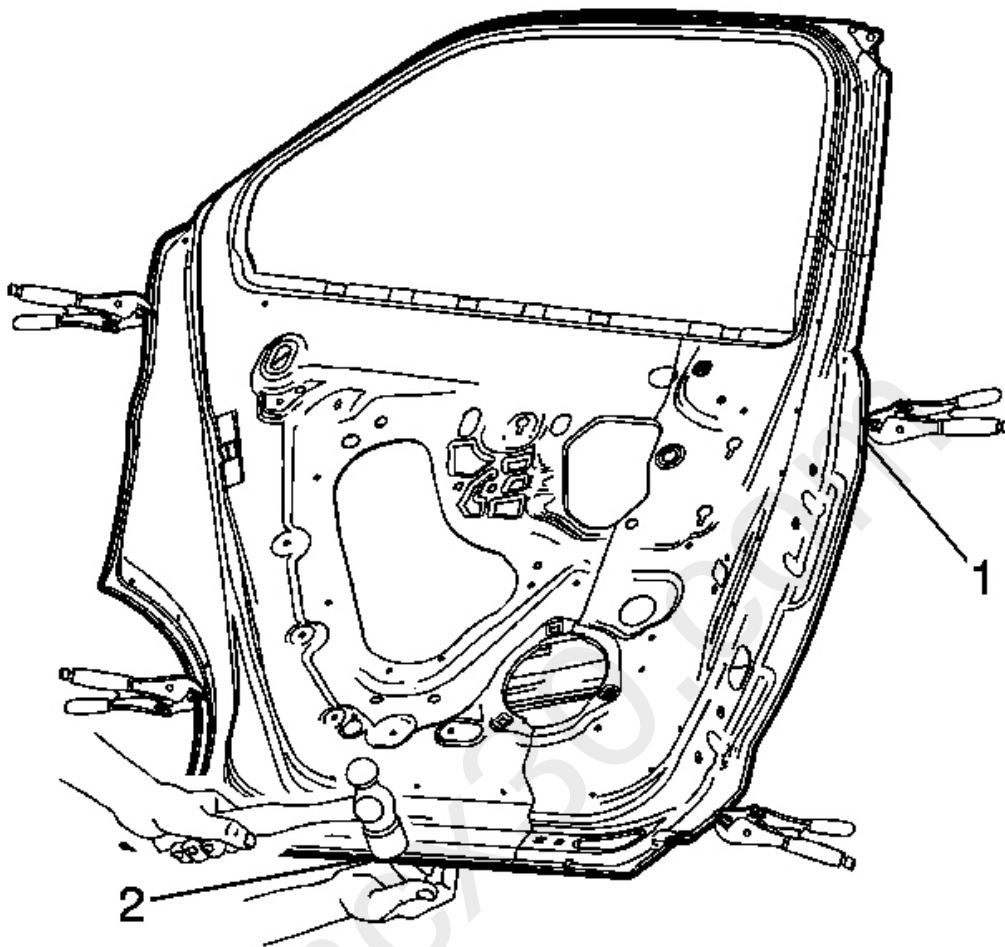
**Fig. 89: Re-Hemming Hem Flanges**  
Courtesy of GENERAL MOTORS CORP.

**NOTE:**        **Do NOT pull the panels apart after being joined together. Slide the panels against each other to realign the panels.**

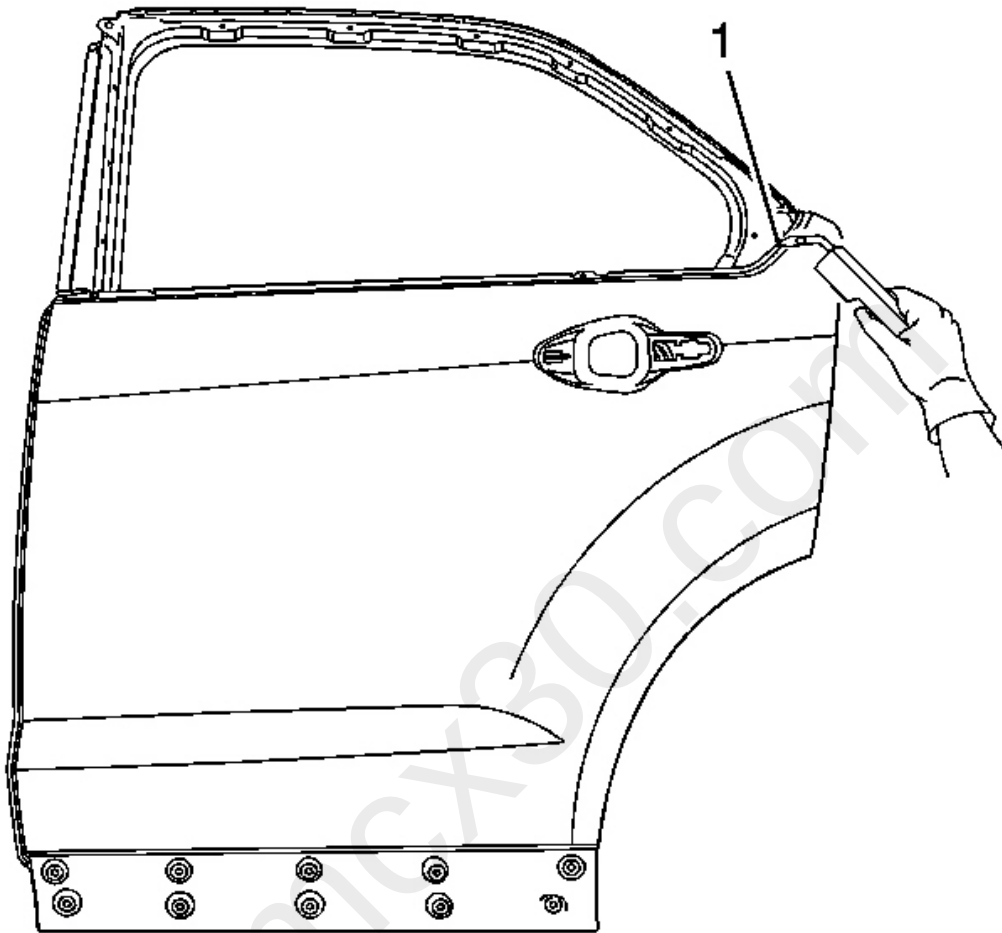
**Fig. 90: Welding Door Outer Panel**  
**Courtesy of GENERAL MOTORS CORP.**

12. Using metal-inert gas (MIG), weld the door outer panel to the door frame in the locations noted at the upper door frame (1).
13. Clean and prepare all welded surfaces.

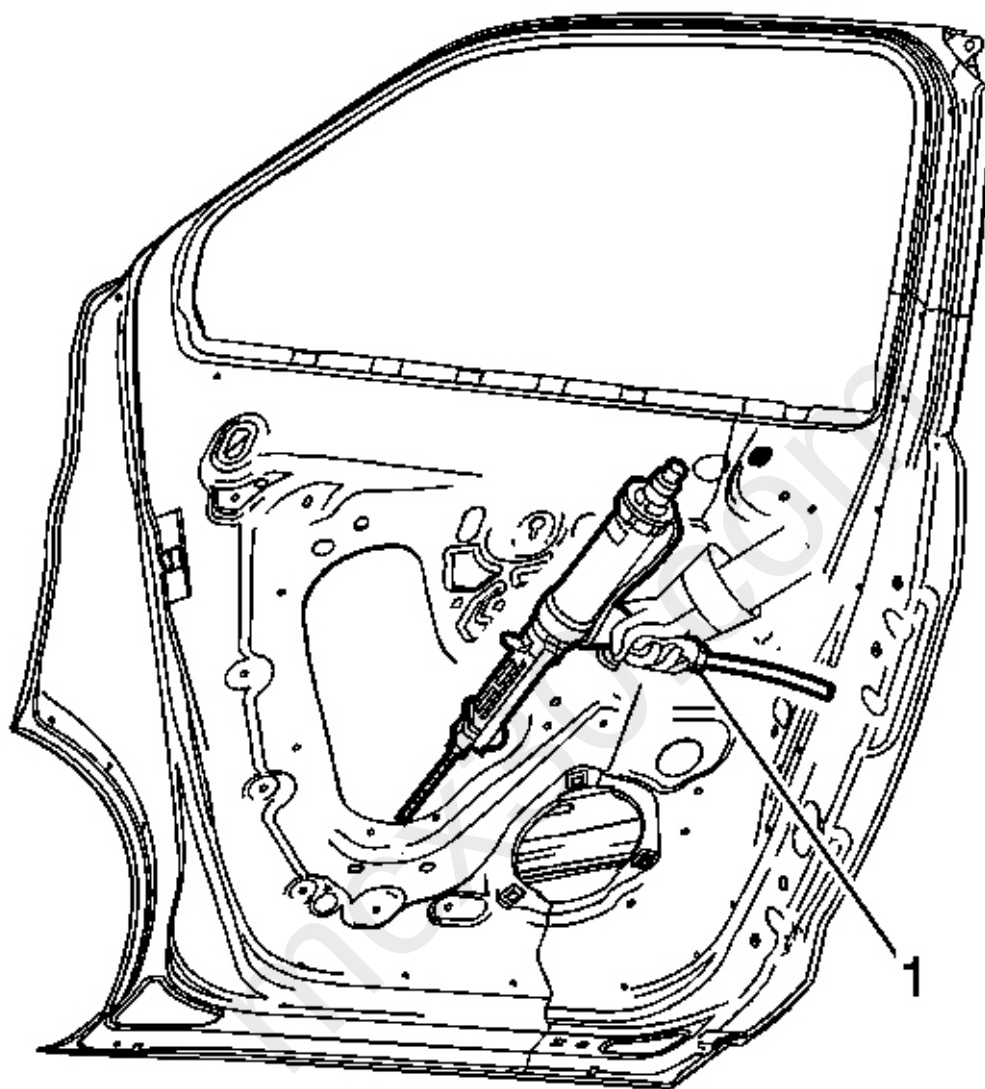
**Fig. 91: Applying Fusor**  
**Courtesy of GENERAL MOTORS CORP.**

14. Apply Fusor super flexible anti-flutter foam-fast set, Fusor P/N 121/124 or equivalent in 4-5 evenly spaced locations between the door outer panel and the impact beam (1).
15. Apply sealers and anti-corrosion materials to the repair area as necessary. Refer to **Anti-Corrosion Treatment and Repair** .
16. Paint the repaired area. Refer to **Basecoat/Clearcoat Paint Systems** .
17. Install the door assembly. Refer to **Front Side Door Replacement** .

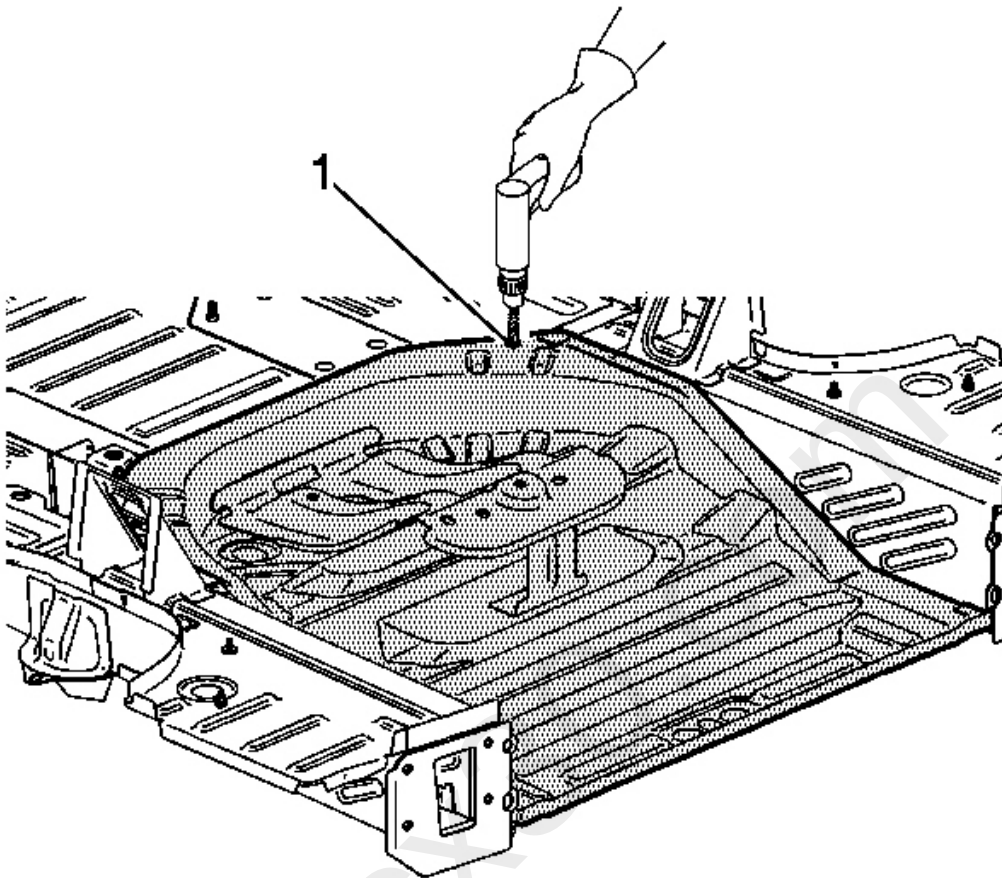
**Fig. 92: Drilling Out Factory Welds**  
Courtesy of GENERAL MOTORS CORP.

**NOTE:** Do not damage any inner panels or reinforcements. Record the number and location of the original welds for installation of the service part.

6. Locate and drill out all factory welds (1).

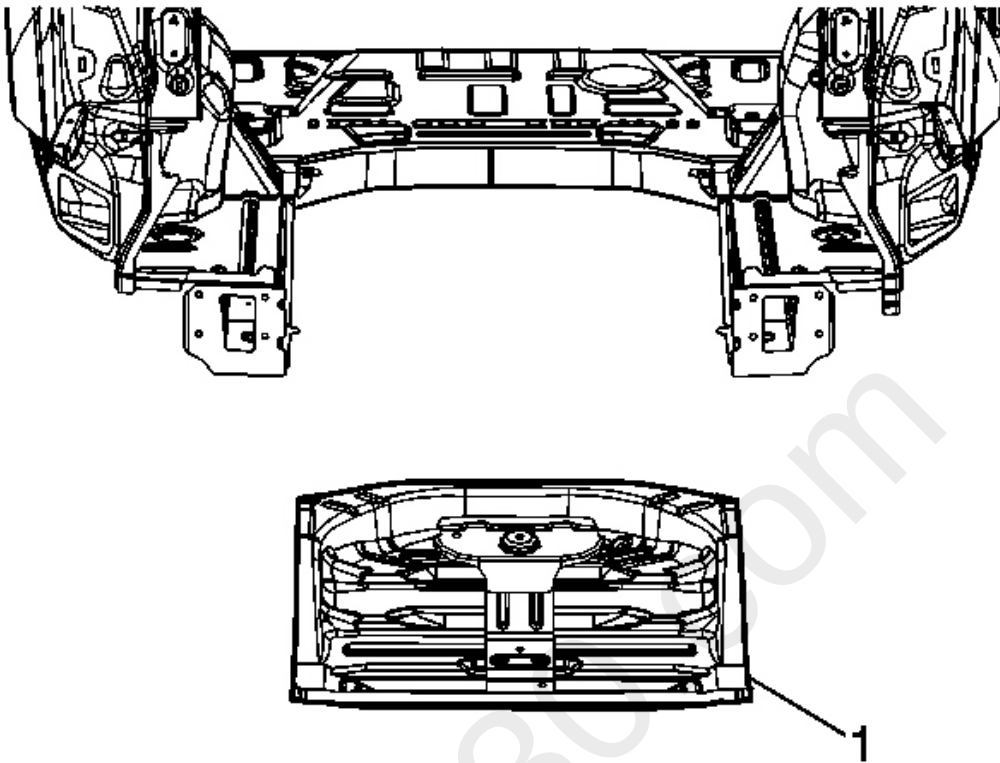
**Fig. 93: Identifying Damaged Rear Floor Panel**  
Courtesy of GENERAL MOTORS CORP.

7. Remove the damaged rear floor panel (1).

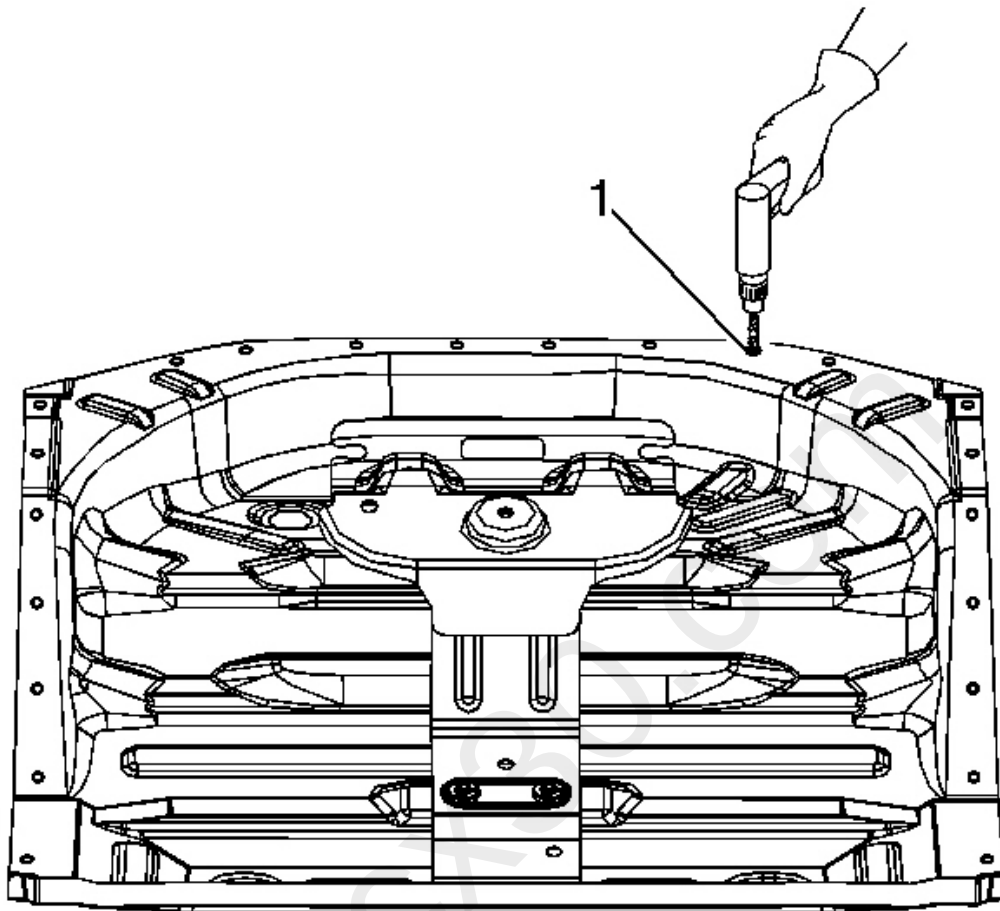
**Fig. 94: Drilling Plug Weld Holes**  
Courtesy of GENERAL MOTORS CORP.

**NOTE:** If the location of the original plug weld holes can not be determined, space the plug weld holes every 40 mm (1 1/2 in) apart.

1. Drill 8 mm (5/16 in) plug weld holes in the service part as necessary in the locations noted from the original panel (1).
2. Prepare all mating surfaces as necessary.
3. Apply GM-approved Weld-Thru Coating or equivalent to all mating surfaces. Refer to **Anti-Corrosion Treatment and Repair**.
4. Position the rear floor panel to the vehicle using 3-dimensional measuring equipment. Clamp the rear floor panel into place.

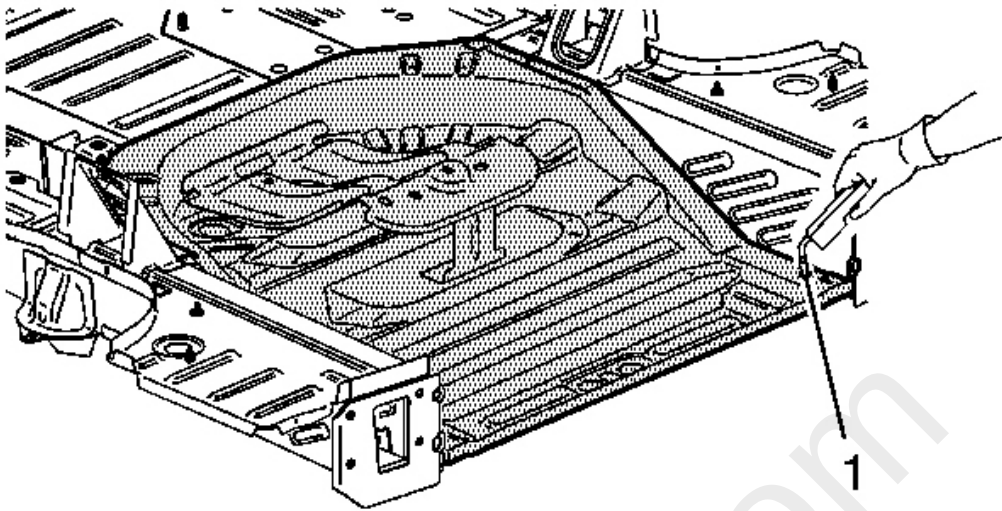
**Fig. 95: Plug Welding**

5. Plug weld accordingly (1).
6. Clean and prepare all welded surfaces.
7. Apply the sealers and anti-corrosion materials to the repair area, as necessary. Refer to **Anti-Corrosion Treatment and Repair** .
8. Paint the repair area. Refer to **Basecoat/Clearcoat Paint Systems** .
9. Install all related panels and components.
10. Connect the negative battery cable. Refer to **Battery Negative Cable Disconnection and Connection** .
11. Enable the SIR system. Refer to **SIR Disabling and Enabling** .

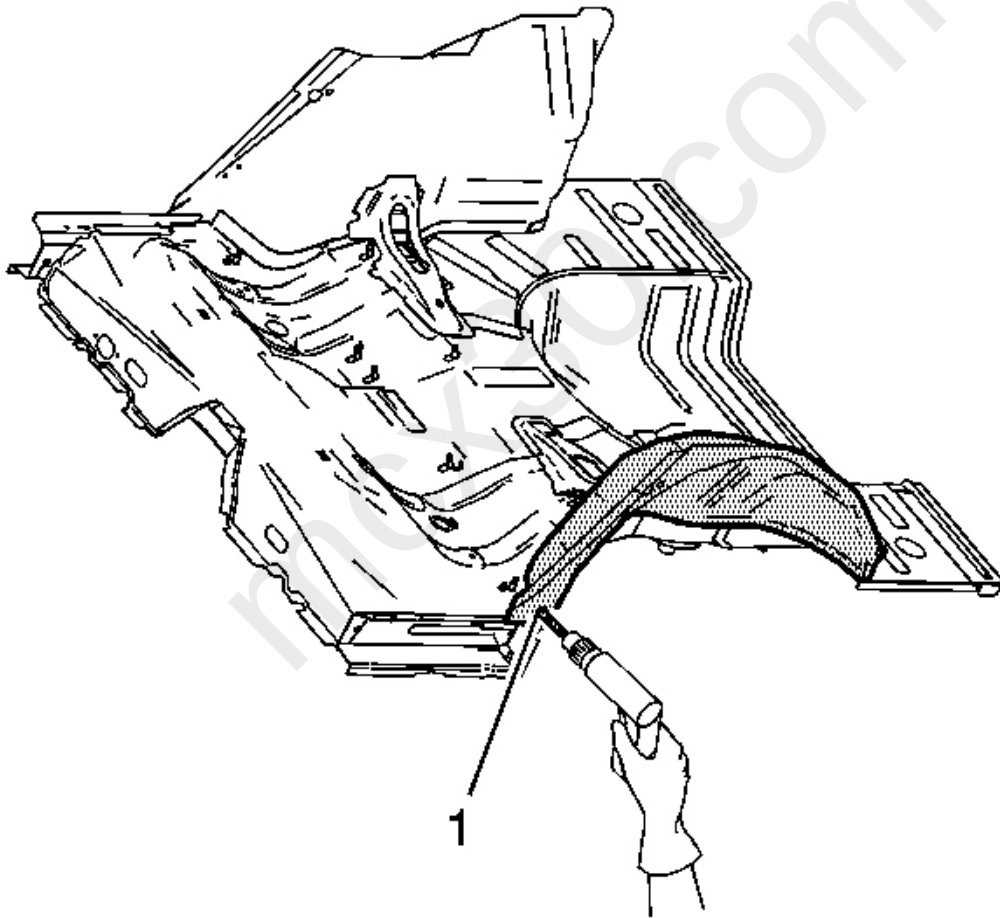
**Fig. 96: Drilling Out Factory Welds**  
Courtesy of GENERAL MOTORS CORP.

**NOTE:** Do not damage any inner panels or reinforcements. Record the number and location of the original welds for installation of the service part.

6. Locate and drill out all the necessary factory welds (1).

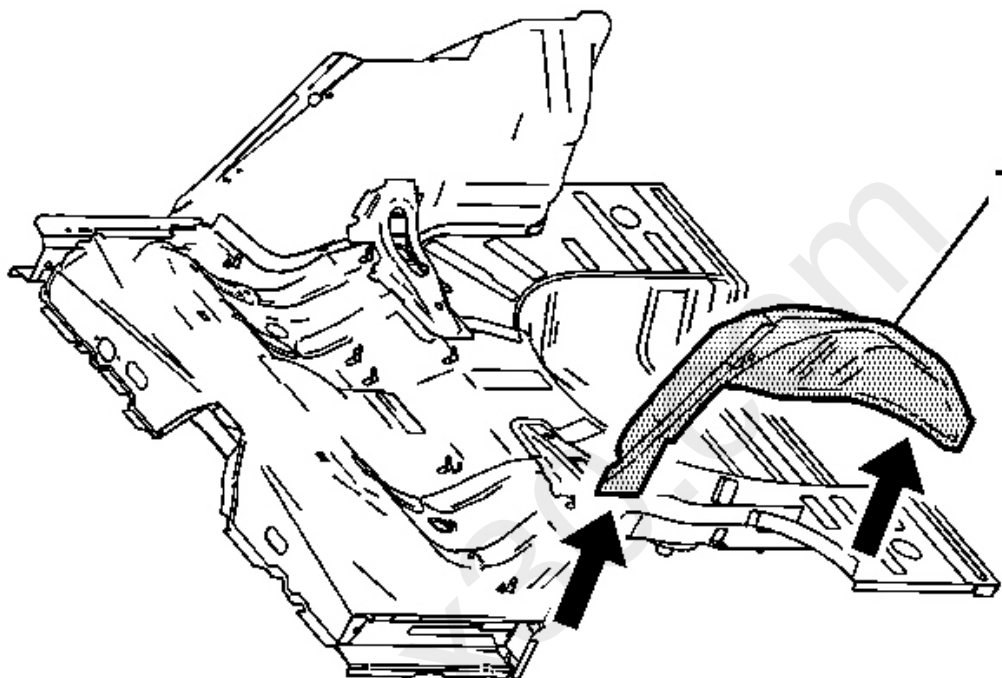
**Fig. 97: Removing Rear Inner Wheelhouse**  
Courtesy of GENERAL MOTORS CORP.

7. Remove the rear inner wheelhouse (1).

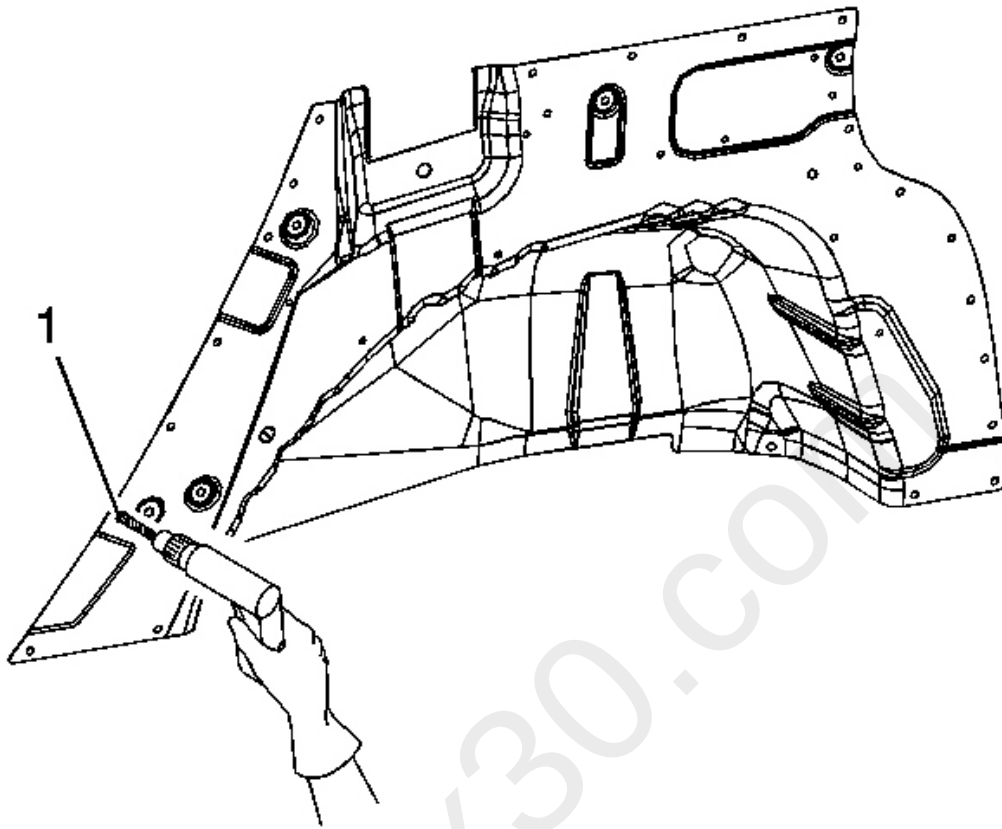
**Fig. 98: Drilling Plug Weld Holes**  
Courtesy of GENERAL MOTORS CORP.

**NOTE:** If the location of the original plug welds cannot be determined or structural weld- thru adhesive was present, space plug weld holes every 40 mm (1 1/2 in) apart.

1. Drill 8 mm (5/16 in) plug weld holes in the service part as necessary in the locations noted from the original panel (1).
2. Prepare all mating surfaces as necessary.
3. Apply GM-approved Weld-Thru Coating or equivalent to all mating surfaces. Refer to **Anti-Corrosion Treatment and Repair** .

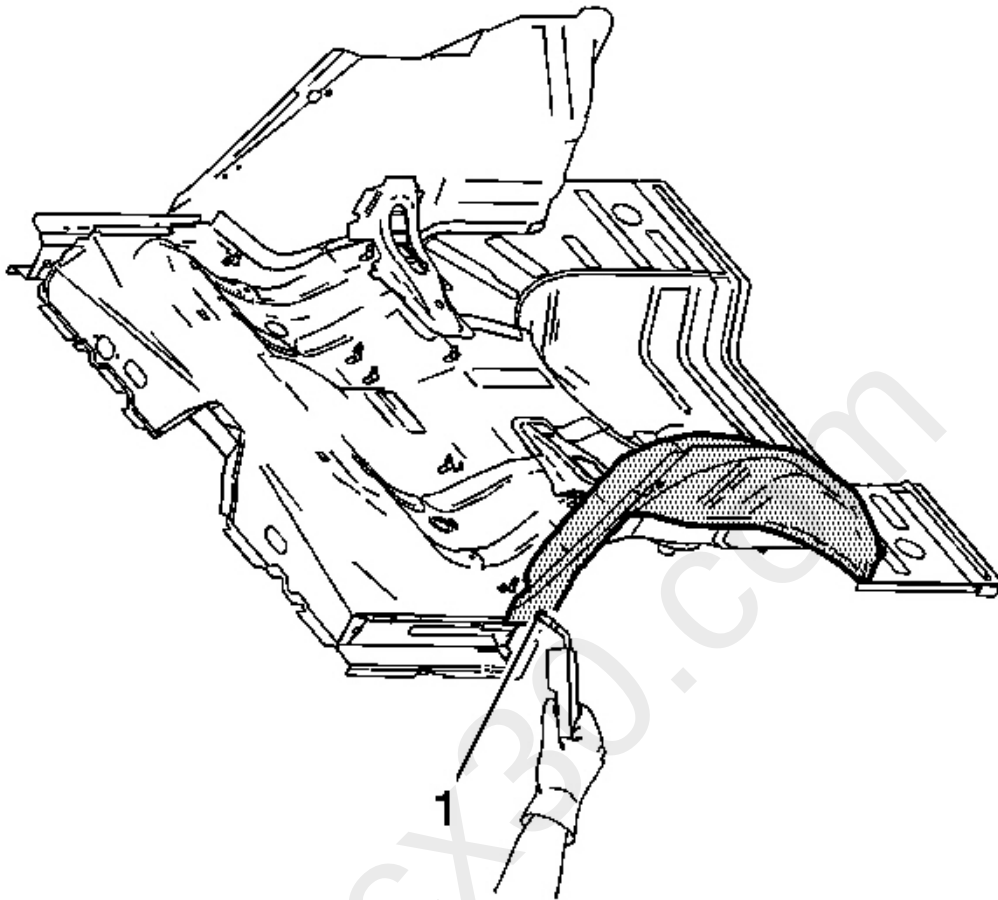
**Fig. 99: Plug Welding**  
Courtesy of GENERAL MOTORS CORP.

4. Plug weld accordingly (1).
5. Clean and prepare all of the welded surfaces.
6. Install all of the related panels and components.
7. Apply the sealers and anti-corrosion materials to the repair area, as necessary. Refer to **Anti-Corrosion Treatment and Repair** .
8. Paint the repair area. Refer to **Basecoat/Clearcoat Paint Systems** .
9. Connect the negative battery cable. Refer to **Battery Negative Cable Disconnection and Connection** .
10. Enable the SIR system. Refer to **SIR Disabling and Enabling** .

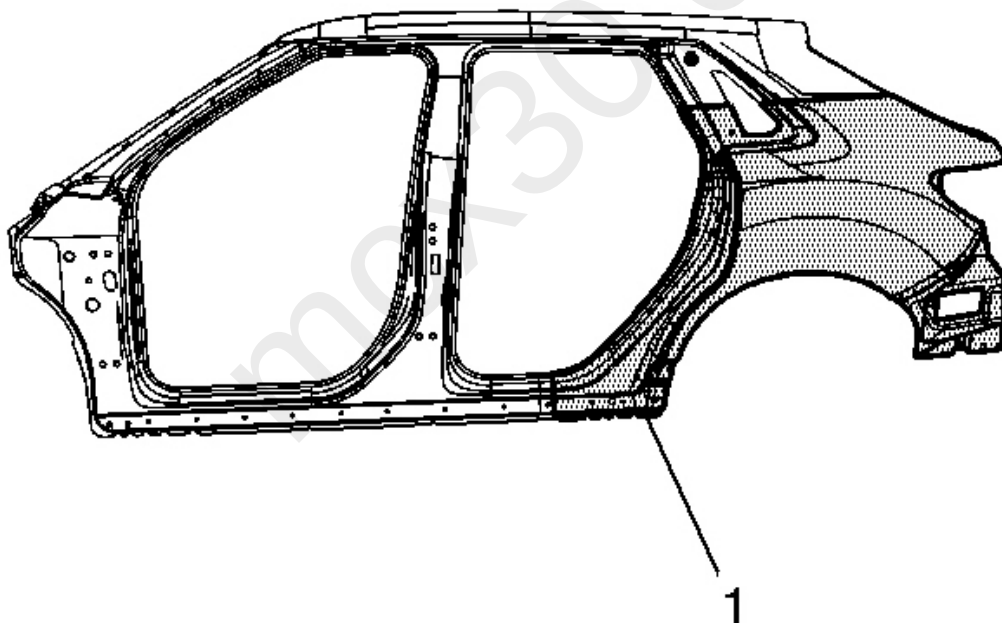
**Fig. 100: Identifying Related Panels & Components**  
Courtesy of GENERAL MOTORS CORP.

3. Remove all related panels and components (1).
4. Repair as much of the damage as possible to factory specifications. Refer to Dimensions - Body.

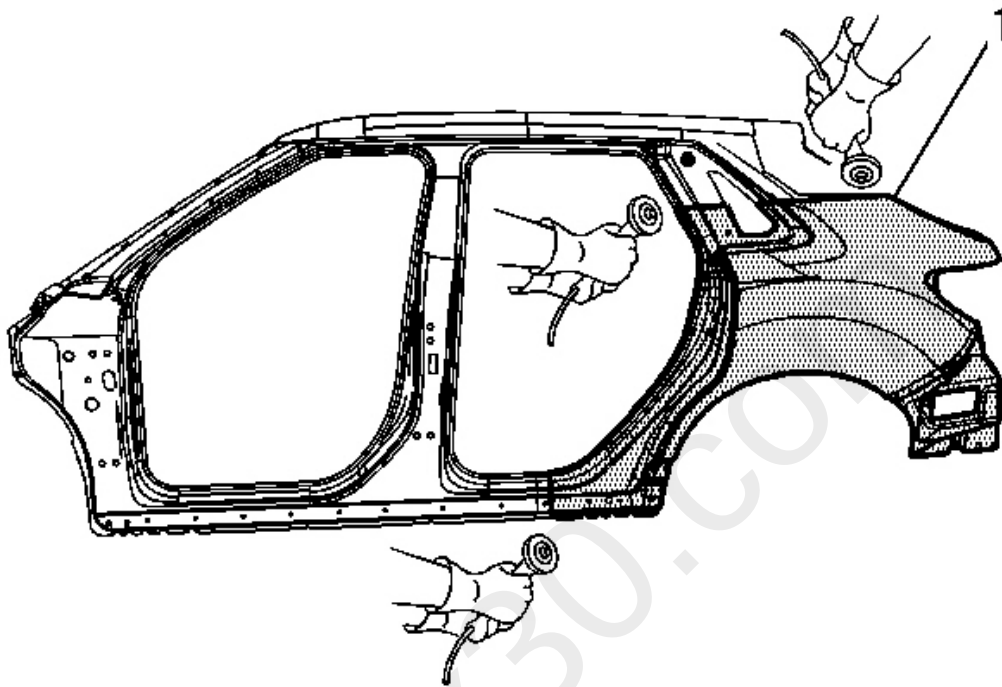
**Fig. 101: Cutting Panel**

**NOTE:** Do NOT damage any inner panels or reinforcements.

6. Cut the panel where sectioning is to be performed (1).

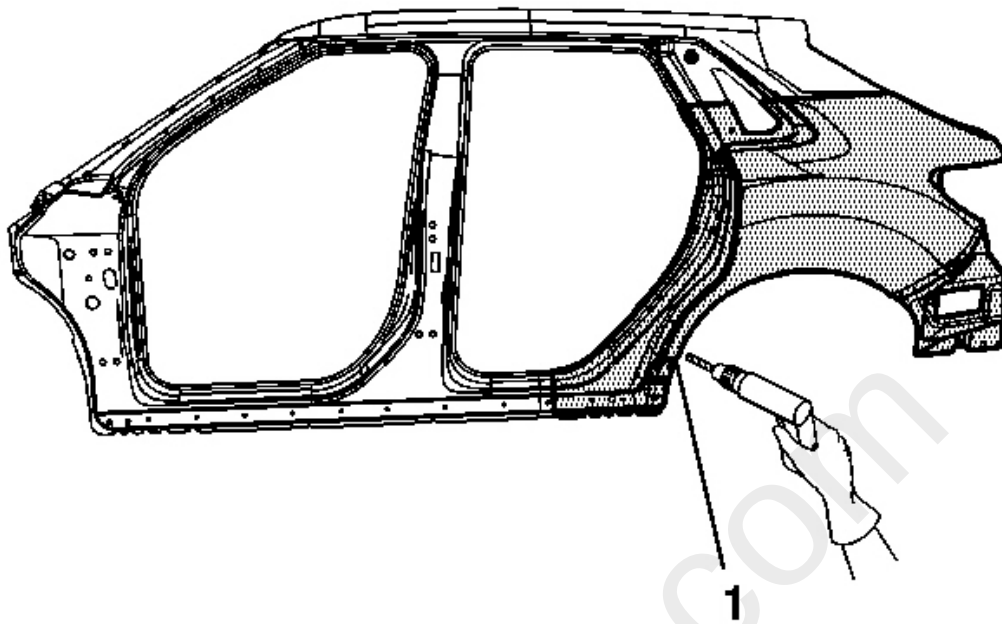
**Fig. 102: Drilling Out Factory Welds**  
**Courtesy of GENERAL MOTORS CORP.**

7. Locate and drill out all factory welds. Note the number and location of the welds for installations of the service part (1).
8. Remove the damaged quarter panel.

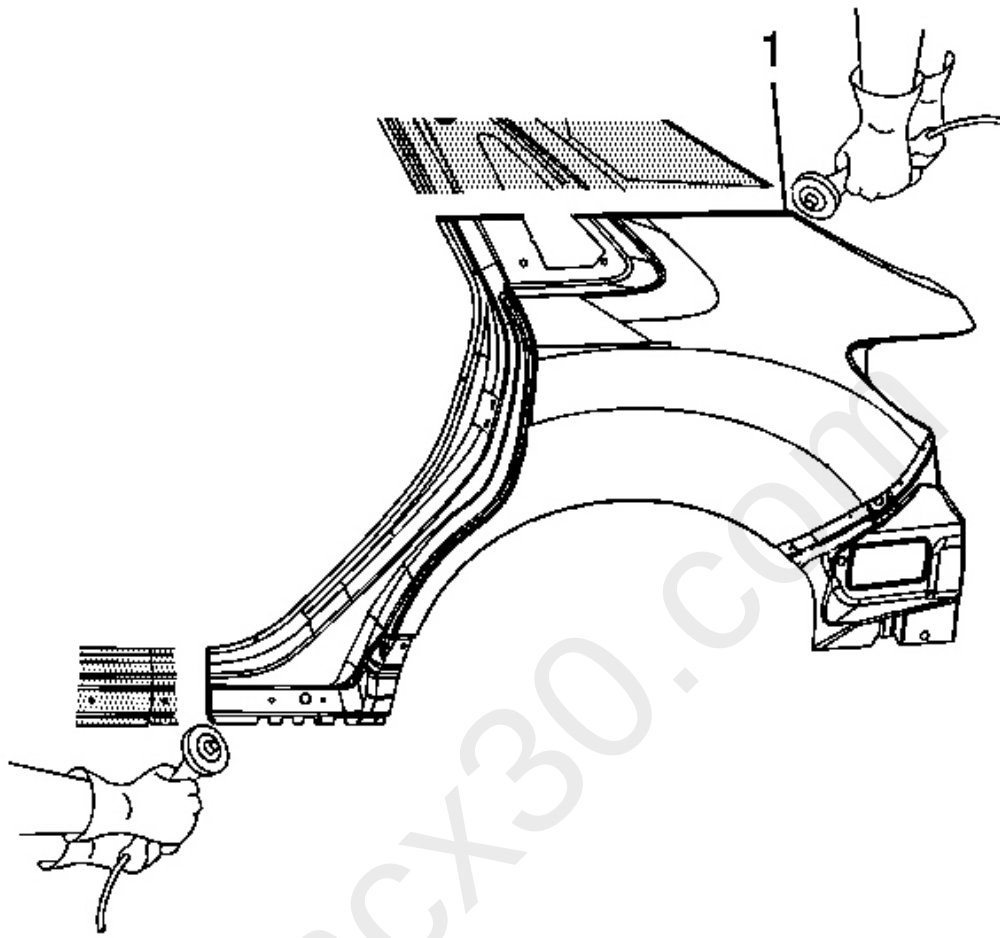
**Fig. 103: Creating Backing Plates**  
**Courtesy of GENERAL MOTORS CORP.**

2. Create two 50 mm (2 in) backing plates and one 100 mm (4 in) backing plate from the unused portion of the service part. Trim the backing plates as necessary to fit behind the sectioning joints where no reinforcements exist.
3. Drill 8 mm (5/16 in) plug weld holes along the sectioning cut on the remaining original part. Locate these holes 13 mm (1/2 in) from the edge and spaced 40 mm (1 1/2 in) apart.

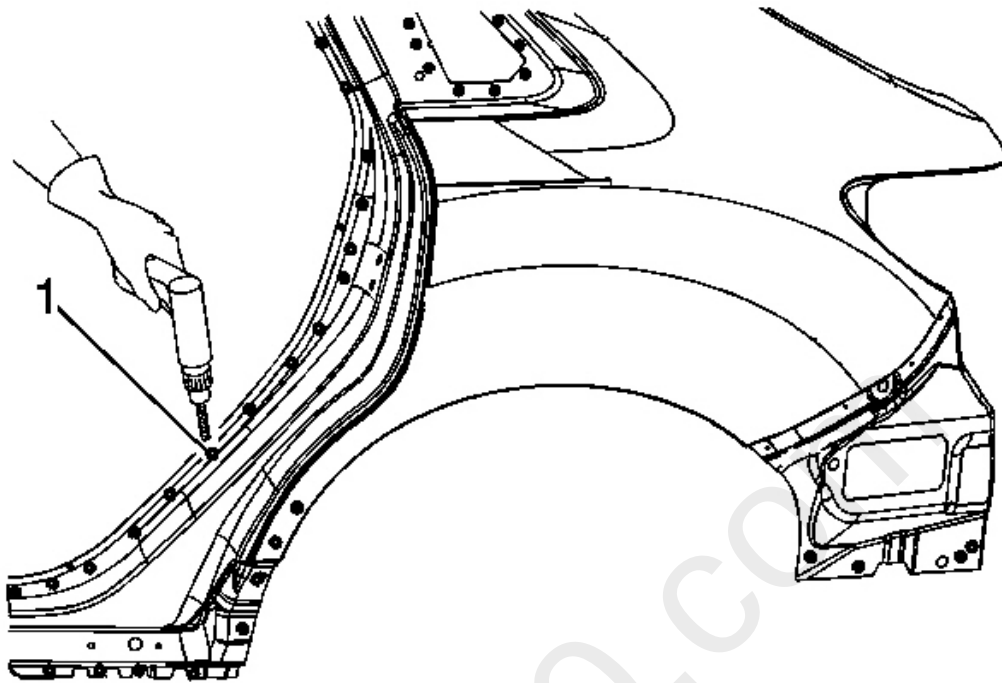
**Fig. 104: Drilling Plug Weld Holes**

**NOTE:** In any area damaged beyond recognition, or if structural Weld-Thru adhesive is present, space the plug weld holes 40 mm (1 1/2 in) apart.

4. Drill 8 mm (5/16 in) plug weld holes in the service part as necessary in the locations noted from the original panel and along the sectioning cut (1).
5. Prepare all mating surfaces, as necessary.
6. Apply GM-approved Weld-Thru Coating or equivalent to all mating surfaces. Refer to **Anti-Corrosion Treatment and Repair** .
7. Fit the backing plates halfway into the sectioning joints, clamp and plug weld to the vehicle.
8. Position the quarter panel.

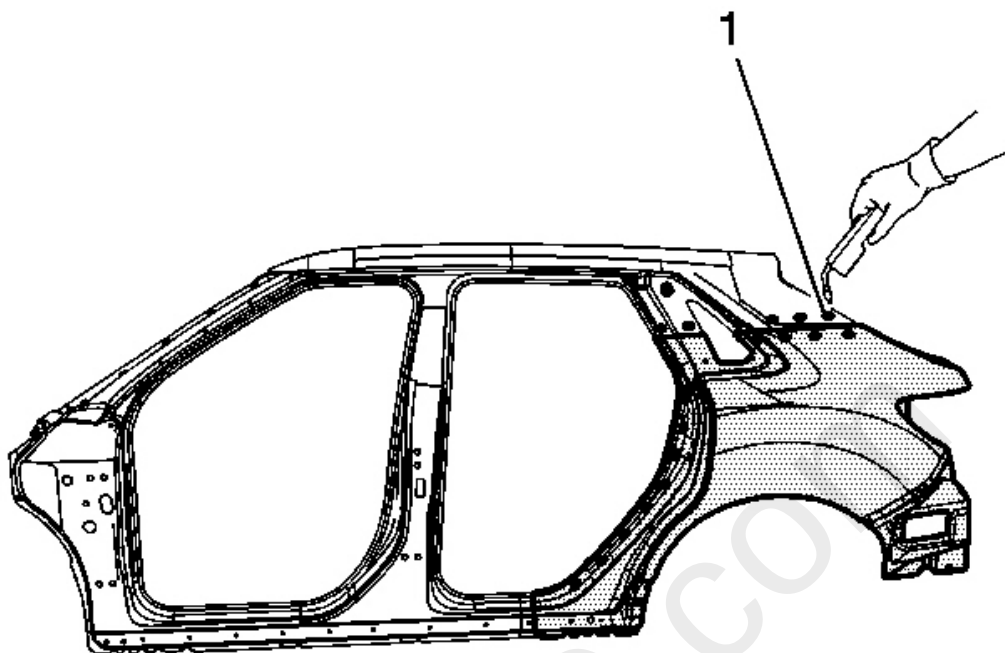
**Fig. 105: Plug Welding**

10. Stitch the weld sectioning joint.
11. Clean and prepare all welded surfaces.
12. Apply the sealers and anti-corrosion materials to the repair area, as necessary. Refer to **Anti-Corrosion Treatment and Repair** .
13. Paint the repair area. Refer to **Basecoat/Clearcoat Paint Systems** .
14. Install all related panels and components.
15. Connect the negative battery cable. Refer to **Battery Negative Cable Disconnection and Connection** .
16. Enable the SIR system. Refer to **SIR Disabling and Enabling** .

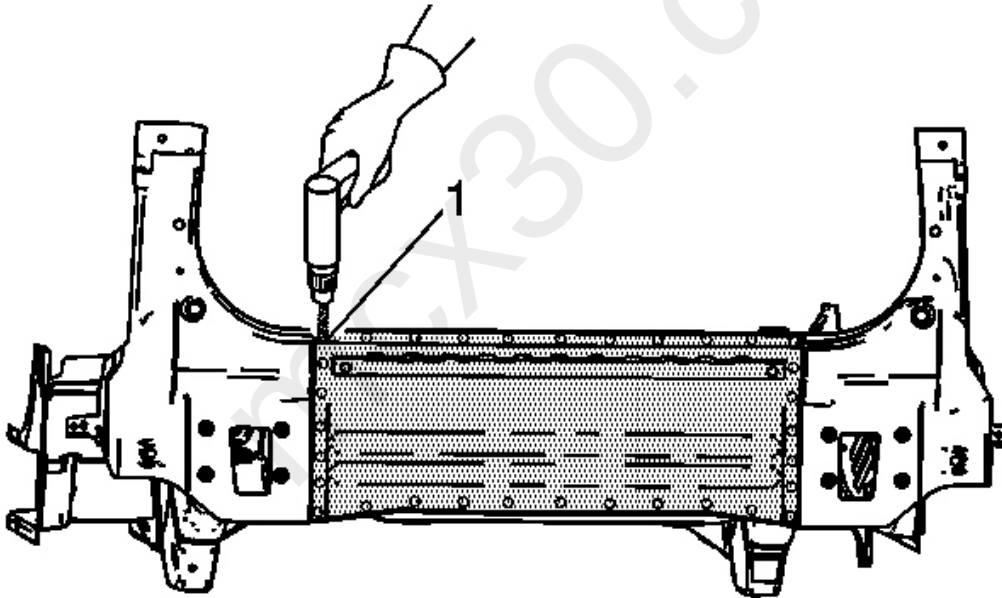
**Fig. 106: Drilling Out Factory Welds**  
Courtesy of GENERAL MOTORS CORP.

**NOTE:** Do not damage any inner panels or reinforcements. Record the number and location of the original welds for installation of the service part..

6. Locate and drill out all factory welds (1).

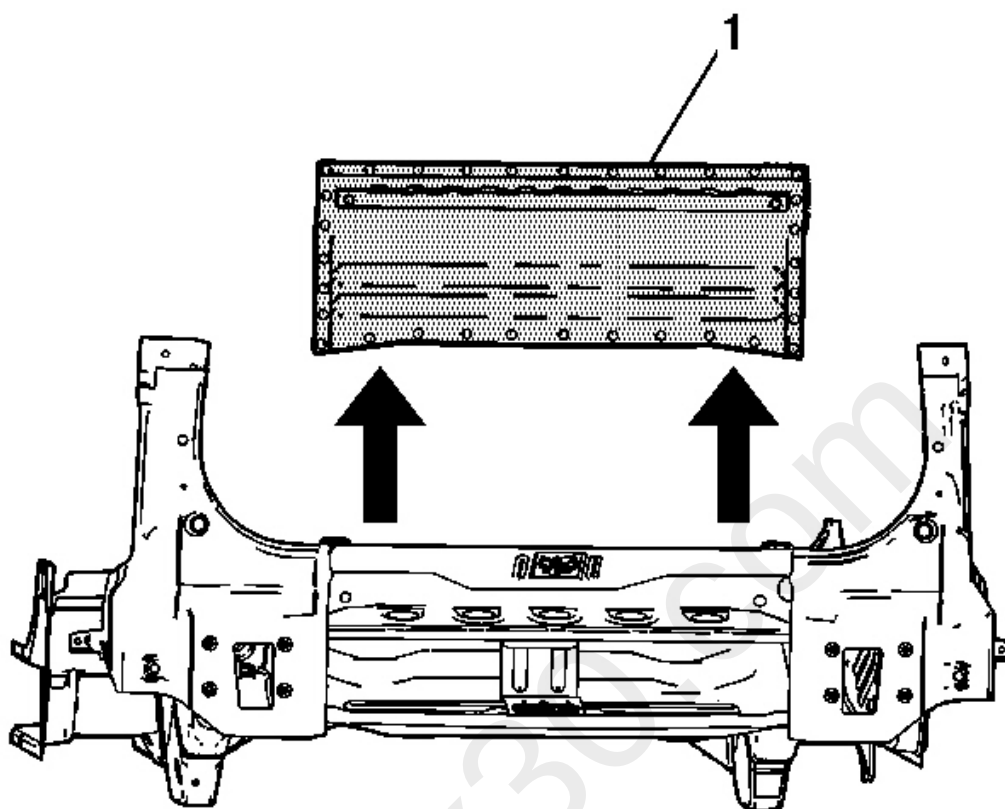
**Fig. 107: Removing Damaged Rear End Panel**  
Courtesy of GENERAL MOTORS CORP.

7. Remove the damaged rear end panel (1).

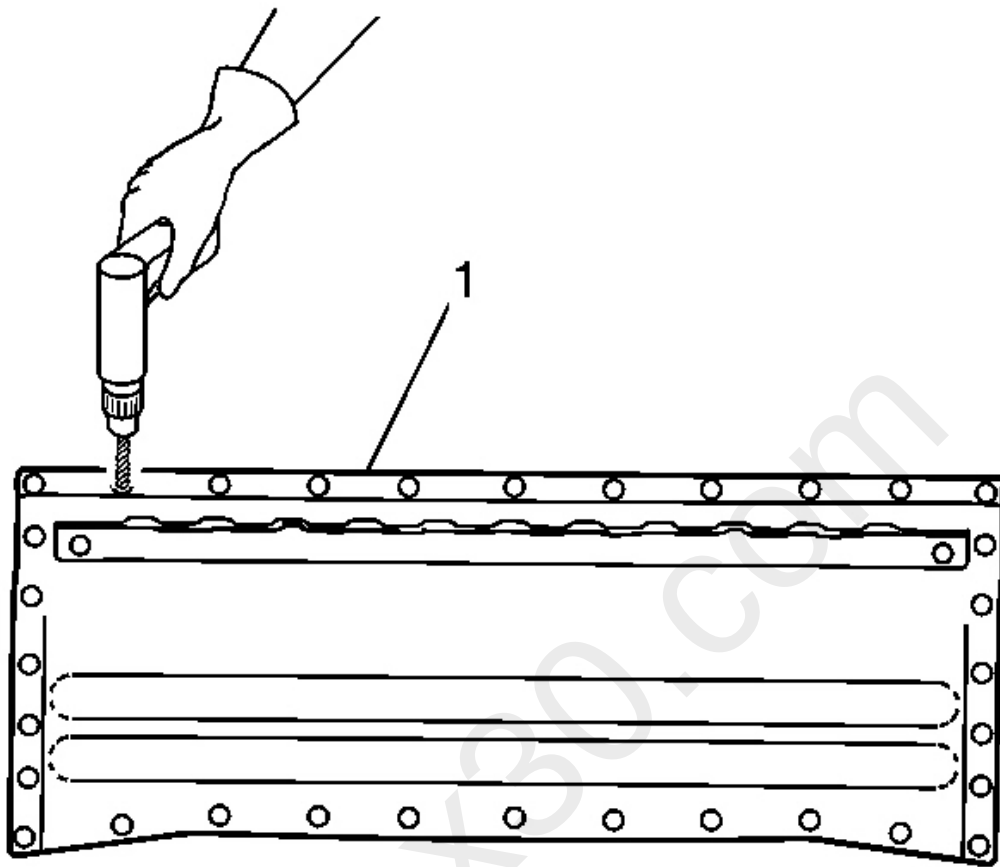
**Fig. 108: Drilling Plug Weld Holes**  
Courtesy of GENERAL MOTORS CORP.

**NOTE:** If the location of the original plug welds cannot be determined or structural weld- thru adhesive was present, space plug weld holes every 40 mm (1 1/2 in) apart.

1. Drill 8 mm (5/16 in) plug weld holes in the service part as necessary in the locations noted from the original panel (1).
2. Prepare all mating surfaces as necessary.
3. Apply GM-approved Weld-Thru Coating or equivalent to all mating surfaces. Refer to **Anti-Corrosion Treatment and Repair** .

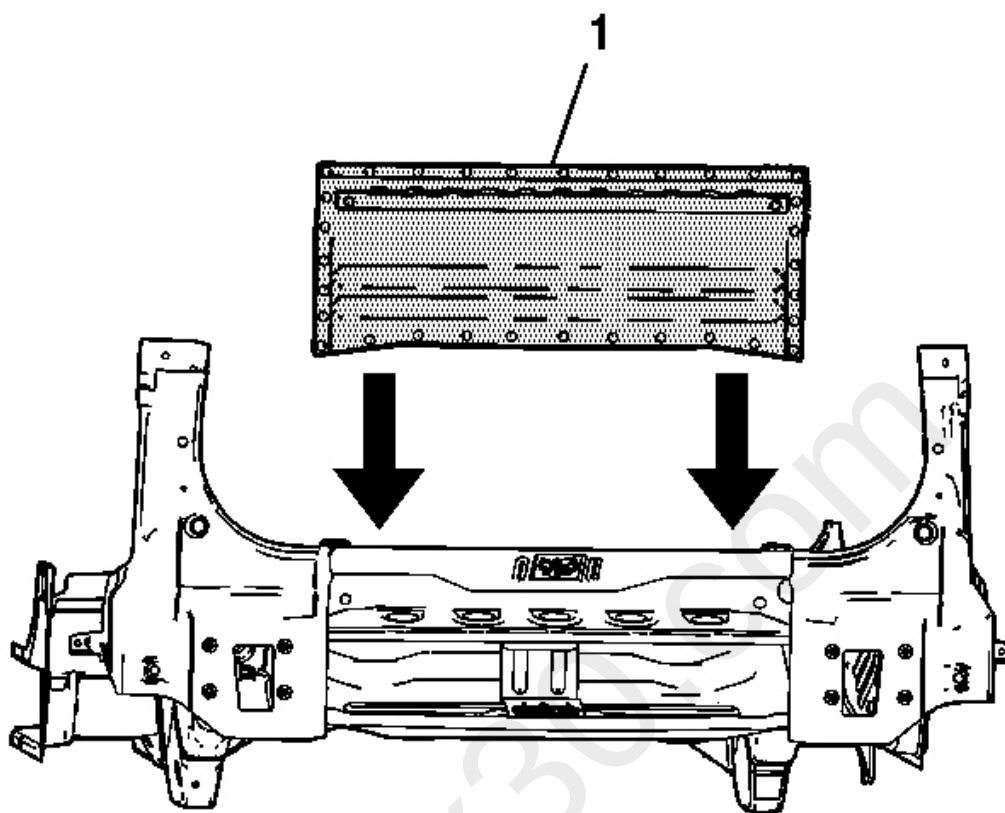
**Fig. 109: Positioning Rear End Panel**  
**Courtesy of GENERAL MOTORS CORP.**

4. Position the rear end panel to the vehicle using 3-dimensional measuring equipment (1). Clamp the rear end panel into place.

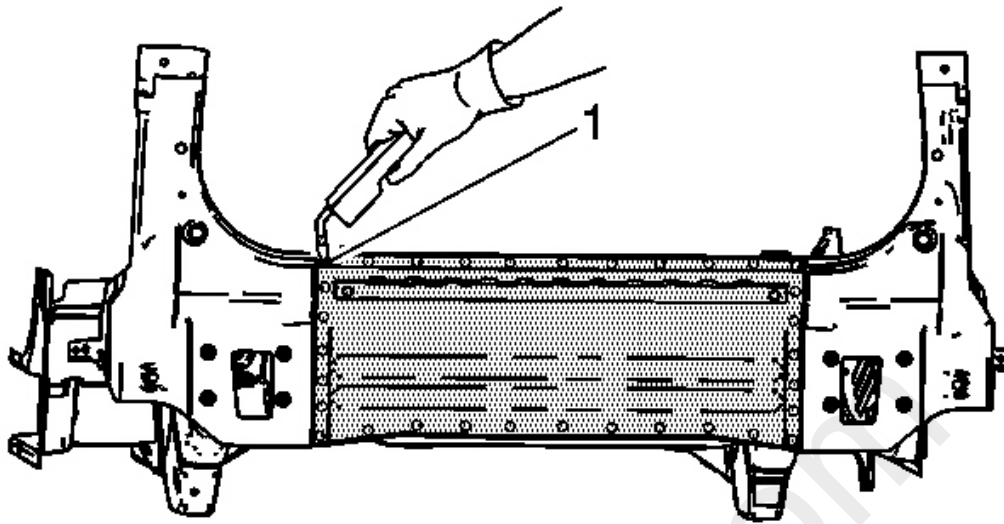
**Fig. 110: Plug Welding**  
**Courtesy of GENERAL MOTORS CORP.**

5. Plug weld accordingly (1).
6. Clean and prepare all welded surfaces.
7. Apply the sealers and anti-corrosion materials to the repair area, as necessary. Refer to **Anti-Corrosion Treatment and Repair** .
8. Paint the repair area. Refer to **Basecoat/Clearcoat Paint Systems** .
9. Install all related panels and components.
10. Connect the negative battery cable. Refer to **Battery Negative Cable Disconnection and Connection** .
11. Enable the SIR system. Refer to **SIR Disabling and Enabling** .

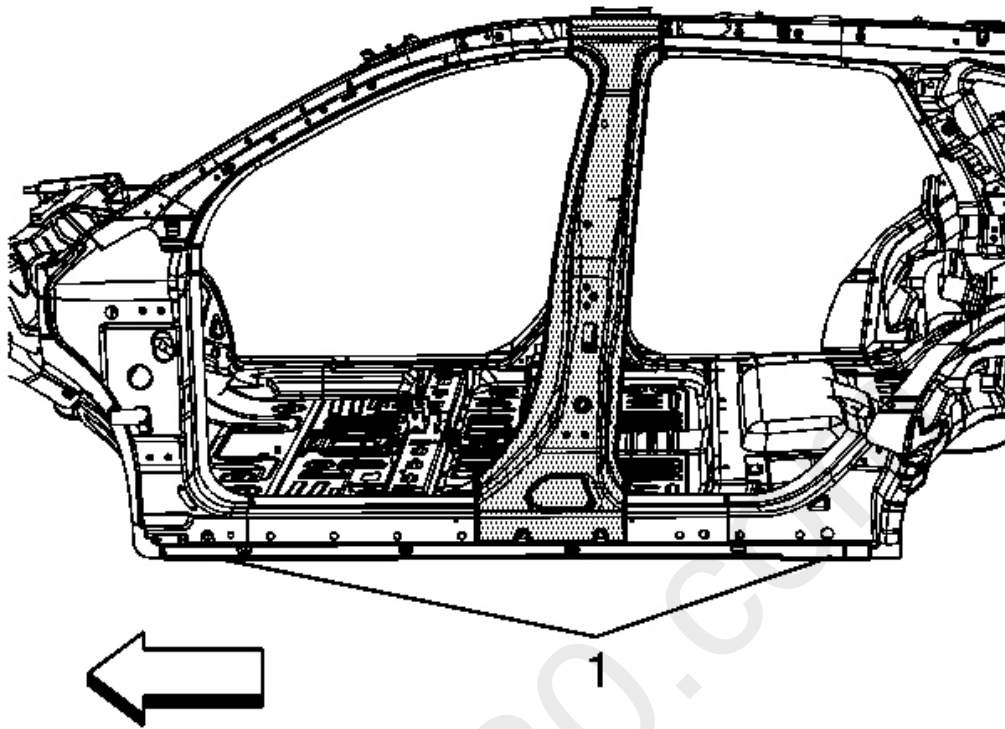
**Fig. 111: Center Pillar Outer Panel Reinforcement**  
Courtesy of GENERAL MOTORS CORP.

**NOTE:** The service B-Pillar will come as a complete assembly and the center B-Pillar Reinforcement is constructed of ultra high strength steel (martensitic) and can not be sectioned. It can only be replaced as a one piece unit.

3. Remove all related panels and components (1).
4. Repair as much of the damaged area as possible. Refer to Dimensions - Body.
5. Remove the sealers and anti-corrosion materials from the repair area, as necessary. Refer to Anti-Corrosion Treatment and Repair .
