## 2010 ACCESSORIES & EQUIPMENT

### Collision Repair - Equinox & Terrain

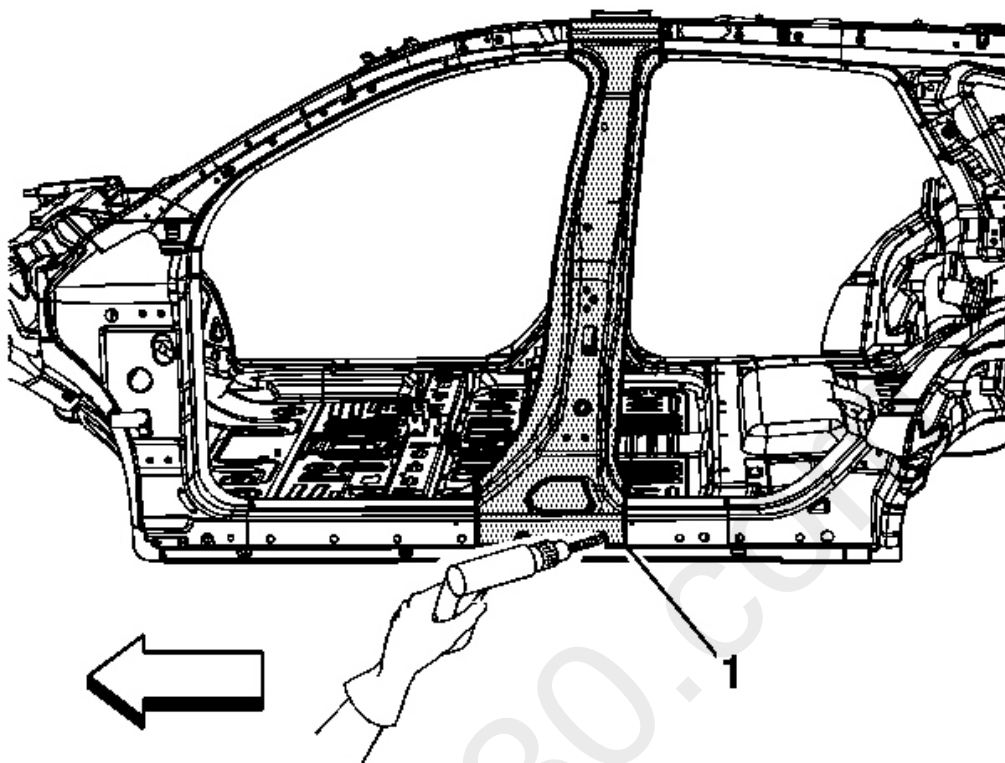
**Fig. 112: Drilling Out Factory Welds**  
Courtesy of GENERAL MOTORS CORP.

**NOTE:** Note the number and location of the factory welds for installation of the inner pillar lock front door.

6. Locate and drill out all the necessary factory welds (1).

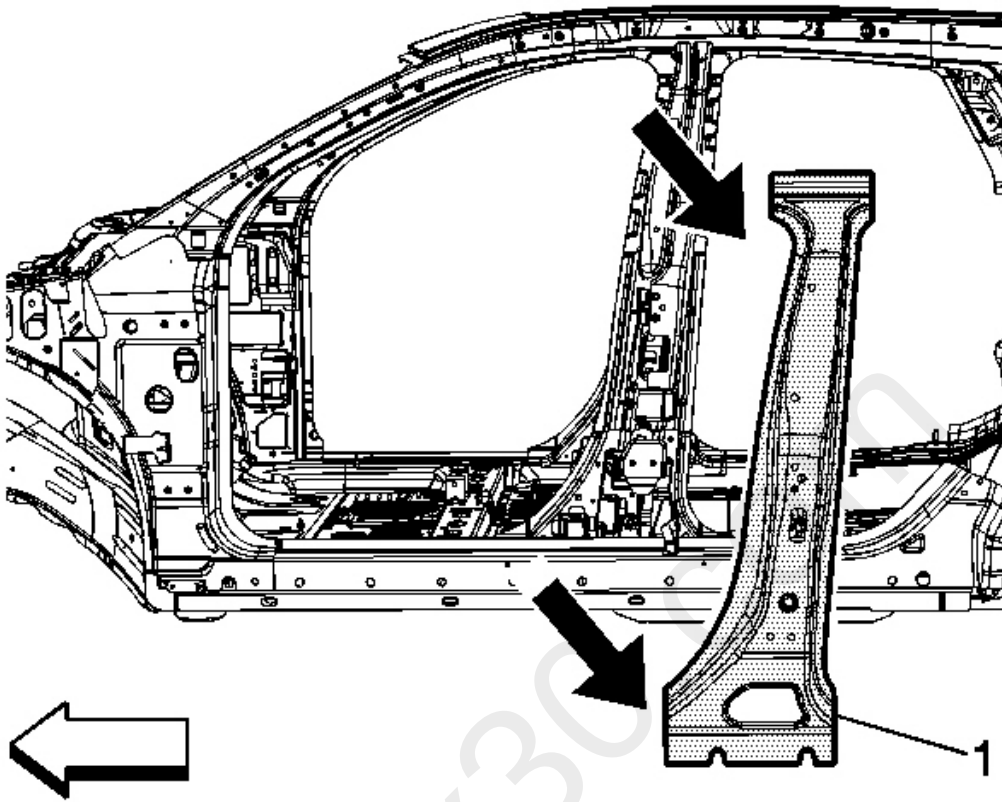
**Fig. 113: Removing Center B-Pillar**  
Courtesy of GENERAL MOTORS CORP.

7. Remove the Center B-Pillar from the factory seams (1).

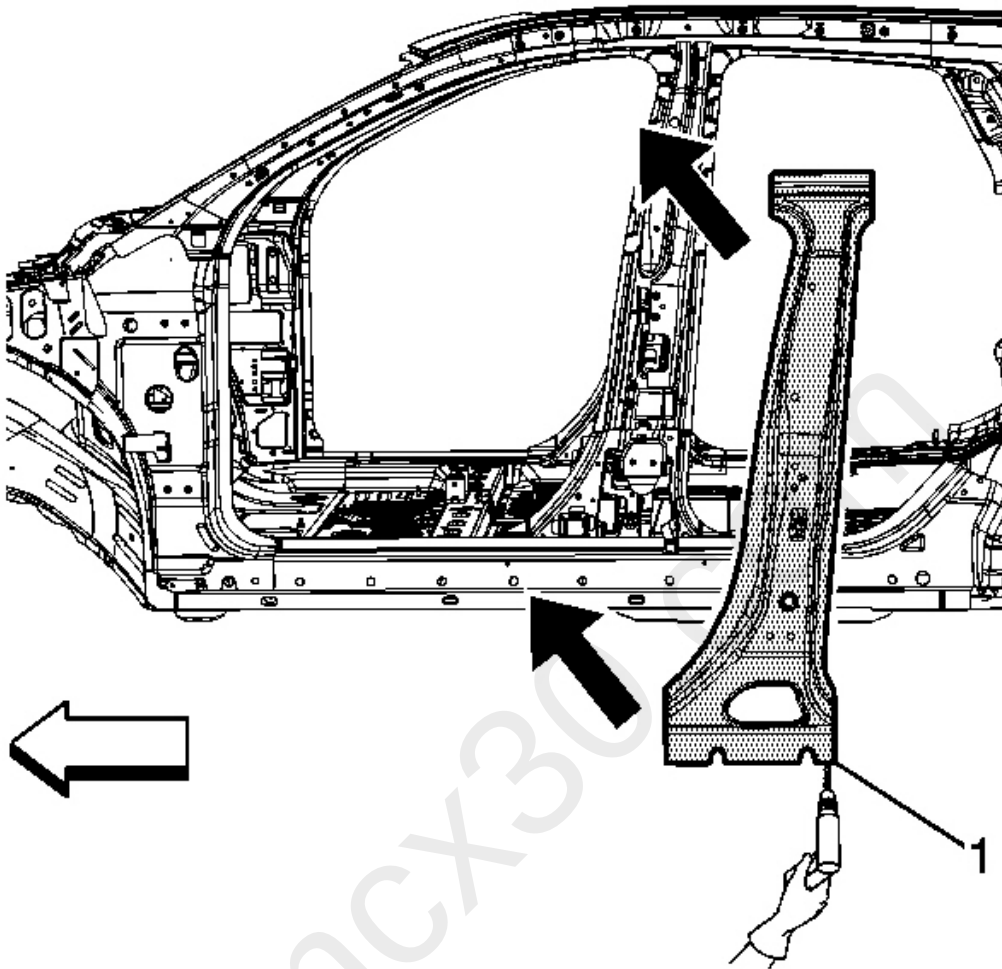
**Fig. 114: Drilling Plug Weld Holes**  
Courtesy of GENERAL MOTORS CORP.

**NOTE:** If the location of the original plug weld holes can not be determined, space the plug weld holes every 40 mm (1 in) apart.

1. Drill 8 mm (5/16 in) plug weld holes in the service part as necessary in the corresponding locations noted on the original panel (1).
2. Prepare all mating surfaces for welding as necessary.
3. Apply GM approved Weld-Thru Coating or equivalent to all mating surfaces. Refer to **Anti-Corrosion Treatment and Repair**.
4. Position the service part on the vehicle using 3-dimensional measuring equipment. Clamp the part in

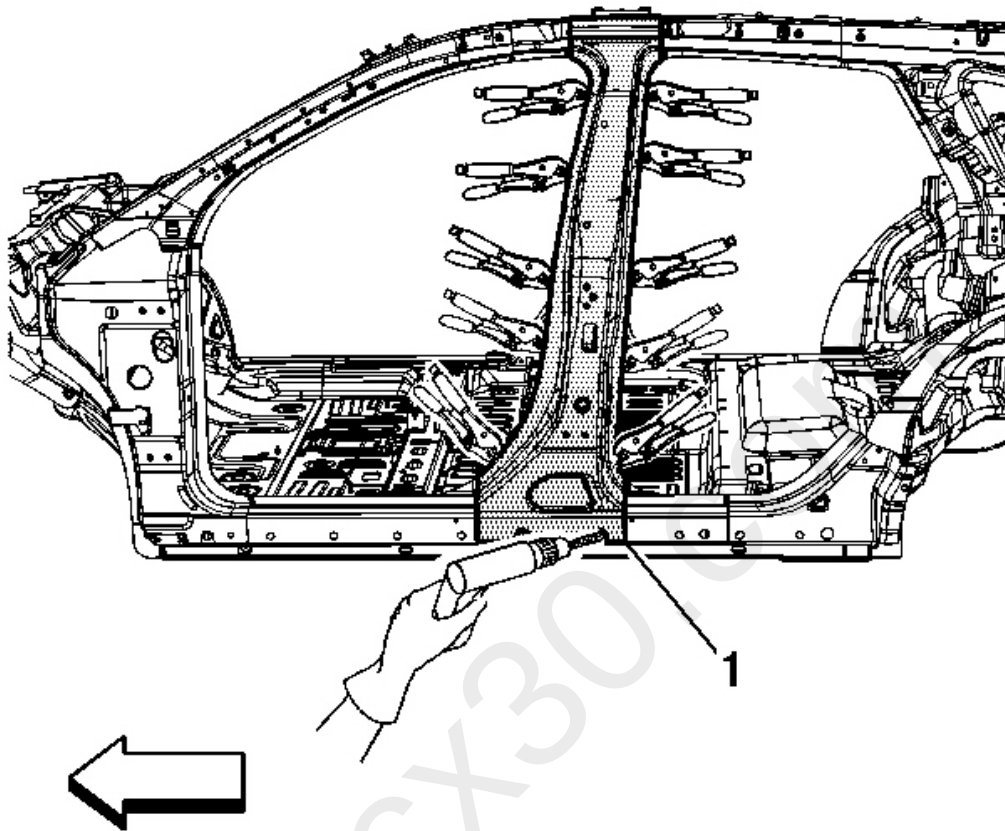
**Fig. 115: Plug Welding Center B-Pillar**  
Courtesy of GENERAL MOTORS CORP.

5. Plug weld accordingly (1).
6. Clean and prepare all welded surfaces.
7. Apply the sealers and anti-corrosion materials to the repair area, as necessary. Refer to **Anti-Corrosion Treatment and Repair** .
8. Paint the repair area. Refer to **Basecoat/Clearcoat Paint Systems** .
9. Install all related panels and components.
10. Connect the negative battery cable. Refer to **Battery Negative Cable Disconnection and Connection** .
11. Enable the SIR system. Refer to **SIR Disabling and Enabling**

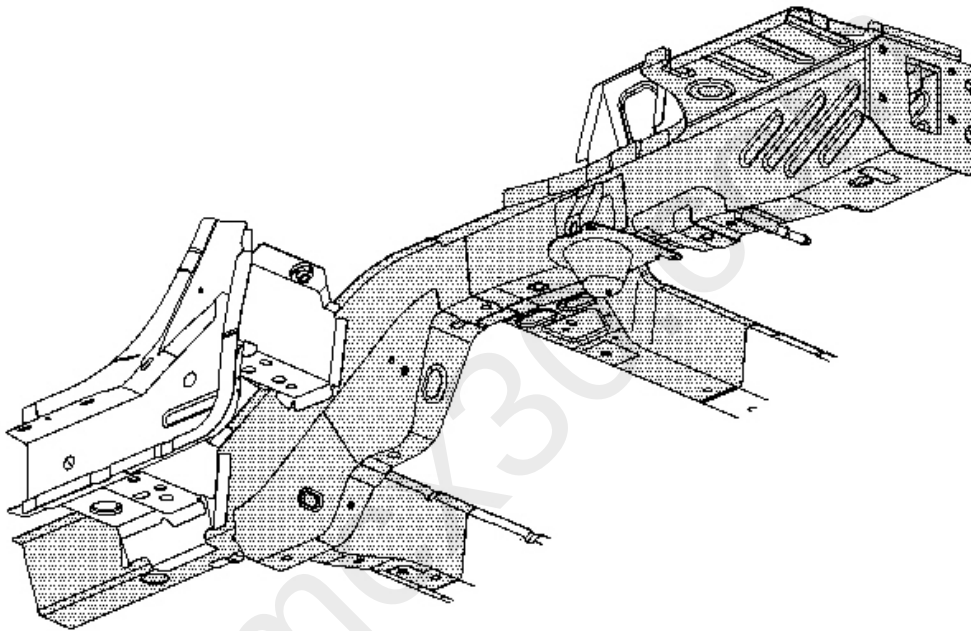
**Fig. 116: View Of Rear Rail**  
Courtesy of GENERAL MOTORS CORP.

1. Disable the supplemental inflatable restraint (SIR) system. Refer to SIR Disabling and Enabling .
2. Disconnect the negative battery cable. Refer to Battery Negative Cable Disconnection and Connection .
3. Remove all related panels and components.

4. Repair as much of the damage as possible to factory specifications. Refer to **Dimensions - Body**.
5. Note the location and remove the sealers and anti-corrosion materials from the repair area, as necessary. Refer to **Anti-Corrosion Treatment and Repair**.

6. Locate and drill out all factory welds. Note the number and location of the welds for installation of the rear rail lower.
7. Remove the damaged rear rail.

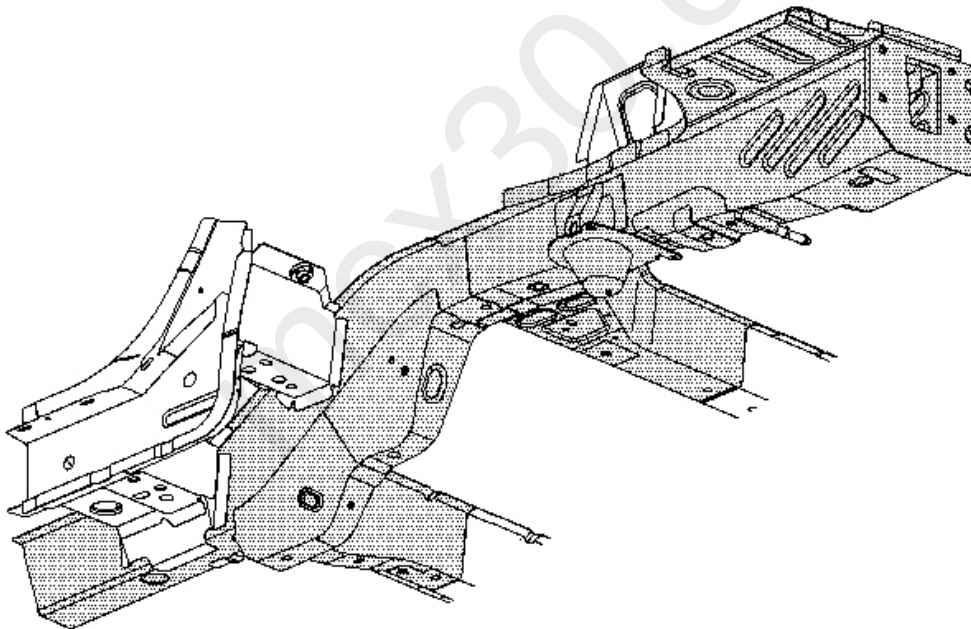
**Fig. 117: View Of Rear Rail**

**NOTE:** If the location of the original plug weld holes can not be determined, space the plug weld holes every 40 mm (1 1/2 in) apart. Some panels may have structural weld-thru adhesive. It is necessary to replace the weld-thru adhesive with an additional spot weld between each factory spot weld.

1. Drill 8 mm (5/16 in) plug weld holes in the service part as necessary in the locations noted from the original panel.
2. Prepare all mating surfaces as necessary.

3. Apply GM-approved Weld-Thru Coating or equivalent to all mating surfaces. Refer to **Anti-Corrosion Treatment and Repair** .
4. Position the rear rail lower to the vehicle using 3-dimensional measuring equipment. Clamp the rear rail lower into place.

5. Plug weld accordingly.
6. Clean and prepare all welded surfaces.
7. Apply the sealers and anti-corrosion materials to the repair area, as necessary. Refer to **Anti-Corrosion Treatment and Repair** .

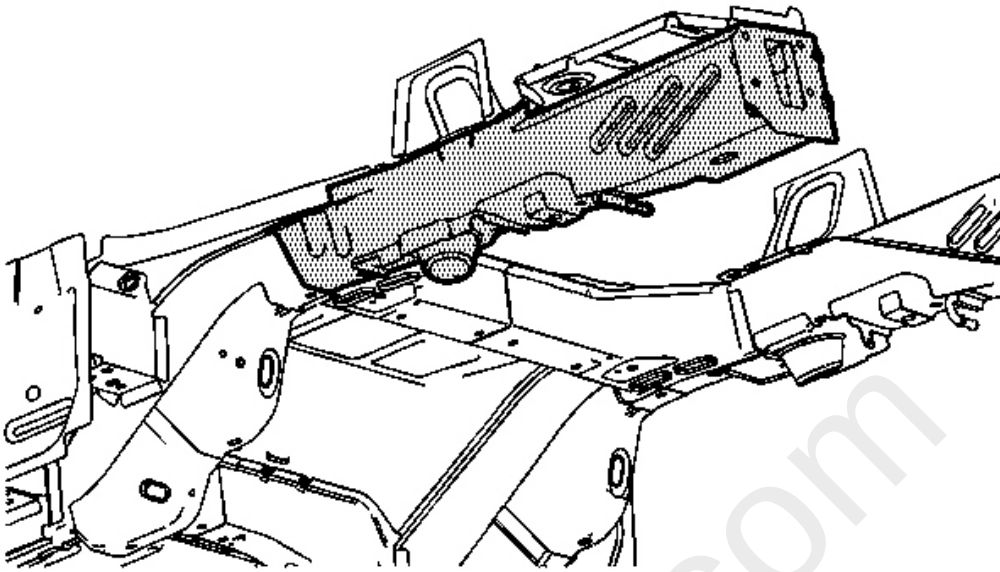
**Fig. 118: View Of Rear Rail Lower - Section**  
**Courtesy of GENERAL MOTORS CORP.**

1. Disable the supplemental inflatable restraint (SIR) system. Refer to **SIR Disabling and Enabling** .
2. Disconnect the negative battery cable. Refer to **Battery Negative Cable Disconnection and Connection** .
3. Remove all related panels and components.
4. Repair as much of the damage as possible to factory specifications. Refer to **Dimensions - Body**.
5. Note the location and remove the sealers and anti-corrosion materials from the repair area, as necessary. Refer to **Anti-Corrosion Treatment and Repair** .

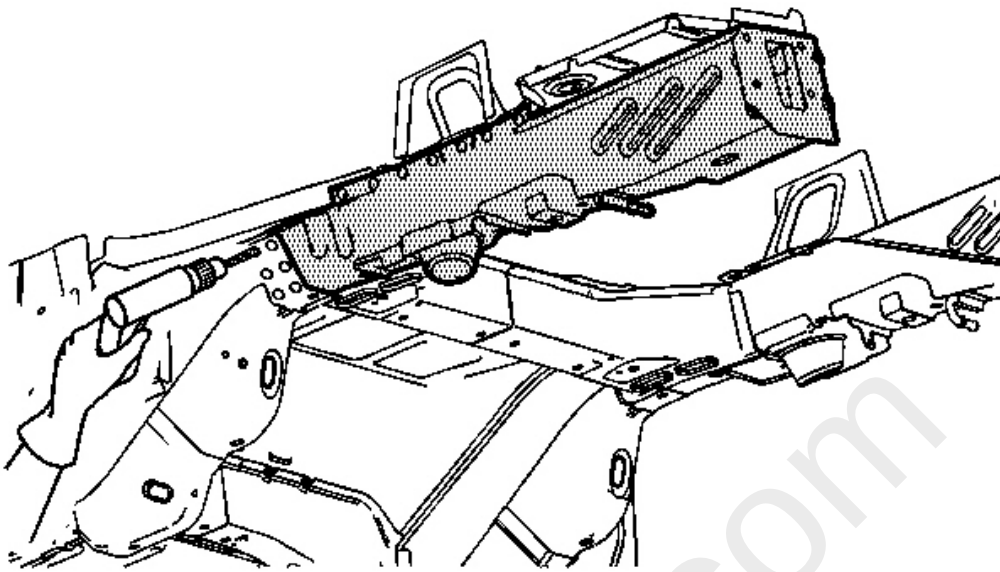
**Fig. 119: Drilling Out Factory Welds On Rear Rail Lower - Half**  
Courtesy of GENERAL MOTORS CORP.

**NOTE:** Do not damage any inner panels or reinforcements.

6. From inside of the vehicle, locate and drill out all factory welds. Note the number and location of the welds for installation of the rear rail lower - half.
7. Remove the No. 5 crossbar.

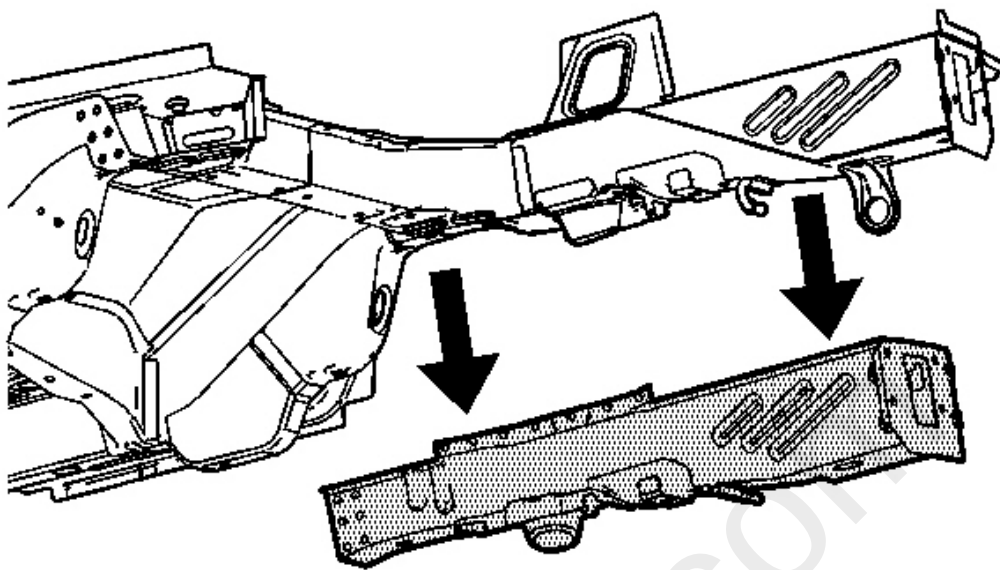
**Fig. 120: Identifying Rear Rail Lower - Section**  
 Courtesy of GENERAL MOTORS CORP.

8. Remove the damaged rear rail lower - section

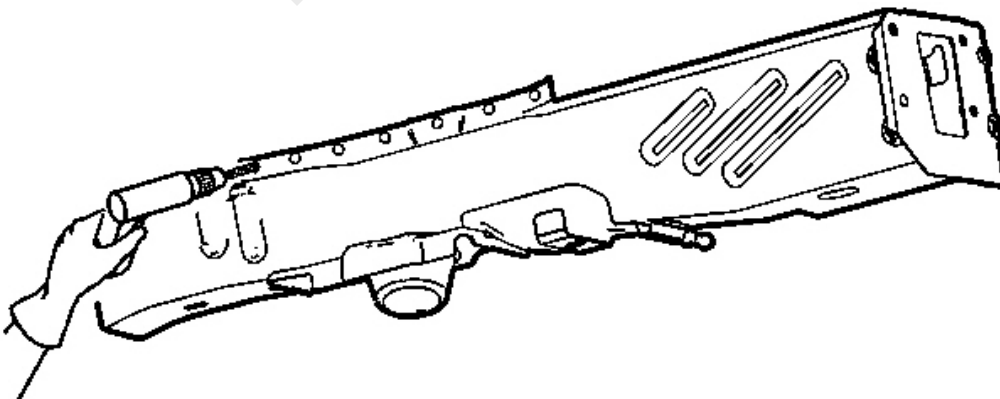
**Fig. 121: Drilling Plug Weld Holes On Rear Rail Lower - Section**  
Courtesy of GENERAL MOTORS CORP.

**NOTE:** If the location of the original plug weld holes can not be determined, space the plug weld holes every 40 mm (1 1/2 in) apart.  
Some panels may have structural weld-thru adhesive. It is necessary to replace the weld-thru adhesive with an additional spot weld between each factory spot weld.

1. Drill 8 mm (5/16 in) plug weld holes in the service part as necessary in the locations noted from the original panel.
2. Prepare all mating surfaces as necessary.
3. Apply GM-approved Weld-Thru Coating or equivalent to all mating surfaces. Refer to **Anti-Corrosion Treatment and Repair**.

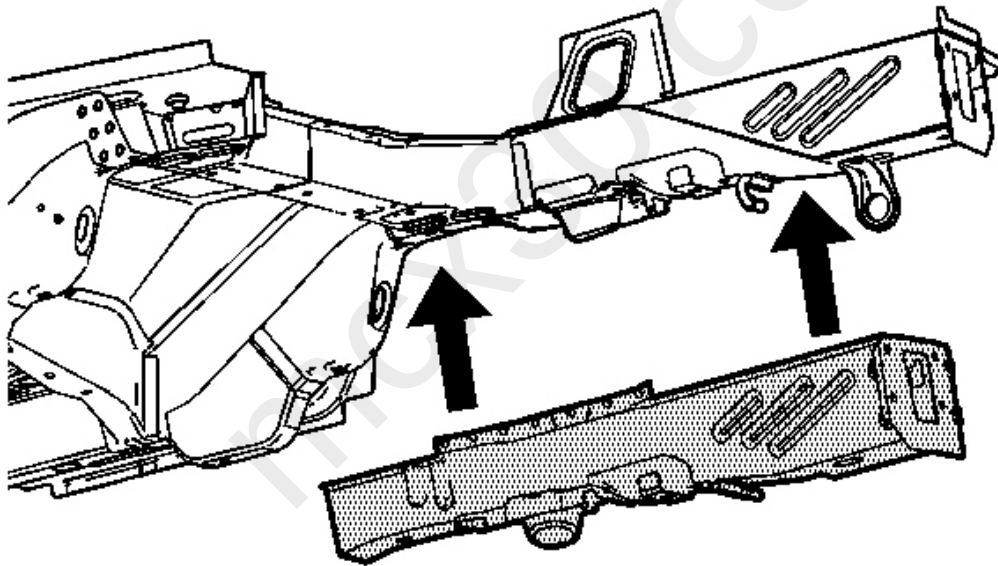
**Fig. 122: View Of Rear Rail Lower - Section**  
Courtesy of GENERAL MOTORS CORP.

4. Position the rear rail lower - rear section, rear rail upper, and No. 5 crossbar to the vehicle using 3-dimensional measuring equipment. Clamp the parts into place.

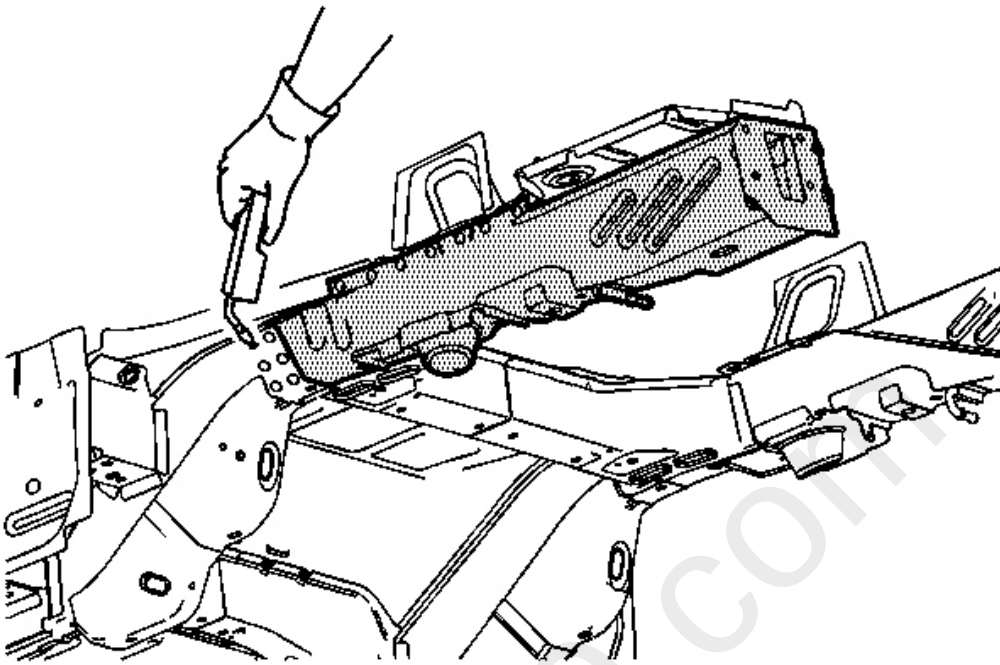
**Fig. 123: Plug Welding Rear Rail Lower - Section**  
**Courtesy of GENERAL MOTORS CORP.**

5. Plug weld accordingly.
6. Clean and prepare all welded surfaces.
7. Apply the sealers and anti-corrosion materials to the repair area, as necessary. Refer to **Anti-Corrosion Treatment and Repair**.
8. Paint the repair area. Refer to **Basecoat/Clearcoat Paint Systems**.
9. Install all related panels and components.
10. Connect the negative battery cable. Refer to **Battery Negative Cable Disconnection and Connection**.
11. Enable the SIR system. Refer to **SIR Disabling and Enabling**.
