## 2017 ACCESSORIES & EQUIPMENT

### Floor Coverings and Headlinings - Encore, Trax

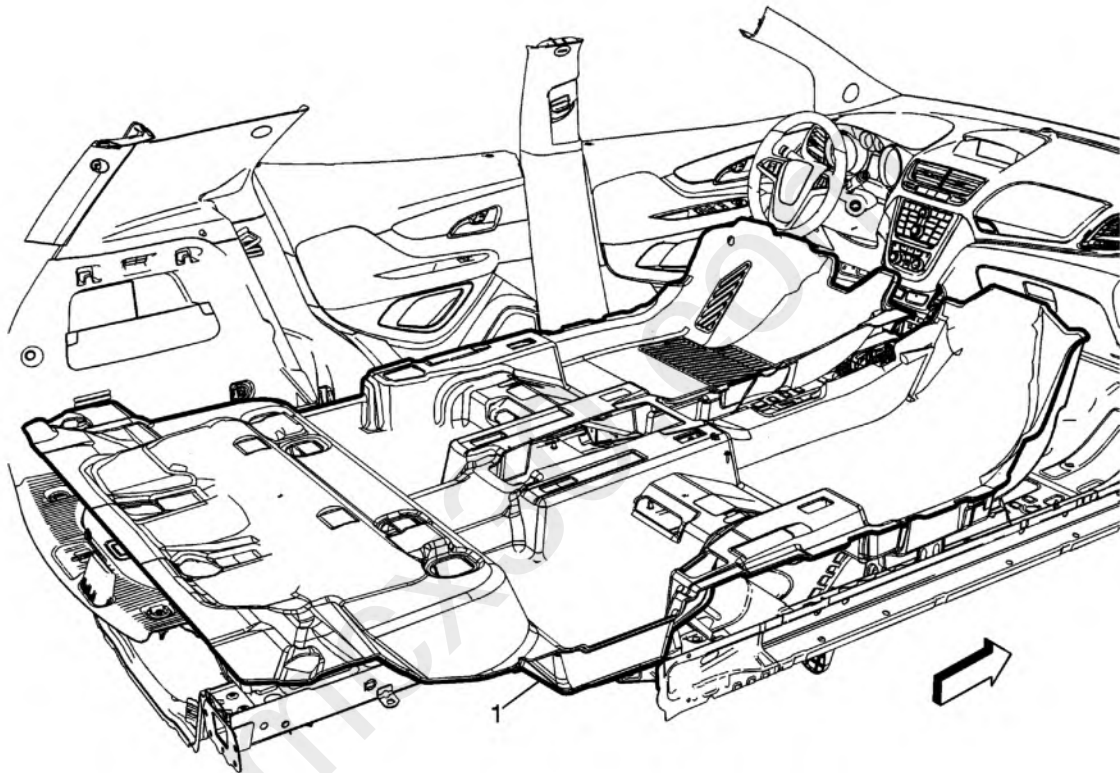
**Fig. 1: Floor Panel Carpet (Encore)**

| Callout | Component Name |
|---|---|
| <b>Preliminary Procedures</b> <ol style="list-style-type: none"> <li>1. Remove the front seats. Refer to <a href="#">Driver or Passenger Seat Removal and Installation</a> .</li> <li>2. Remove the rear seat cushion. Refer to <a href="#">Rear Seat Cushion Removal and Installation</a> .</li> <li>3. Remove the rear seat back cushion. Refer to <a href="#">Rear Seat Back Cushion Removal and Installation (40%)</a> <a href="#">Rear Seat Back Cushion Removal and Installation (60%)</a> .</li> <li>4. Remove the rear seat shoulder belt anchor bolt. Refer to <a href="#">Rear Seat Belt Retractor Replacement</a> .</li> <li>5. Remove the front floor console. Refer to <a href="#">Front Floor Console Replacement (Buick)</a> .</li> <li>6. Remove the floor auxiliary mat lower retainer. Refer to <a href="#">Floor Auxiliary Mat Lower Retainer Replacement (Buick)</a>.</li> <li>7. Remove the rear side door step mat retainer. Refer to <a href="#">Rear Side Door Step Mat Retainer Replacement</a>.</li> <li>8. Remove the center pillar lower trim panels. Refer to <a href="#">Center Pillar Lower Trim Panel Replacement (Buick)</a> .</li> </ol> | |

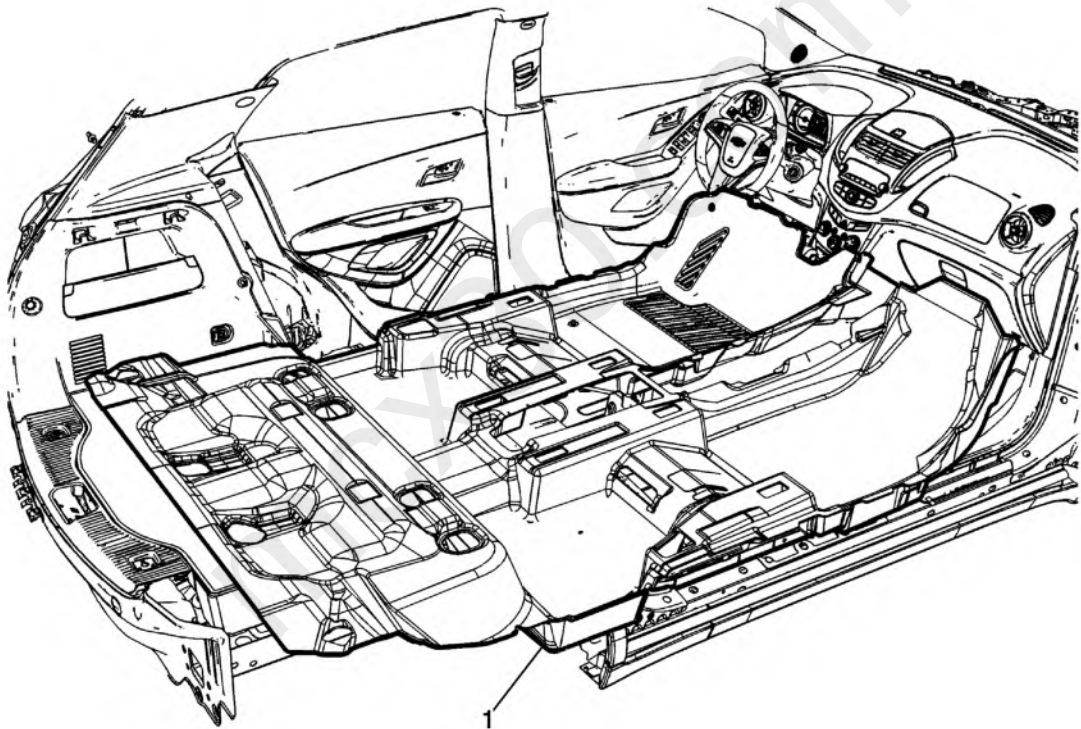
**Fig. 2: Floor Panel Carpet (Trax)**  
 Courtesy of GENERAL MOTORS COMPANY

| Callout | Component Name |
|---|---|
| <ol style="list-style-type: none"> <li>1. Remove the front seats. Refer to <a href="#">Driver or Passenger Seat Removal and Installation</a> .</li> <li>2. Remove the rear seat cushion. Refer to <a href="#">Rear Seat Cushion Removal and Installation</a> .</li> <li>3. Remove the rear seat shoulder anchor bolt. Refer to <a href="#">Rear Seat Belt Retractor Replacement</a> .</li> <li>4. Remove the front floor console. Refer to <a href="#">Front Floor Console Replacement (Chevrolet)</a> .</li> <li>5. Remove the floor auxiliary mat lower retainer. Refer to <a href="#">Floor Auxiliary Mat Lower Retainer Replacement (Chevrolet)</a> .</li> <li>6. Remove the rear side door step mat retainer. Refer to <a href="#">Rear Side Door Step Mat Retainer Replacement</a> .</li> <li>7. Remove the center pillar lower trim panels. Refer to <a href="#">Center Pillar Lower Trim Panel Replacement (Chevrolet)</a> .</li> </ol> | |

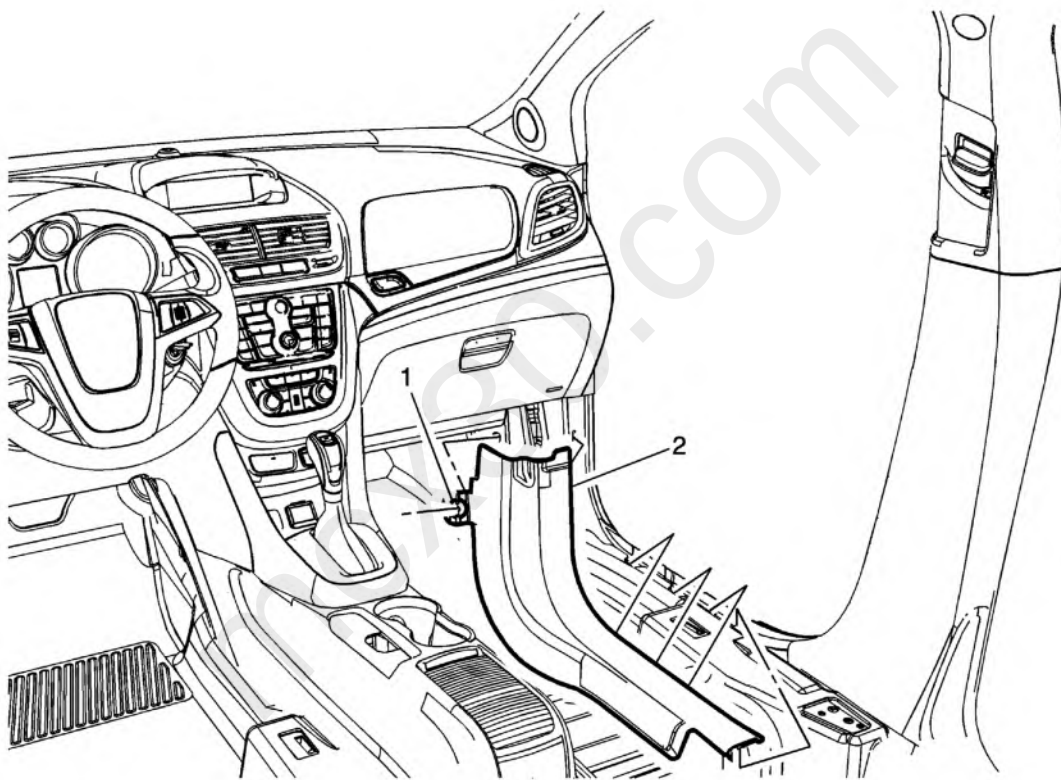
**Fig. 3: Floor Auxiliary Mat Lower Retainer (Encore)**

| Callout | Component Name |
|---|---|
| 2 | Floor Auxiliary Mat Lower Retainer Assembly |

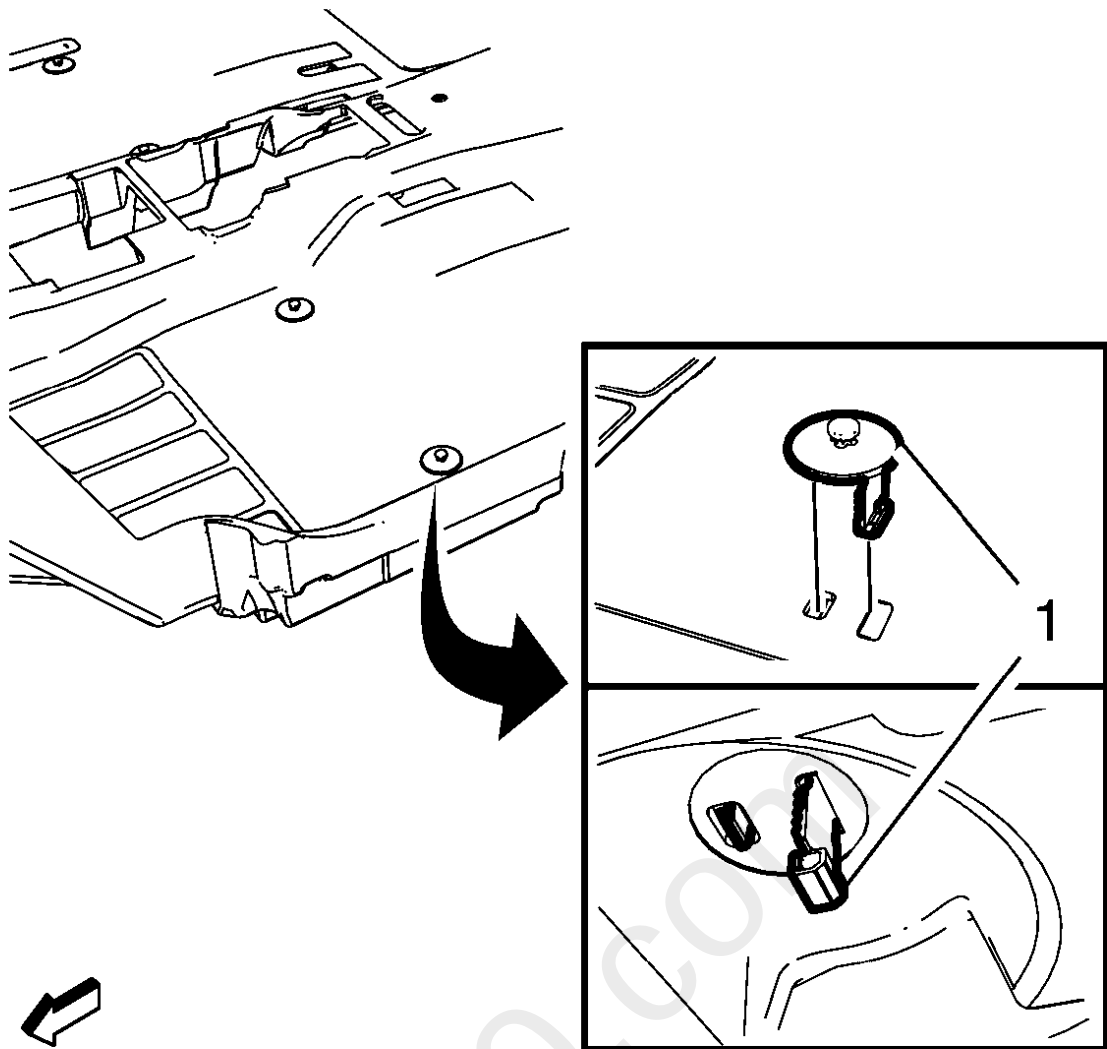
**Fig. 5: Floor Panel Carpet Retainer**

1. Align the floor carpet auxiliary mat retainer (1) to the cutout in the carpet.
2. Engage the floor carpet auxiliary mat retainer (1) on the rear side of the floor panel carpet.
3. Reposition the floor panel carpet as needed. [Floor Panel Carpet Replacement \(Buick\)](#)[Floor Panel Carpet Replacement \(Chevrolet\)](#)
4. Install Floor Auxiliary Mat Lower Retainer -Driver Side - [Floor Auxiliary Mat Lower Retainer Replacement \(Buick\)](#)[Floor Auxiliary Mat Lower Retainer Replacement \(Chevrolet\)](#)

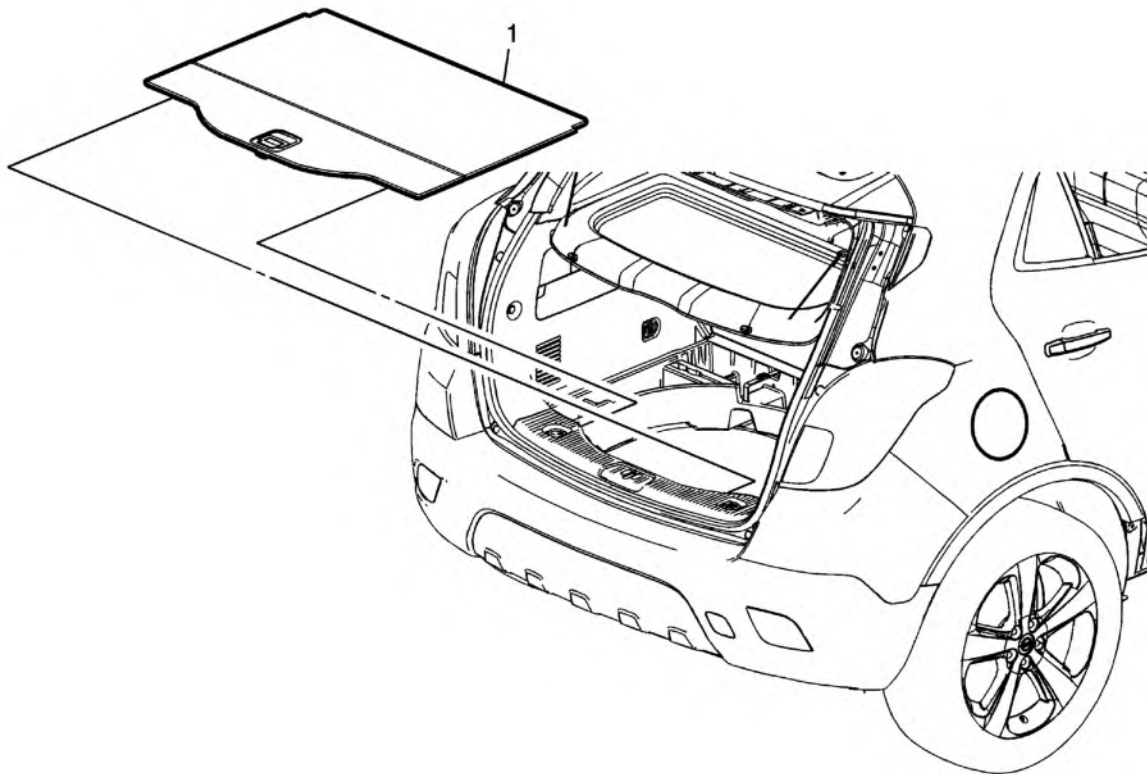
**Fig. 7: Load Floor Stowage Compartment Cover (Encore)**

| Callout | Component Name |
|---|---|
| 1 | Load Floor Stowage Compartment Cover Assembly |

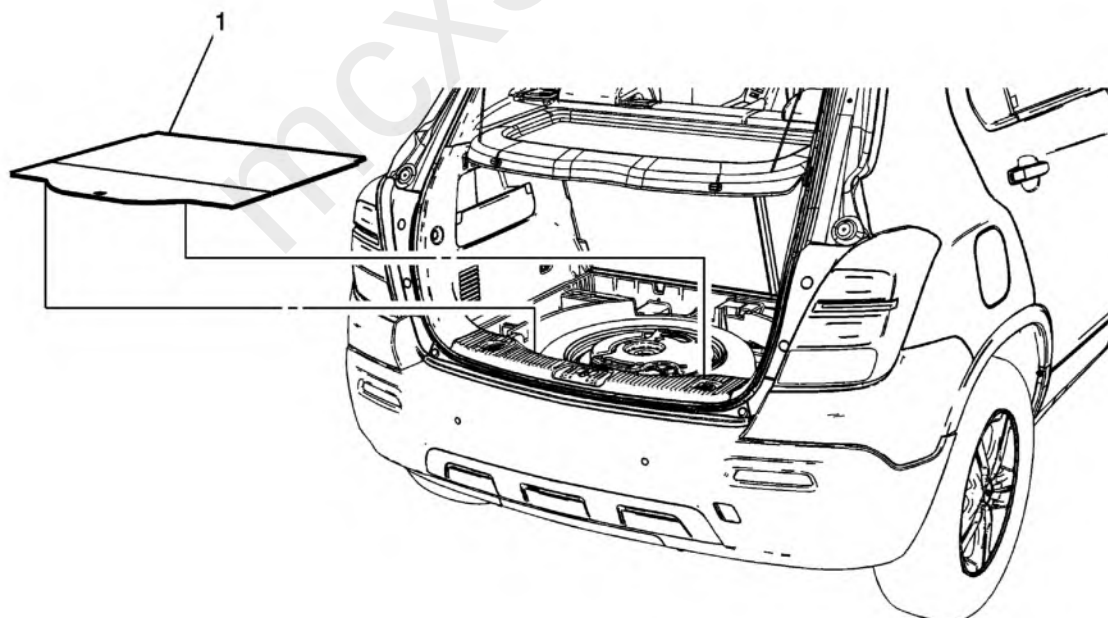
**Fig. 8: Load Floor Stowage Compartment Cover (Trax)**

| Callout | Component Name |
|---|---|
| 1 | Load Floor Stowage Compartment Cover Assembly |

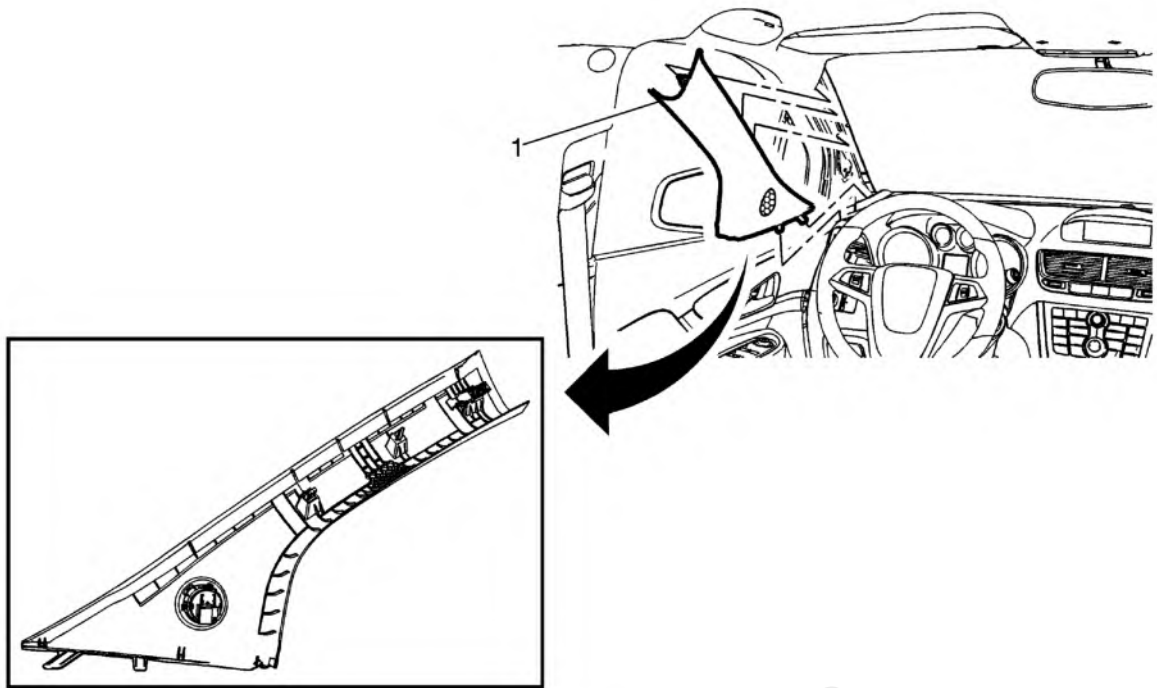
**Fig. 10: Windshield Garnish Molding Assembly.**  
 Courtesy of GENERAL MOTORS COMPANY

2. Remove the windshield garnish molding assembly (1). Refer to [Windshield Garnish Molding Replacement \(Buick\)](#).

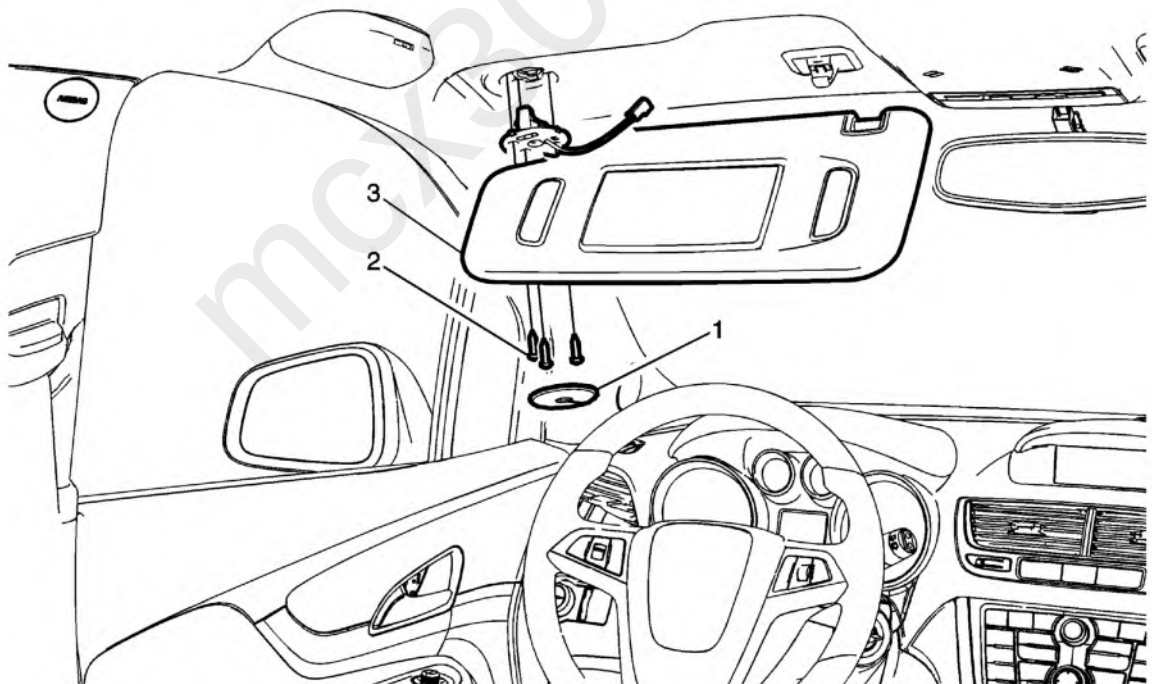
**Fig. 11: Sunshade Assembly.**  
 Courtesy of GENERAL MOTORS COMPANY

3. Remove the sunshade assembly (3). Refer to [Sunshade Replacement \(Buick\)](#).

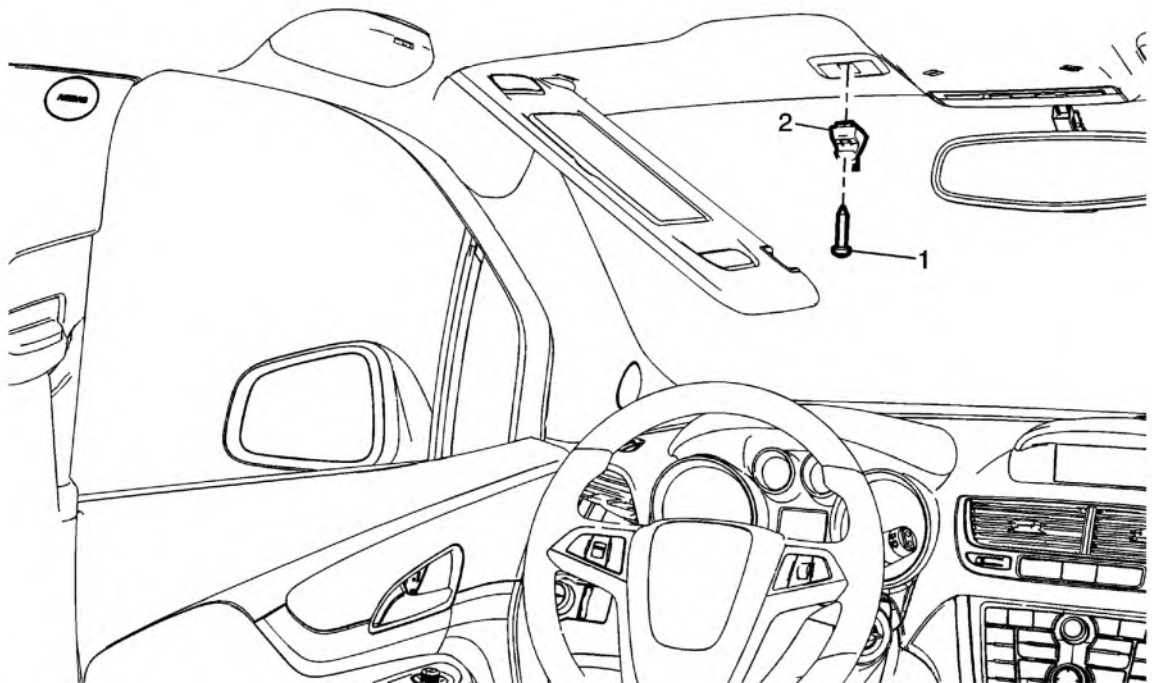
**Fig. 12: Sunshade Support Assembly.**

4. Remove the sunshade support assembly (2). Refer to [Sunshade Support Replacement \(Buick\)](#).

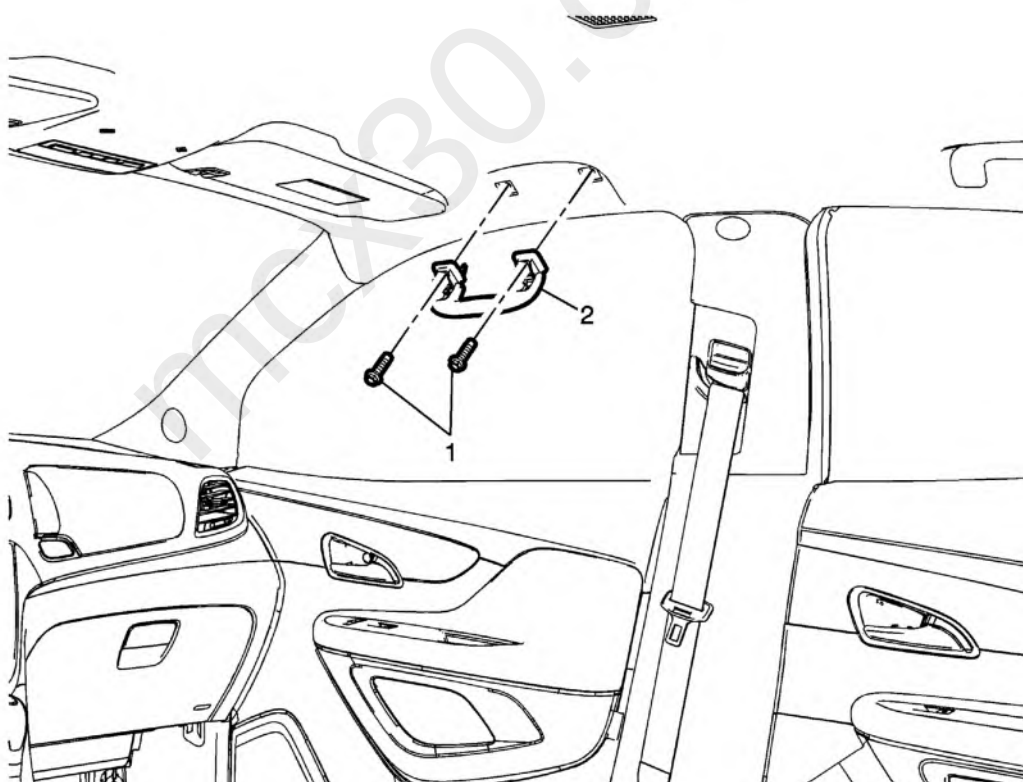
**Fig. 13: Roof Rail Assist Handle Assembly.**

5. Remove the roof rail assist handle assembly (2). Refer to [Roof Rail Assist Handle Replacement \(Buick\)](#).

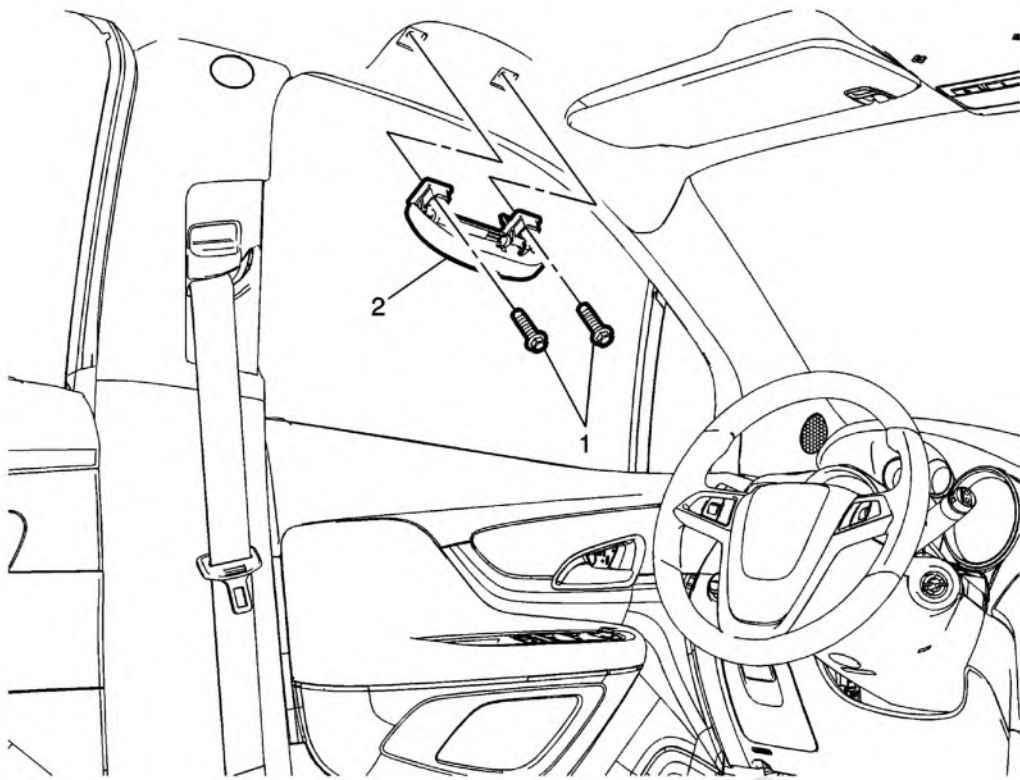
**Fig. 14: Roof Rail Front Stowage Compartment**  
 Courtesy of GENERAL MOTORS COMPANY

6. Remove the roof rail front stowage compartment (2). Refer to [Roof Rail Front Stowage Compartment Replacement \(Buick\)](#).

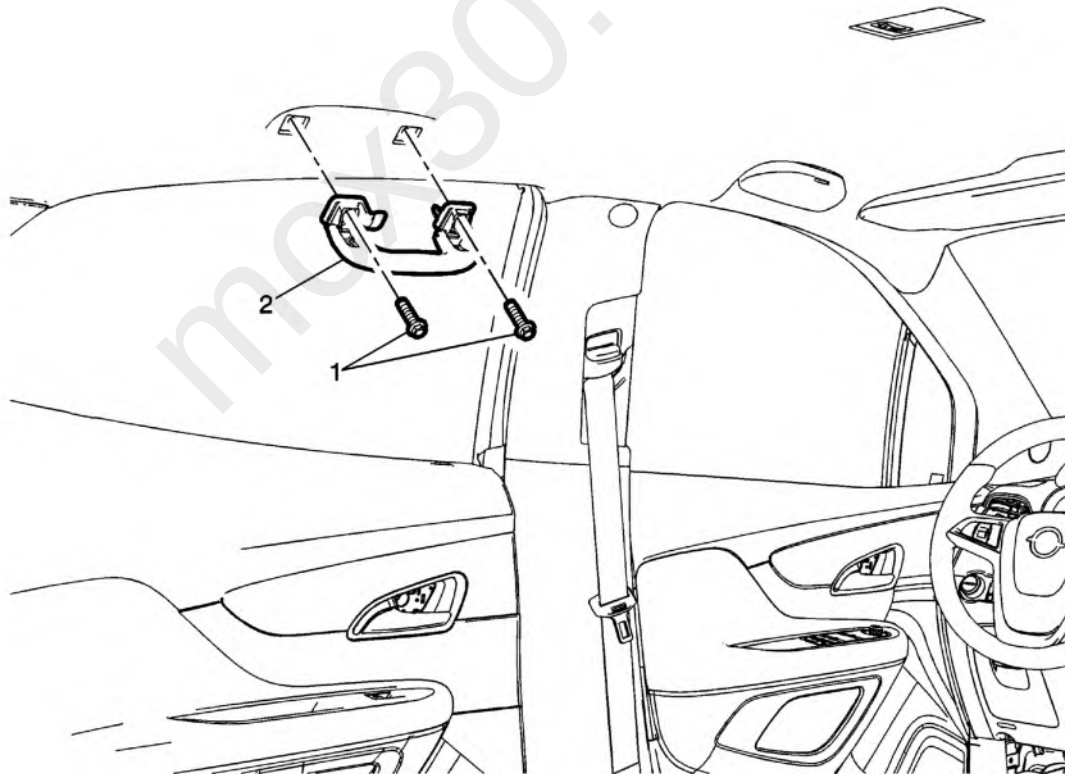
**Fig. 15: Roof Rail Rear Assist Handle Assembly**  
 Courtesy of GENERAL MOTORS COMPANY

7. Remove the roof rail rear assist handle assembly (2). Refer to [Roof Rail Rear Assist Handle Replacement \(Buick\)](#).

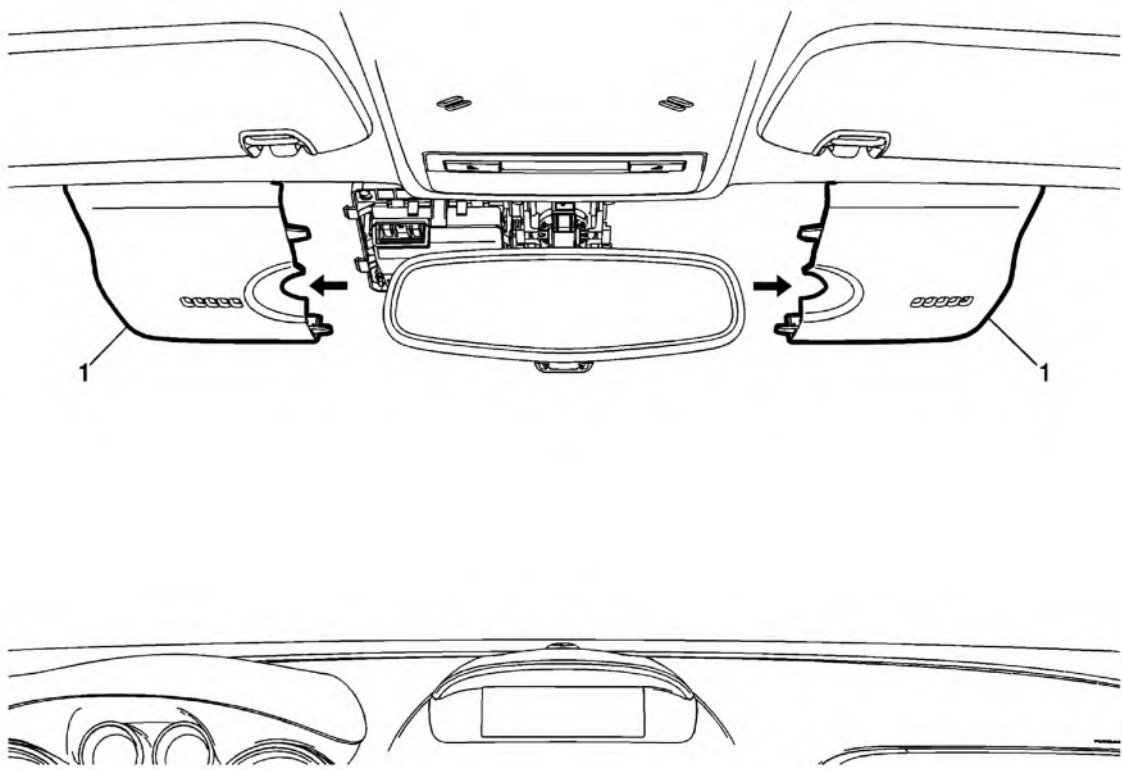
**Fig. 16: Windshield Outside Moisture Sensor Cover**  
**Courtesy of GENERAL MOTORS COMPANY**

8. Remove the windshield outside moisture sensor cover (1). Refer to [Windshield Outside Moisture Sensor Cover Replacement \(Buick\)](#).

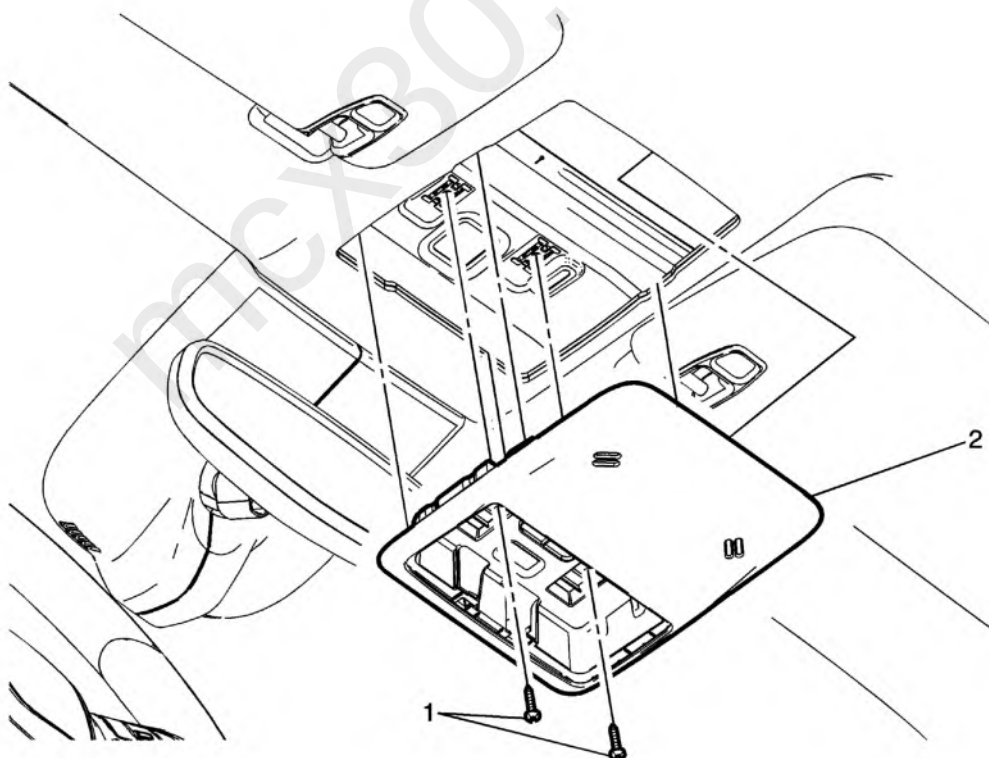
**Fig. 17: Roof Console Assembly**  
**Courtesy of GENERAL MOTORS COMPANY**

9. Remove the roof console assembly (2). Refer to [Roof Console Replacement](#).

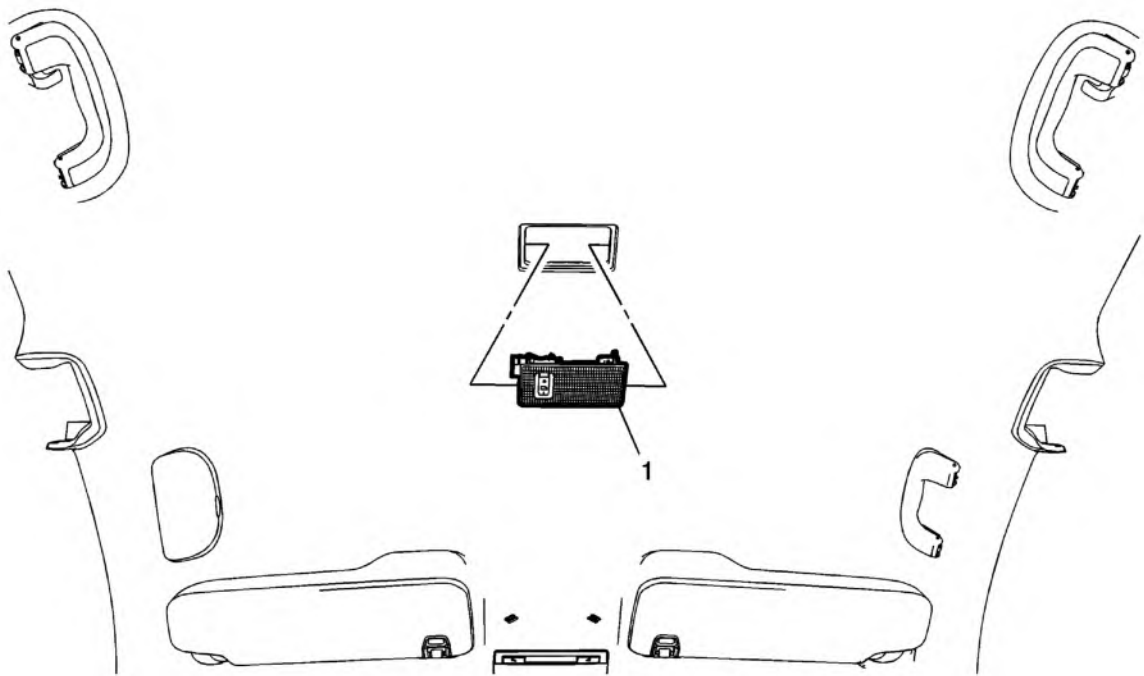
**Fig. 18: Rear Seat Position Center Courtesy Lamp**  
 Courtesy of GENERAL MOTORS COMPANY

10. Remove the rear seat position center courtesy lamp (1). Refer to [Rear Seat Position Center Courtesy Lamp Replacement](#) .

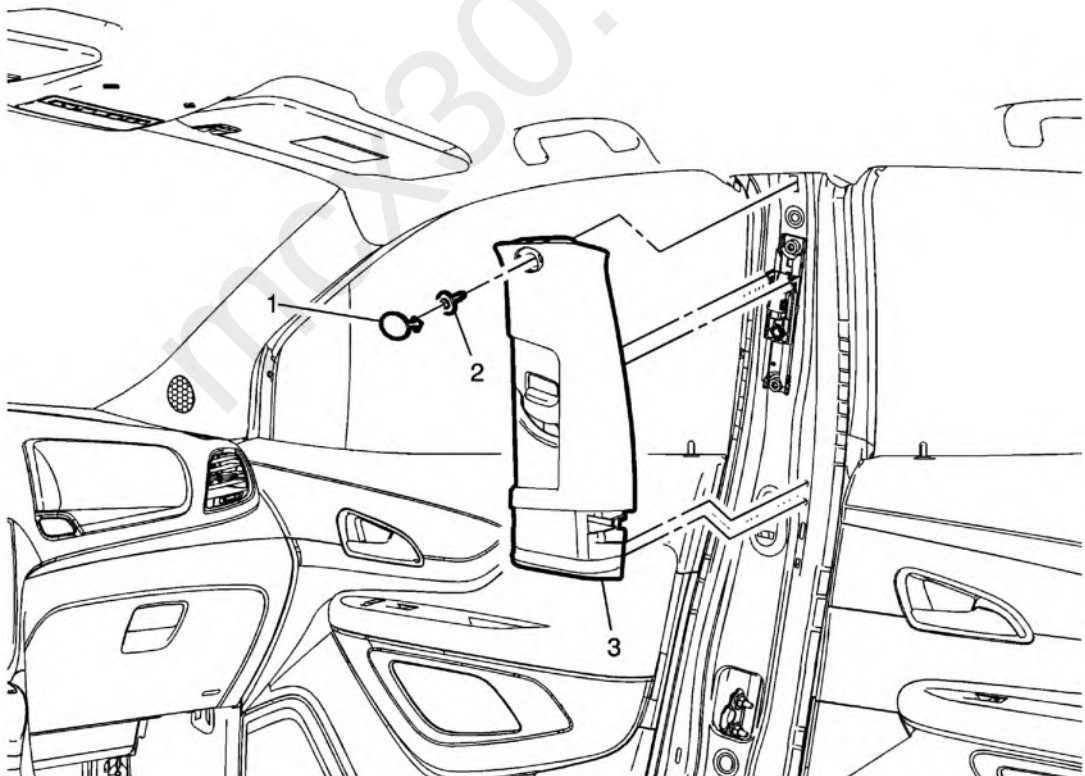
**Fig. 19: Center Pillar Upper Trim Panel Assembly**  
 Courtesy of GENERAL MOTORS COMPANY

11. Remove the center pillar upper trim panel assembly (3). Refer to [Center Pillar Upper Trim Panel Replacement \(Buick\)](#) .

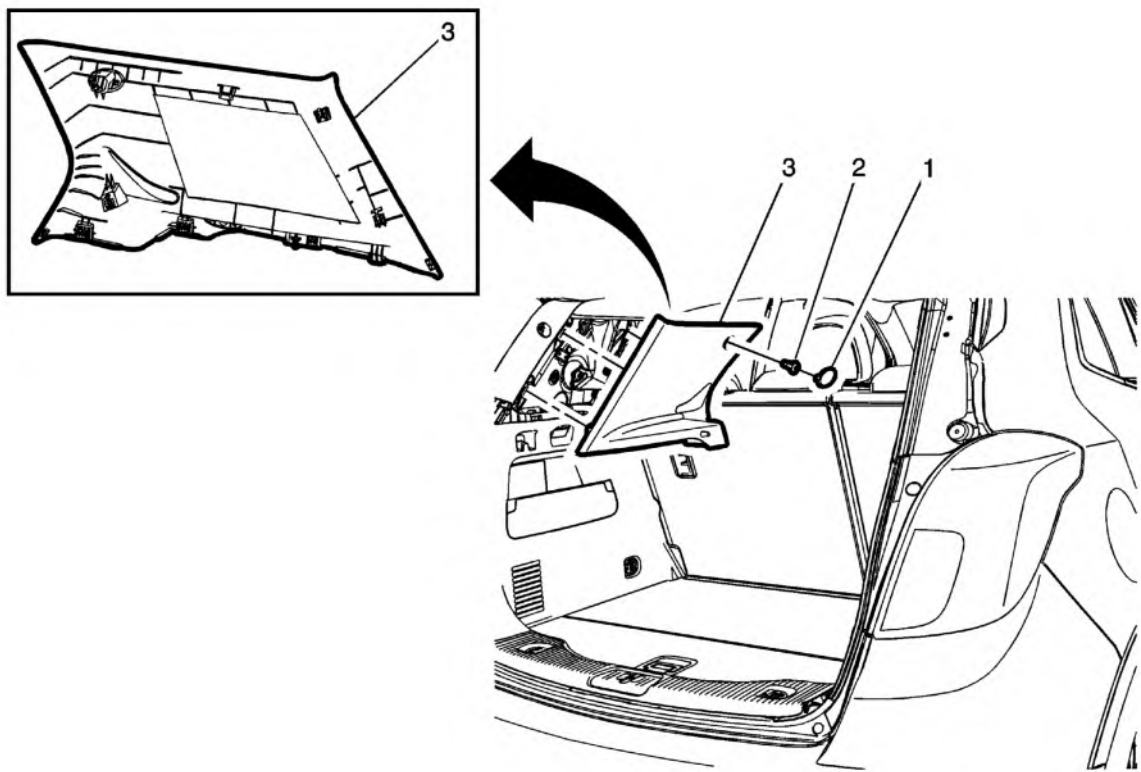
**Fig. 20: Body Lock Pillar Upper Trim Panel**  
 Courtesy of GENERAL MOTORS COMPANY

12. Remove the body lock pillar upper trim panel (3). Refer to [Body Lock Pillar Upper Trim Panel Replacement](#).
13. Fully recline the driver and passenger seats backward.
14. Fold down the rear seat backs.

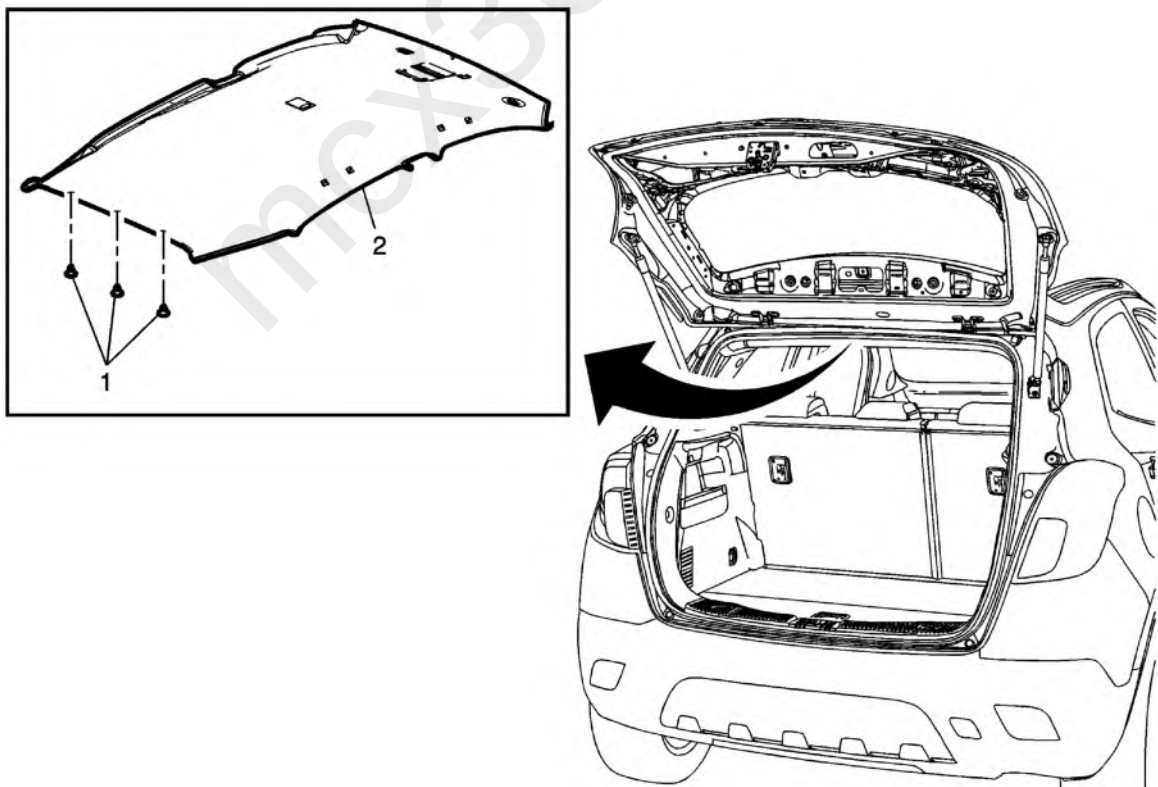
**Fig. 21: Headliner Trim Panel Retainers**  
 Courtesy of GENERAL MOTORS COMPANY

15. Remove the 3 headliner trim panel retainers (1).
16. Lower the headliner in the vehicle.
17. Disconnect the electrical connectors from the headliner trim panel assembly.

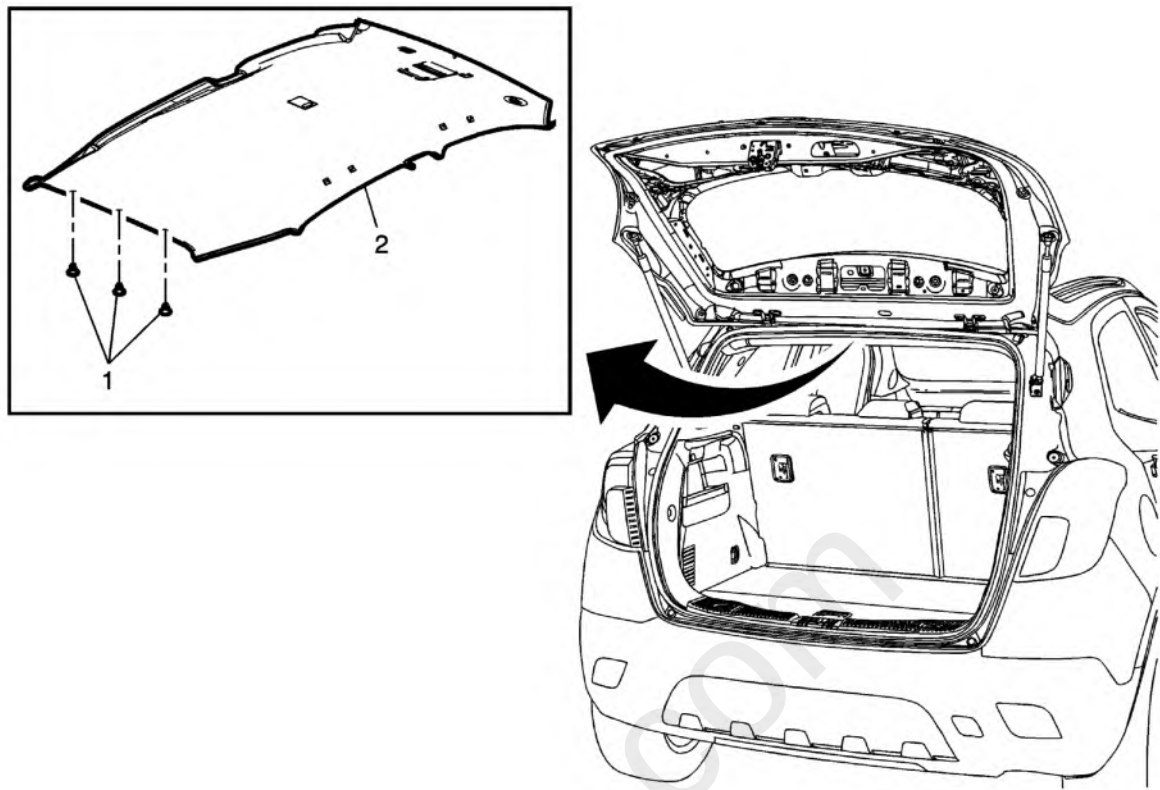
**Fig. 22: Headliner Trim Panel Retainers**  
**Courtesy of GENERAL MOTORS COMPANY**

1. With the aid of an assistant, position the headliner trim panel assembly (2) into the vehicle through the liftgate opening.
2. Connect the electrical connectors to the headliner trim panel assembly (2).
3. Glue the headliner harness back onto the headliner in the same locations noted during removal.
4. Tape any unused connectors to the headliner with a high adhesive tape.
5. Install the 3 headliner trim panel retainers (1).

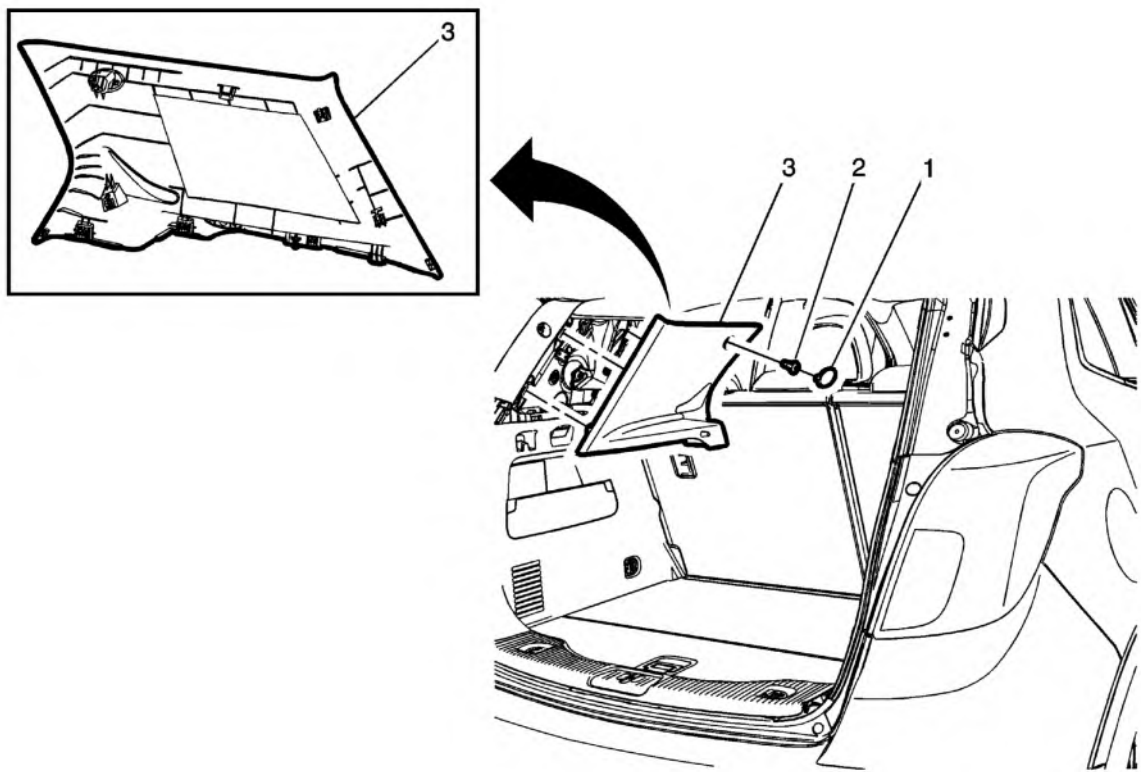
**Fig. 23: Body Lock Pillar Upper Trim Panel**  
 Courtesy of GENERAL MOTORS COMPANY

6. Install the body lock pillar upper trim panel (3). Refer to [Body Lock Pillar Upper Trim Panel Replacement](#) .

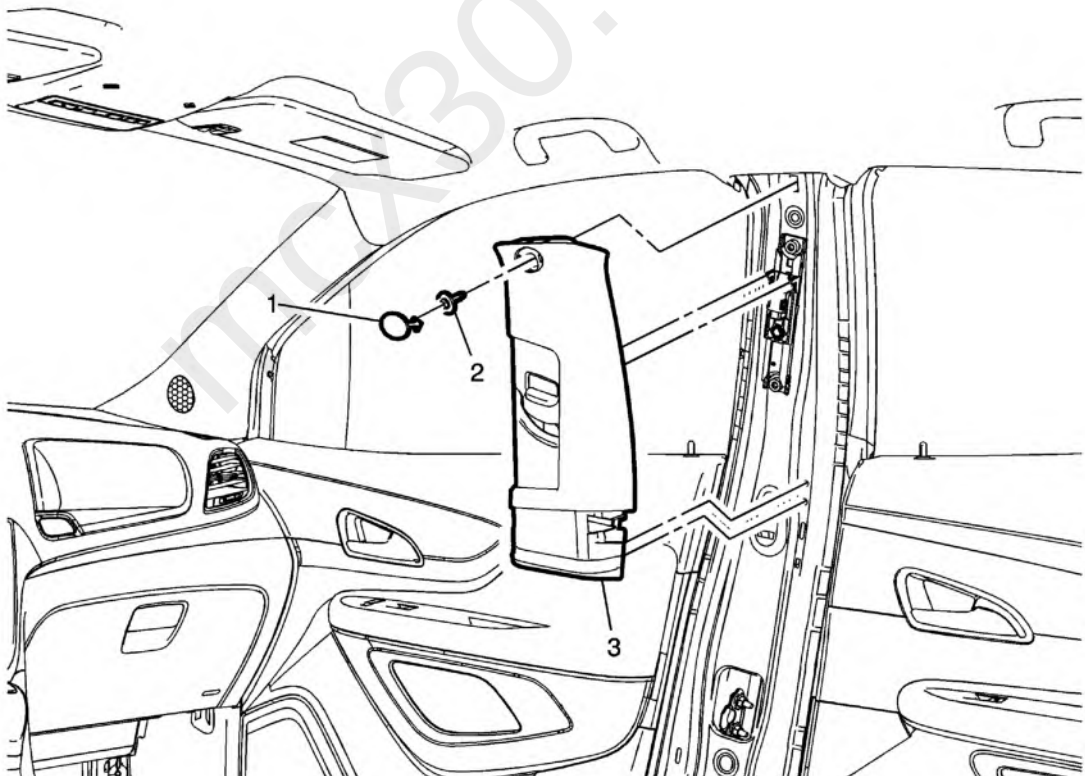
**Fig. 24: Center Pillar Upper Trim Panel Assembly**  
 Courtesy of GENERAL MOTORS COMPANY

7. Install the center pillar upper trim panel assembly (3). Refer to [Center Pillar Upper Trim Panel Replacement \(Buick\)](#) .

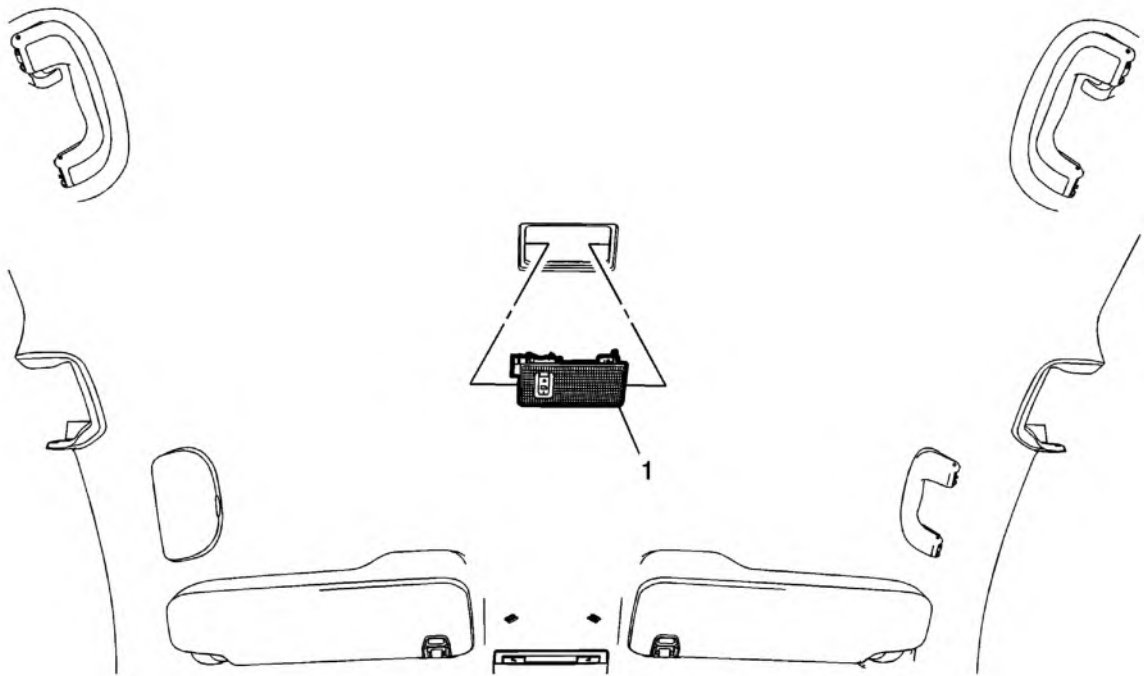
**Fig. 25: Rear Seat Position Center Courtesy Lamp**  
Courtesy of GENERAL MOTORS COMPANY

8. Install the rear seat position center courtesy lamp (1). Refer to [Rear Seat Position Center Courtesy Lamp Replacement](#) .

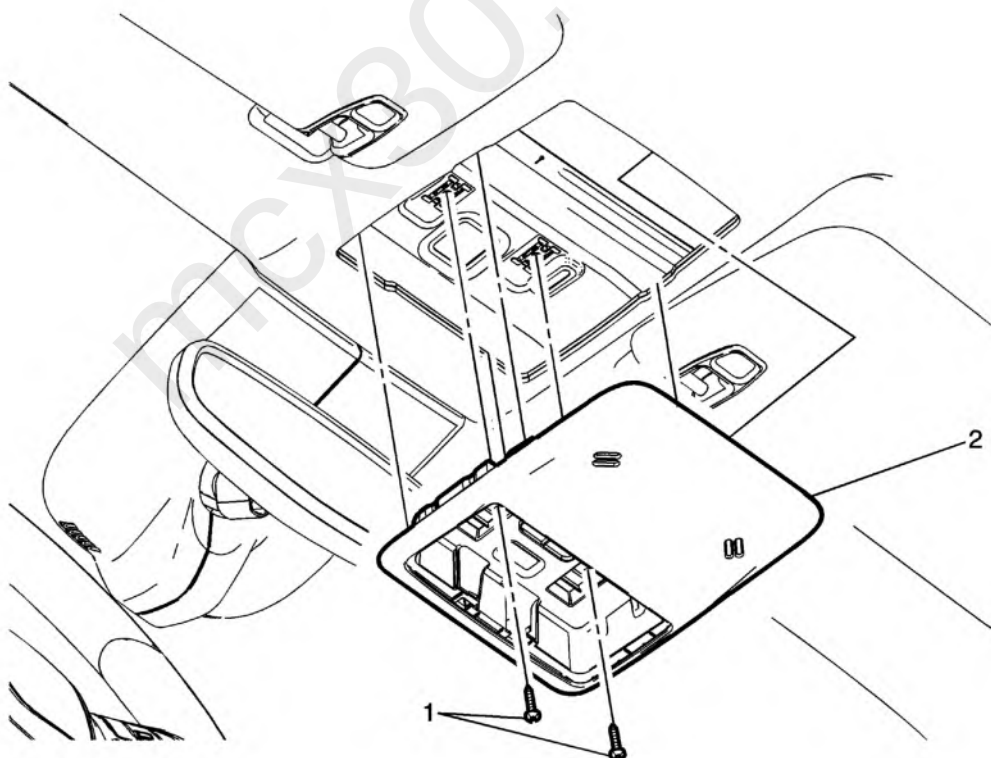
**Fig. 26: Roof Console Assembly**  
Courtesy of GENERAL MOTORS COMPANY

9. Install the roof console assembly (2). Refer to [Roof Console Replacement](#) .

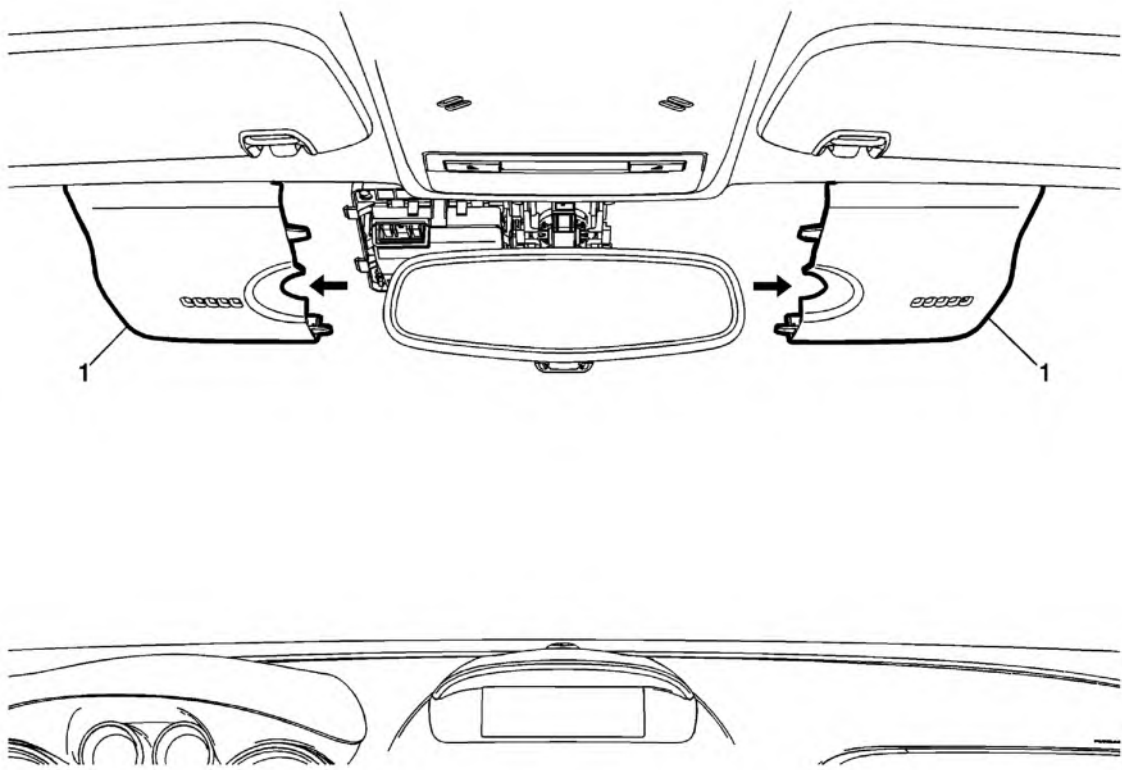
**Fig. 27: Windshield Outside Moisture Sensor Cover**  
 Courtesy of GENERAL MOTORS COMPANY

10. Install the windshield outside moisture sensor cover (1). Refer to [Windshield Outside Moisture Sensor Cover Replacement \(Buick\)](#).

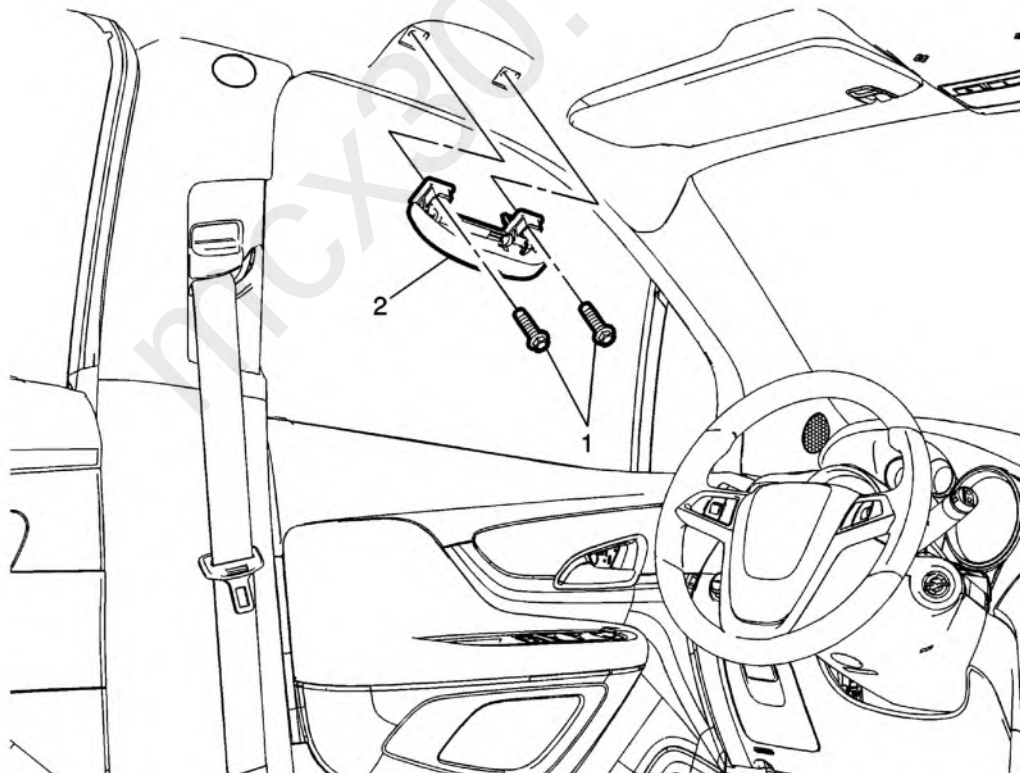
**Fig. 28: Roof Rail Front Stowage Compartment**  
 Courtesy of GENERAL MOTORS COMPANY

11. Install the roof rail front stowage compartment (2). Refer to [Roof Rail Front Stowage Compartment Replacement \(Buick\)](#).
