## 2017 ACCESSORIES & EQUIPMENT

### Floor Coverings and Headlinings - Encore, Trax

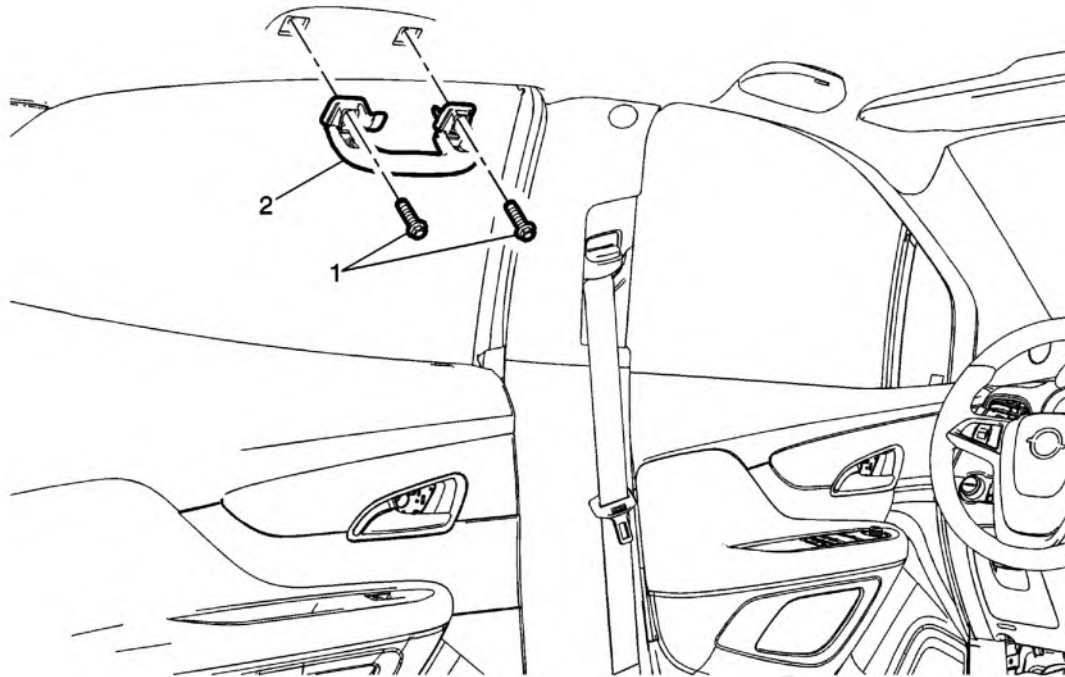
**Fig. 29: Roof Rail Rear Assist Handle Assembly.**  
 Courtesy of GENERAL MOTORS COMPANY

12. Install the roof rail rear assist handle assembly (2). Refer to [Roof Rail Rear Assist Handle Replacement \(Buick\)](#).

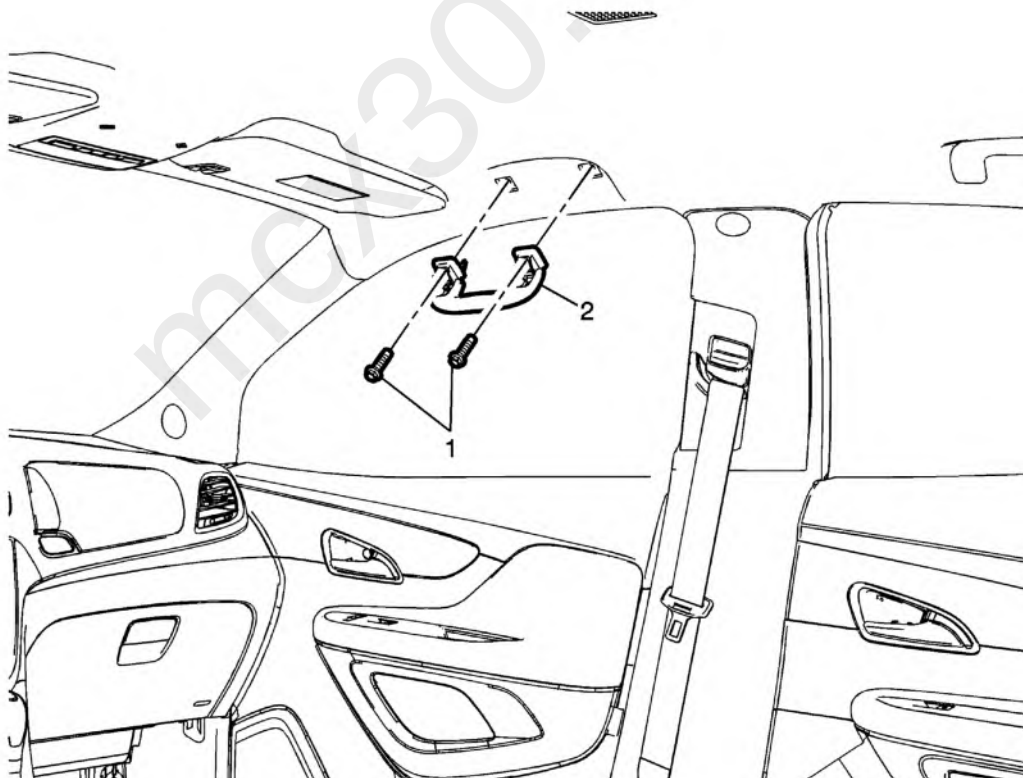
**Fig. 30: Roof Rail Assist Handle Assembly.**  
 Courtesy of GENERAL MOTORS COMPANY

13. Install the roof rail assist handle assembly (2). Refer to [Roof Rail Assist Handle Replacement \(Buick\)](#).

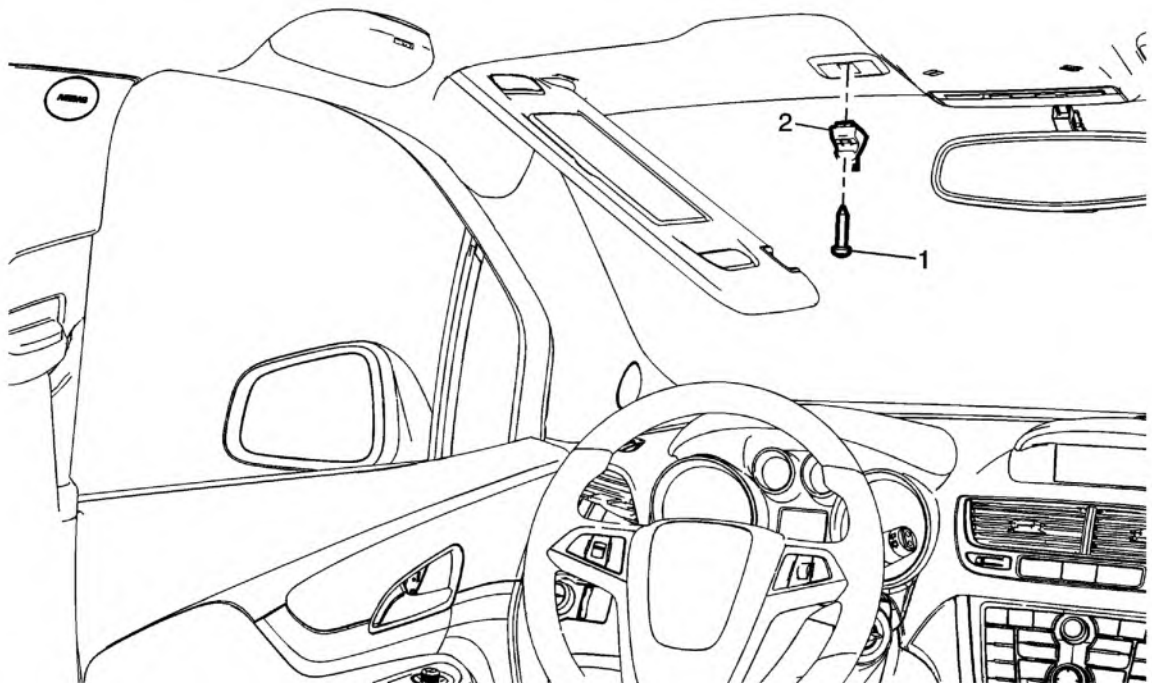
**Fig. 31: Sunshade Support Assembly.**

14. Install the sunshade support assembly (2). Refer to [Sunshade Support Replacement \(Buick\)](#).

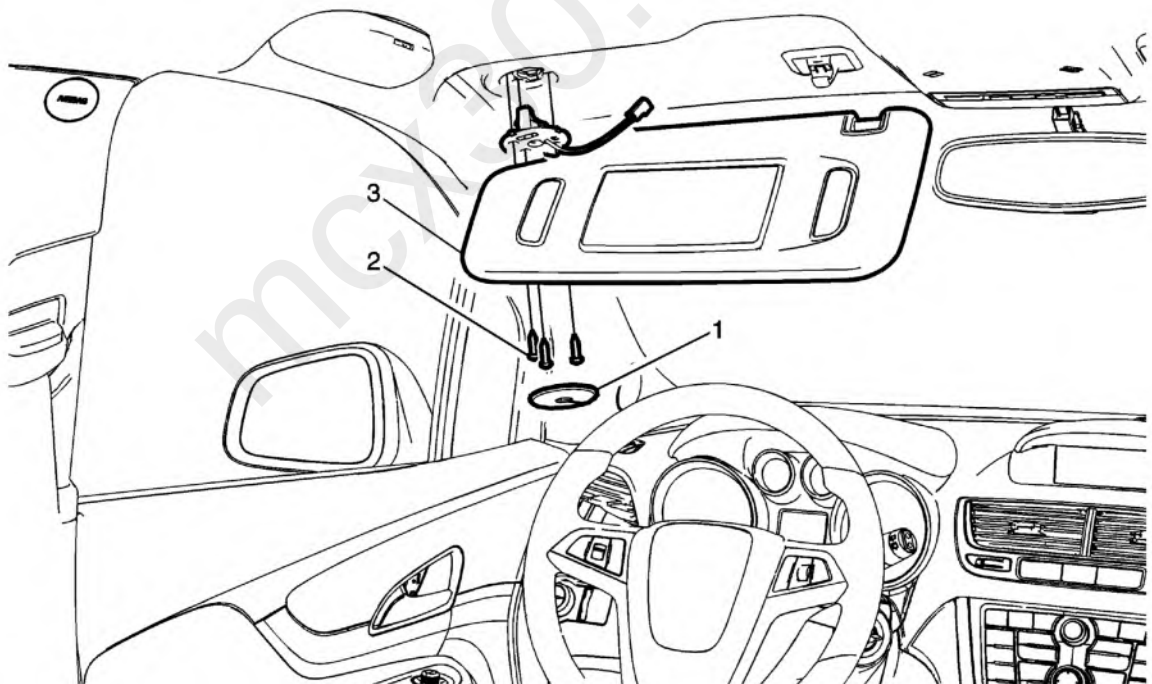
**Fig. 32: Sunshade Assembly.**

15. Install the sunshade assembly (3). Refer to [Sunshade Replacement \(Buick\)](#).

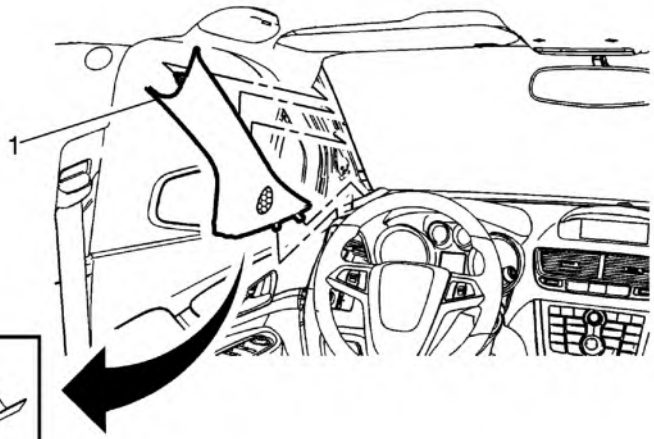
**Fig. 33: Windshield Garnish Molding Assembly.**  
Courtesy of GENERAL MOTORS COMPANY

16. Install the windshield garnish molding assembly (1). Refer to [Windshield Garnish Molding Replacement \(Buick\)](#).
17. Enable the SIR system. Refer to [SIR Disabling and Enabling](#).

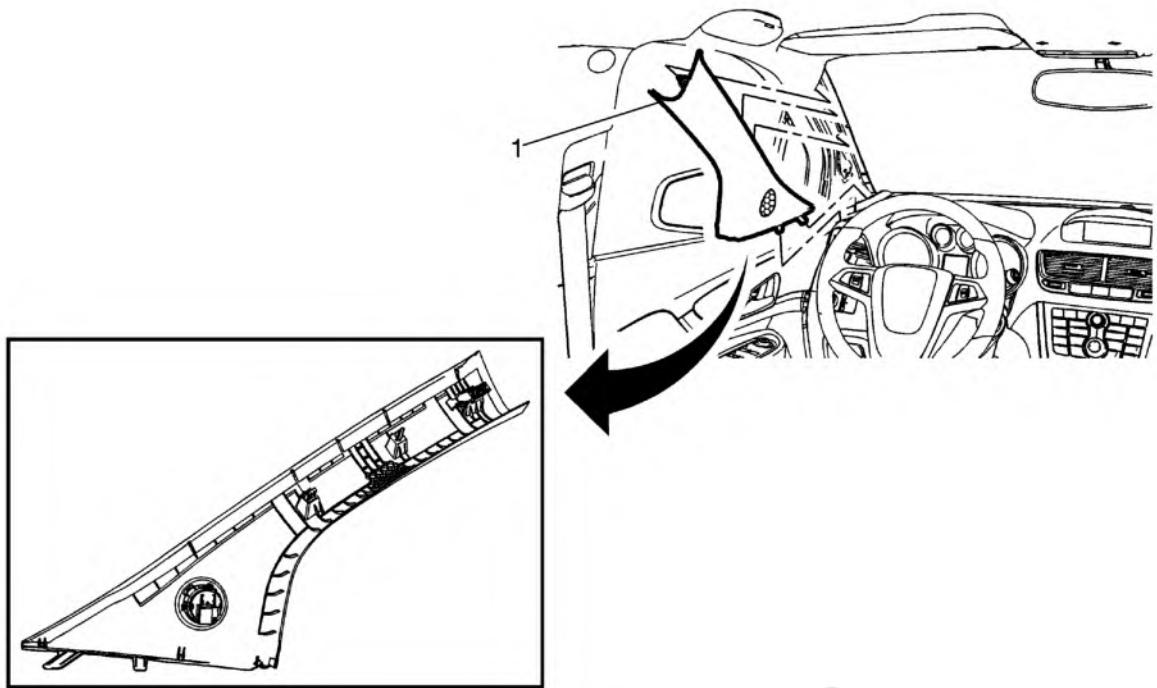
**Fig. 34: Windshield Garnish Molding Assembly.**  
 Courtesy of GENERAL MOTORS COMPANY

2. Remove the windshield garnish molding assembly (1). Refer to [Windshield Garnish Molding Replacement \(Buick\)](#).

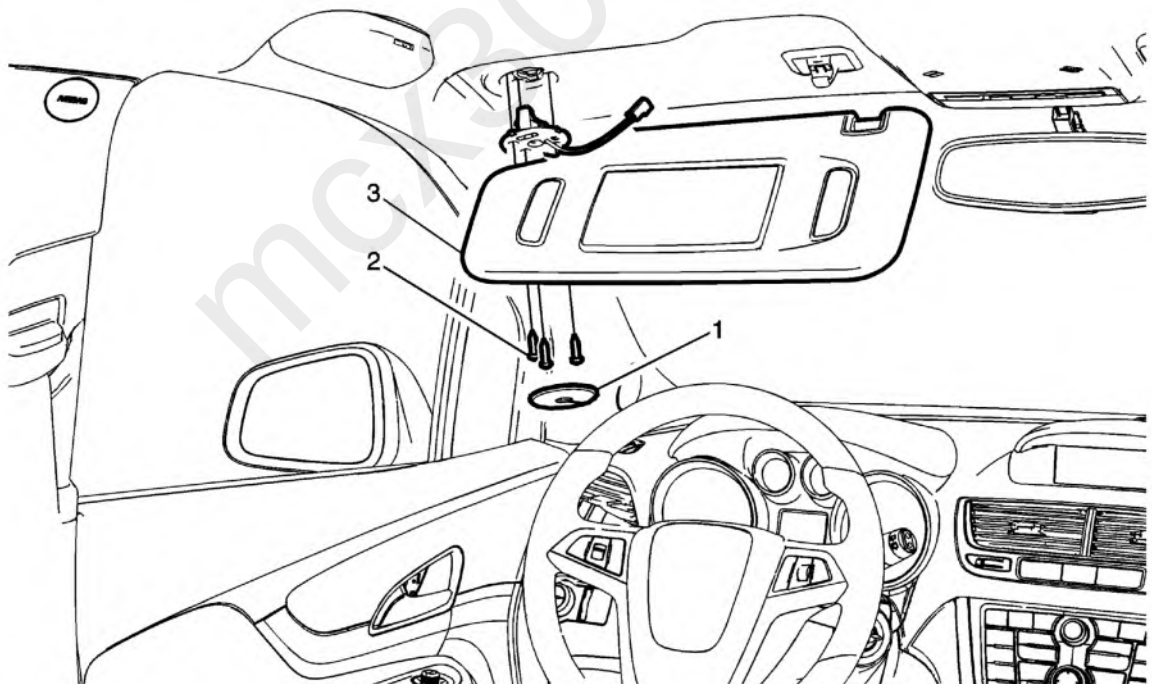
**Fig. 35: Sunshade Assembly.**  
 Courtesy of GENERAL MOTORS COMPANY

3. Remove the sunshade assembly (3). Refer to [Sunshade Replacement \(Buick\)](#).

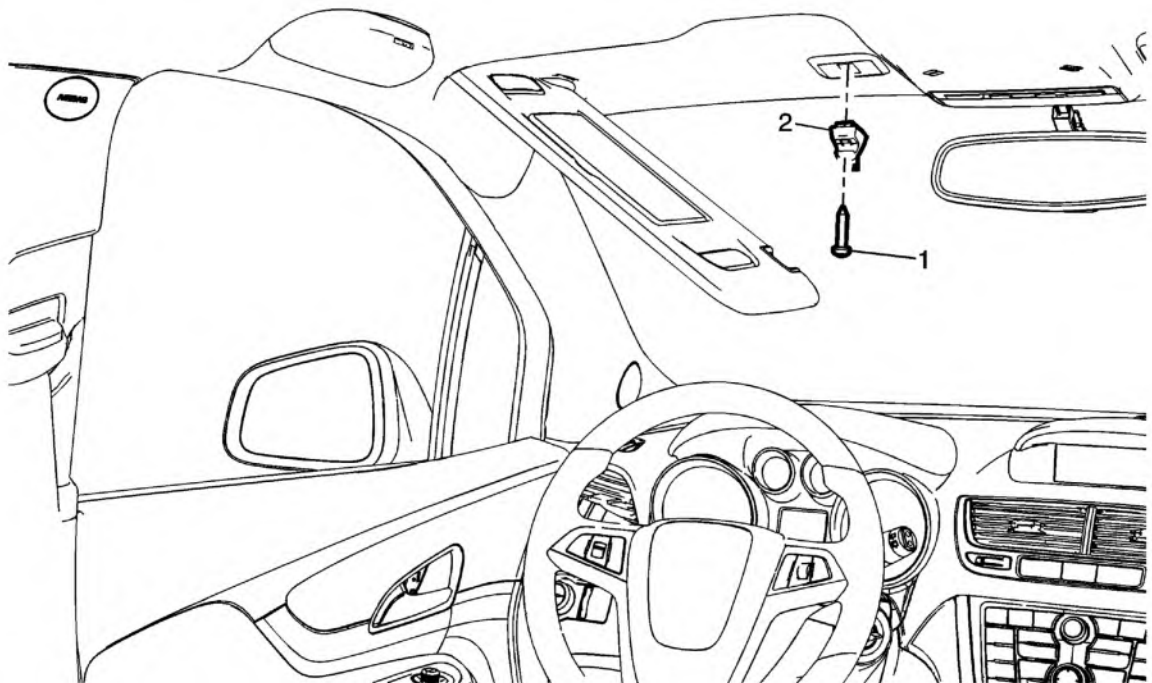
**Fig. 36: Sunshade Support Assembly.**

4. Remove the sunshade support assembly (2). Refer to [Sunshade Support Replacement \(Buick\)](#).

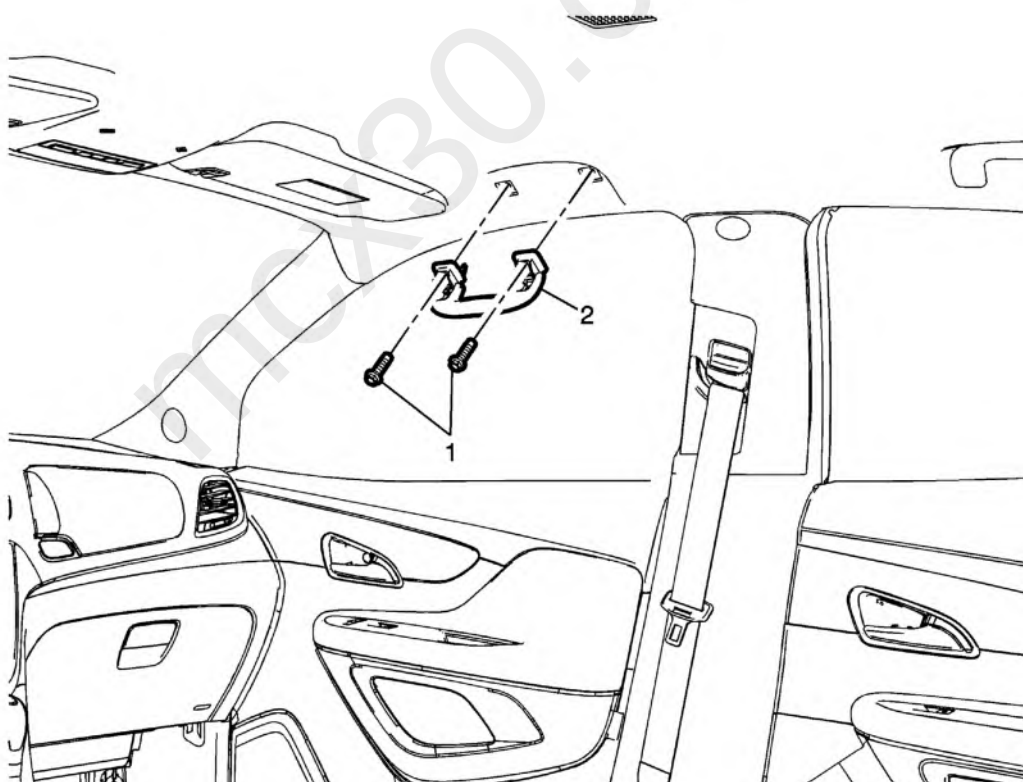
**Fig. 37: Roof Rail Assist Handle Assembly.**

5. Remove the roof rail assist handle assembly (2). Refer to [Roof Rail Assist Handle Replacement \(Buick\)](#).

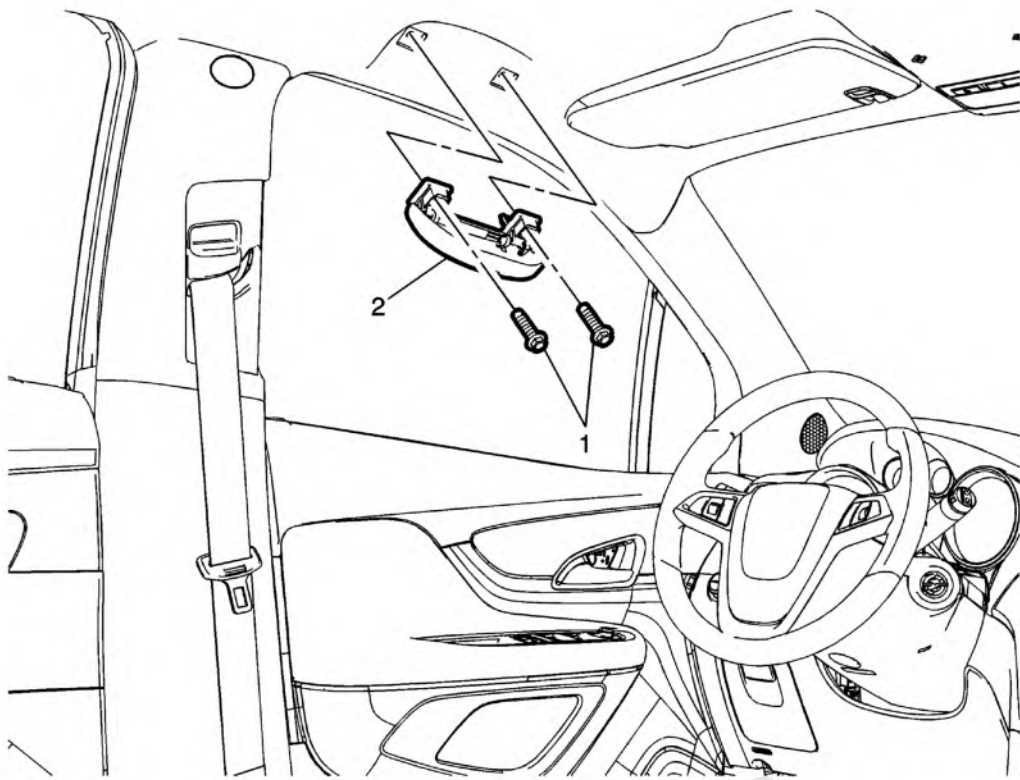
**Fig. 38: Roof Rail Front Stowage Compartment**  
 Courtesy of GENERAL MOTORS COMPANY

6. Remove the roof rail front stowage compartment (2). Refer to [Roof Rail Front Stowage Compartment Replacement \(Buick\)](#).

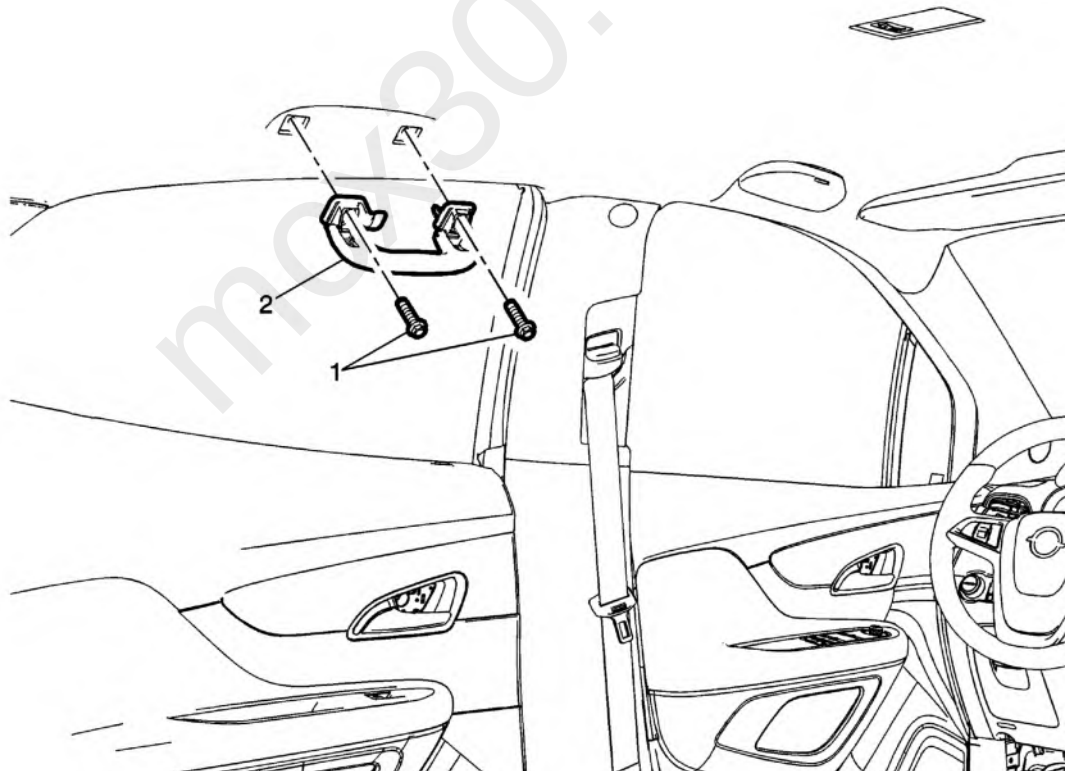
**Fig. 39: Roof Rail Rear Assist Handle Assembly**  
 Courtesy of GENERAL MOTORS COMPANY

7. Remove the roof rail rear assist handle assembly (2). Refer to [Roof Rail Rear Assist Handle Replacement \(Buick\)](#).

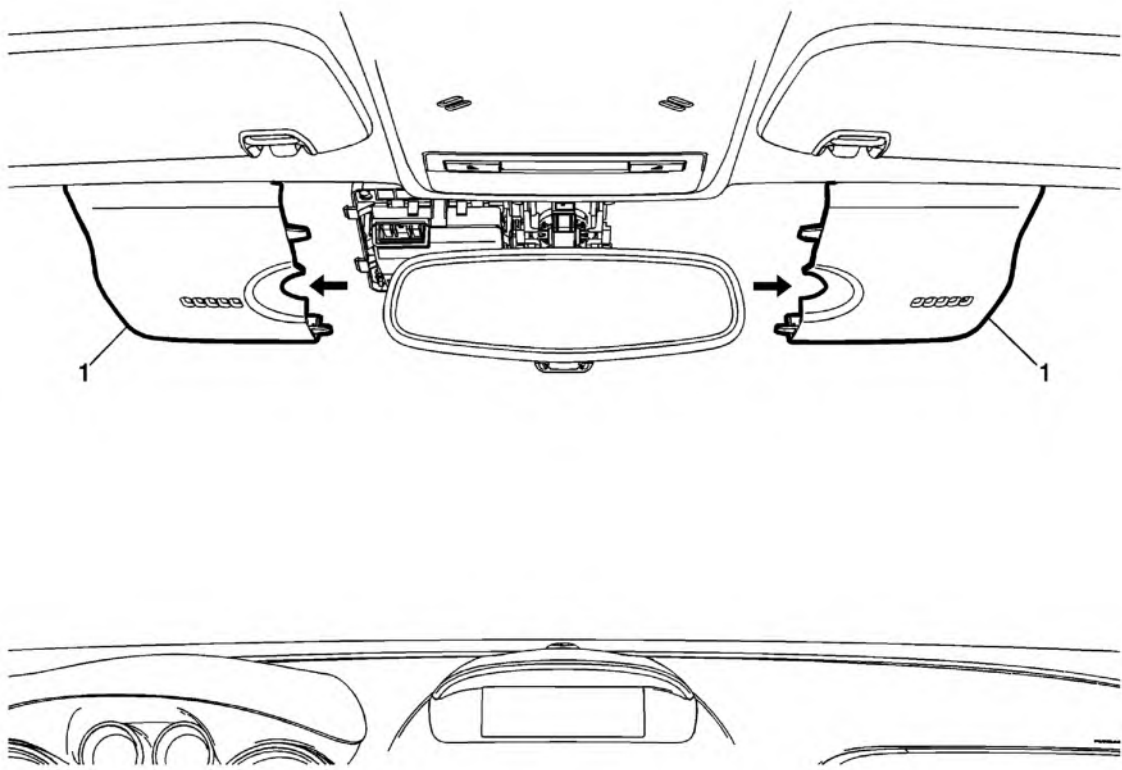
**Fig. 40: Windshield Outside Moisture Sensor Cover**  
 Courtesy of GENERAL MOTORS COMPANY

8. Remove the windshield outside moisture sensor cover (1). Refer to [Windshield Outside Moisture Sensor Cover Replacement \(Buick\)](#).

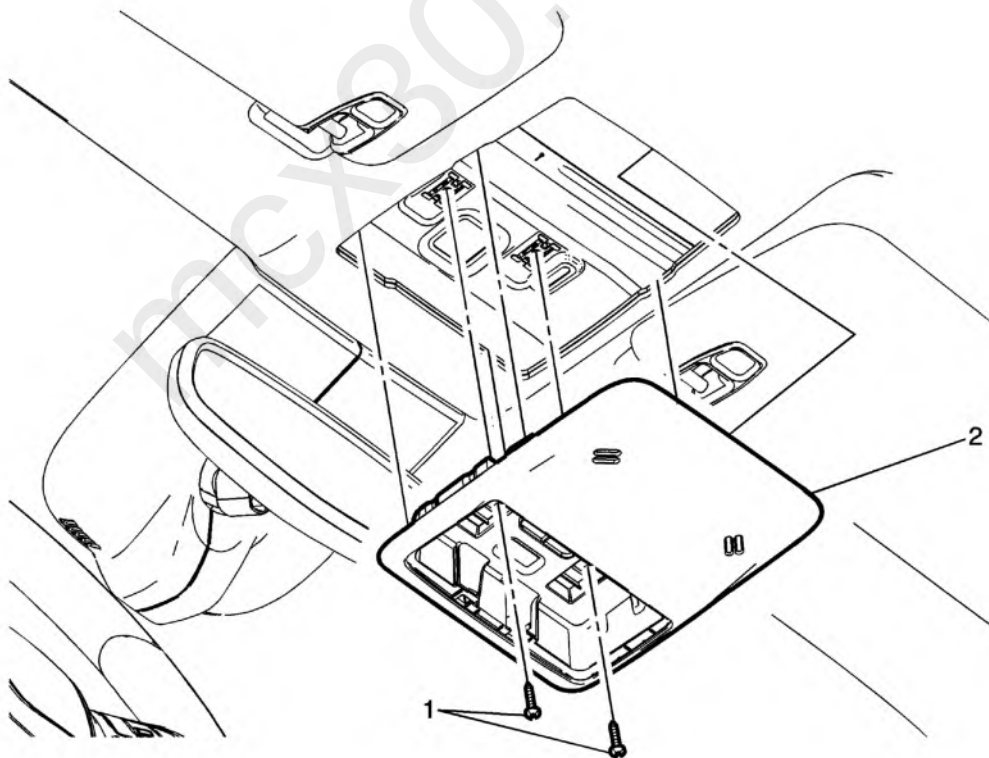
**Fig. 41: Roof Console Assembly**  
 Courtesy of GENERAL MOTORS COMPANY

9. Remove the roof console assembly (2). Refer to [Roof Console Replacement](#).

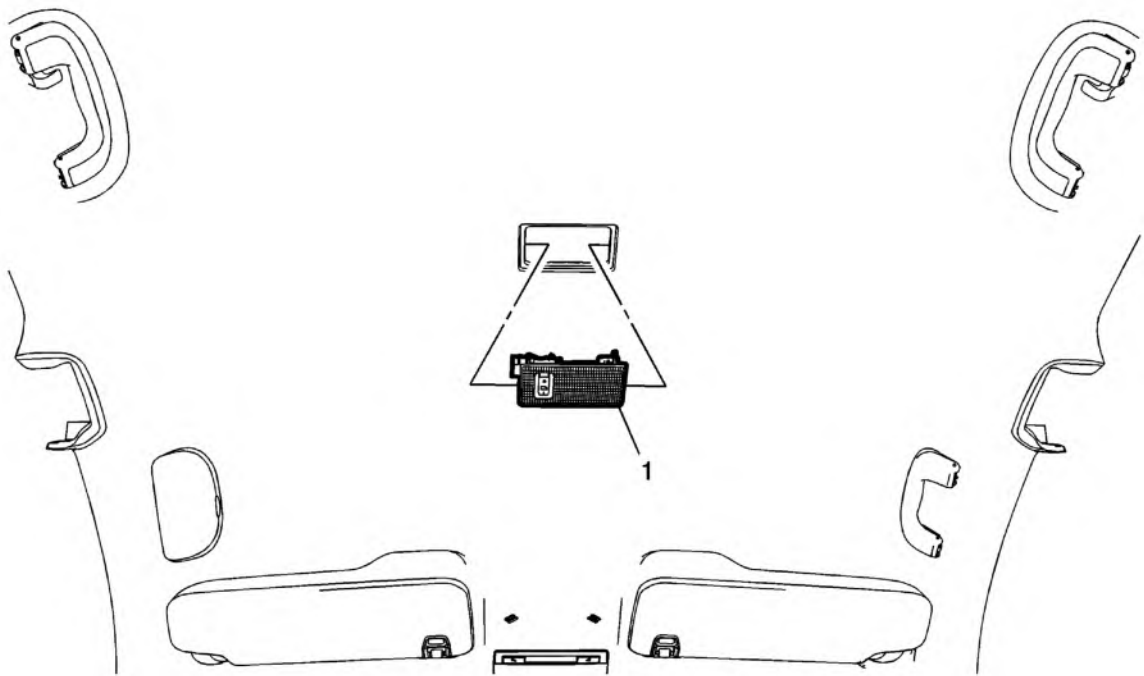
**Fig. 42: Rear Seat Position Center Courtesy Lamp**  
 Courtesy of GENERAL MOTORS COMPANY

10. Remove the rear seat position center courtesy lamp (1). Refer to [Rear Seat Position Center Courtesy Lamp Replacement](#) .

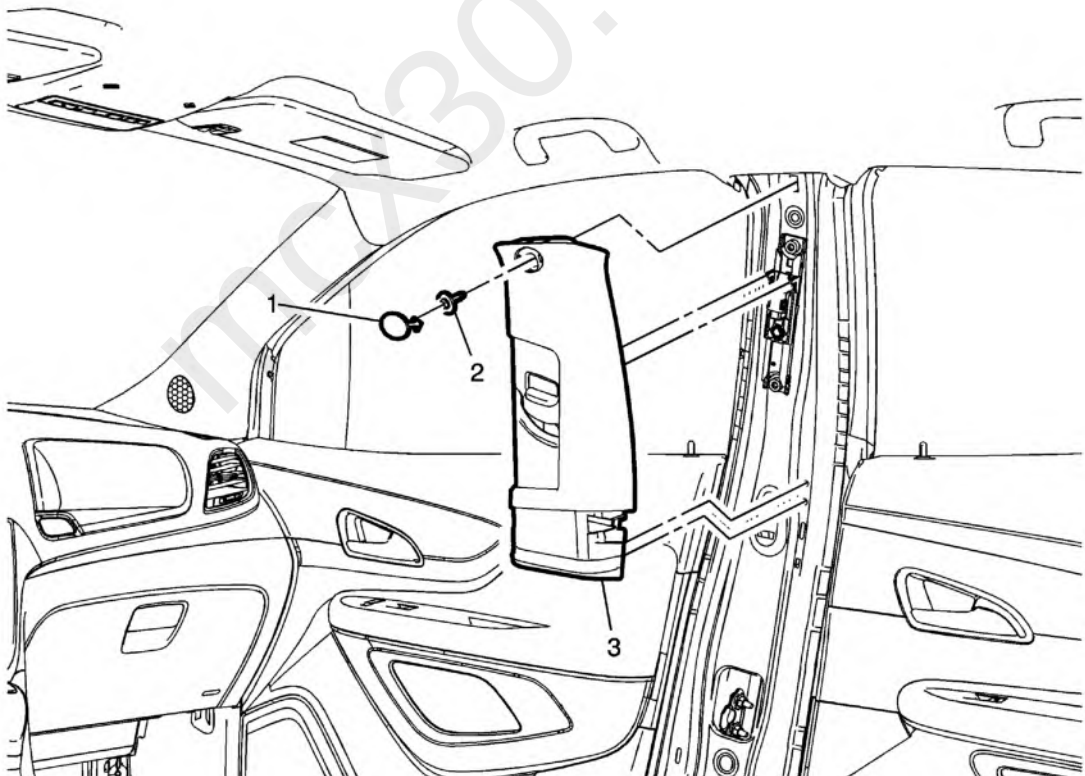
**Fig. 43: Center Pillar Upper Trim Panel Assembly**  
 Courtesy of GENERAL MOTORS COMPANY

11. Remove the center pillar upper trim panel assembly (3). Refer to [Center Pillar Upper Trim Panel Replacement \(Buick\)](#) .

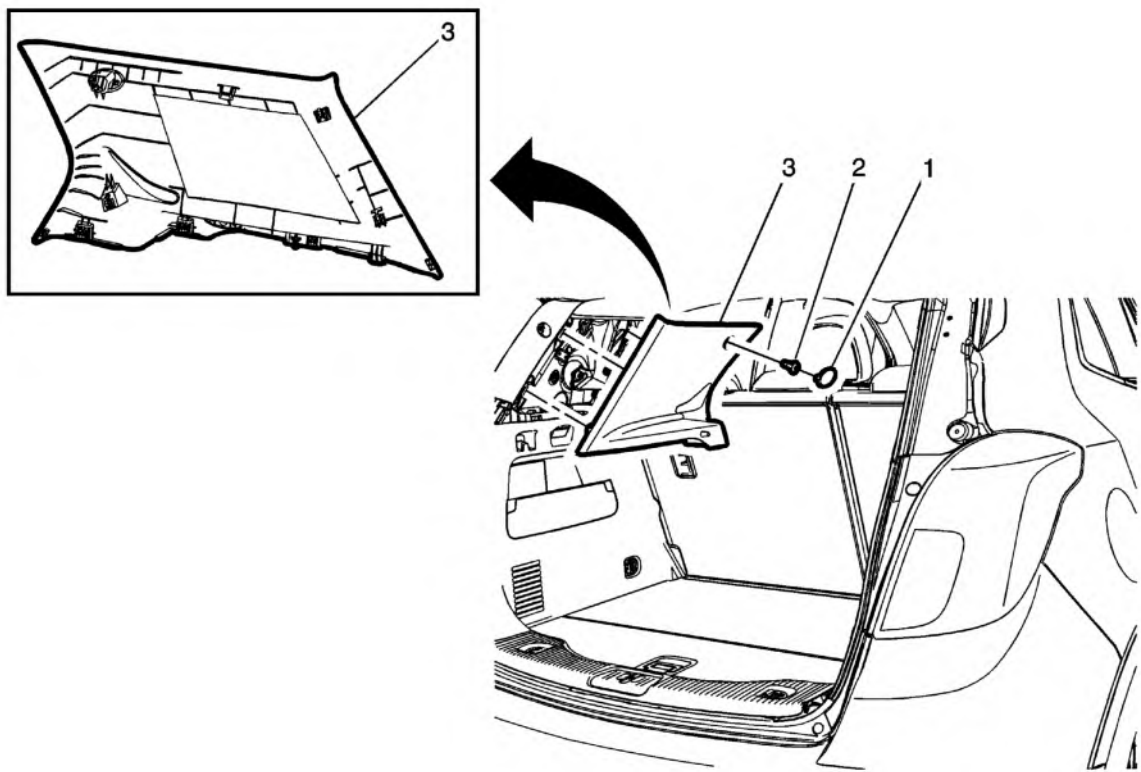
**Fig. 44: Body Lock Pillar Upper Trim Panel**  
 Courtesy of GENERAL MOTORS COMPANY

12. Remove the body lock pillar upper trim panel (3). Refer to [Body Lock Pillar Upper Trim Panel Replacement](#).
13. Fully recline the driver and passenger seats backward.
14. Fold down the rear seat backs.

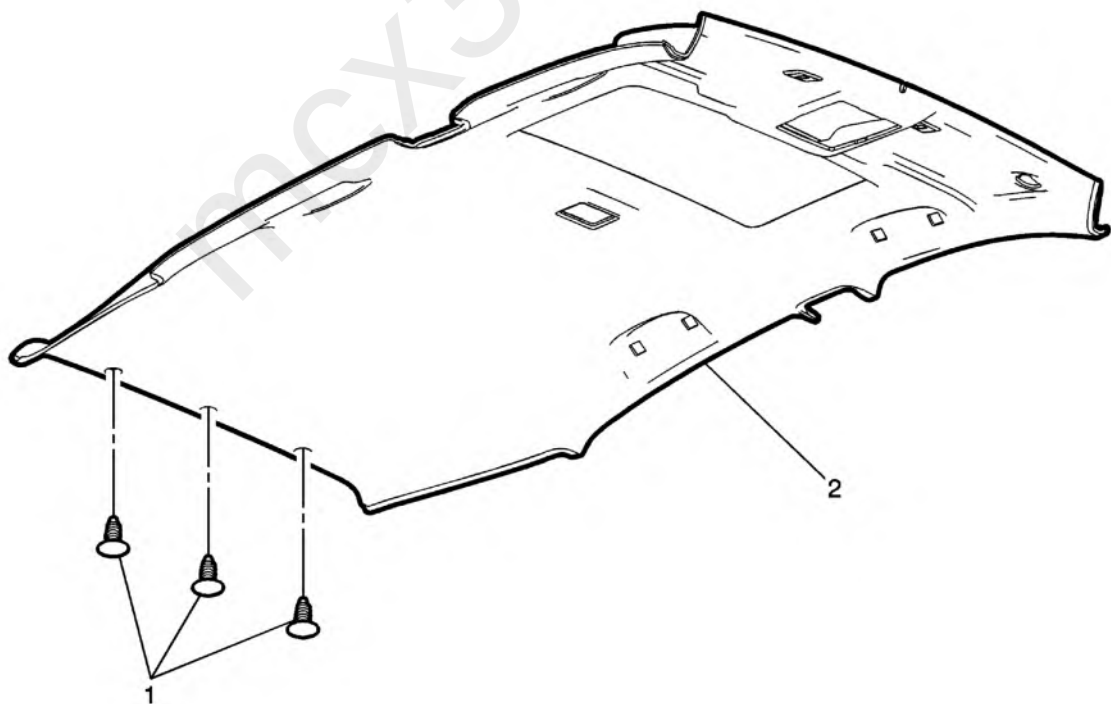
**Fig. 45: Headliner Trim Panel And Retainers**  
 Courtesy of GENERAL MOTORS COMPANY

15. Remove the 3 headliner trim panel retainers (1).
16. Disconnect the electrical connectors from the headliner trim panel assembly.

17. With the aid of an assistant, remove the headliner trim panel assembly (2) from the vehicle through the liftgate opening.
18. Prior to removal, note the routing of the wire harness to aid in reassembly and ensure proper installation.

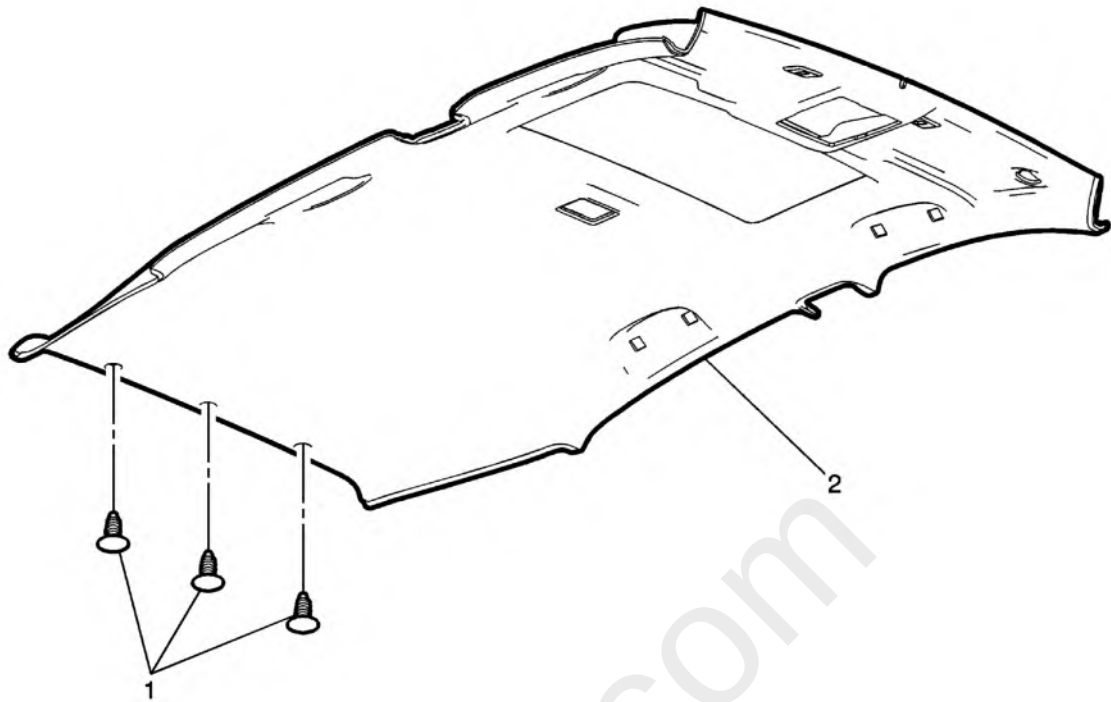
**Fig. 46: Headliner Trim Panel And Retainers**  
**Courtesy of GENERAL MOTORS COMPANY**

1. With the aid of an assistant, position the headliner trim panel assembly (2) into the vehicle through the liftgate opening.
2. Connect the electrical connectors to the headliner trim panel assembly (2).
3. Tape any unused connectors to the headliner with a high adhesive tape.
4. Install the 3 headliner trim panel retainers (1).

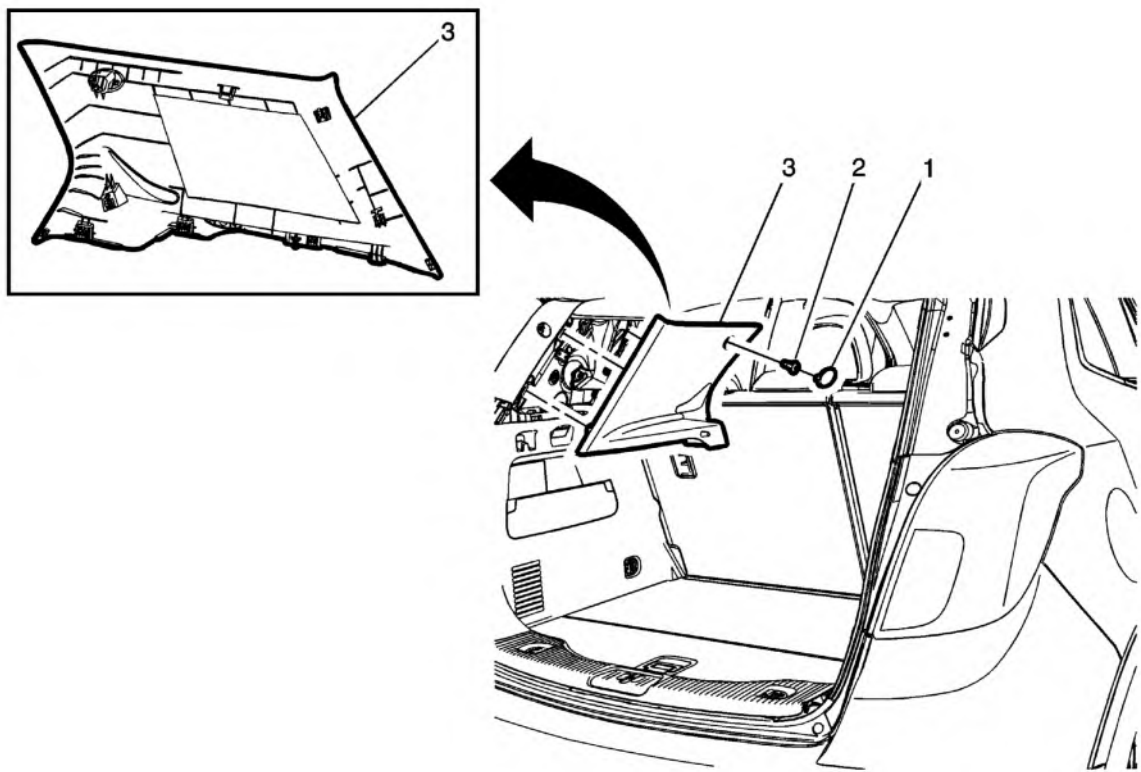
**Fig. 47: Body Lock Pillar Upper Trim Panel**  
 Courtesy of GENERAL MOTORS COMPANY

5. Install the body lock pillar upper trim panel (3). Refer to [Body Lock Pillar Upper Trim Panel Replacement](#) .

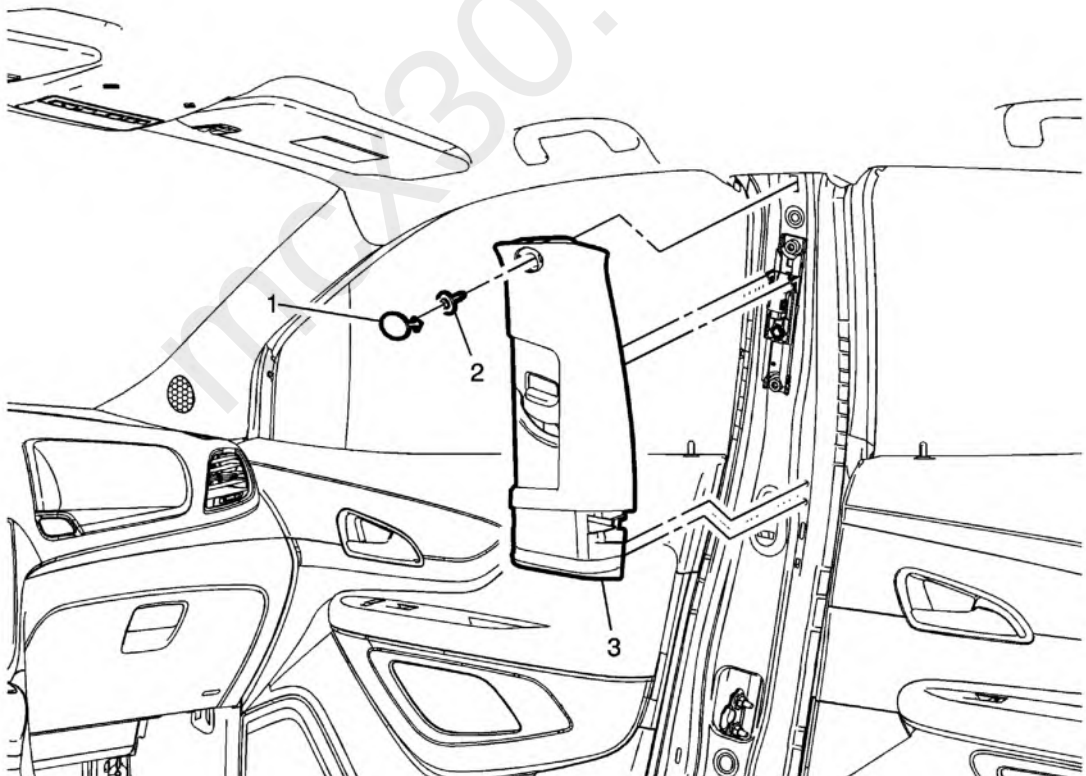
**Fig. 48: Center Pillar Upper Trim Panel Assembly**  
 Courtesy of GENERAL MOTORS COMPANY

6. Install the center pillar upper trim panel assembly (3). Refer to [Center Pillar Upper Trim Panel Replacement \(Buick\)](#) .

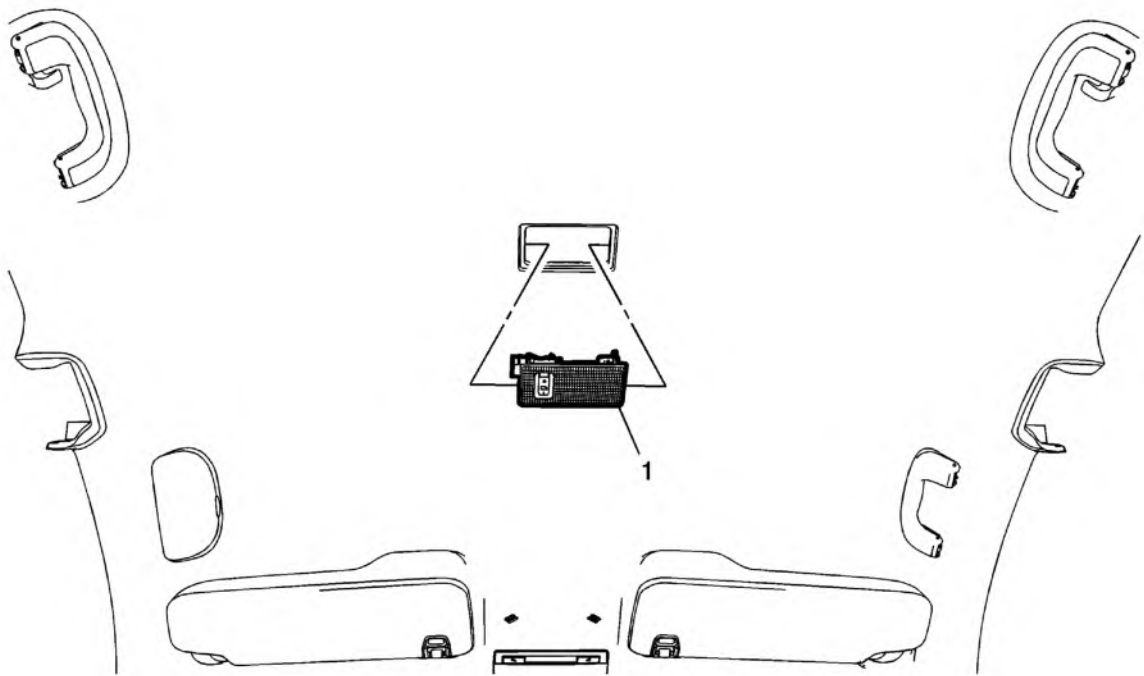
**Fig. 49: Rear Seat Position Center Courtesy Lamp**  
 Courtesy of GENERAL MOTORS COMPANY

7. Install the rear seat position center courtesy lamp (1). Refer to [Rear Seat Position Center Courtesy Lamp Replacement](#) .

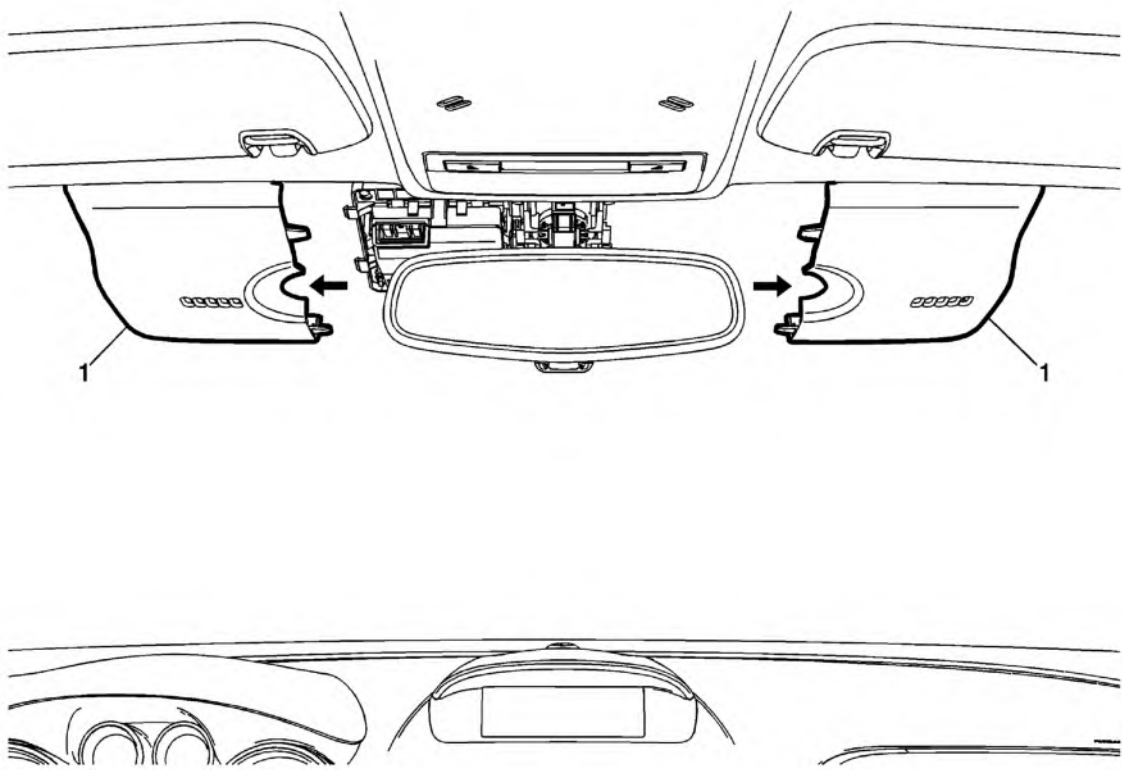
**Fig. 51: Windshield Outside Moisture Sensor Cover**  
 Courtesy of GENERAL MOTORS COMPANY

9. Install the windshield outside moisture sensor cover (1). Refer to [Windshield Outside Moisture Sensor Cover Replacement \(Buick\)](#).

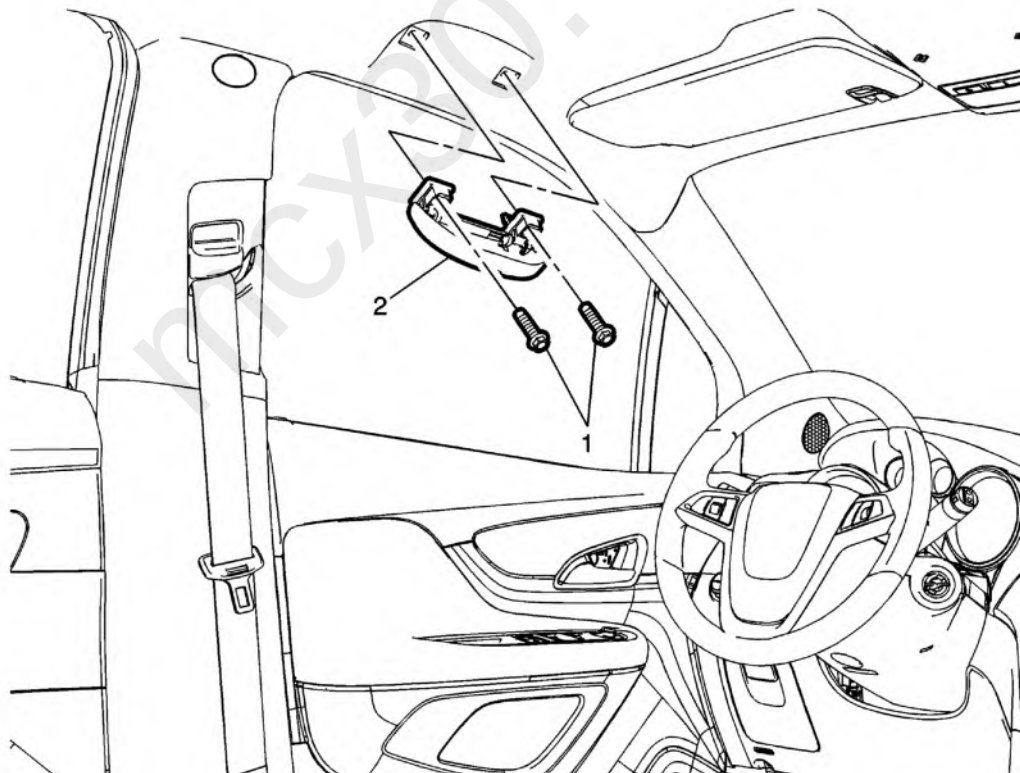
**Fig. 52: Roof Rail Front Stowage Compartment**  
 Courtesy of GENERAL MOTORS COMPANY

10. Install the roof rail front stowage compartment (2). Refer to [Roof Rail Front Stowage Compartment Replacement \(Buick\)](#).

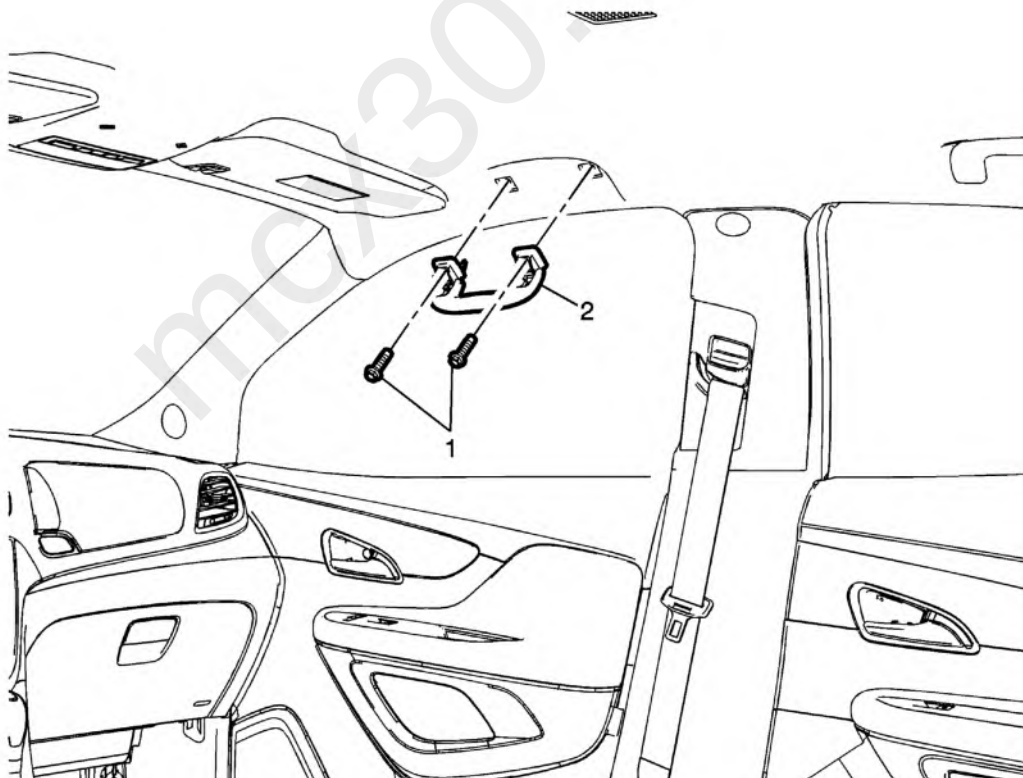
**Fig. 54: Roof Rail Assist Handle Assembly.**  
 Courtesy of GENERAL MOTORS COMPANY

12. Install the roof rail assist handle assembly (2). Refer to [Roof Rail Assist Handle Replacement \(Buick\)](#).

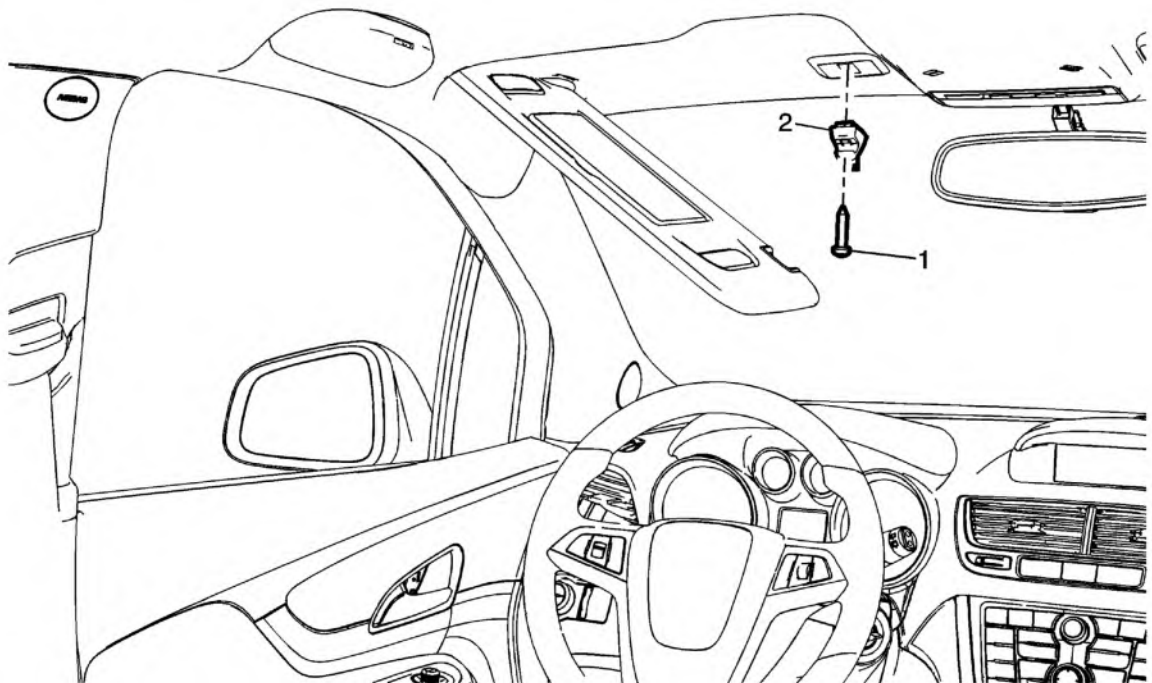
**Fig. 55: Sunshade Support Assembly.**  
 Courtesy of GENERAL MOTORS COMPANY

13. Install the sunshade support assembly (2). Refer to [Sunshade Support Replacement \(Buick\)](#).

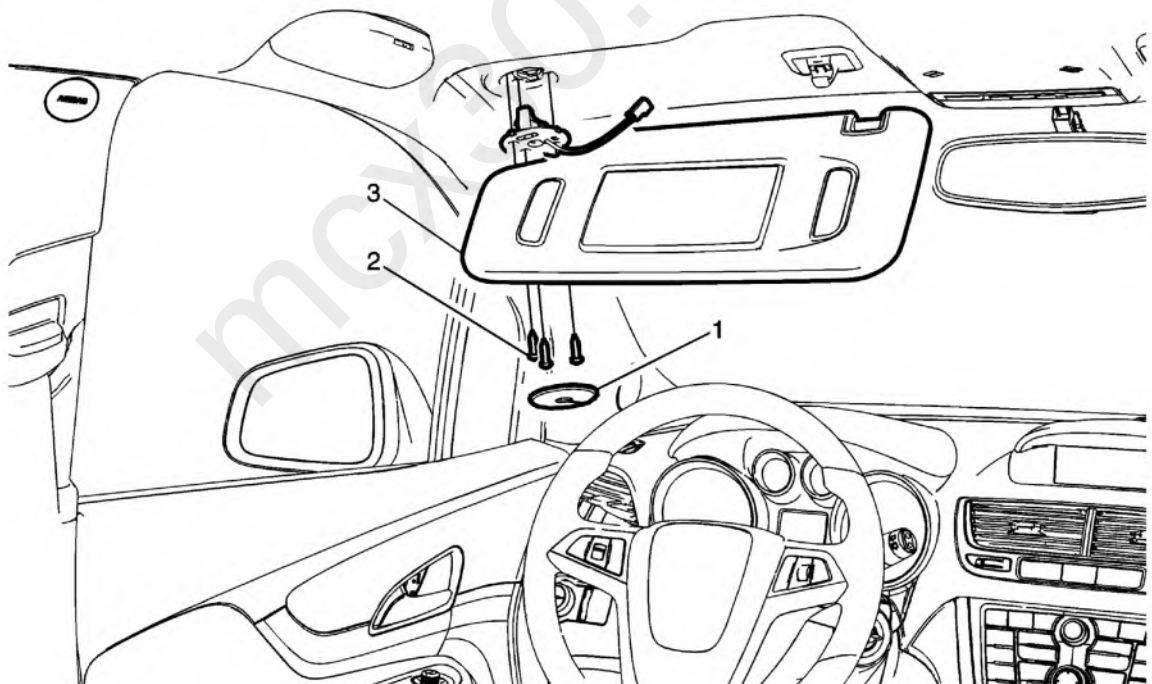
**Fig. 56: Sunshade Assembly.**  
 Courtesy of GENERAL MOTORS COMPANY

14. Install the sunshade assembly (3). Refer to [Sunshade Replacement \(Buick\)](#).

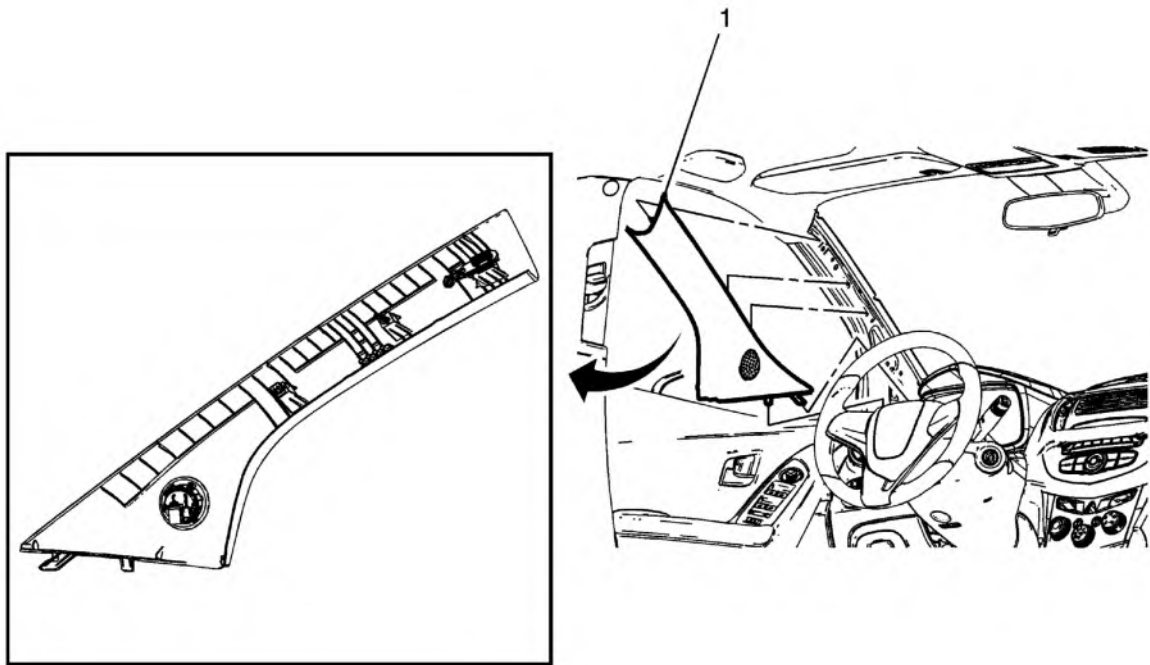
**Fig. 58: Windshield Garnish Molding Assembly.**  
 Courtesy of GENERAL MOTORS COMPANY

2. Remove the windshield garnish molding assembly (1). Refer to [Windshield Garnish Molding Replacement \(Chevrolet\)](#).
