## 2017 ACCESSORIES & EQUIPMENT

### Floor Coverings and Headlinings - Encore, Trax

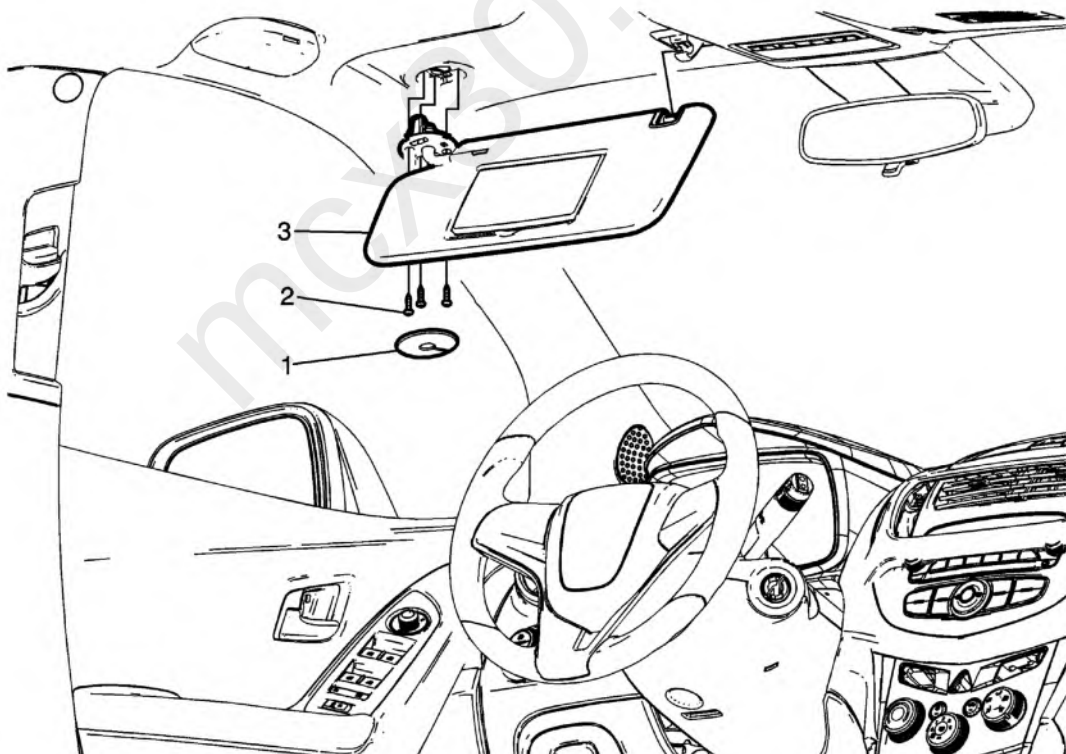
**Fig. 59: Sunshade Assembly.**  
 Courtesy of GENERAL MOTORS COMPANY

3. Remove the sunshade assembly (3). Refer to [Sunshade Replacement \(Chevrolet\)](#).

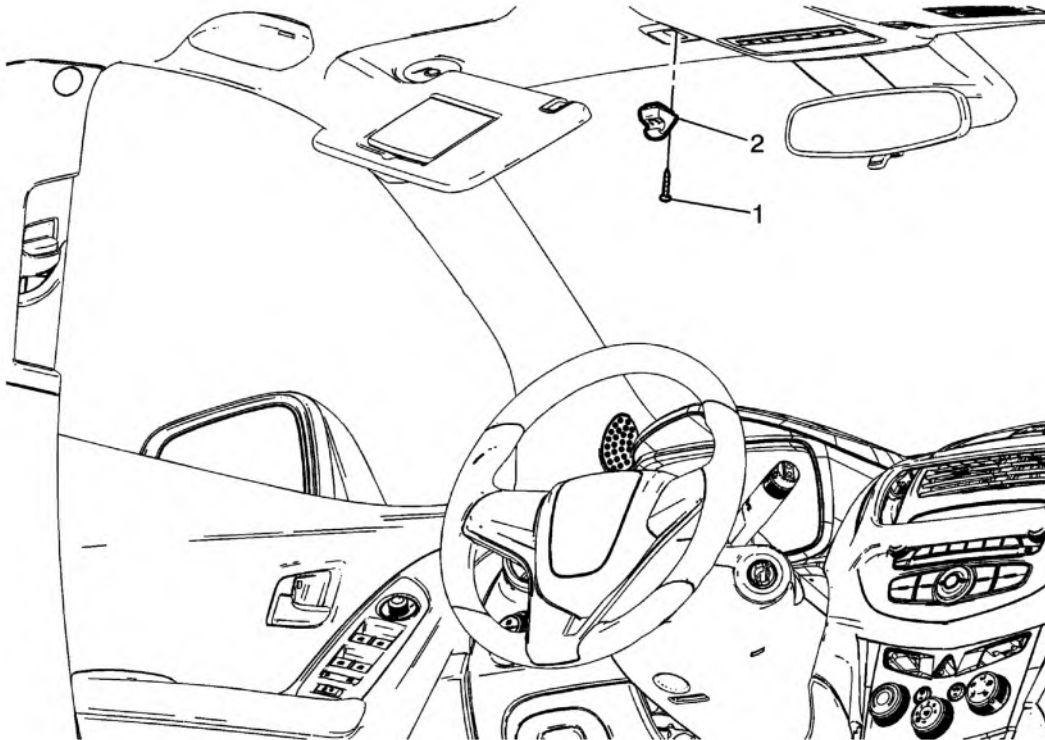
**Fig. 60: Sunshade Support Assembly.**

4. Remove the sunshade support assembly (2). Refer to [Sunshade Support Replacement \(Chevrolet\)](#).

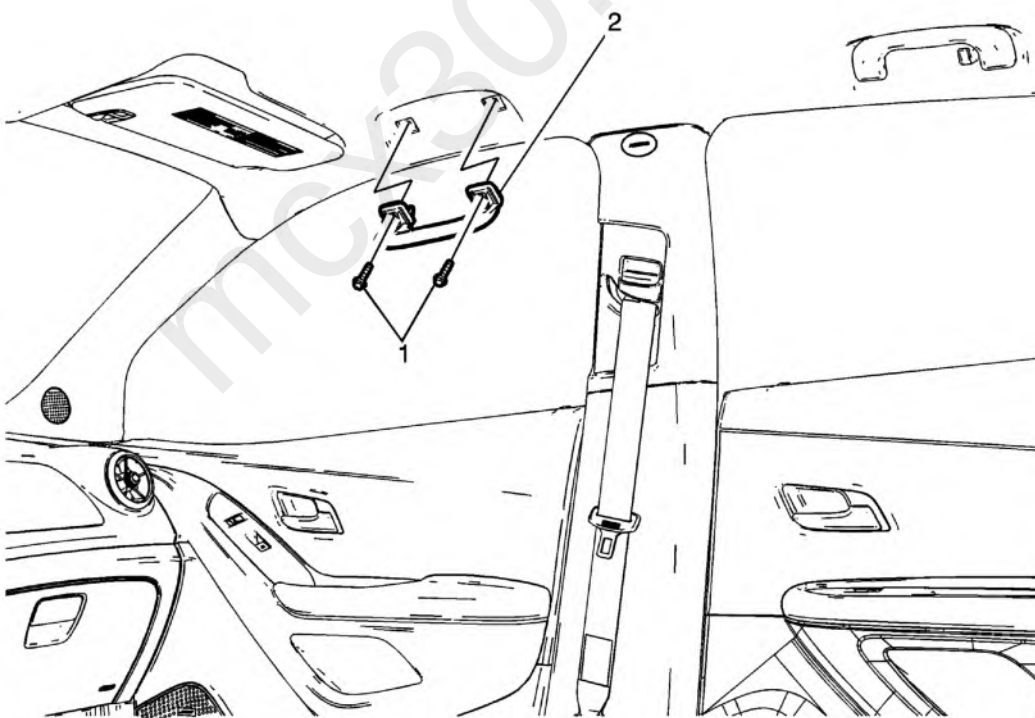
**Fig. 61: Roof Rail Assist Handle Assembly.**

5. Remove the roof rail assist handle assembly (2). Refer to [Roof Rail Assist Handle Replacement \(Chevrolet\)](#).

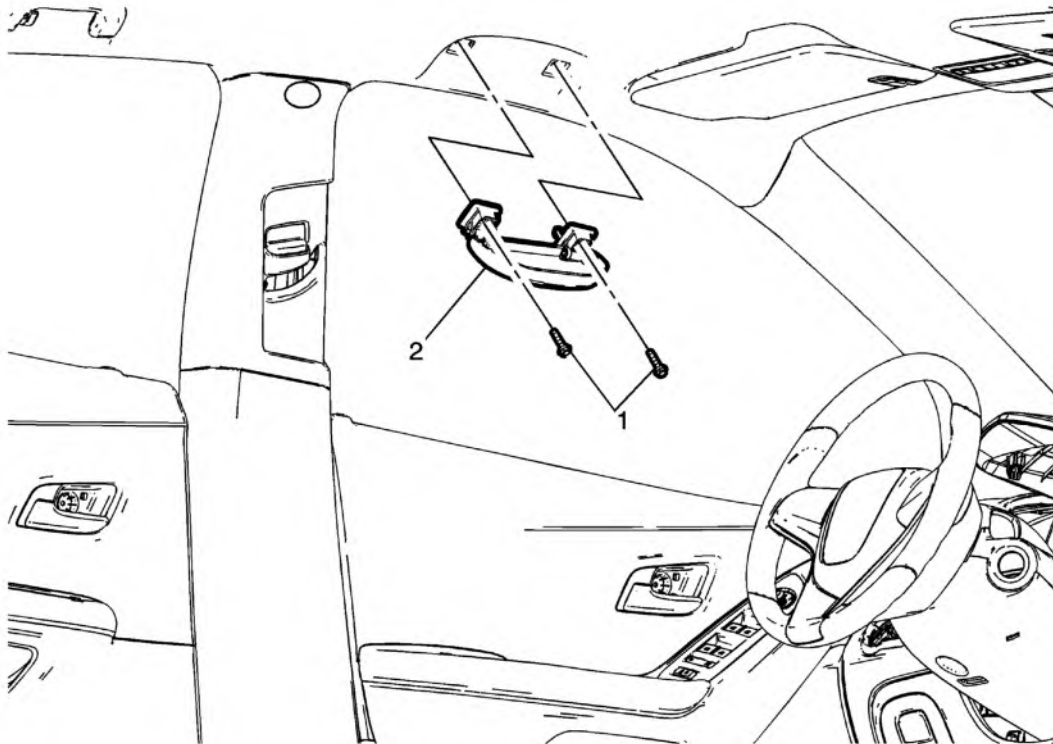
**Fig. 62: Roof Rail Front Stowage Compartment**  
 Courtesy of GENERAL MOTORS COMPANY

6. Remove the roof rail front stowage compartment (2). Refer to [Roof Rail Front Stowage Compartment Replacement \(Chevrolet\)](#).

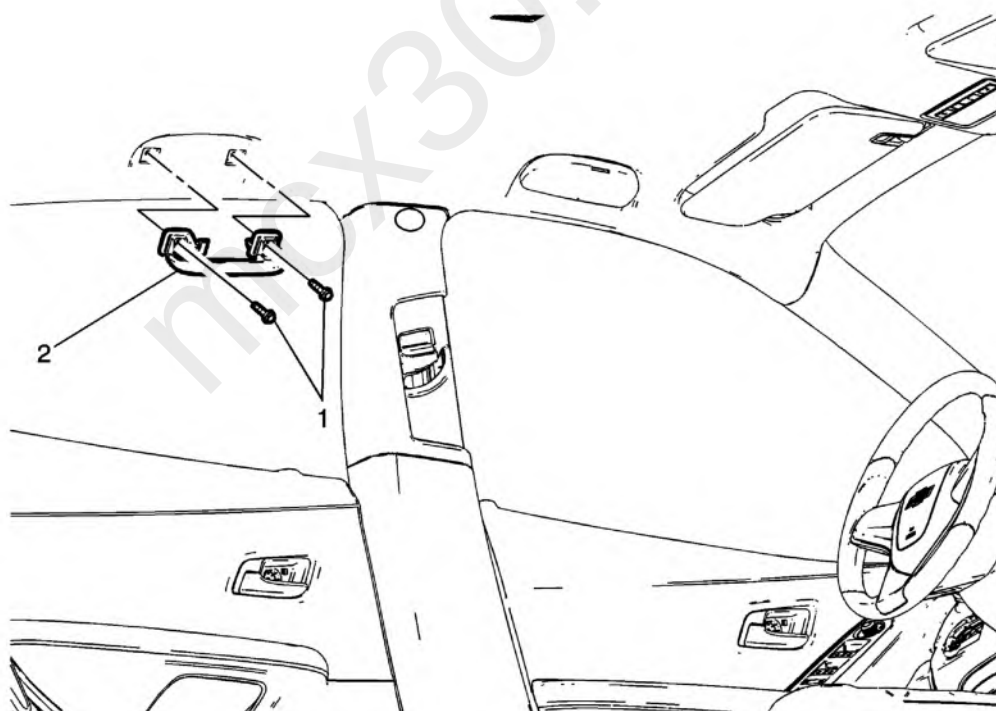
**Fig. 63: Roof Rail Rear Assist Handle Assembly**  
 Courtesy of GENERAL MOTORS COMPANY

7. Remove the roof rail rear assist handle assembly (2). Refer to [Roof Rail Rear Assist Handle Replacement \(Chevrolet\)](#).

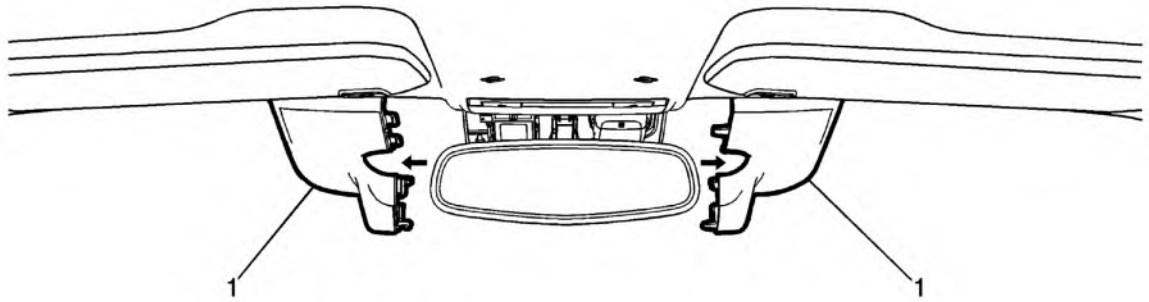
**Fig. 64: Windshield Outside Moisture Sensor Cover**  
 Courtesy of GENERAL MOTORS COMPANY

8. Remove the windshield outside moisture sensor cover (1). Refer to [Windshield Outside Moisture Sensor Cover Replacement \(Chevrolet\)](#).

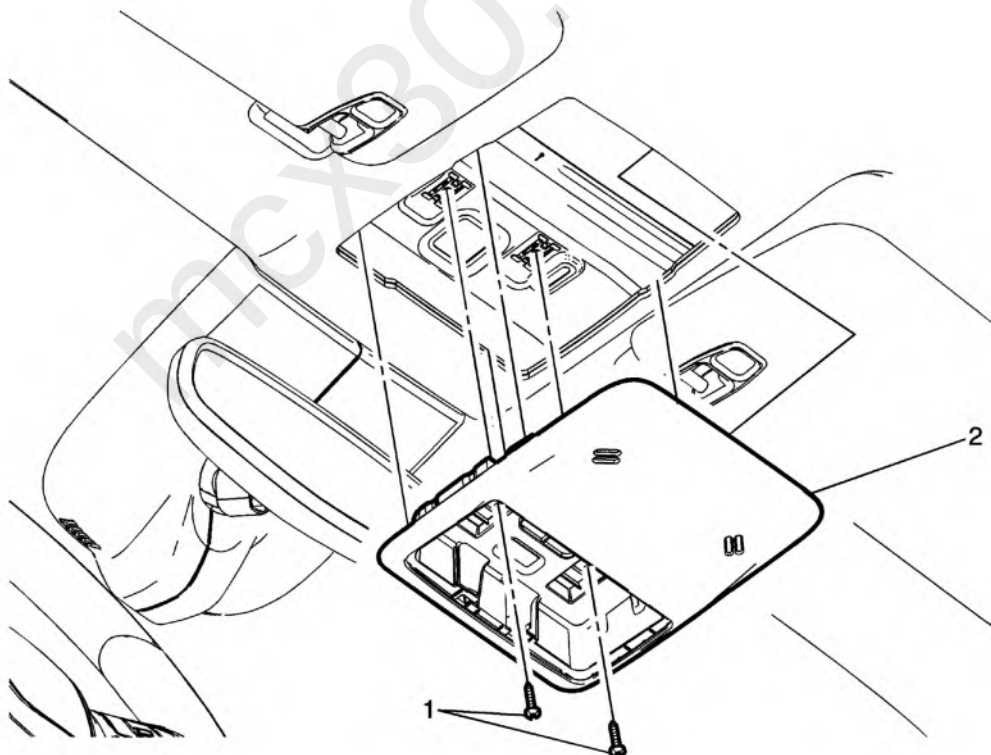
**Fig. 65: Roof Console Assembly**  
 Courtesy of GENERAL MOTORS COMPANY

9. Remove the roof console assembly (2). Refer to [Roof Console Replacement](#).

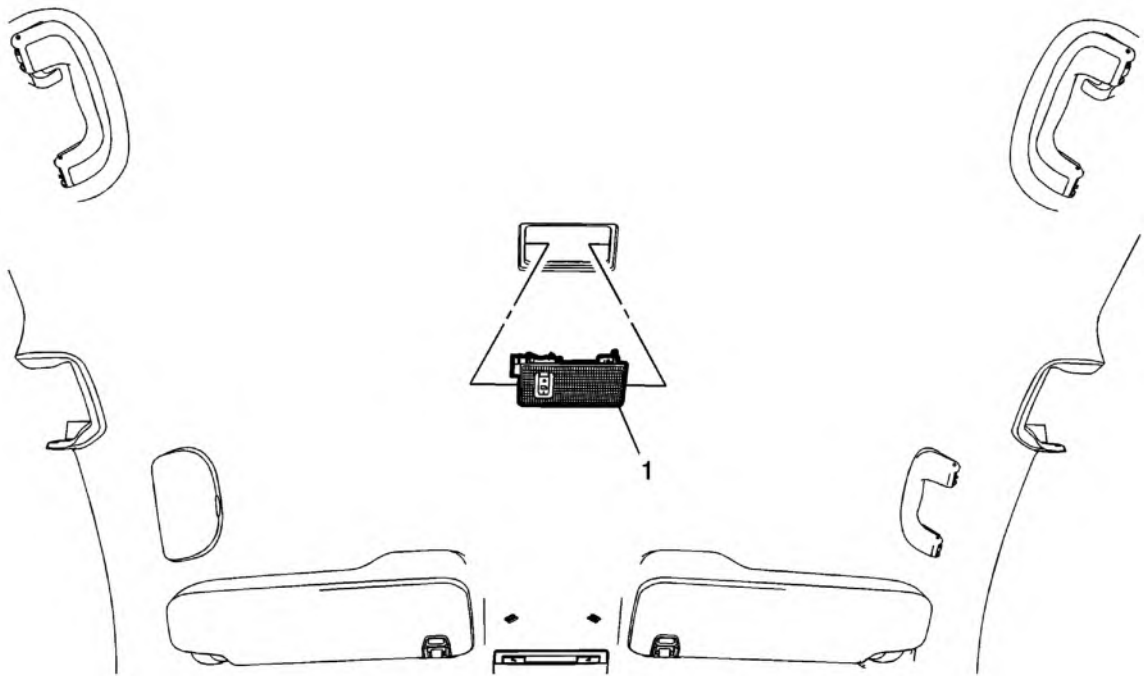
**Fig. 66: Rear Seat Position Center Courtesy Lamp**  
 Courtesy of GENERAL MOTORS COMPANY

10. Remove the rear seat position center courtesy lamp (1). Refer to [Rear Seat Position Center Courtesy Lamp Replacement](#) .

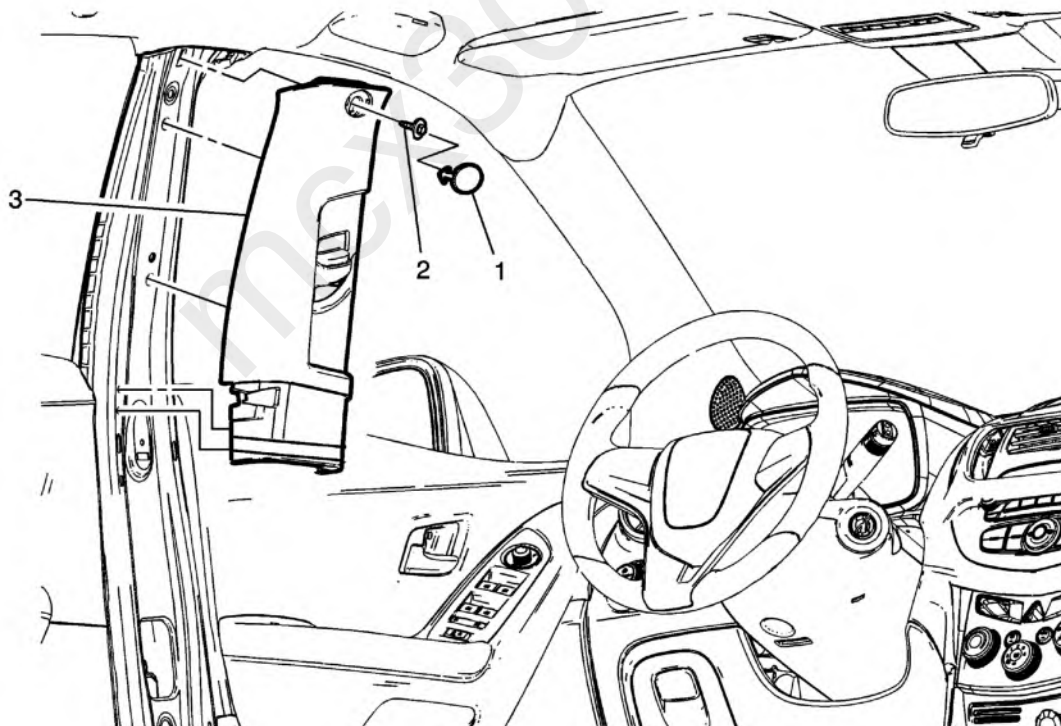
**Fig. 67: Center Pillar Upper Trim Panel Assembly**  
 Courtesy of GENERAL MOTORS COMPANY

11. Remove the center pillar upper trim panel assembly (3). Refer to [Center Pillar Upper Trim Panel Replacement \(Buick\)](#) [Center Pillar Upper Trim Panel Replacement \(Chevrolet\)](#) .

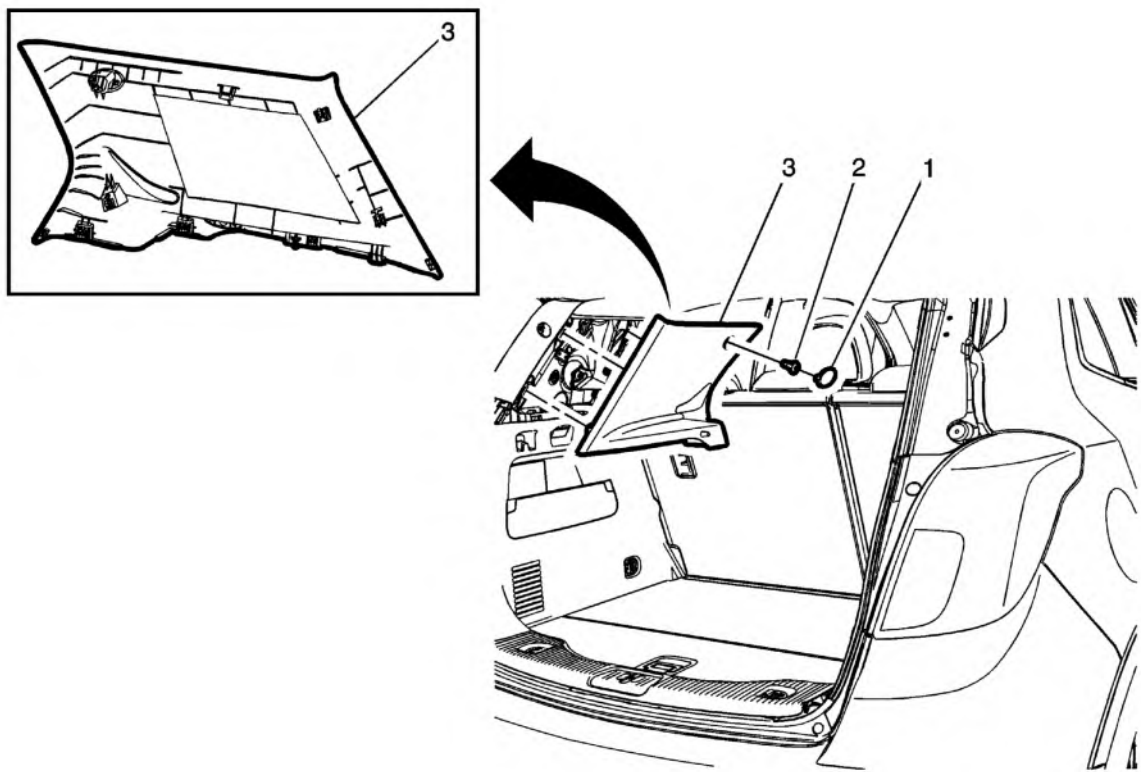
**Fig. 68: Body Lock Pillar Upper Trim Panel**  
 Courtesy of GENERAL MOTORS COMPANY

12. Remove the body lock pillar upper trim panel (3). Refer to [Body Lock Pillar Upper Trim Panel Replacement](#).
13. Fully recline the driver and passenger seats backward.
14. Fold down the rear seat backs.

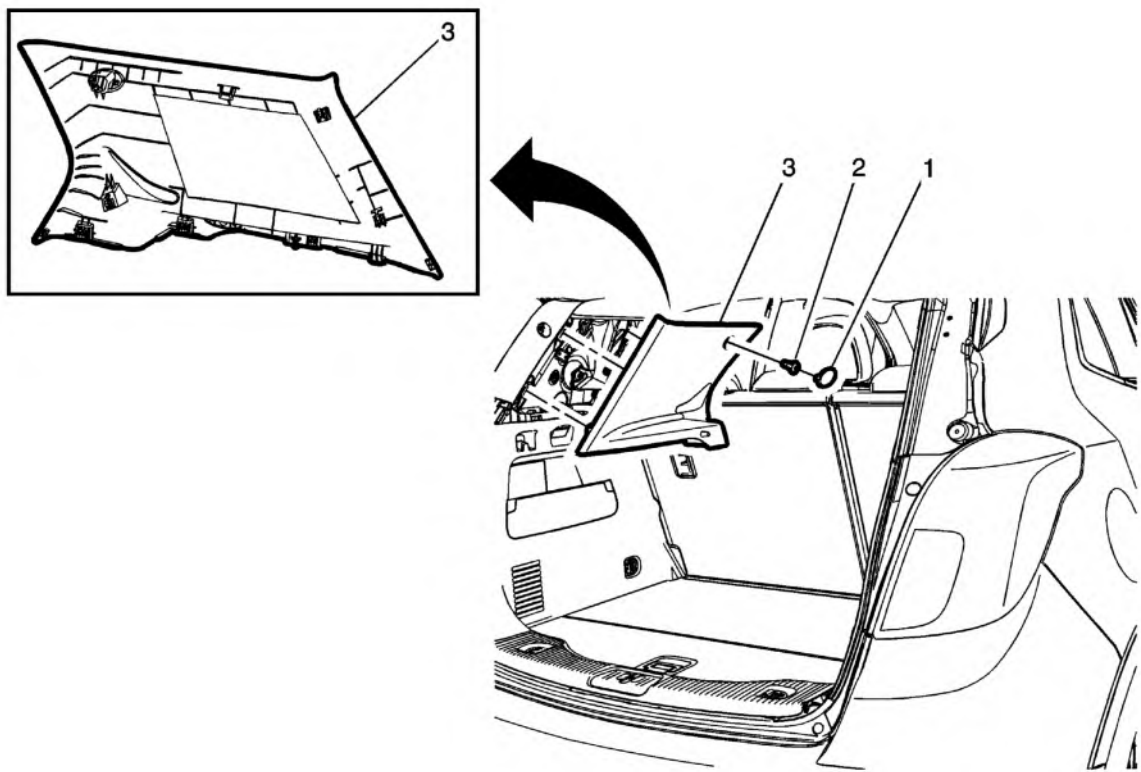
**Fig. 71: Body Lock Pillar Upper Trim Panel**  
 Courtesy of GENERAL MOTORS COMPANY

5. Install the body lock pillar upper trim panel (3). Refer to [Body Lock Pillar Upper Trim Panel Replacement](#) .

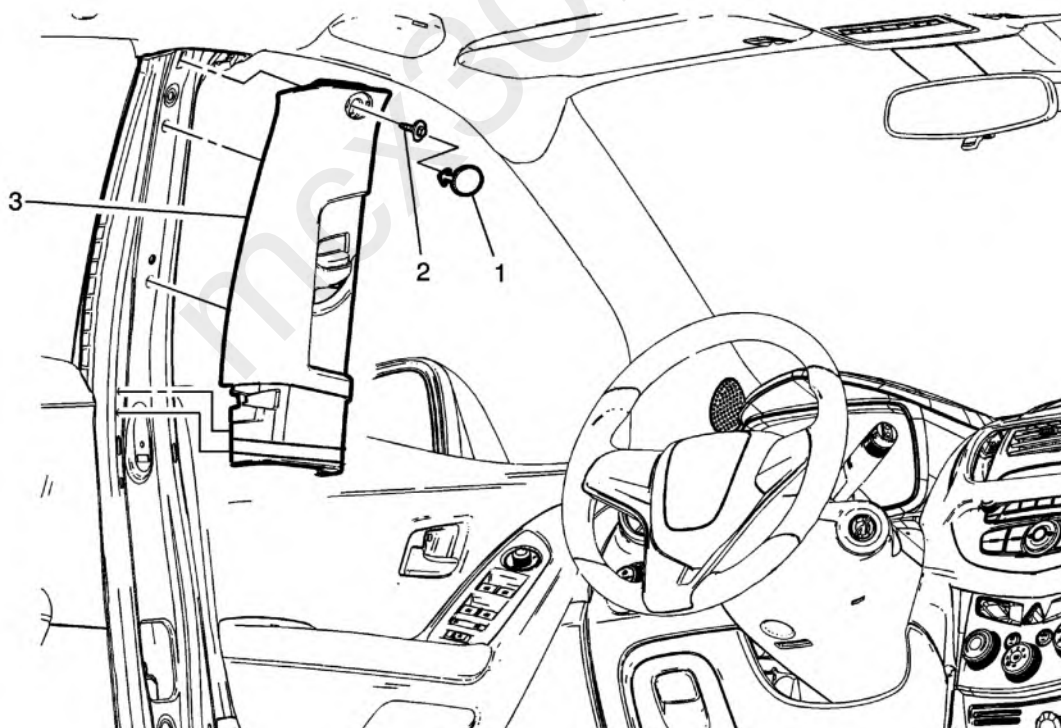
**Fig. 72: Center Pillar Upper Trim Panel Assembly**  
 Courtesy of GENERAL MOTORS COMPANY

6. Install the center pillar upper trim panel assembly (3). Refer to [Center Pillar Upper Trim Panel Replacement \(Chevrolet\)](#) .

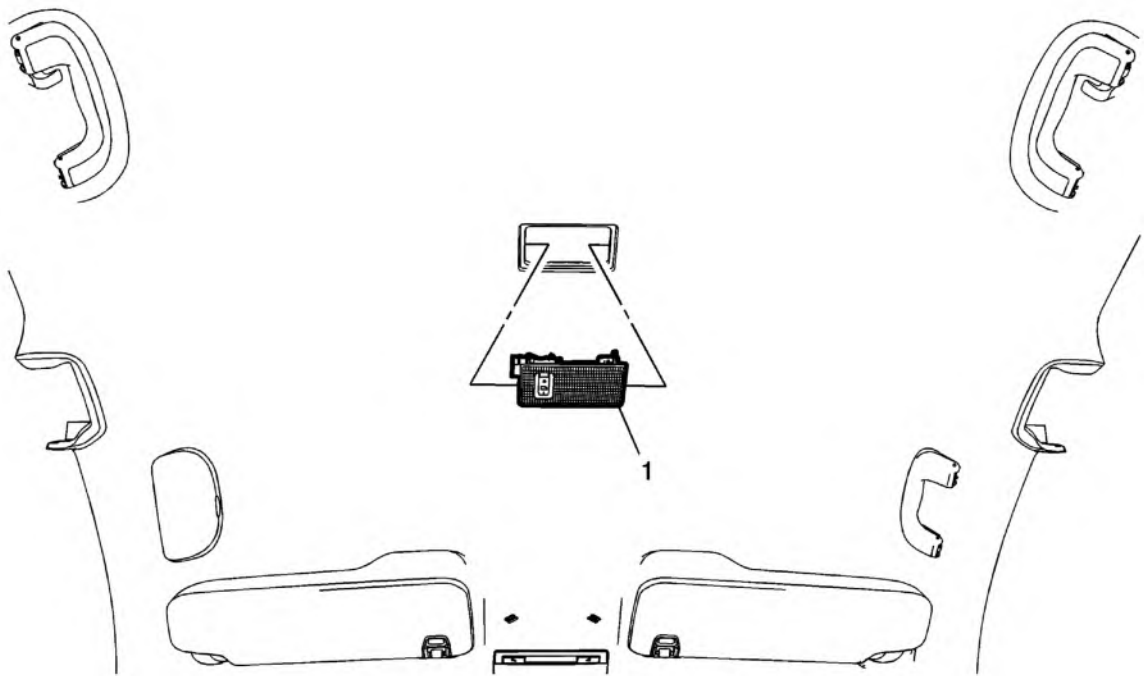
**Fig. 73: Rear Seat Position Center Courtesy Lamp**  
Courtesy of GENERAL MOTORS COMPANY

7. Install the rear seat position center courtesy lamp (1). Refer to [Rear Seat Position Center Courtesy Lamp Replacement](#) .

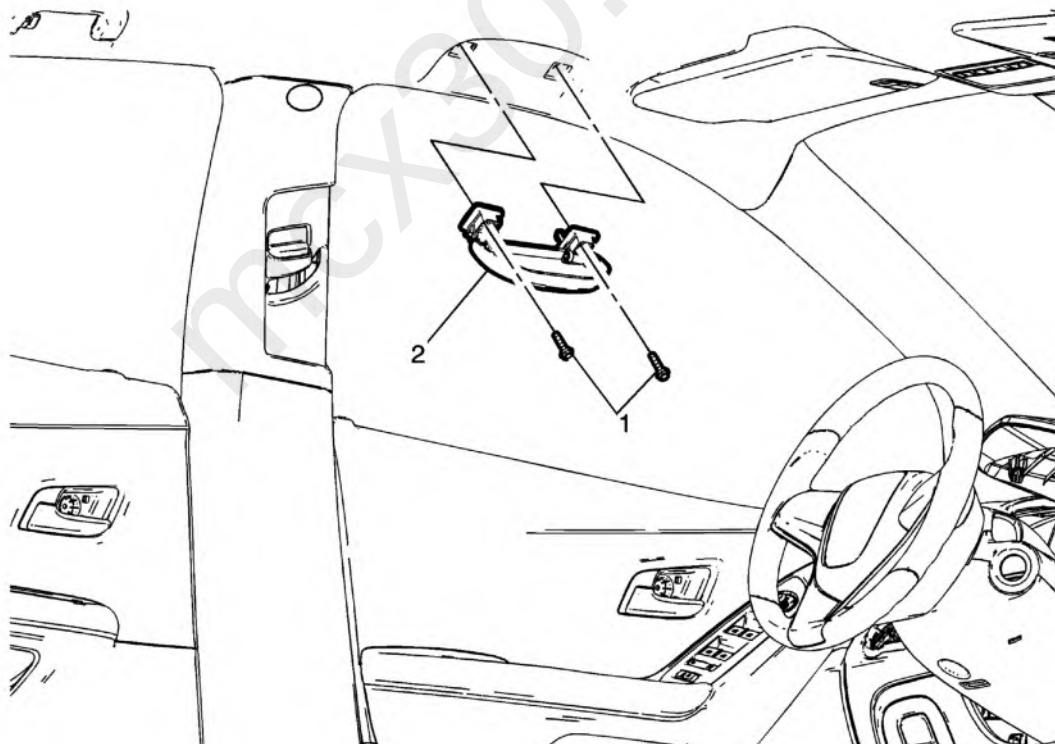
**Fig. 76: Roof Rail Front Stowage Compartment**  
 Courtesy of GENERAL MOTORS COMPANY

10. Install the roof rail front stowage compartment (2). Refer to [Roof Rail Front Stowage Compartment Replacement \(Chevrolet\)](#) .

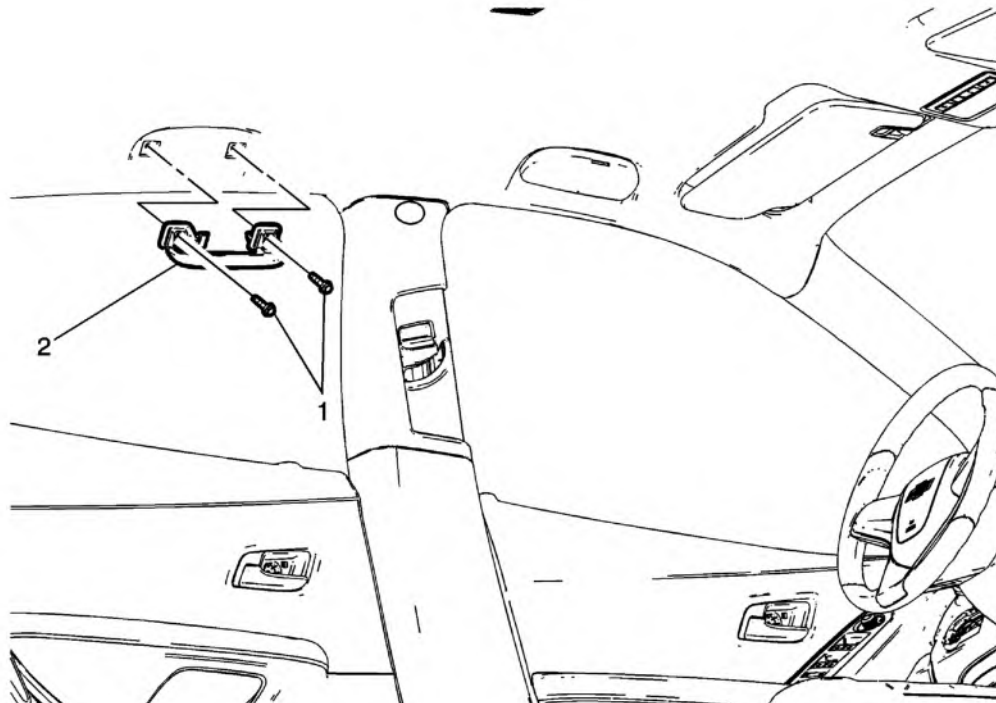
**Fig. 77: Roof Rail Rear Assist Handle Assembly.**  
 Courtesy of GENERAL MOTORS COMPANY

11. Install the roof rail rear assist handle assembly (2). Refer to [Roof Rail Rear Assist Handle Replacement \(Chevrolet\)](#).

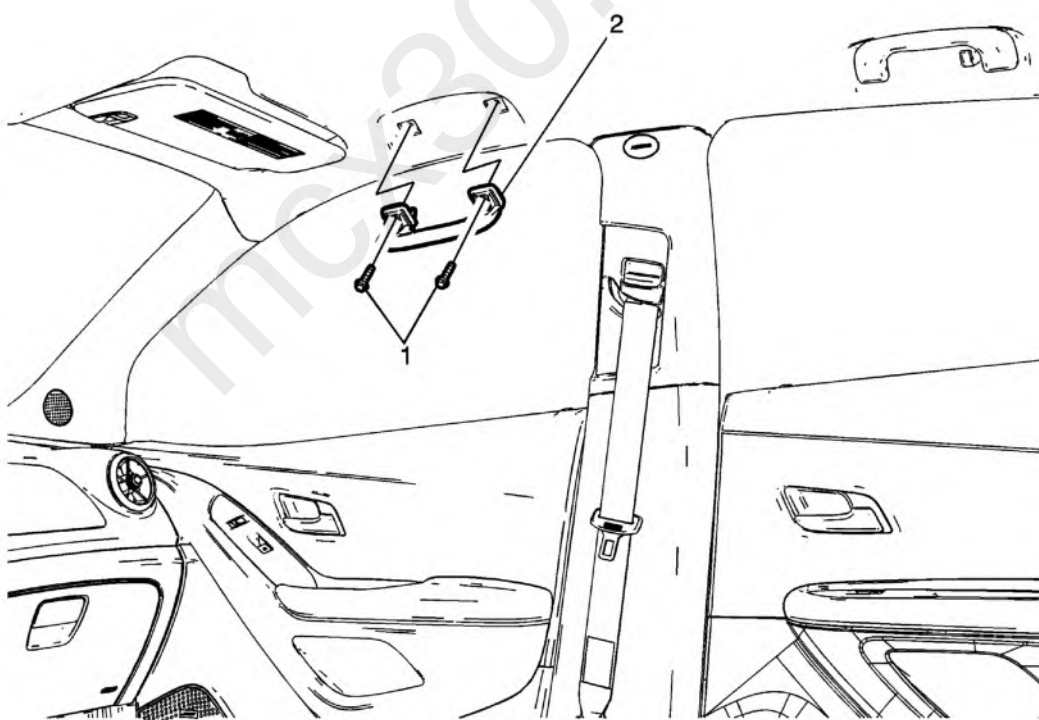
**Fig. 78: Roof Rail Assist Handle Assembly.**  
 Courtesy of GENERAL MOTORS COMPANY

12. Install the roof rail assist handle assembly (2). Refer to [Roof Rail Assist Handle Replacement \(Chevrolet\)](#).

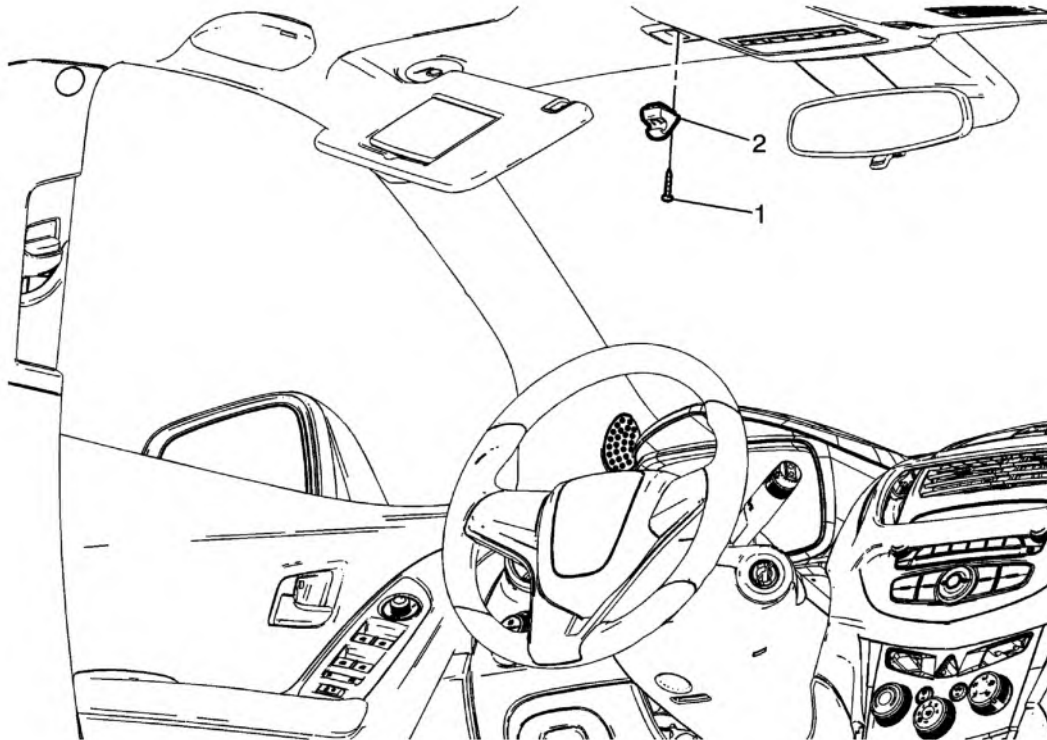
**Fig. 79: Sunshade Support Assembly.**

13. Install the sunshade support assembly (2). Refer to [Sunshade Support Replacement \(Chevrolet\)](#).

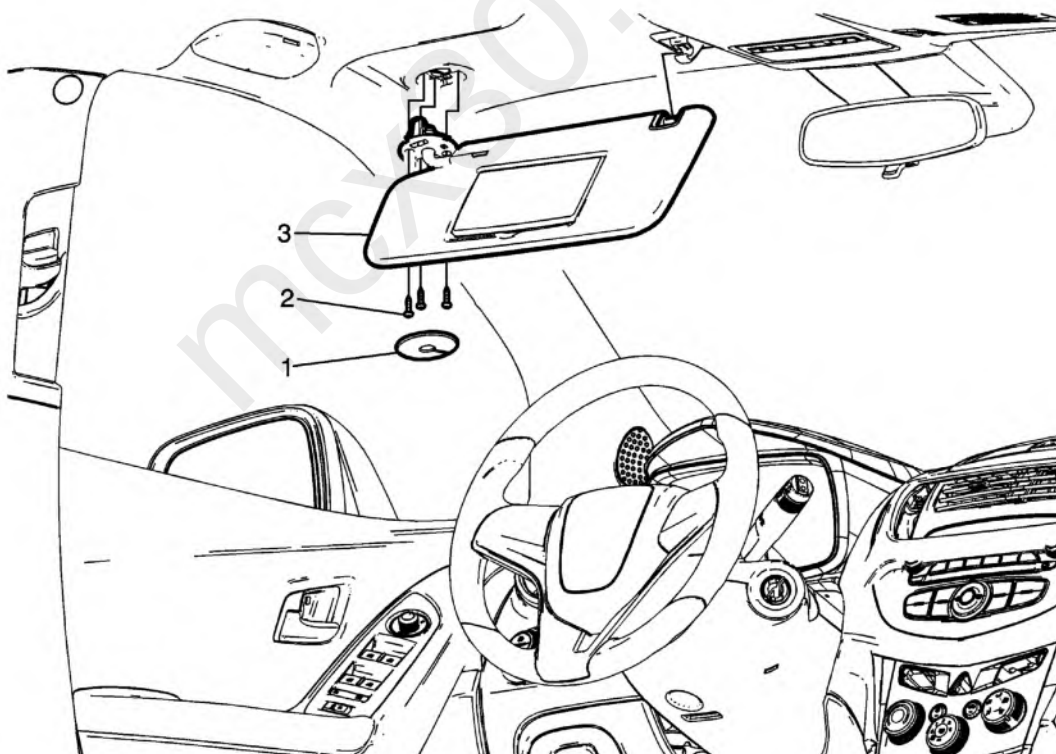
**Fig. 80: Sunshade Assembly.**

14. Install the sunshade assembly (3). Refer to [Sunshade Replacement \(Chevrolet\)](#).

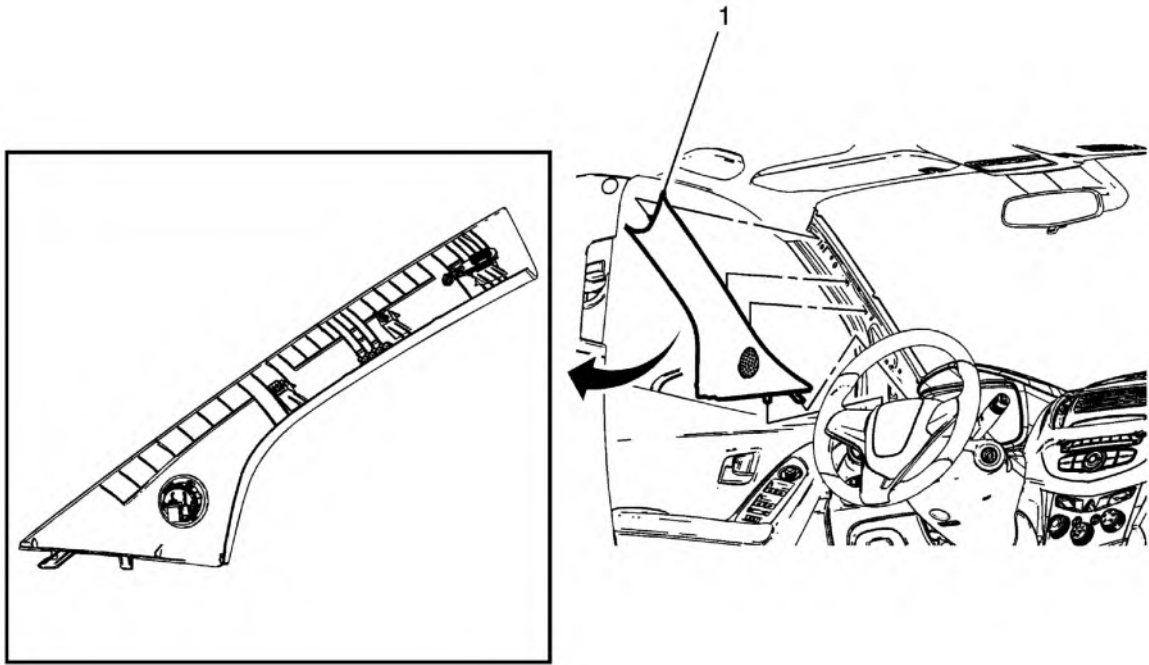
**Fig. 82: Windshield Garnish Molding Assembly.**  
 Courtesy of GENERAL MOTORS COMPANY

2. Remove the windshield garnish molding assembly (1). Refer to [Windshield Garnish Molding Replacement \(Chevrolet\)](#).

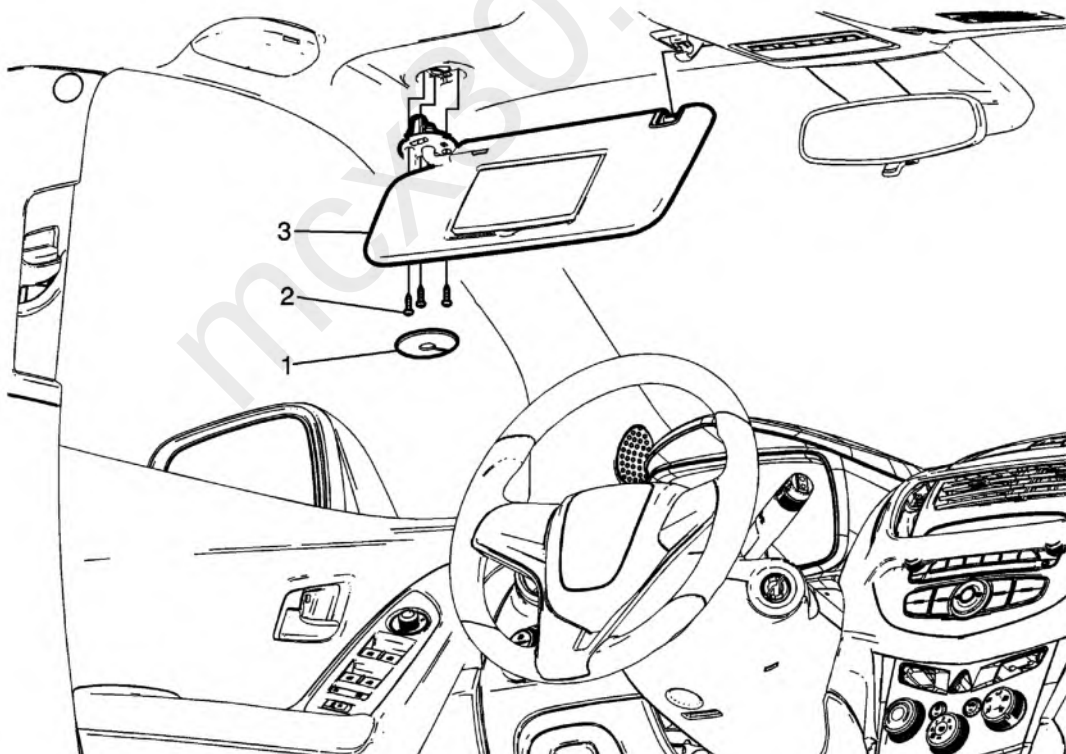
**Fig. 83: Sunshade Assembly.**  
 Courtesy of GENERAL MOTORS COMPANY

3. Remove the sunshade assembly (3). Refer to [Sunshade Replacement \(Chevrolet\)](#).

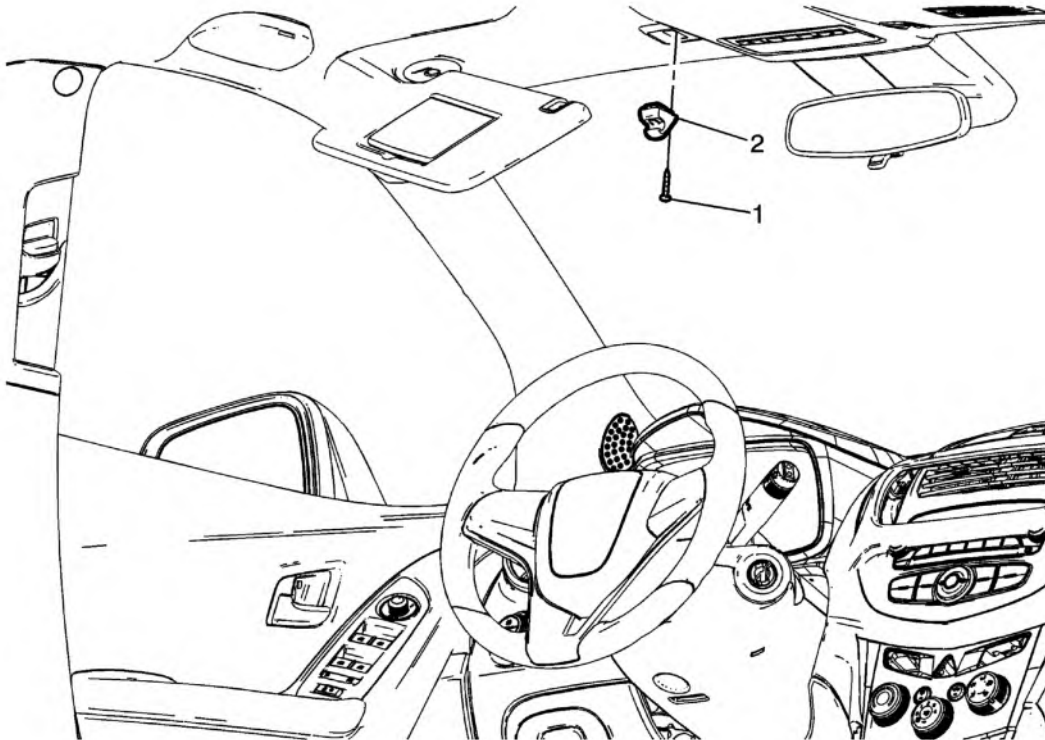
**Fig. 84: Sunshade Support Assembly.**

4. Remove the sunshade support assembly (2). Refer to [Sunshade Support Replacement \(Chevrolet\)](#).

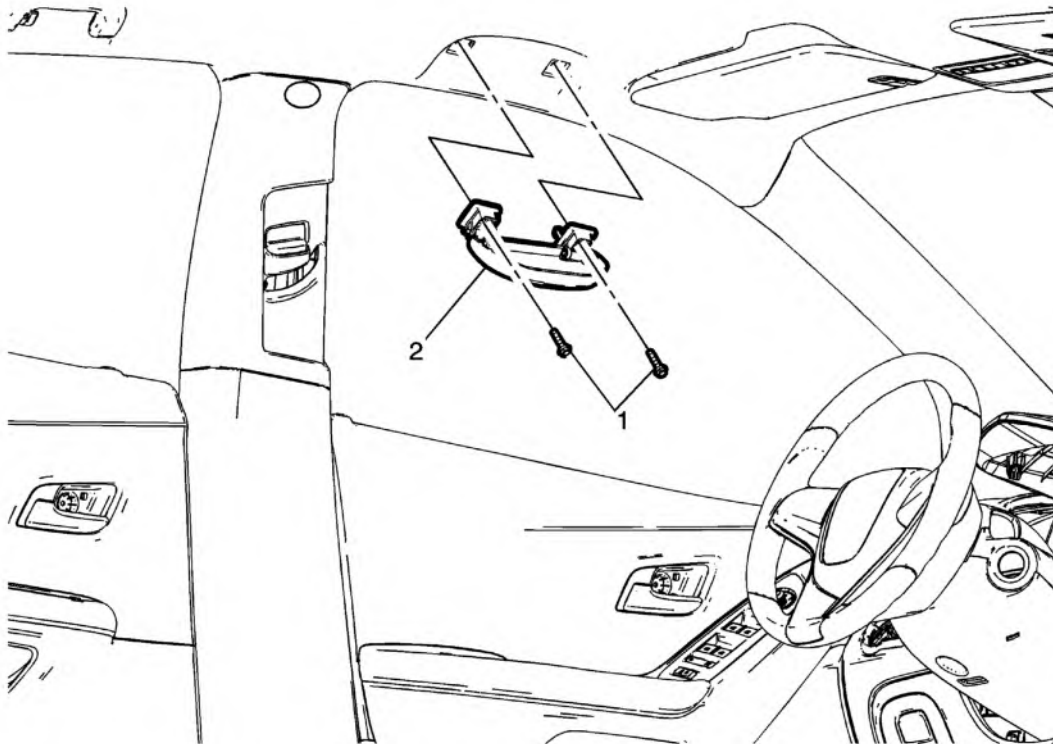
**Fig. 86: Roof Rail Front Stowage Compartment**  
 Courtesy of GENERAL MOTORS COMPANY

6. Remove the roof rail front stowage compartment (2). Refer to [Roof Rail Front Stowage Compartment Replacement \(Chevrolet\)](#).

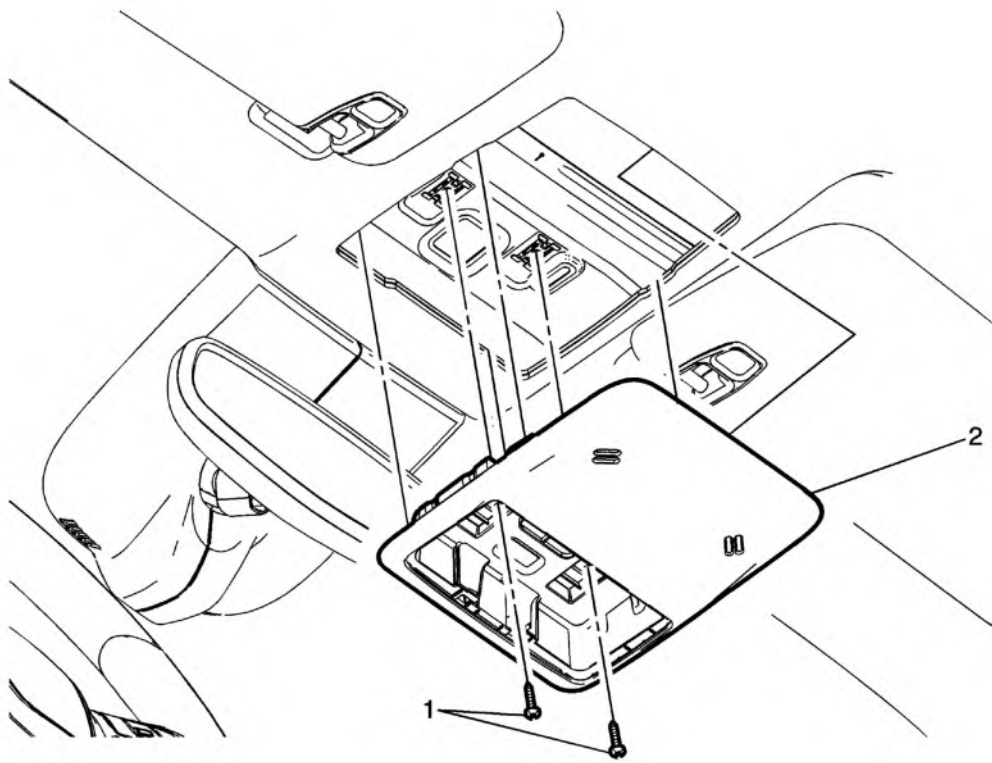
**Fig. 88: Roof Console Assembly**  
 Courtesy of GENERAL MOTORS COMPANY

9. Remove the roof console assembly (2). Refer to [Roof Console Replacement](#) .

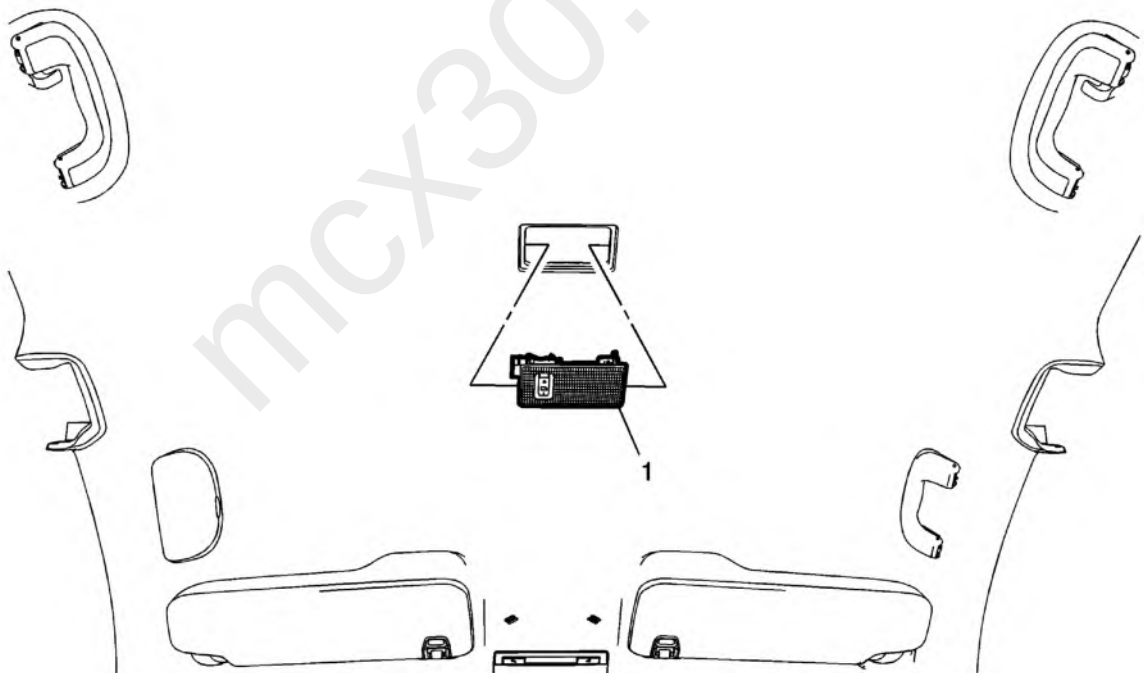
**Fig. 89: Rear Seat Position Center Courtesy Lamp**  
 Courtesy of GENERAL MOTORS COMPANY

10. Remove the rear seat position center courtesy lamp (1). Refer to [Rear Seat Position Center Courtesy Lamp Replacement](#) .

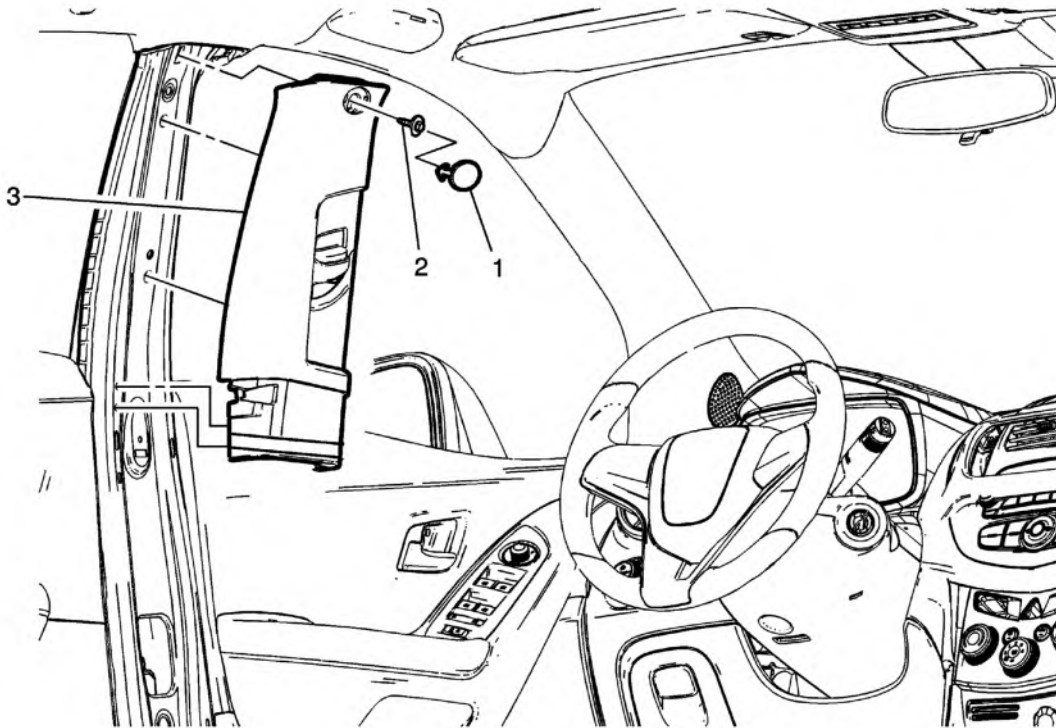
**Fig. 90: Center Pillar Upper Trim Panel Assembly.**  
 Courtesy of GENERAL MOTORS COMPANY

11. Remove the center pillar upper trim panel assembly (3). Refer to [Center Pillar Upper Trim Panel Replacement \(Chevrolet\)](#).

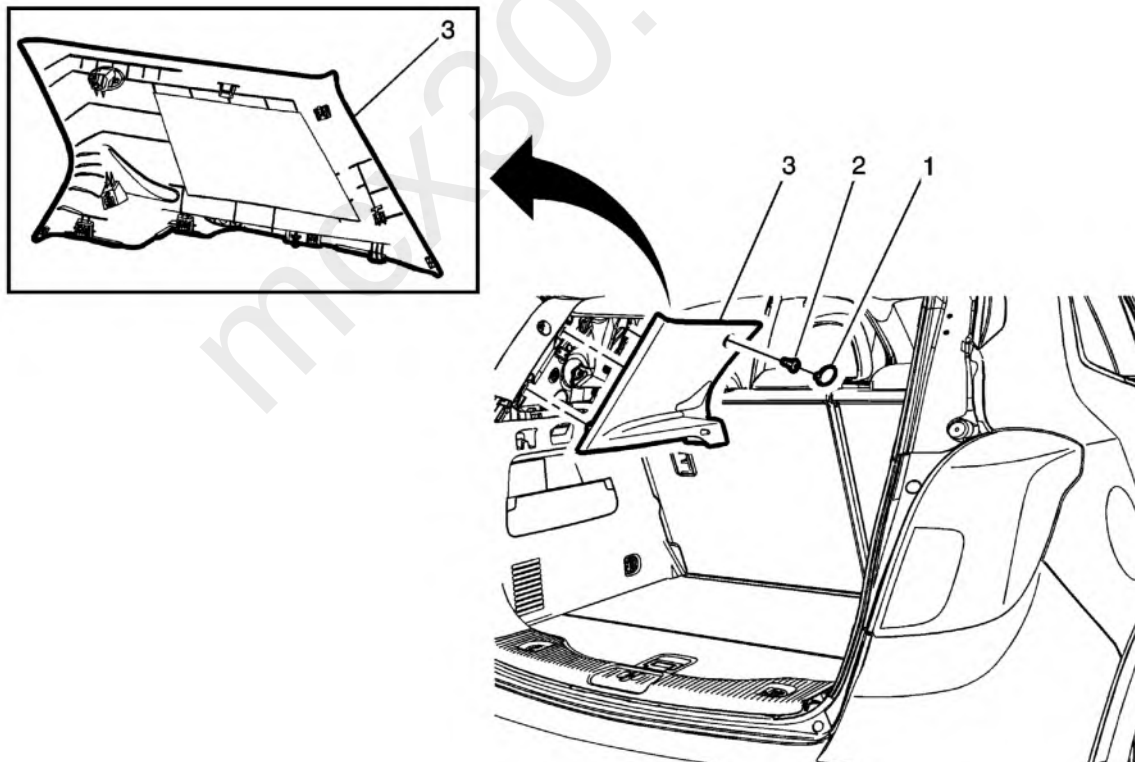
**Fig. 91: Body Lock Pillar Upper Trim Panel**  
 Courtesy of GENERAL MOTORS COMPANY

12. Remove the body lock pillar upper trim panel (3). Refer to [Body Lock Pillar Upper Trim Panel Replacement](#).
13. Fully recline the driver and passenger seats backward.
14. Fold down the rear seat backs.

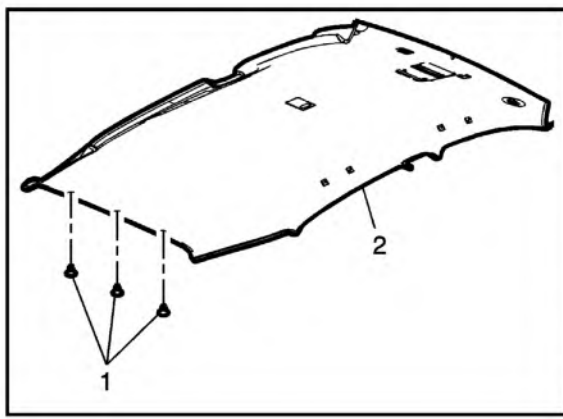
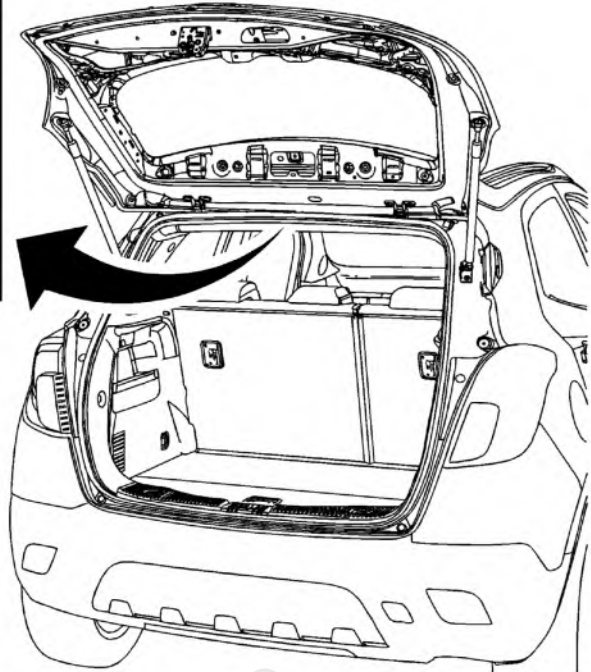
**Fig. 92: Headliner Trim Panel Retainers**  
 Courtesy of GENERAL MOTORS COMPANY

15. Remove the 3 headliner trim panel retainers (1).
16. Disconnect the electrical connectors from the headliner trim panel assembly.
17. With the aid of an assistant, remove the headliner trim panel assembly (2) from the vehicle through the liftgate opening.
18. Prior to removal, note the routing of the wire harness to aid in reassembly and ensure proper installation.

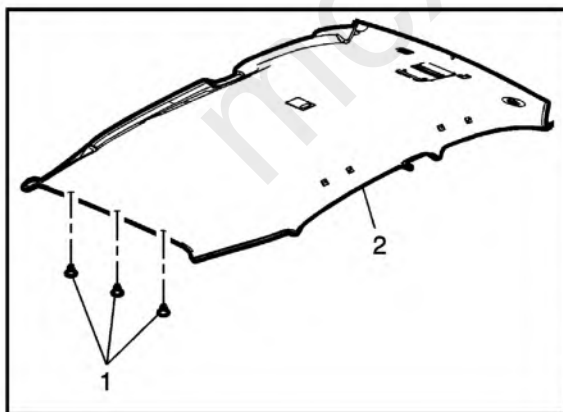
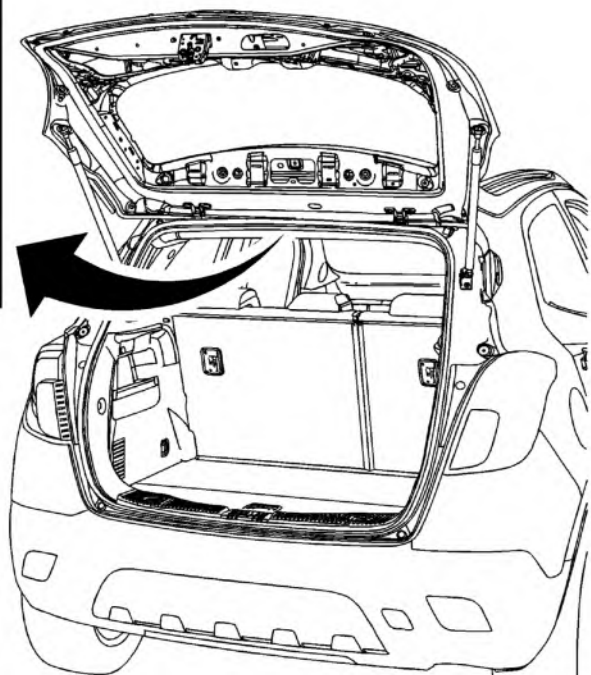
**Fig. 93: Headliner Trim Panel Retainers**  
 Courtesy of GENERAL MOTORS COMPANY

1. With the aid of an assistant, position the headliner trim panel assembly (2) into the vehicle through the liftgate opening.
2. Connect the electrical connectors to the headliner trim panel assembly (2).
3. Tape any unused connectors to the headliner with a high adhesive tape.
4. Install the 3 headliner trim panel retainers (1).
