## 2017 ACCESSORIES & EQUIPMENT

### Floor Coverings and Headlinings - Encore, Trax

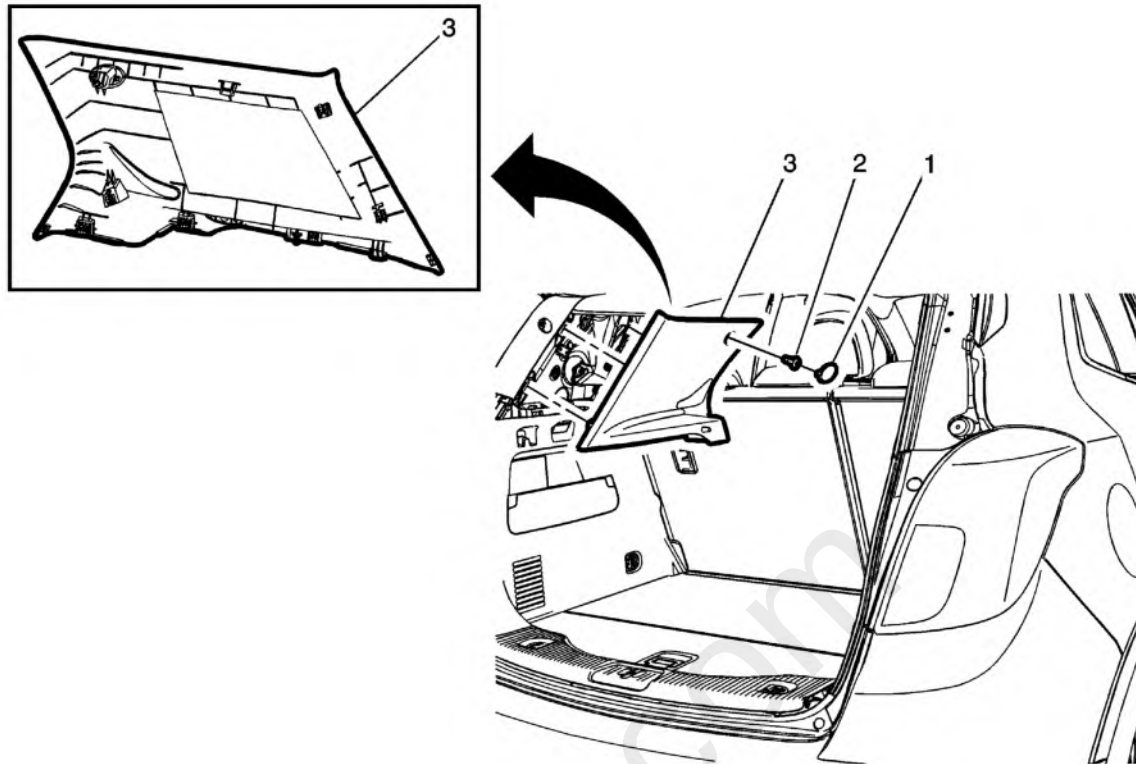
**Fig. 94: Body Lock Pillar Upper Trim Panel**  
Courtesy of GENERAL MOTORS COMPANY

5. Install the body lock pillar upper trim panel (3). Refer to [Body Lock Pillar Upper Trim Panel Replacement](#).

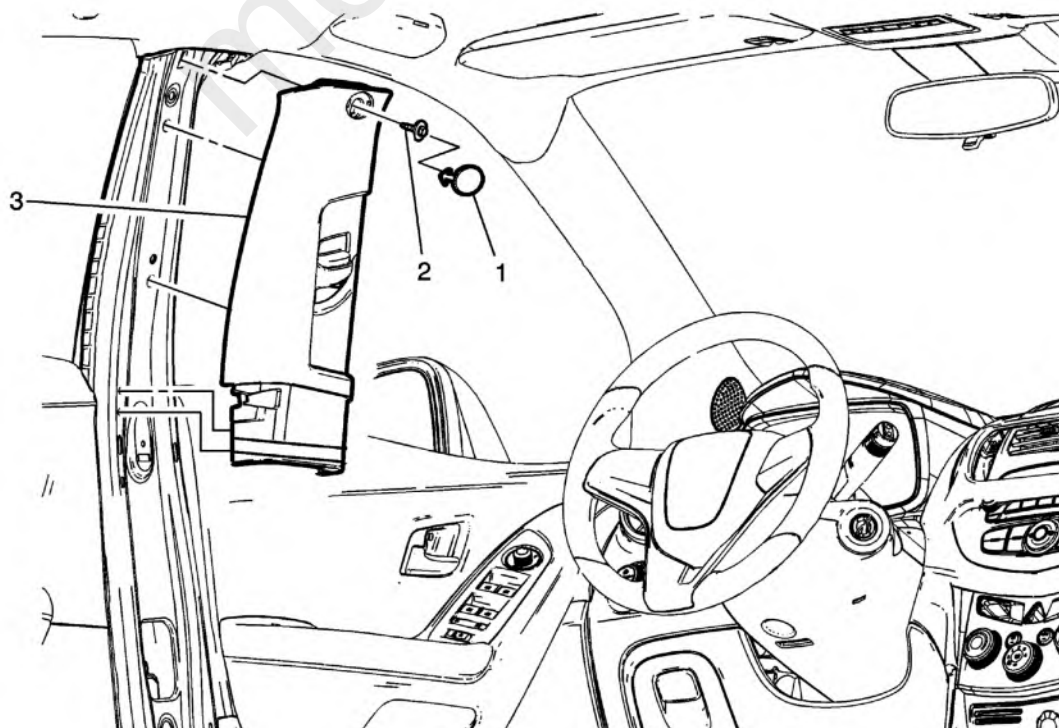
**Fig. 95: Center Pillar Upper Trim Panel Assembly**  
Courtesy of GENERAL MOTORS COMPANY

6. Install the center pillar upper trim panel assembly (3). Refer to [Center Pillar Upper Trim Panel Replacement \(Chevrolet\)](#) .

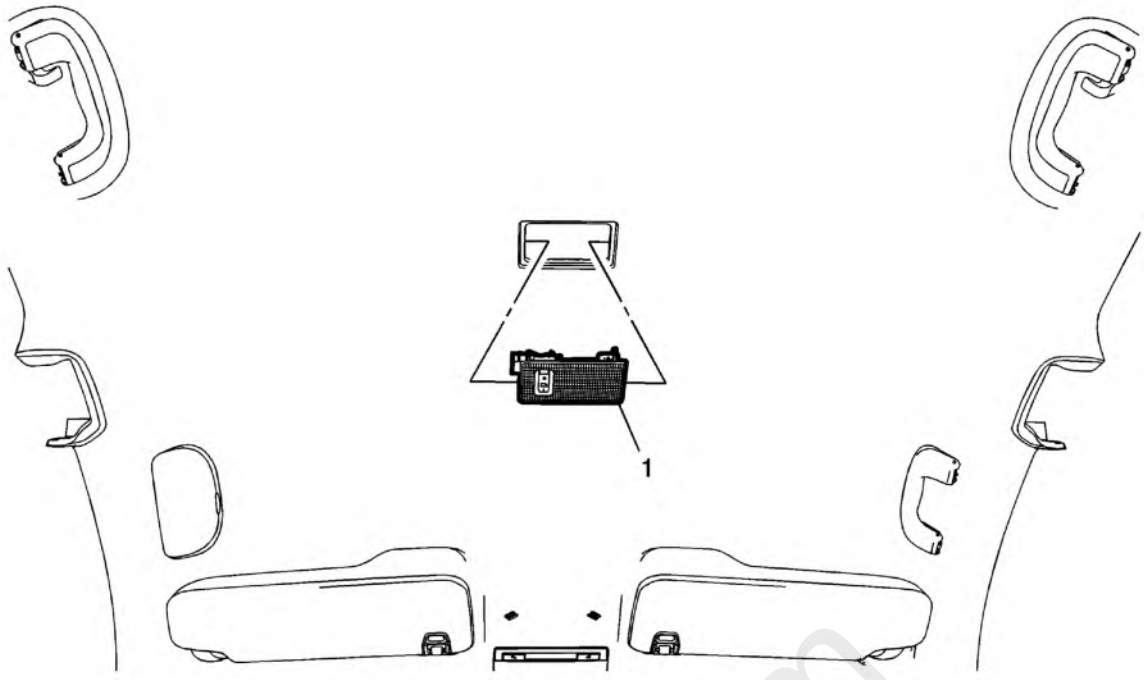
**Fig. 96: Rear Seat Position Center Courtesy Lamp**  
Courtesy of GENERAL MOTORS COMPANY

7. Install the rear seat position center courtesy lamp (1). Refer to [Rear Seat Position Center Courtesy Lamp Replacement](#) .

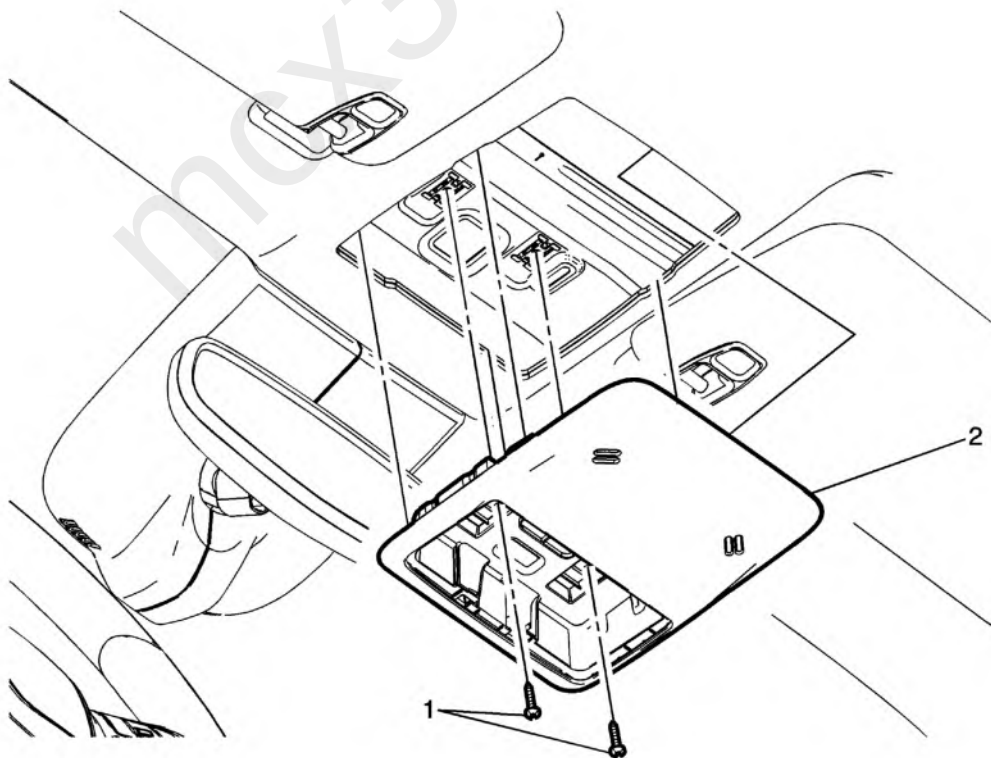
**Fig. 97: Roof Console Assembly**  
Courtesy of GENERAL MOTORS COMPANY

8. Install the roof console assembly (2). Refer to [Roof Console Replacement](#) .

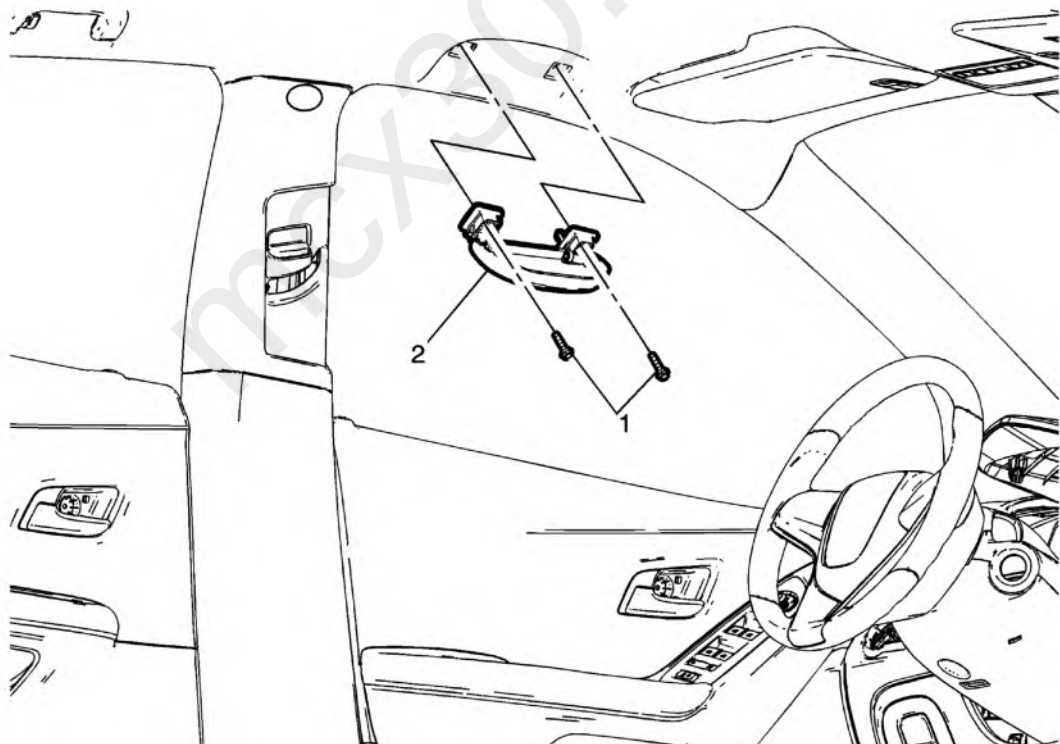
**Fig. 99: Roof Rail Front Stowage Compartment**  
 Courtesy of GENERAL MOTORS COMPANY

10. Install the roof rail front stowage compartment (2). Refer to [Roof Rail Front Stowage Compartment Replacement \(Chevrolet\)](#) .

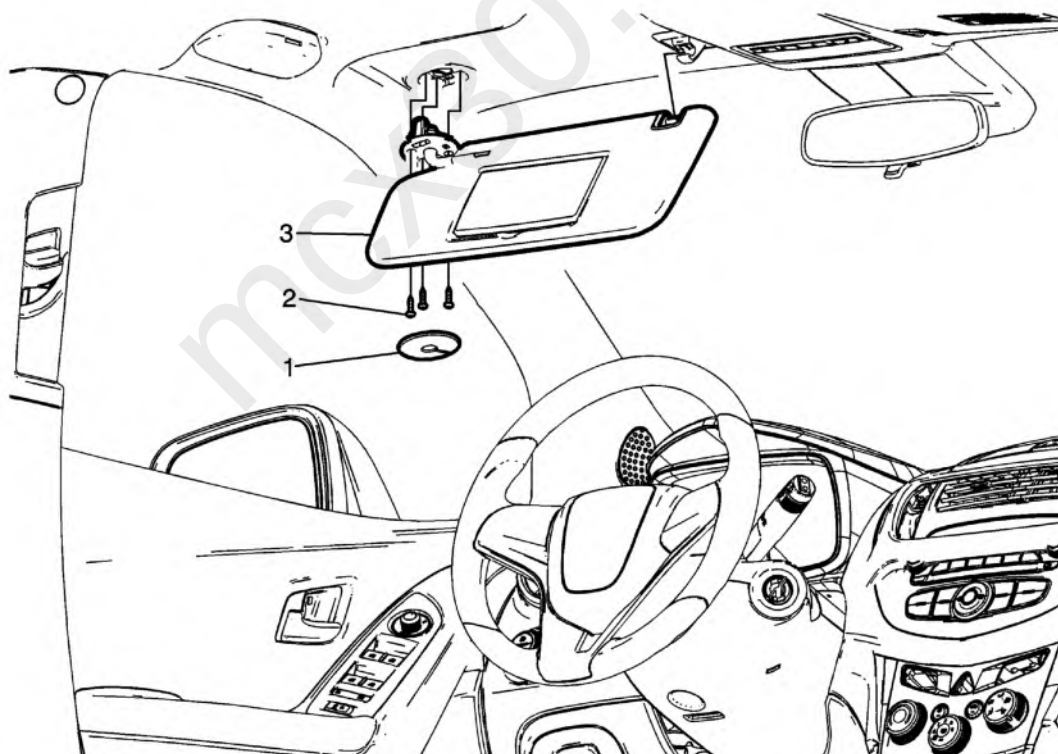
**Fig. 103: Sunshade Assembly.**  
Courtesy of GENERAL MOTORS COMPANY

14. Install the sunshade assembly (3). Refer to [Sunshade Replacement \(Chevrolet\)](#).

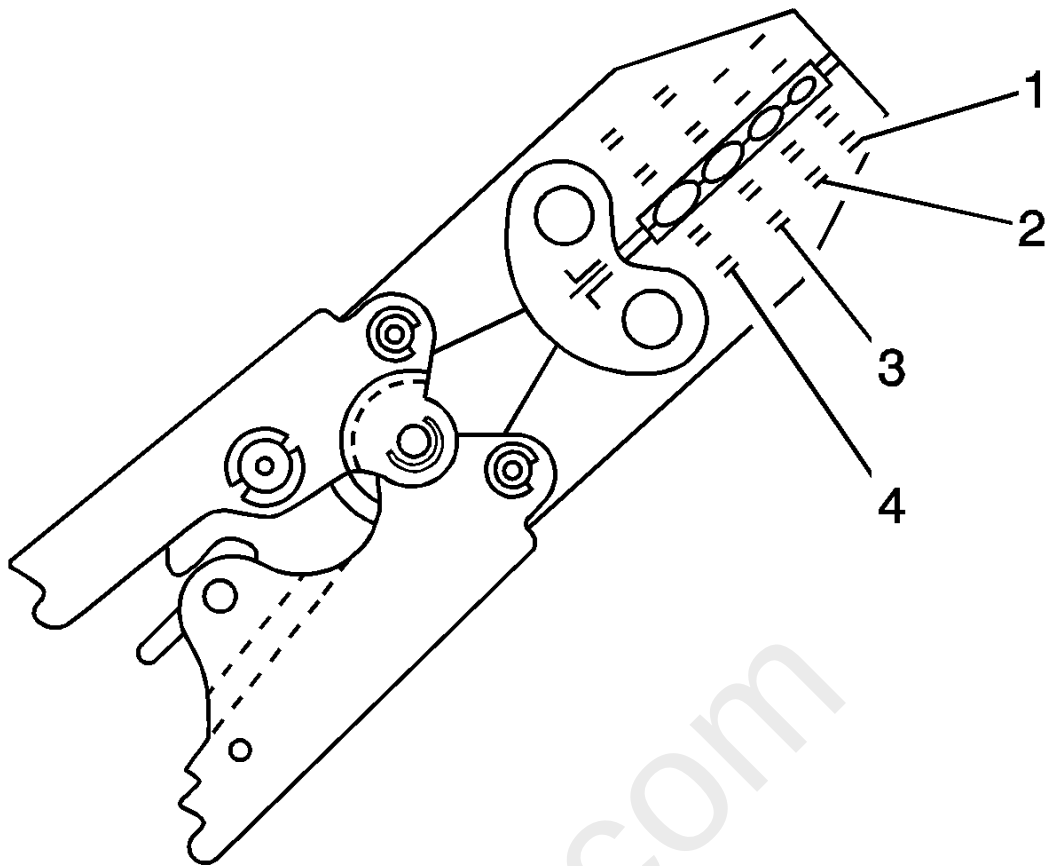
**Fig. 105: Splice Sleeve Crimping Tool With 4 Crimp Nests**

5. Select the proper DuraSeal splice sleeve according to the wire size. Refer to the above table at the beginning of the repair procedure for the color coding of the DuraSeal splice sleeves and the crimp tool nests.

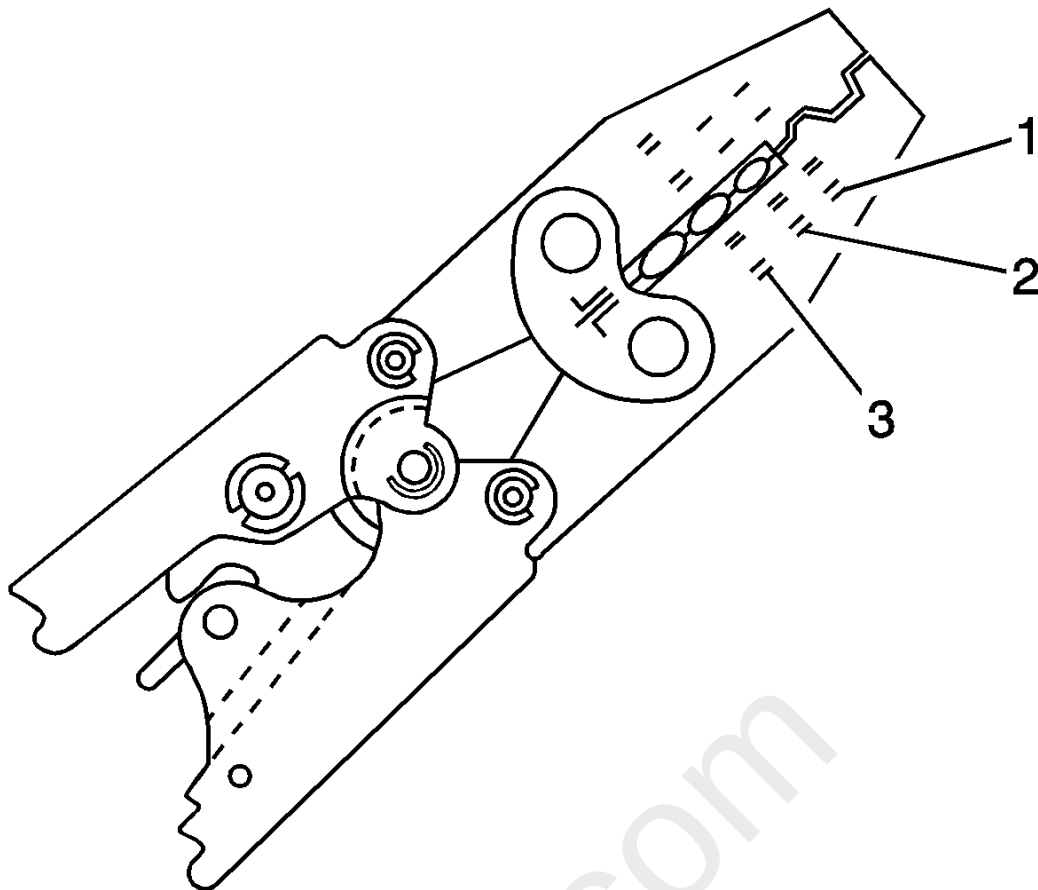
**Fig. 106: Splice Sleeve Crimping Tool With 3 Crimp Nests**  
**Courtesy of GENERAL MOTORS COMPANY**

7. The **J-38125-8** splice sleeve crimping tool has three crimp nests. The largest crimp nest (3) is used for crimping 10 and 12 gauge wires. The second largest crimp nest (2) is used for crimping 14 and 16 gauge wires. The smallest crimp nest (1) is used for crimping 18 to 20 gauge wires. The crimp nests are referenced in the table (farther above) under the crimp tool nest color.

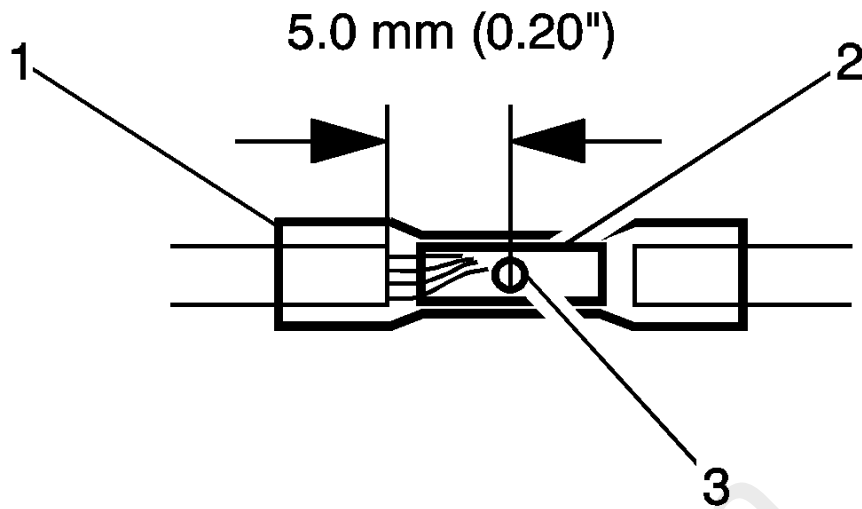
**Fig. 107: Identifying Duraseal Splice Sleeve**  
Courtesy of GENERAL MOTORS COMPANY

9. Place the DuraSeal splice sleeve in the nest. Ensure that the crimp falls midway between the end of the barrel and the stop. The sleeve has a stop (3) in the middle of the barrel (2) in order to prevent the wire (1) from going further. Close the hand crimper handles slightly in order to firmly hold the DuraSeal splice sleeve in the proper nest.

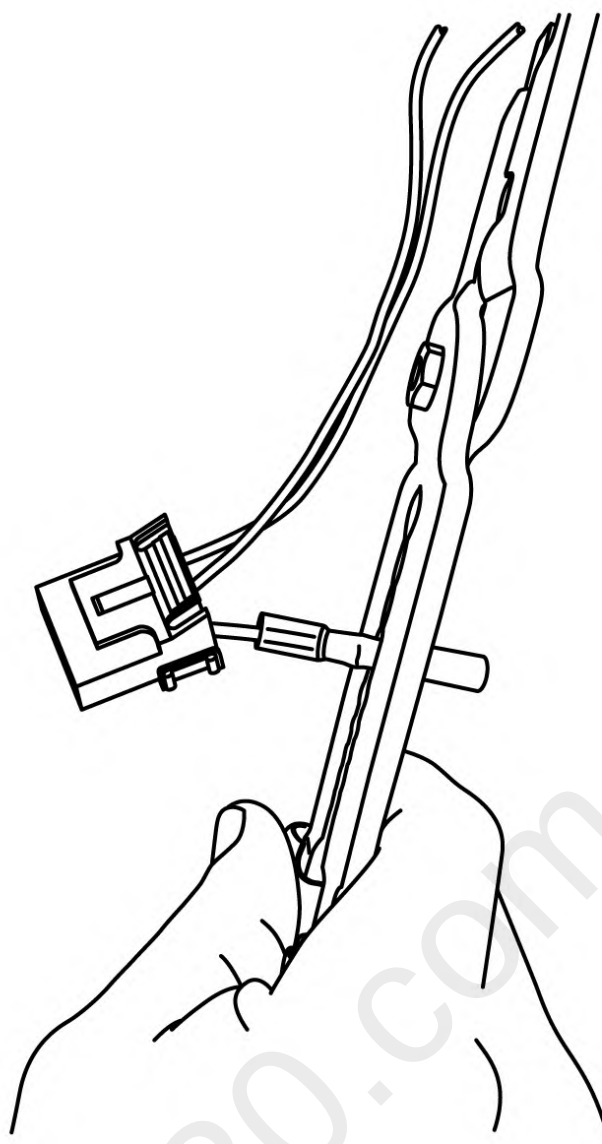
**Fig. 110: Tightly Close Handles Of Crimp Tool**  
**Courtesy of GENERAL MOTORS COMPANY**

2. Tightly close the handles of the crimp tool until the crimper handles open when released.

The crimper handles will not open until you apply the proper amount of pressure to the DuraSeal splice sleeve. Holding the DuraSEAL with one hand gently tug on the wire to ensure it is crimped in the DuraSeal.

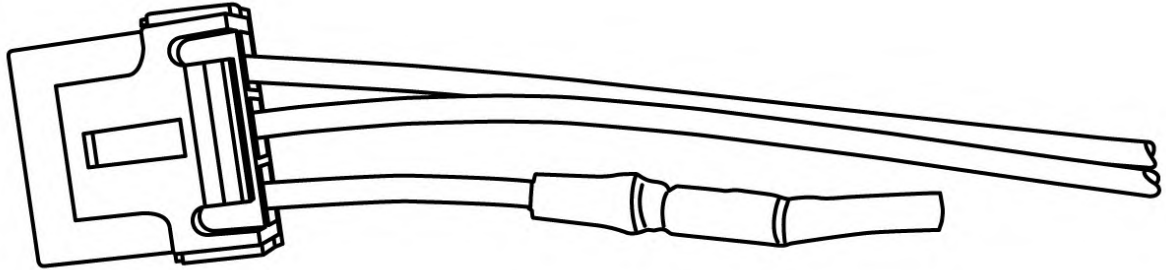
**Fig. 111: Heat To Crimped Area Of Barrel**

3. Using the heat torch, apply heat to the crimped area of the barrel.

4. Start in the middle and gradually move the heat barrel to the open ends of the tubing:
  - The tubing will shrink completely as the heat is moved along the insulation.
  - A small amount of sealant will come out of the end of the tubing when sufficient shrinkage is achieved.

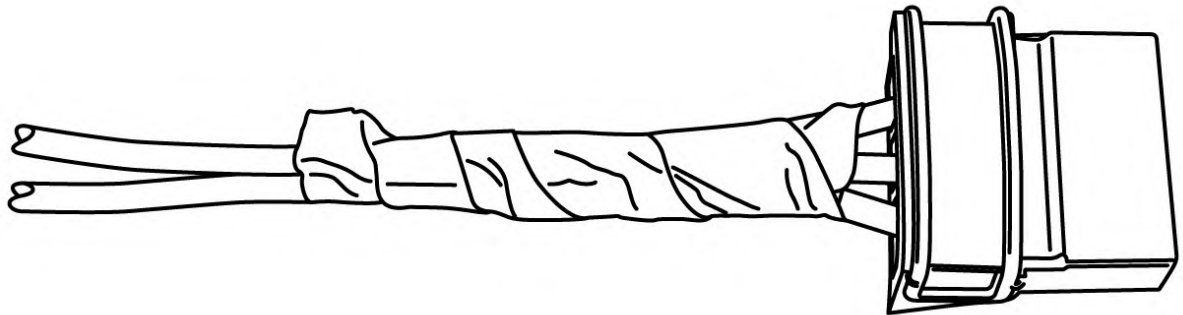
**Fig. 112: Taping Extra Terminated Leads Back Into Harness**  
Courtesy of GENERAL MOTORS COMPANY

5. Tape the extra terminated lead(s) back into the harness.
