## Timing Chain Tensioner

### Removal

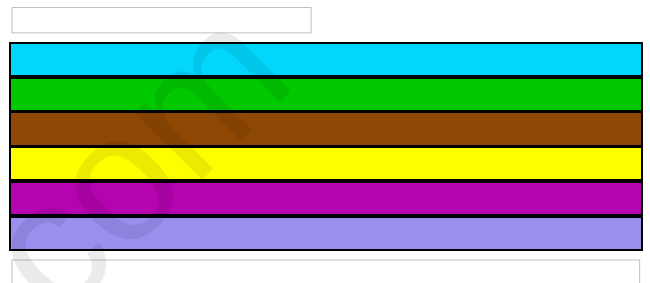
2. Reset the timing chain tensioner.
  1. Position the timing chain tensioner in a soft-jawed vise.
  2. Spread the ends of the ratchet wire clip apart.
  3. Using the soft-jawed vise, compress the plunger to the reset position.
  4. Install a locking pin in the 2 holes of the timing chain tensioner body to hold the plunger in place.

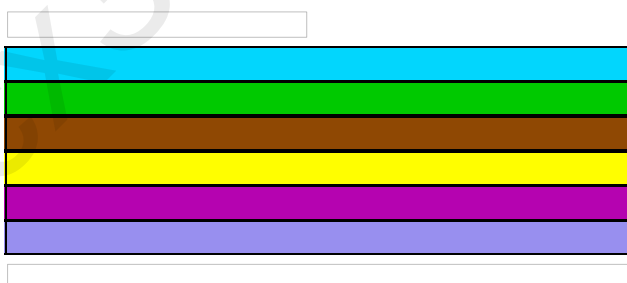
If the exhaust VCT unit was removed, using an open-ended wrench, tighten the new exhaust VCT unit bolt.

Stage 1: 26 lb.ft (35 Nm)

Stage 2: 135°

5. **NOTICE:** Use an open-ended wrench on the flats of the camshaft to prevent the camshaft from turning.

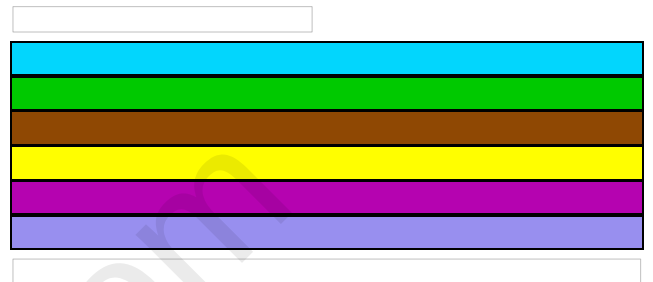
1. Reset the timing chain tensioner.
  1. Position the timing chain tensioner in a soft-jawed vise.
  2. Spread the ends of the ratchet wire clip apart.
  3. Using the soft-jawed vise, compress the plunger to the reset position.
  4. Install a locking pin in the 2 holes of the timing chain tensioner body to hold the plunger in place.

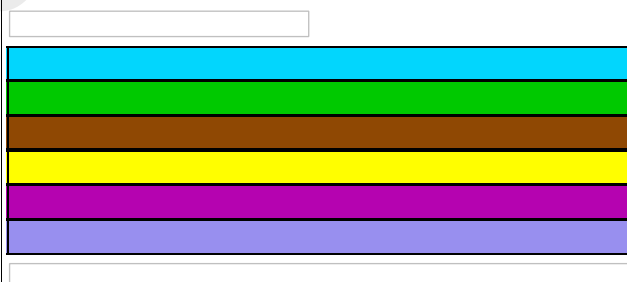
1. Install the timing chain tensioner and the bolts.  
Torque: 97 lb.in (11 Nm)
2. Remove the locking pin.

2. **NOTE:** Do not remove the locking pin until the tensioner bolts are tightened.
