#### H4 CHECK FOR CORRECT HUD (HEAD UP DISPLAY) OPERATION

#### REMOVAL AND INSTALLATION > HEAD UP DISPLAY (HUD) MODULE > REMOVAL

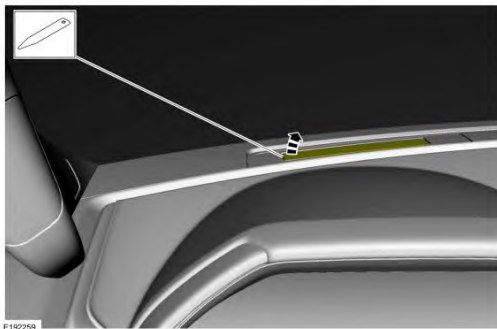
1.

Using a non-marring tool, release the heads up display tab and position the heads up display aside.
