# Driver Side Footwell Air Discharge Temperature Sensor

# Driver Side Register Air Discharge Temperature Sensor

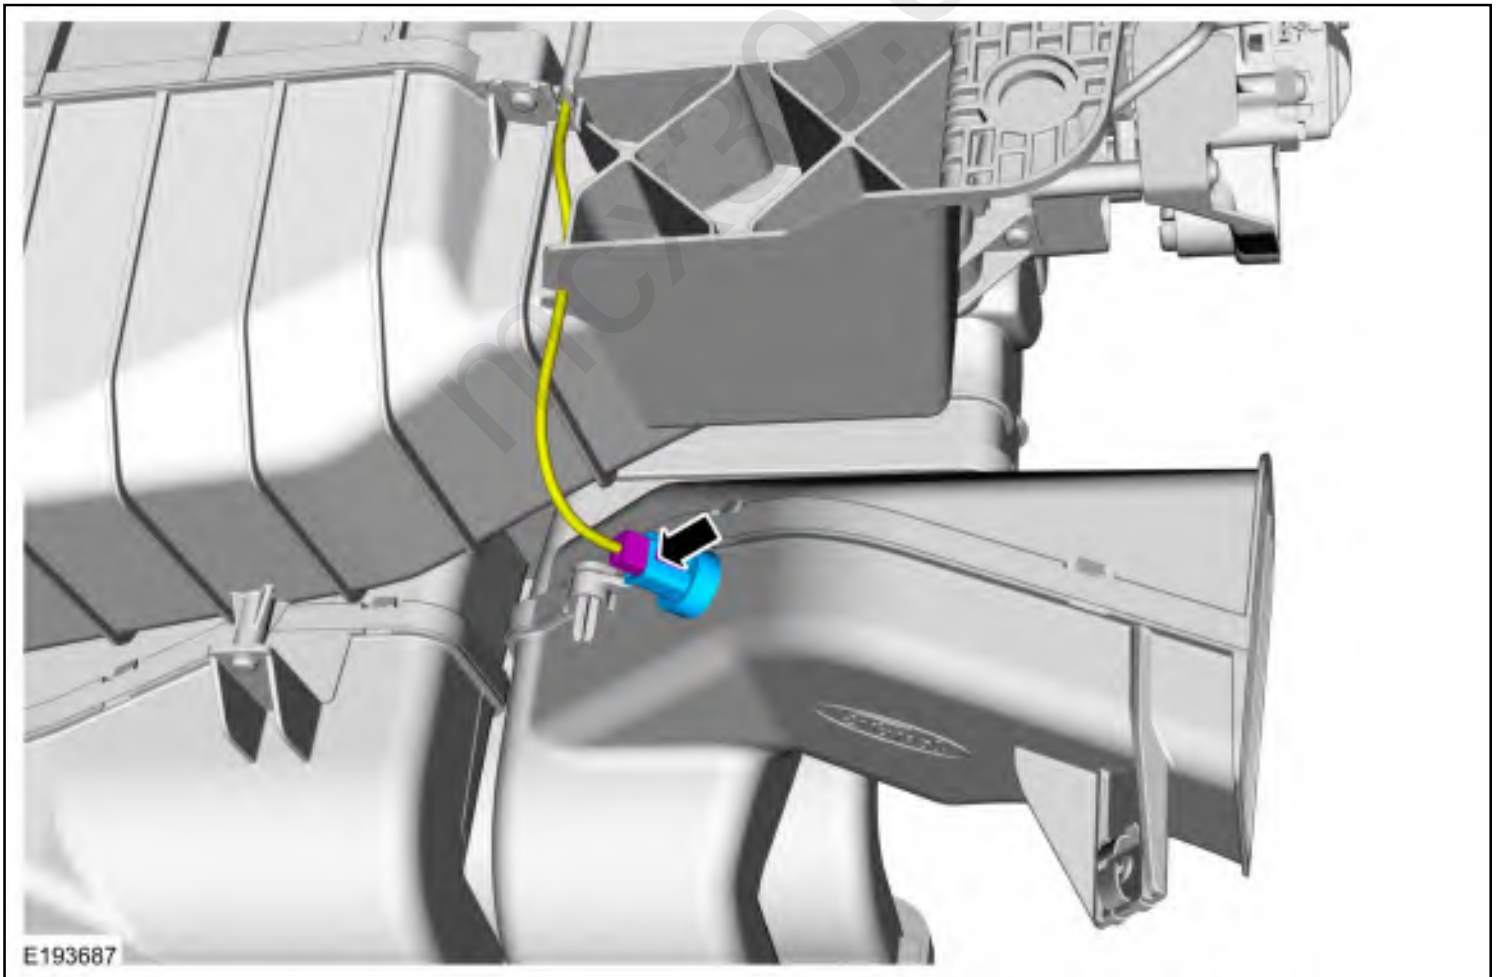
1. Remove the climate control housing.  
Refer to: Climate Control Housing (412-00) .
2. Disconnect the electrical connector and remove the driver side footwell air discharge temperature sensor.

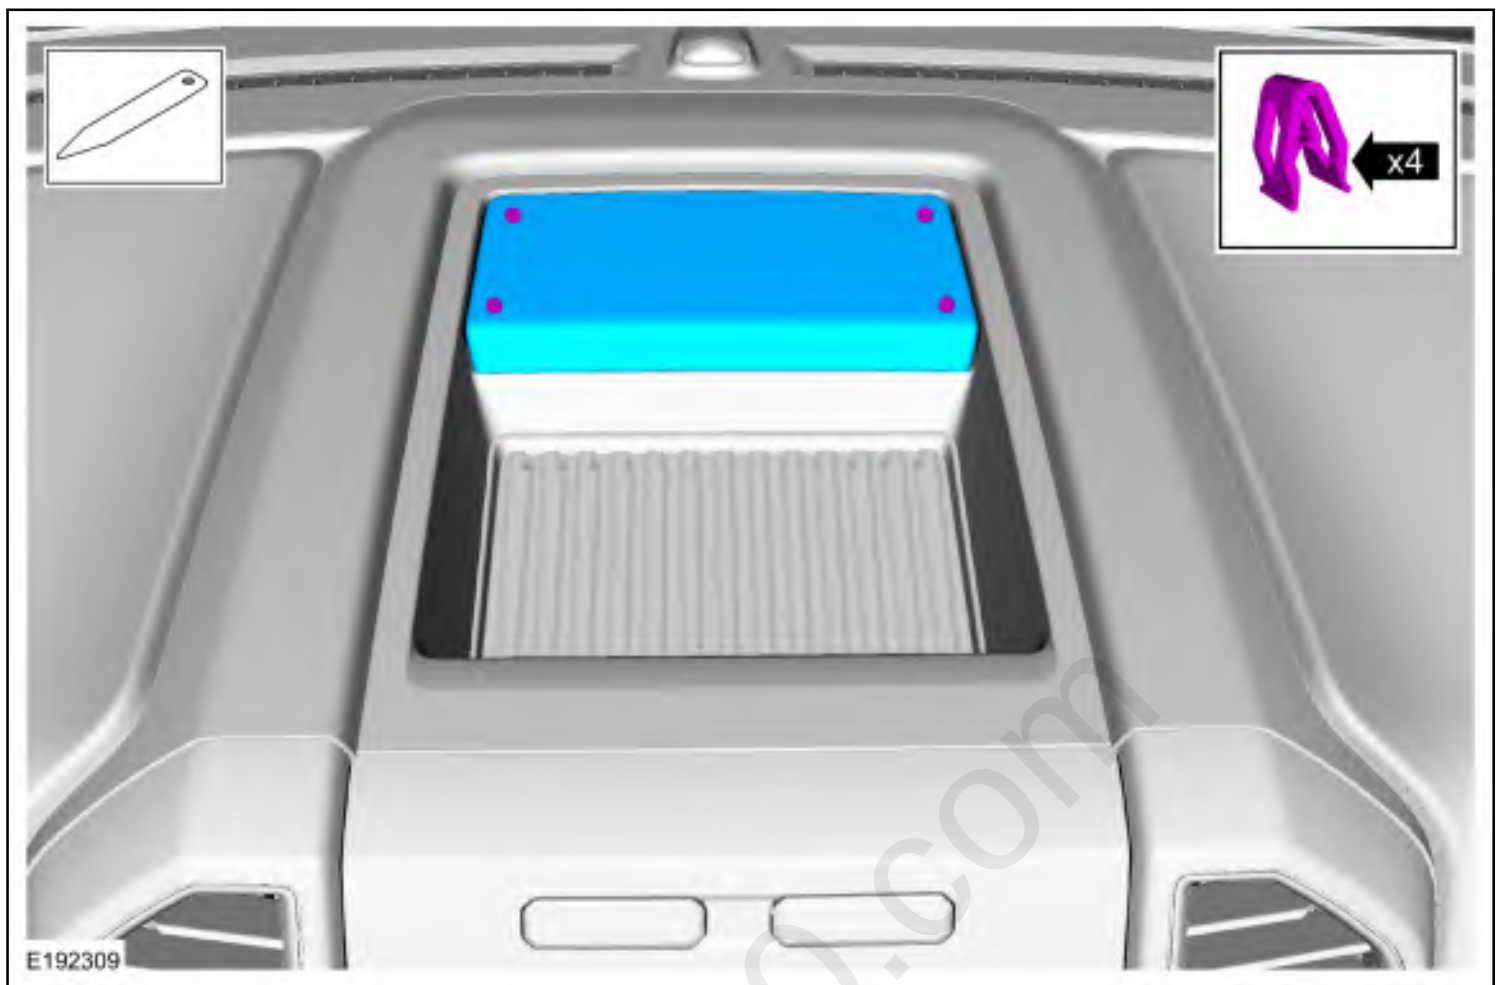
1. If equipped, release the clips and remove the instrument panel speaker grille.  
Use the General Equipment: Interior Trim Remover

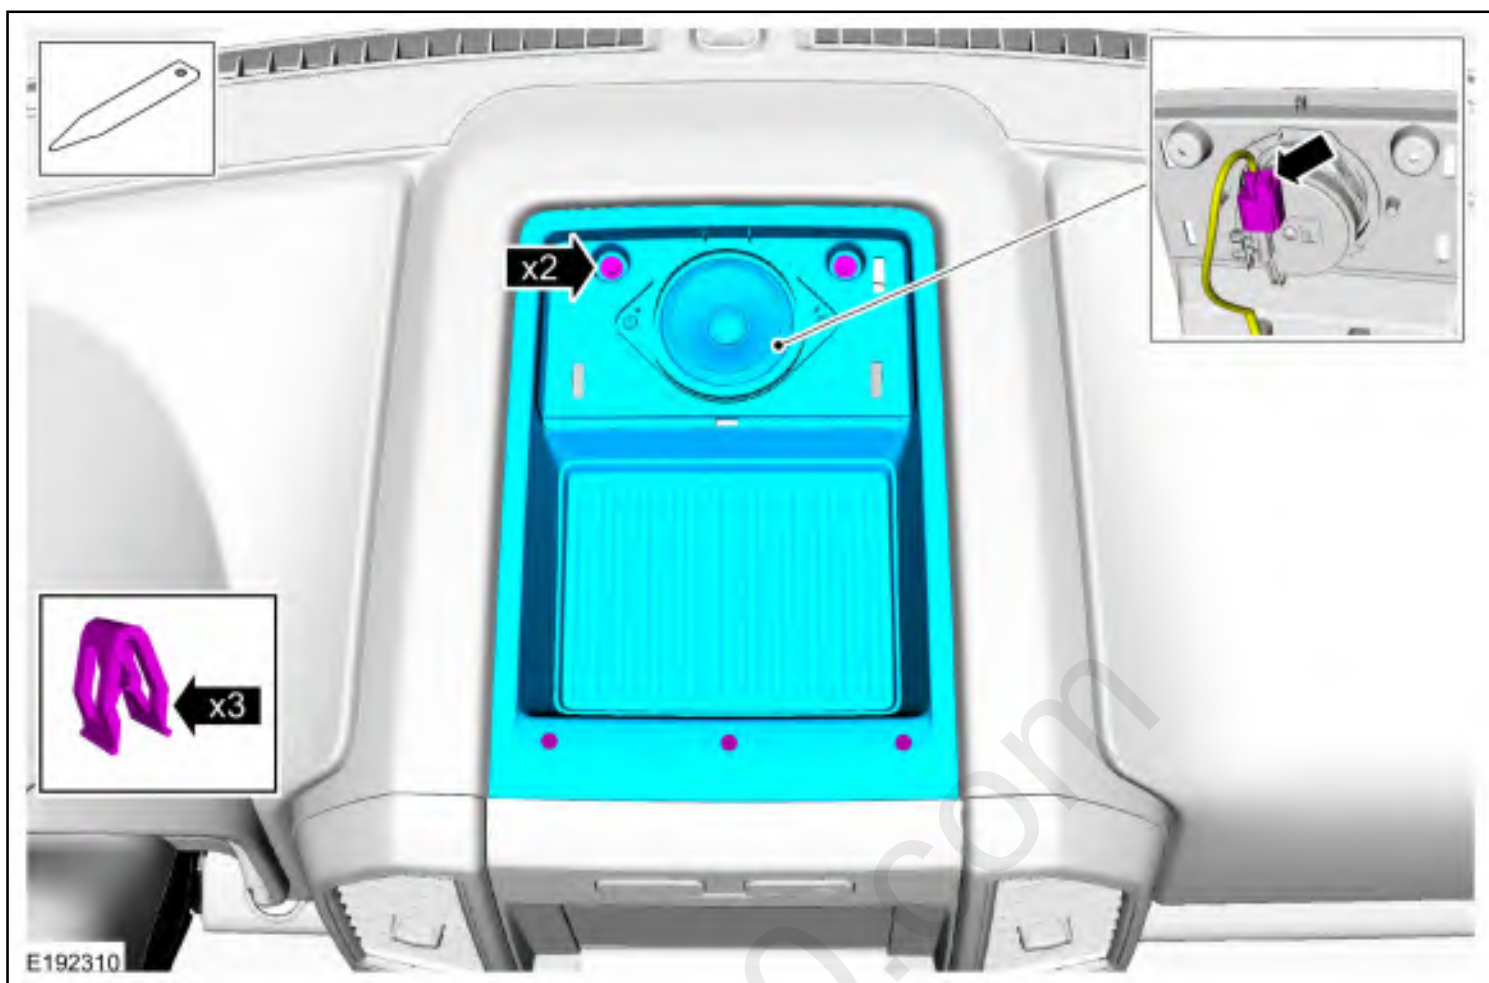
2. **NOTE:** Vehicle with speaker shown, without speaker similar.

Remove the bolts, release the clips and remove the instrument panel center upper trim panel.  
Disconnect the electrical connector.

Torque: 18 lb.in (2 Nm)

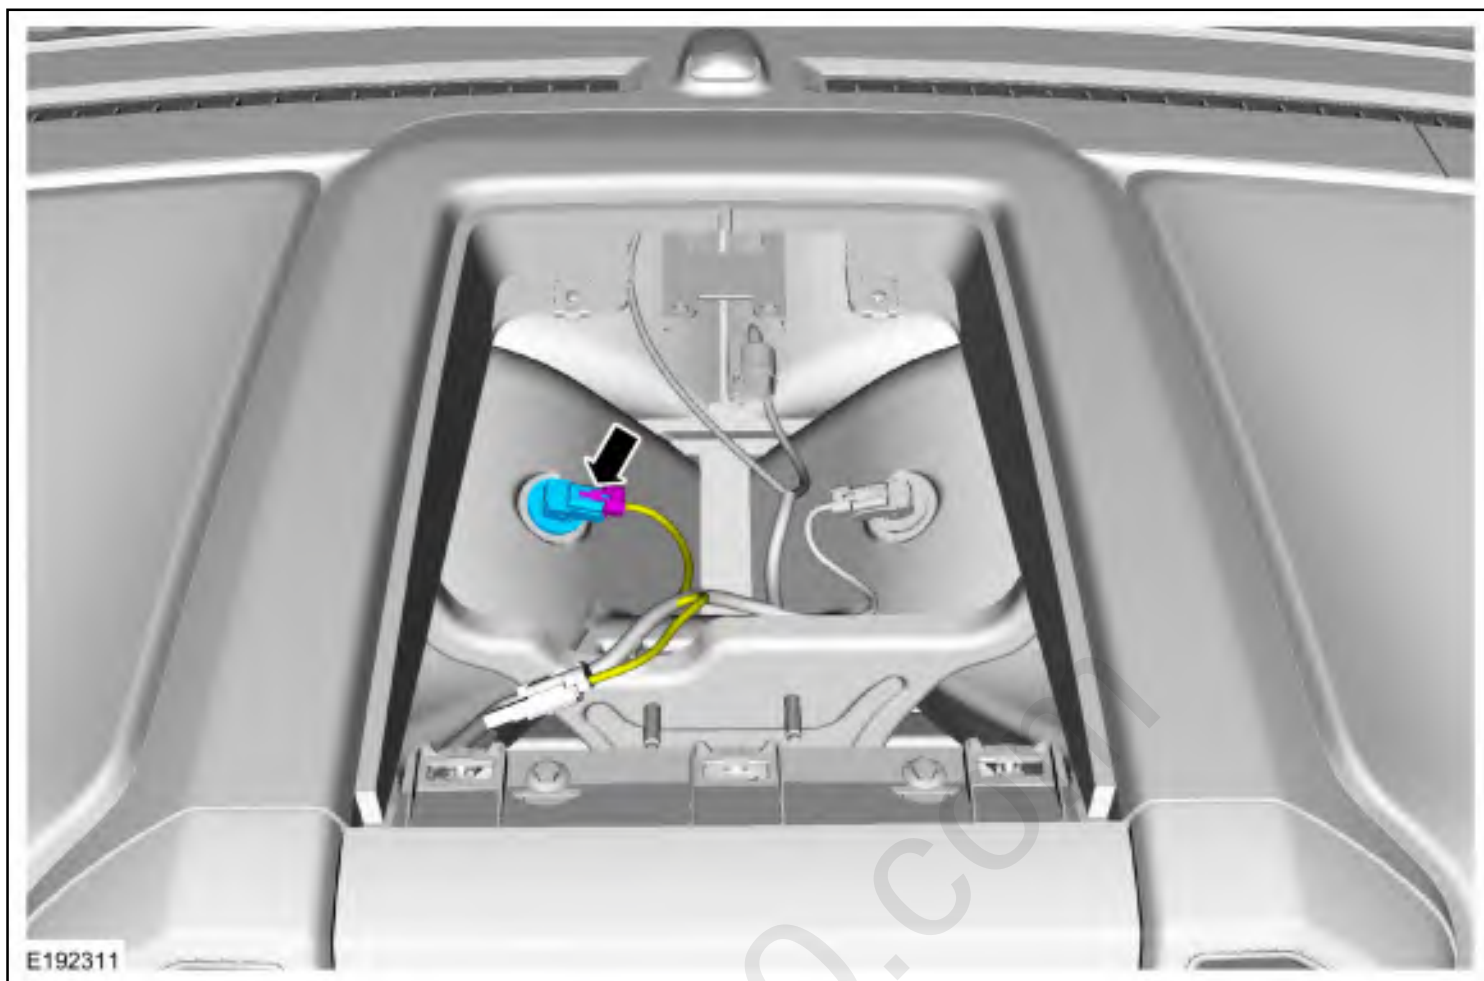
3. Disconnect the electrical connector and remove the driver side register air discharge temperature sensor.
