## Steering Column Control Module (SCCM)

### Removal

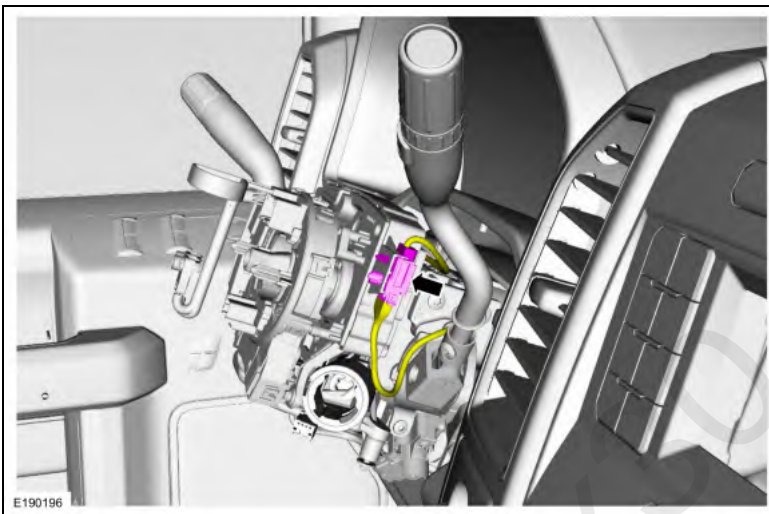
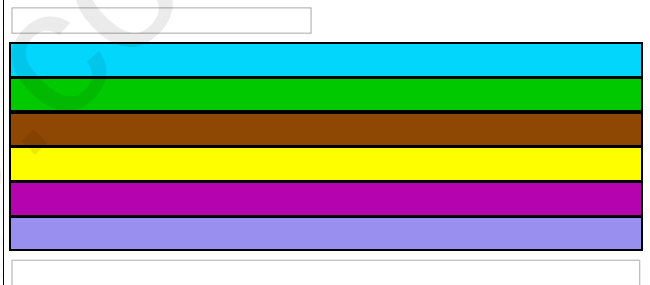
2. Remove the steering wheel.  
Refer to: Steering Wheel (211-04 Steering Column, Removal and Installation).
3. Remove the steering column shrouds.  
Refer to: Steering Column Shrouds (501-05 Interior Trim and Ornamentation, Removal and Installation).
4. Release the selector lever electrical connector retainer from the SCCM.

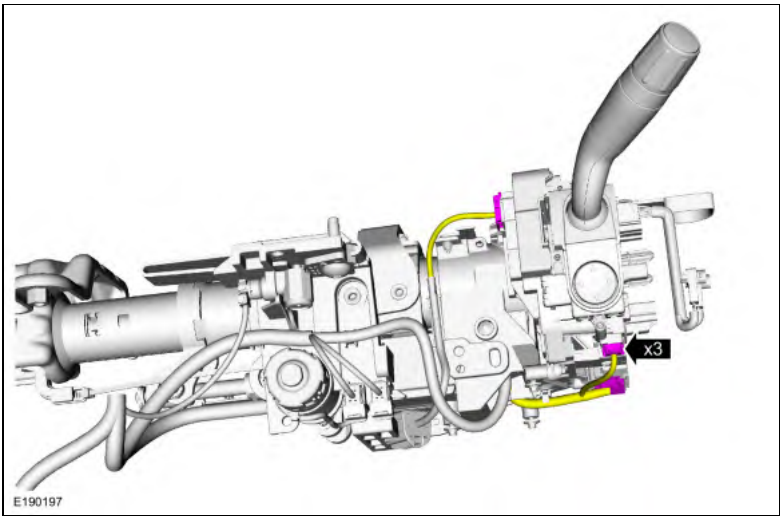
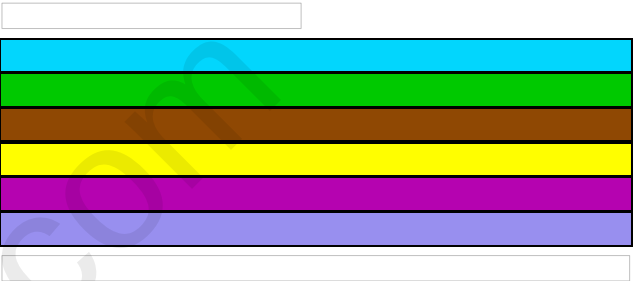
5. Disconnect the SCCM electrical connectors.

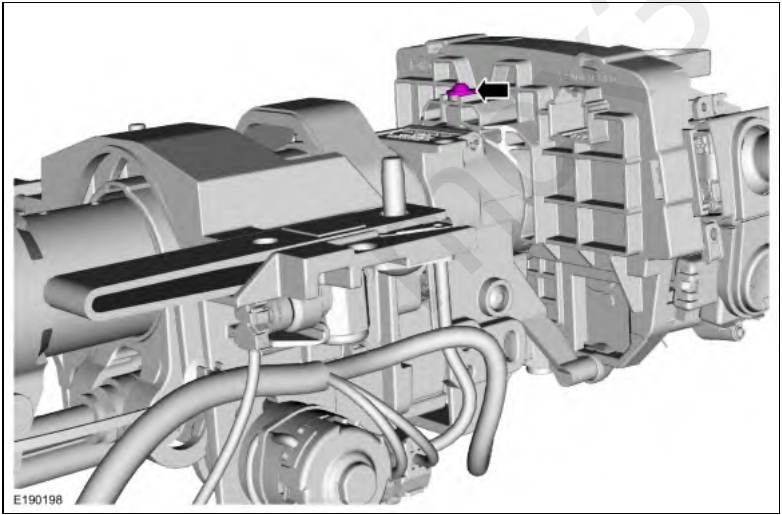
6. Remove the SCCM screw.

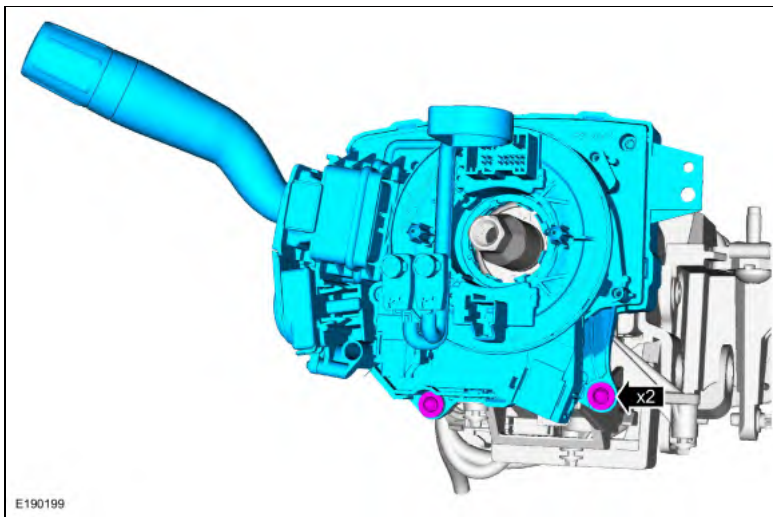
7. Remove the screws and the SCCM.
