## REMOVAL AND INSTALLATION > ACCESSORY DRIVE BELT > REMOVAL

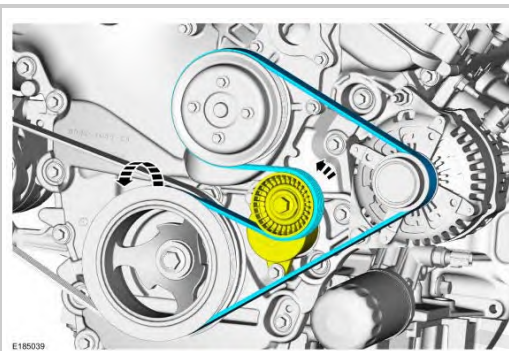
Rotate the accessory drive belt tensioner counter clockwise and remove the accessory drive belt.
