# DASHBOARD ASSEMBLY: EXPLODED VIEW

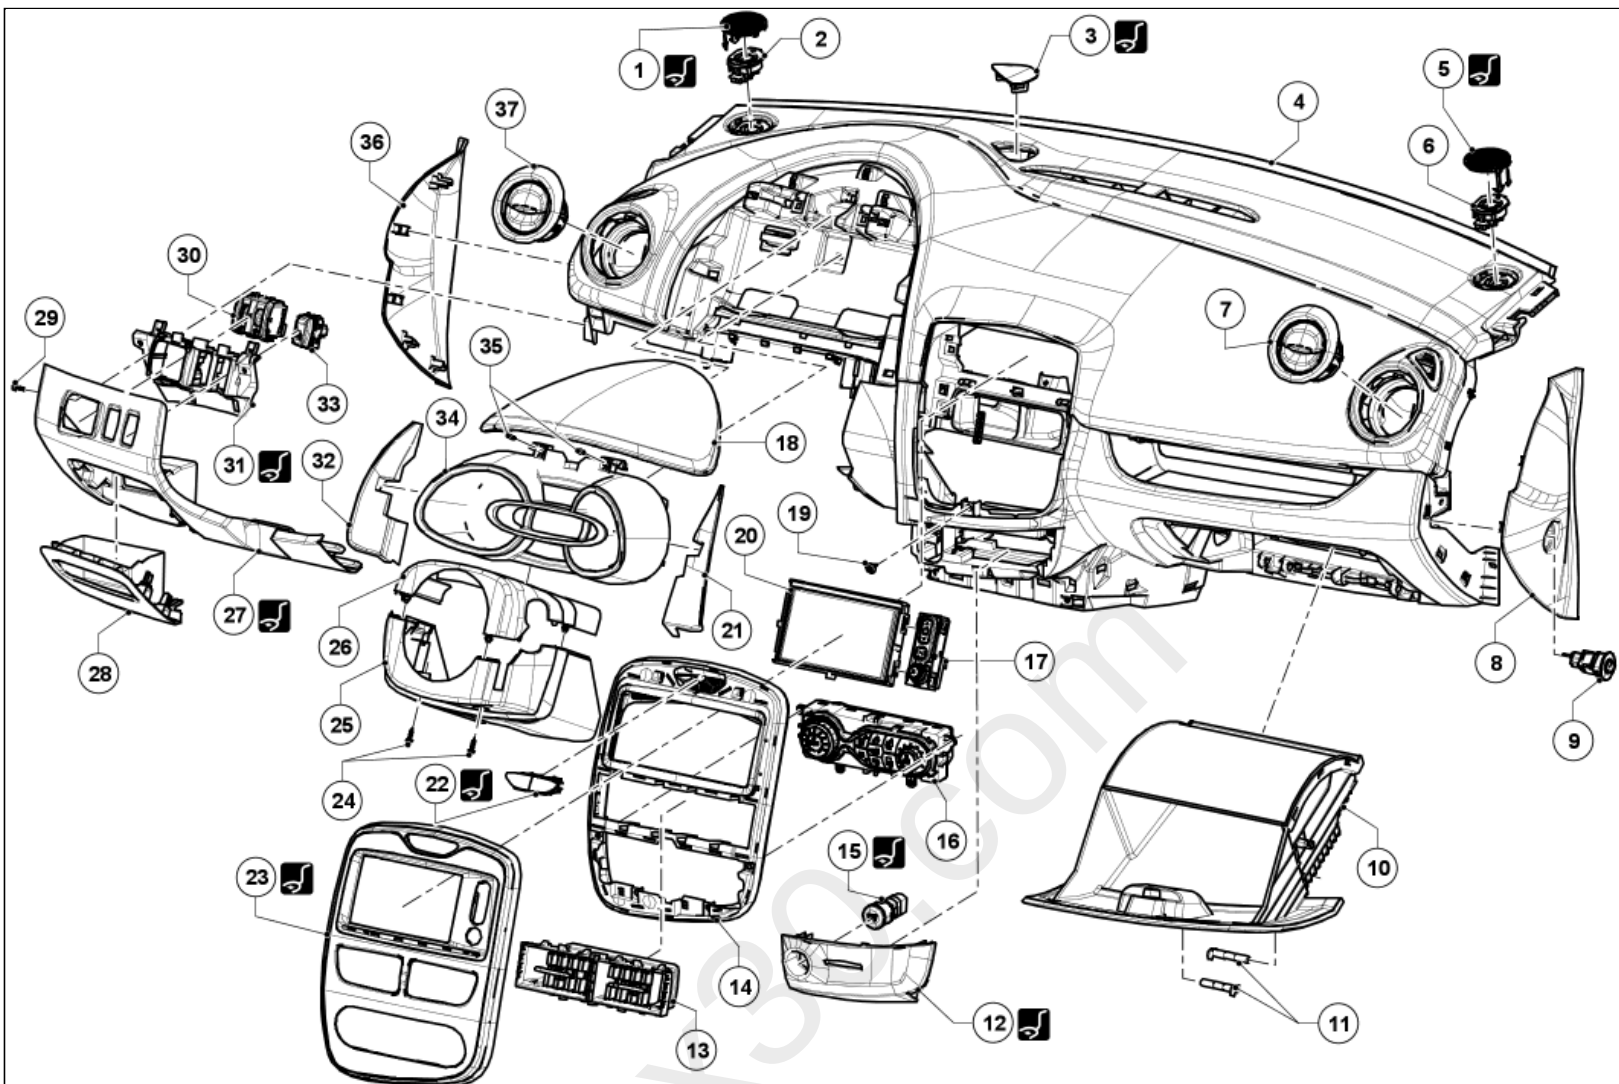
| Marks | Designations | Informations |
| 1 | Tweeter grille | ( Car. 1363 ) |
| 2 | Tweeter | <a href="#">Radio: List and location of components</a> |
| 3 | Dashboard cross member cover | ( Car. 1363 ) |
| 4 | Dashboard | |
| 5 | Tweeter grille | ( Car. 1363 ) |
| 6 | Tweeter | <a href="#">Radio: List and location of components</a> |
| 7 | Dashboard air vent | |
| 8 | Right-hand dashboard side panel | |
| 9 | Airbag inhibitor switch | <a href="#">Passenger compartment switches : List and location of components</a> |
| 10 | Glovebox | |
| 11 | Glovebox hinges | |
| 12 | Centre front panel lower trim | ( Car. 1363 ) |
| 13 | Dashboard centre air vent | |
| 14 | Centre front panel support | |
| 15 | Start button | <a href="#">Immobiliser system: List and location of components</a><br>( Car. 1363 ) |
| 16 | Air conditioning control panel | <a href="#">Passenger compartment heating and ventilation assembly: Exploded view</a> |
| 17 | Navigation keypad | <a href="#">Navigation: List and location of components</a> |
| 18 | Dashboard centre visor | |
| 19 | Dashboard screws | |
| 20 | Multifunction screen | <a href="#">Navigation: List and location of components</a> |
| 21 | Instrument panel right-hand trim | |
| 22 | Switch | ( Car. 1363 ) |
| 23 | Centre front panel trim | ( Car. 1363 ) |
| 24 | Screws | |
| 25 | Under steering wheel shell | |
| 26 | Under steering wheel shell | |
| 27 | Dashoard lower trim | ( Car. 1363 ) |
| 28 | Fuse flap | |
| 29 | Screws | |
