# DASHBOARD:REMOVAL-REFITTING

## REMOVAL

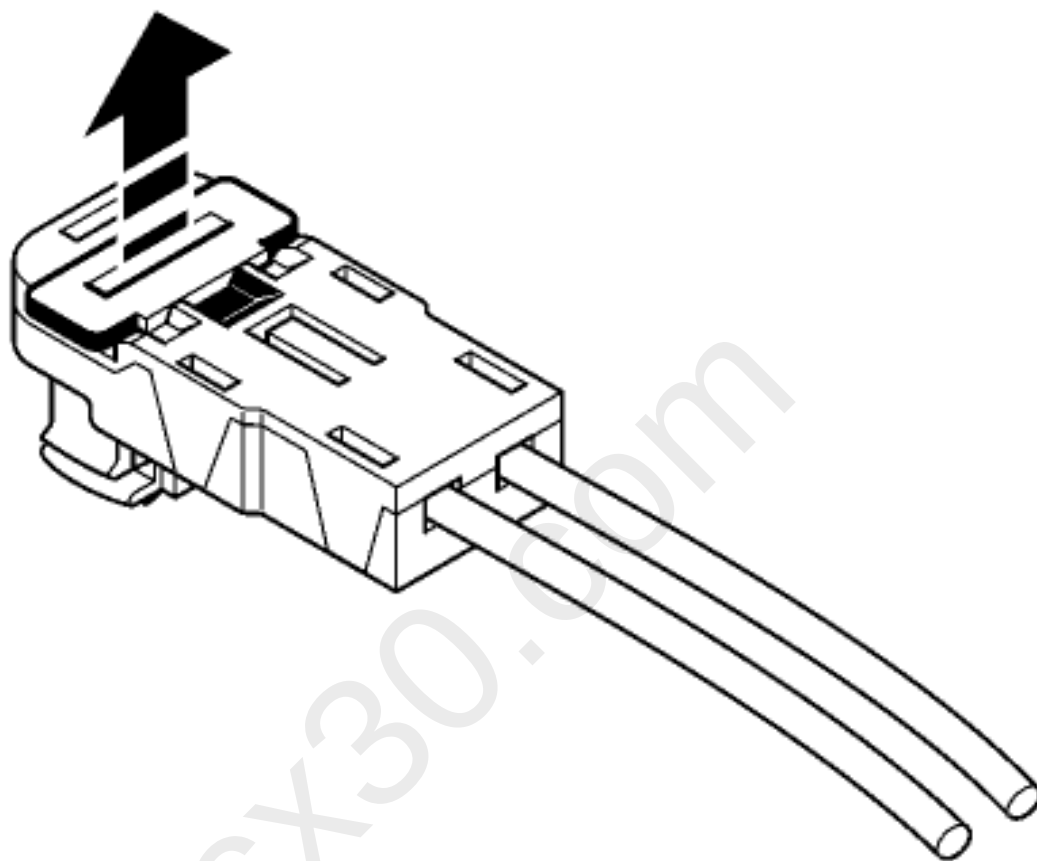
101920

Unlock the passenger front airbag connector.

Disconnect the passenger front airbag connector.

Remove the passenger front airbag bolts on the cross member.
