# FAN ASSEMBLY: REMOVAL - REFITTING

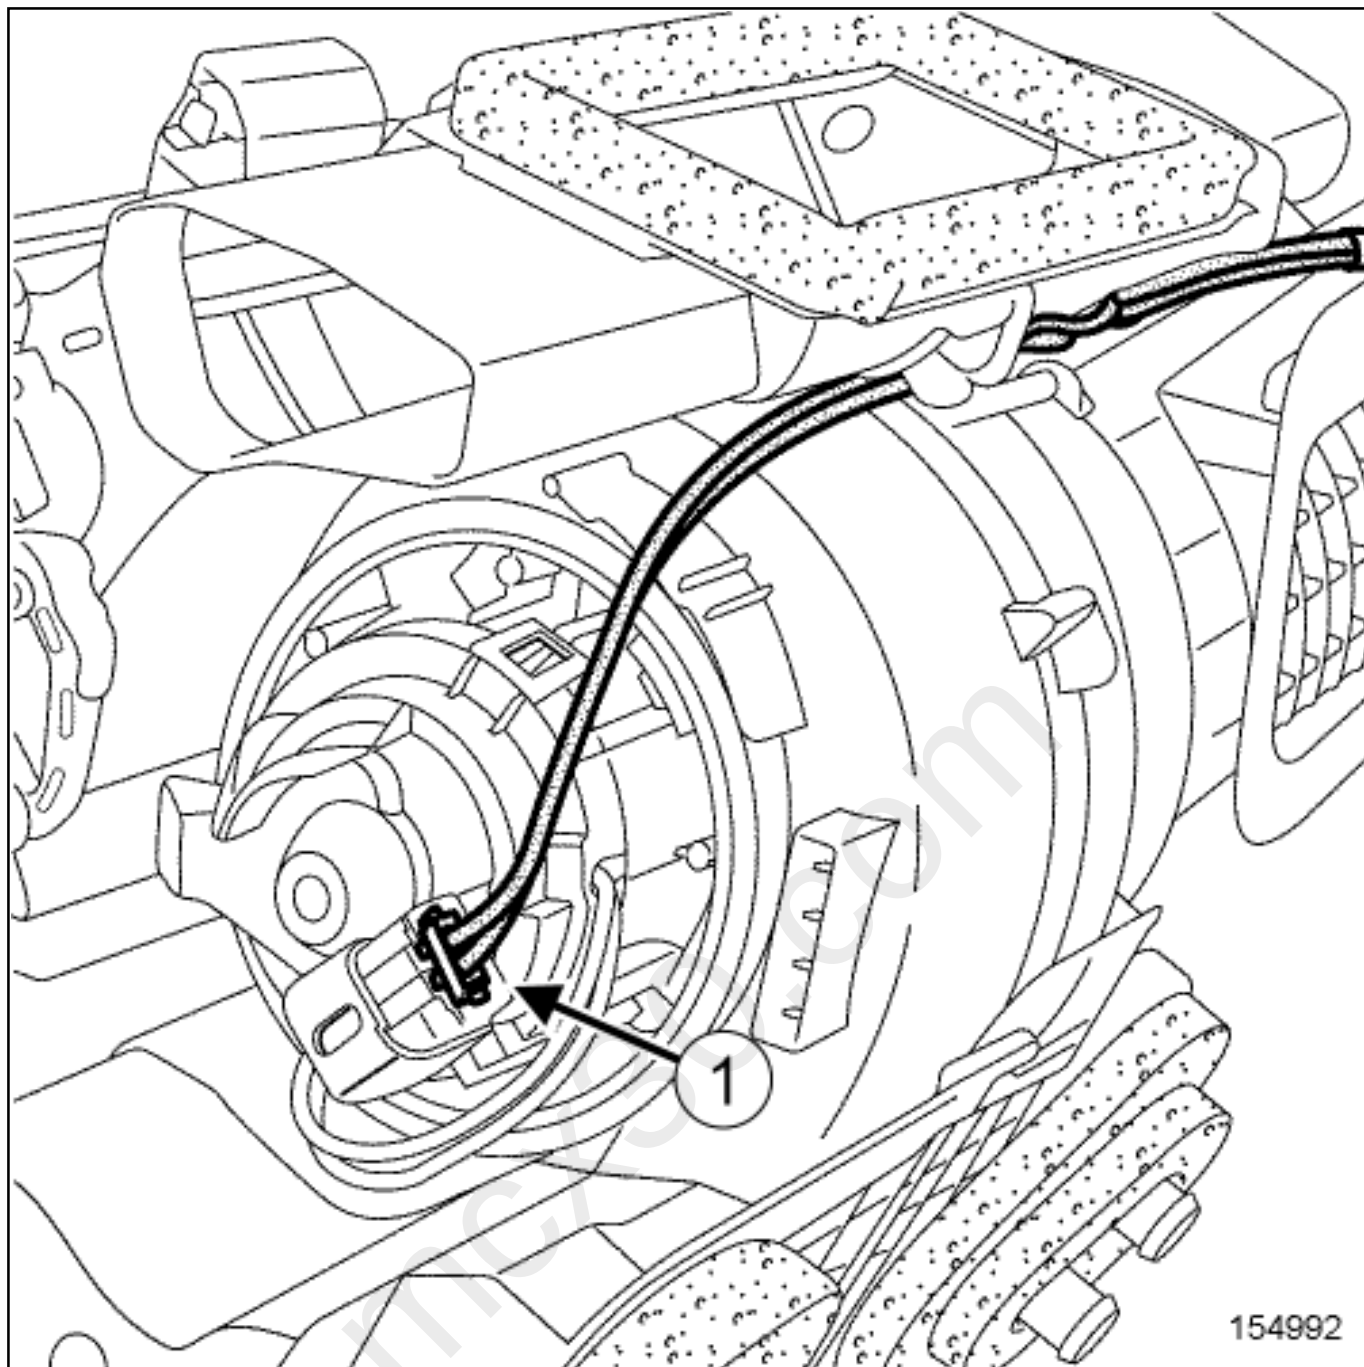
■ Disconnect the fan assembly connector(1) .

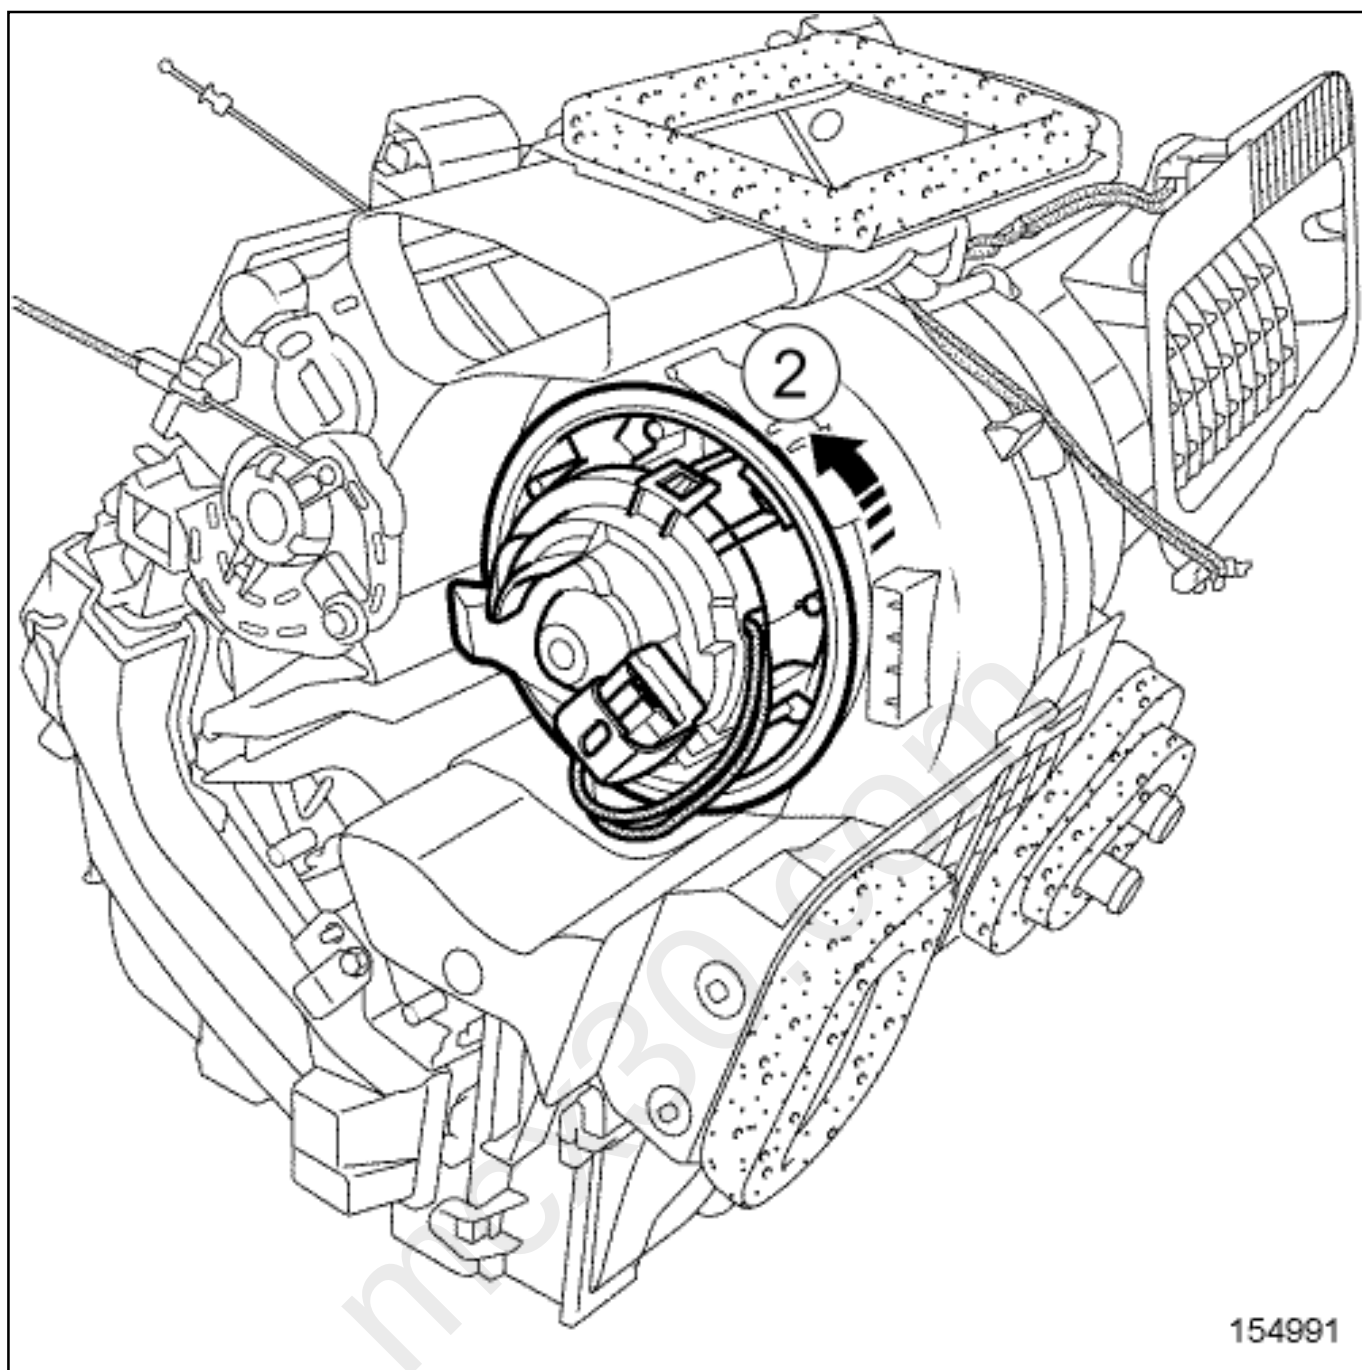
Turn the fan assembly anti-clockwise(2) .

Remove the fan assembly([see 61A, Heating, Passenger compartment heating and ventilation assembly: Exploded view](#)) .

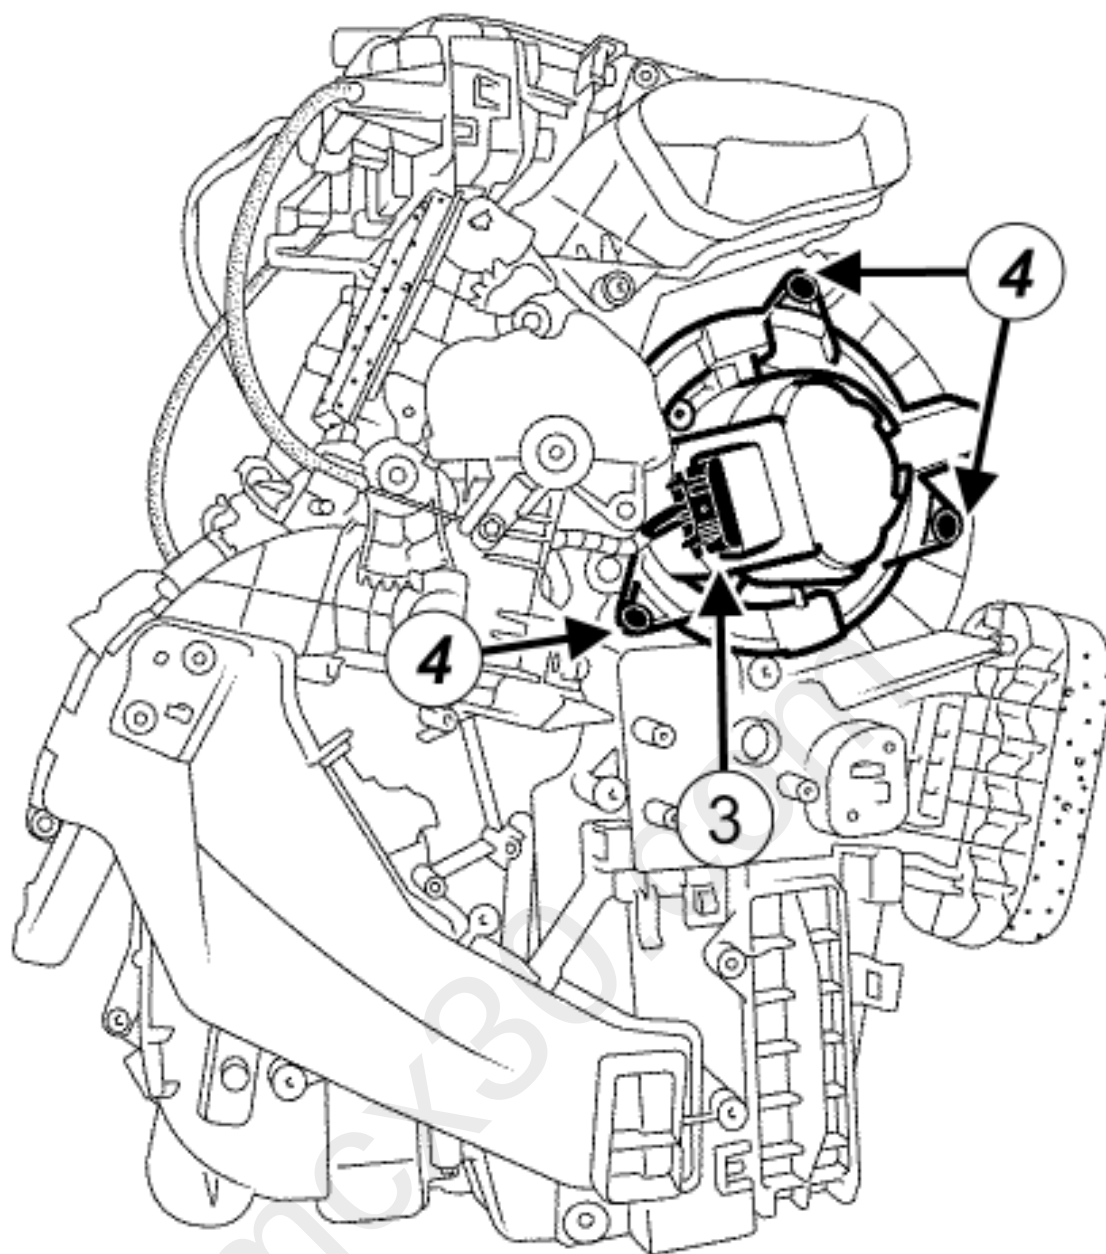
156321

Disconnect the fan assembly connector(3) .

Remove:

- the fan assembly bolts(4) ,

- the fan assembly.
