# HEADLINING:REMOVAL-REFITTING

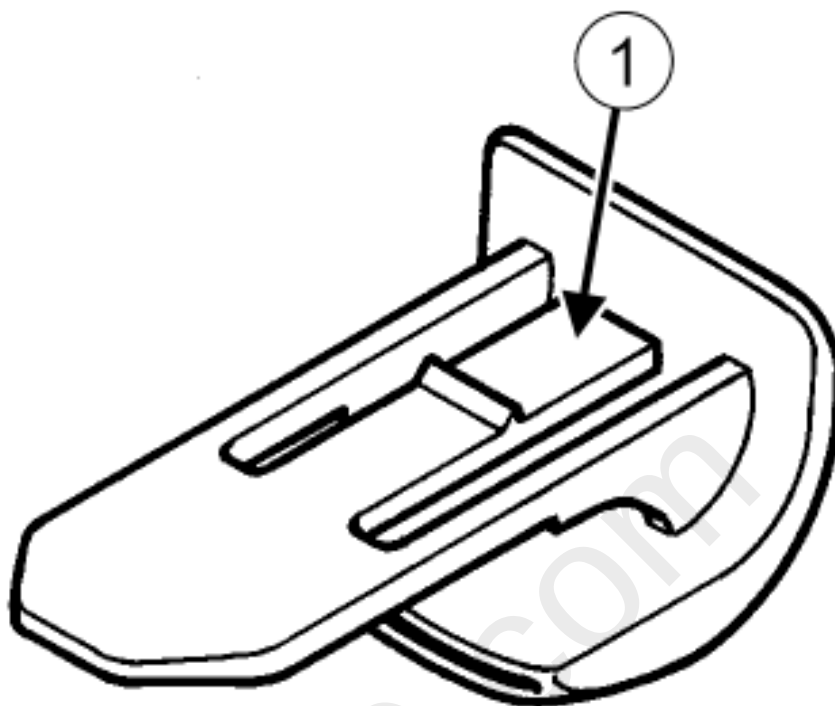
97193

Remove [\(see 71A, Body internal trim, Roof trim assembly: Exploded view\)](#) :

- 
- the rear clips by pressing on the clip(1) using a small flat-blade screwdriver,
- the headlining by removing from the front (this operation requires two people).
