# RADIO: LIST AND LOCATION OF COMPONENTS

## 1. LIST OF COMPONENTS

## 2. LOCATION OF COMPONENTS

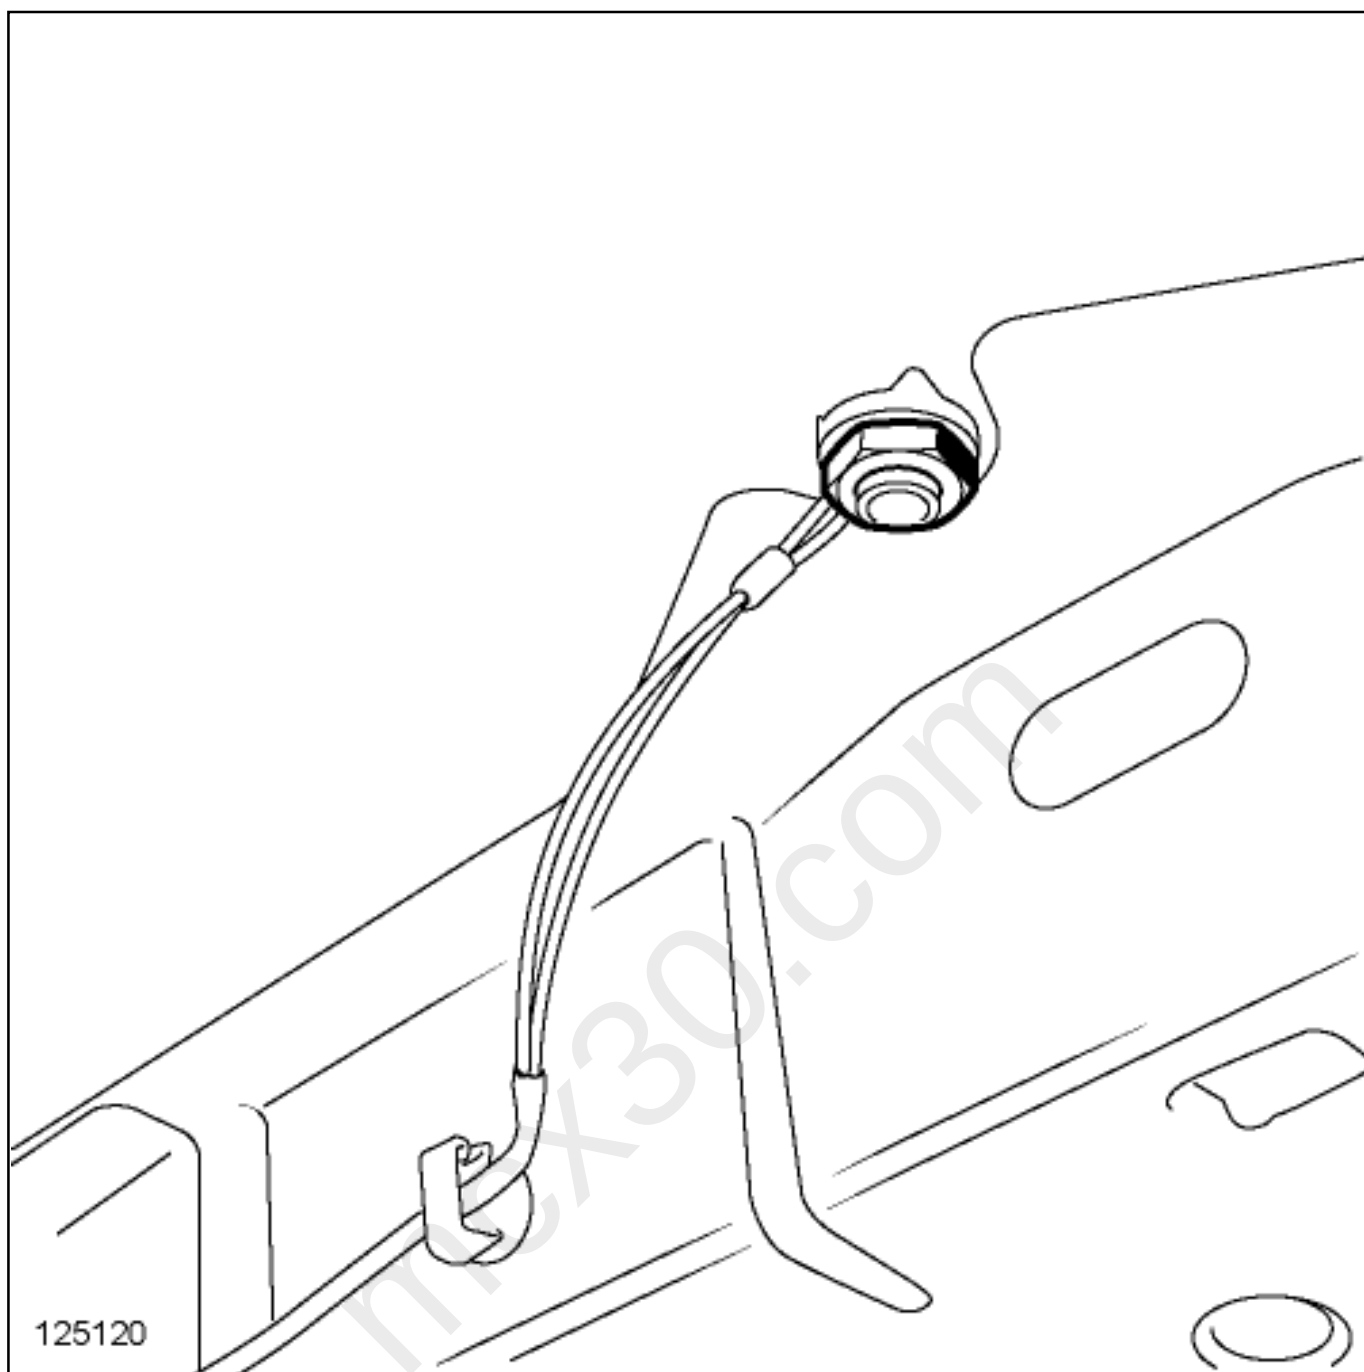
### 1- AERIAL

To ensure correct operation:

do not pinch the aerial cable,

do not bend the aerial cable,

do not force the aerial cable when refitting.
