# RADIO: LIST AND LOCATION OF COMPONENTS

## 1. LIST OF COMPONENTS

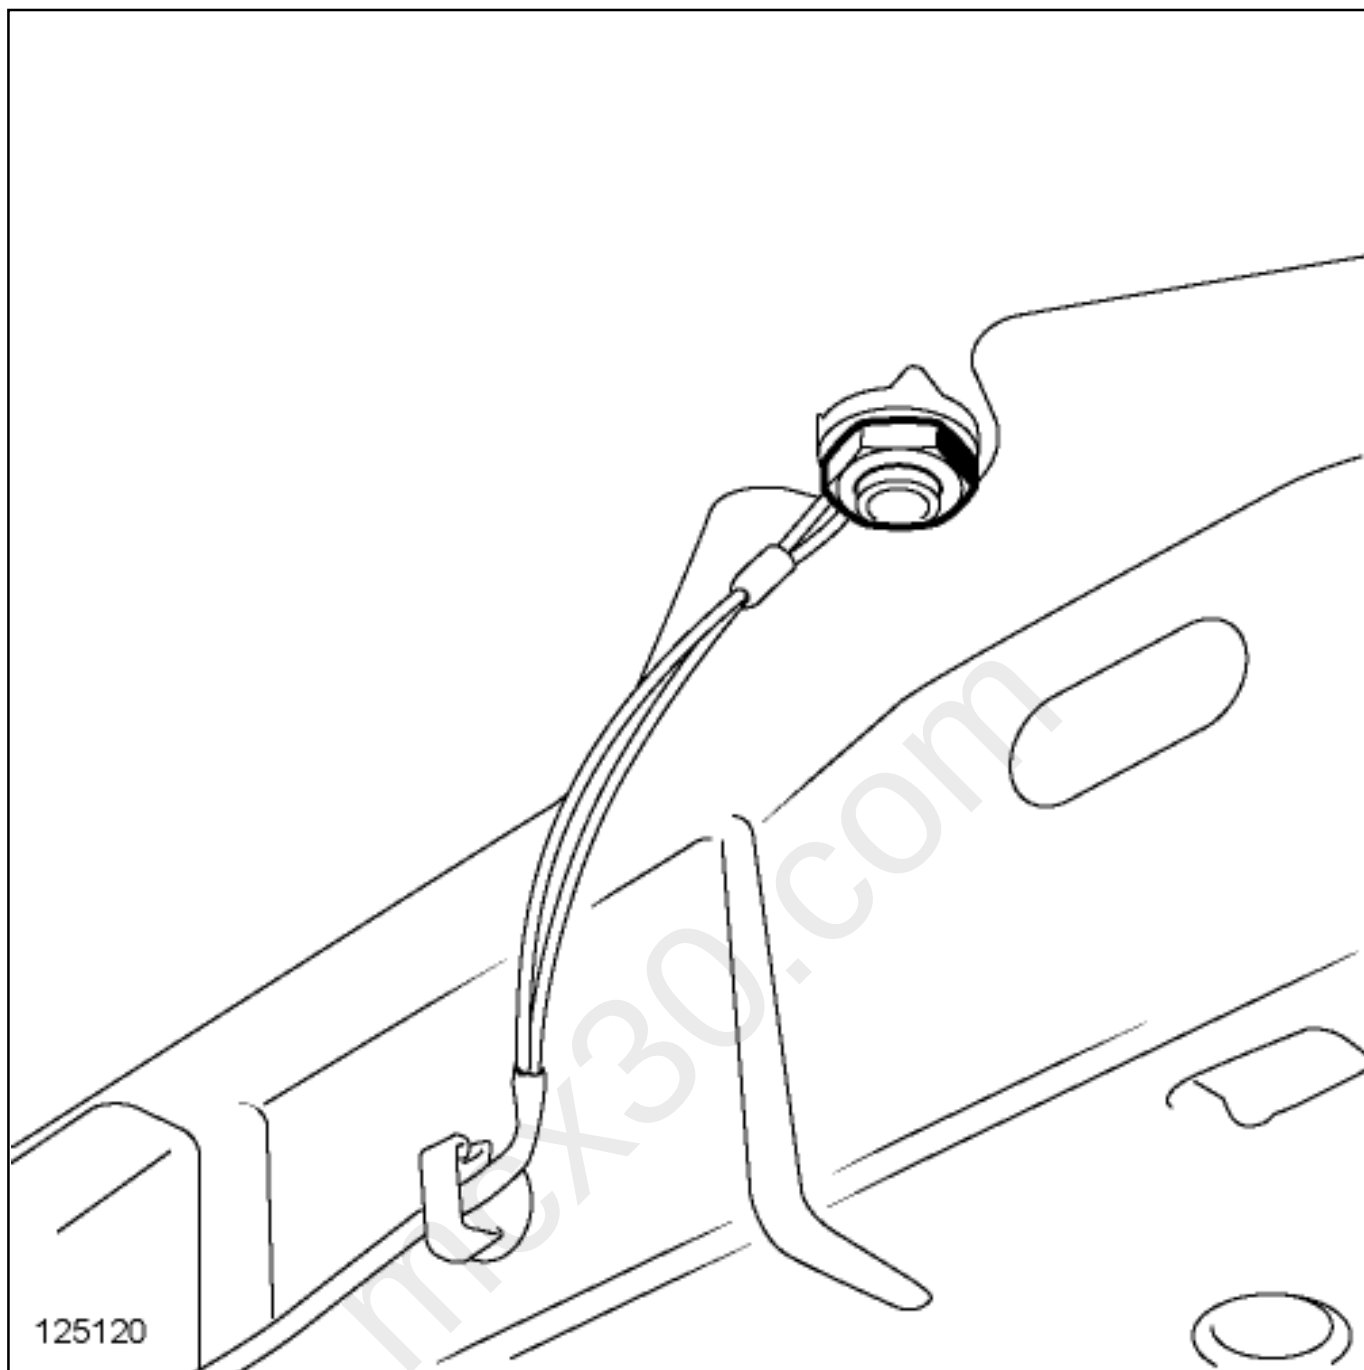
### 1- AERIAL
