# DASHBOARD ASSEMBLY: EXPLODED VIEW

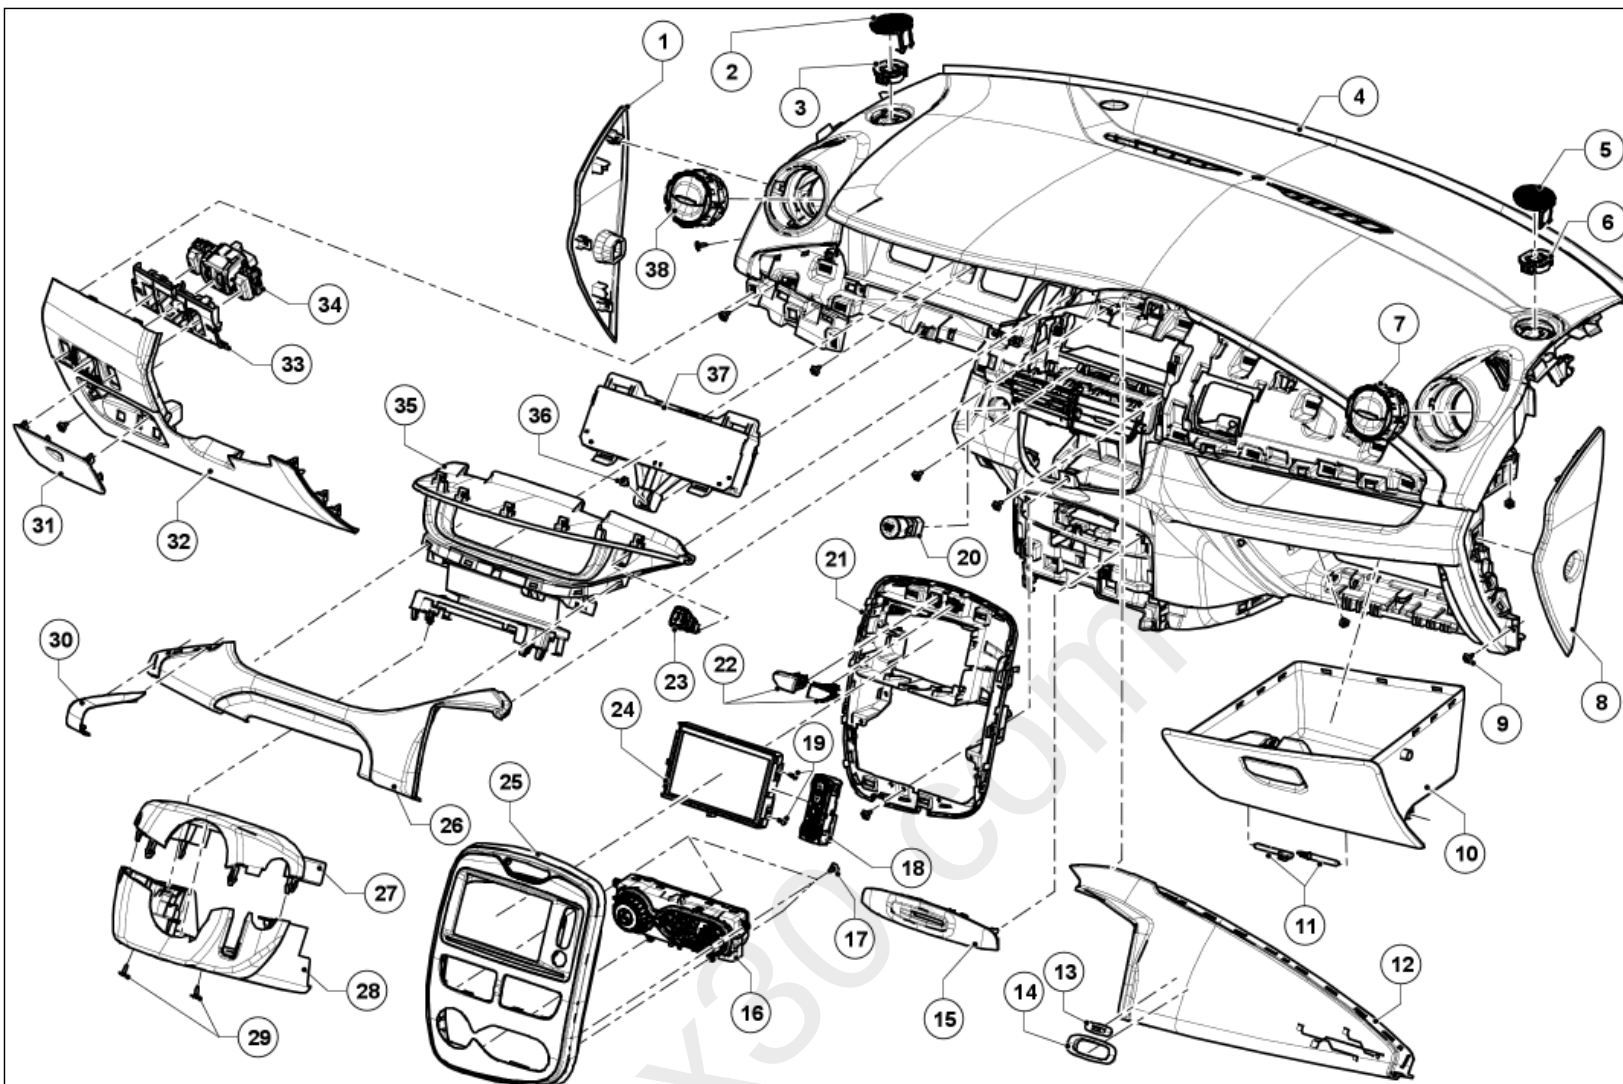
| Marks | Designations | Informations |
| 1 | Left-hand dashboard side panel | ( Car.1363 ) |
| 2 | Tweeter grille | ( Car.1363 ) |
| 3 | Tweeter | |
| 4 | Dashboard | |
| 5 | Tweeter grille | ( Car.1363 ) |
| 6 | Tweeter | |
| 7 | Dashboard air vent | ( Car.1363 ) |
| 8 | Blanking cover of dashboard side panel | ( Car.1363 ) |
| 9 | Dashboard screws | |
| 10 | Glovebox | |
| 11 | Left-hand glovebox cover hinge pins | |
| 12 | Right-hand dashboard trim | |
| 13 | Drawer of air freshener | ( Car.1363 ) |
| 14 | Grille air freshener | ( Car.1363 ) |
| 15 | Centre console lower front panel | ( Car.1363 ) |
| 16 | Air conditioning control panel | |
| 17 | Air conditioning control panel bolt | |
| 18 | Navigation keypad | |
| 19 | Multifunction screen trim bolt | |
| 20 | Start button | ( Car.1363 ) |
| 21 | Structure totem of dashboard | |
| 22 | Switch | ( Car.1363 ) |
| 23 | Switch | ( Car.1363 ) |
| 24 | Multifunction screen | |
| 25 | Dashboard central upper trim | ( Car.1363 ) |
| 26 | Left-hand dashboard trim | ( Car.1363 ) |
| 27 | Under steering wheel shell | |
| 28 | Under steering wheel shell | |
| 29 | Bolt | |
| 30 | Left-hand dashboard side panel | ( Car.1363 ) |

| 31 | Fuses flap | |
| 32 | Dashboard lower trim | ( Car.1363 ) |
| 33 | Interruptors support plate | |
| 34 | Switch | |
| 35 | Instrument panel front visor | |
| 36 | Instrument panel lower screws | |
| 37 | Instrument panel | |
| 38 | Dashboard air vent | |
