# DRIVER'S FRONTAL AIRBAG: REMOVAL - REFITTING

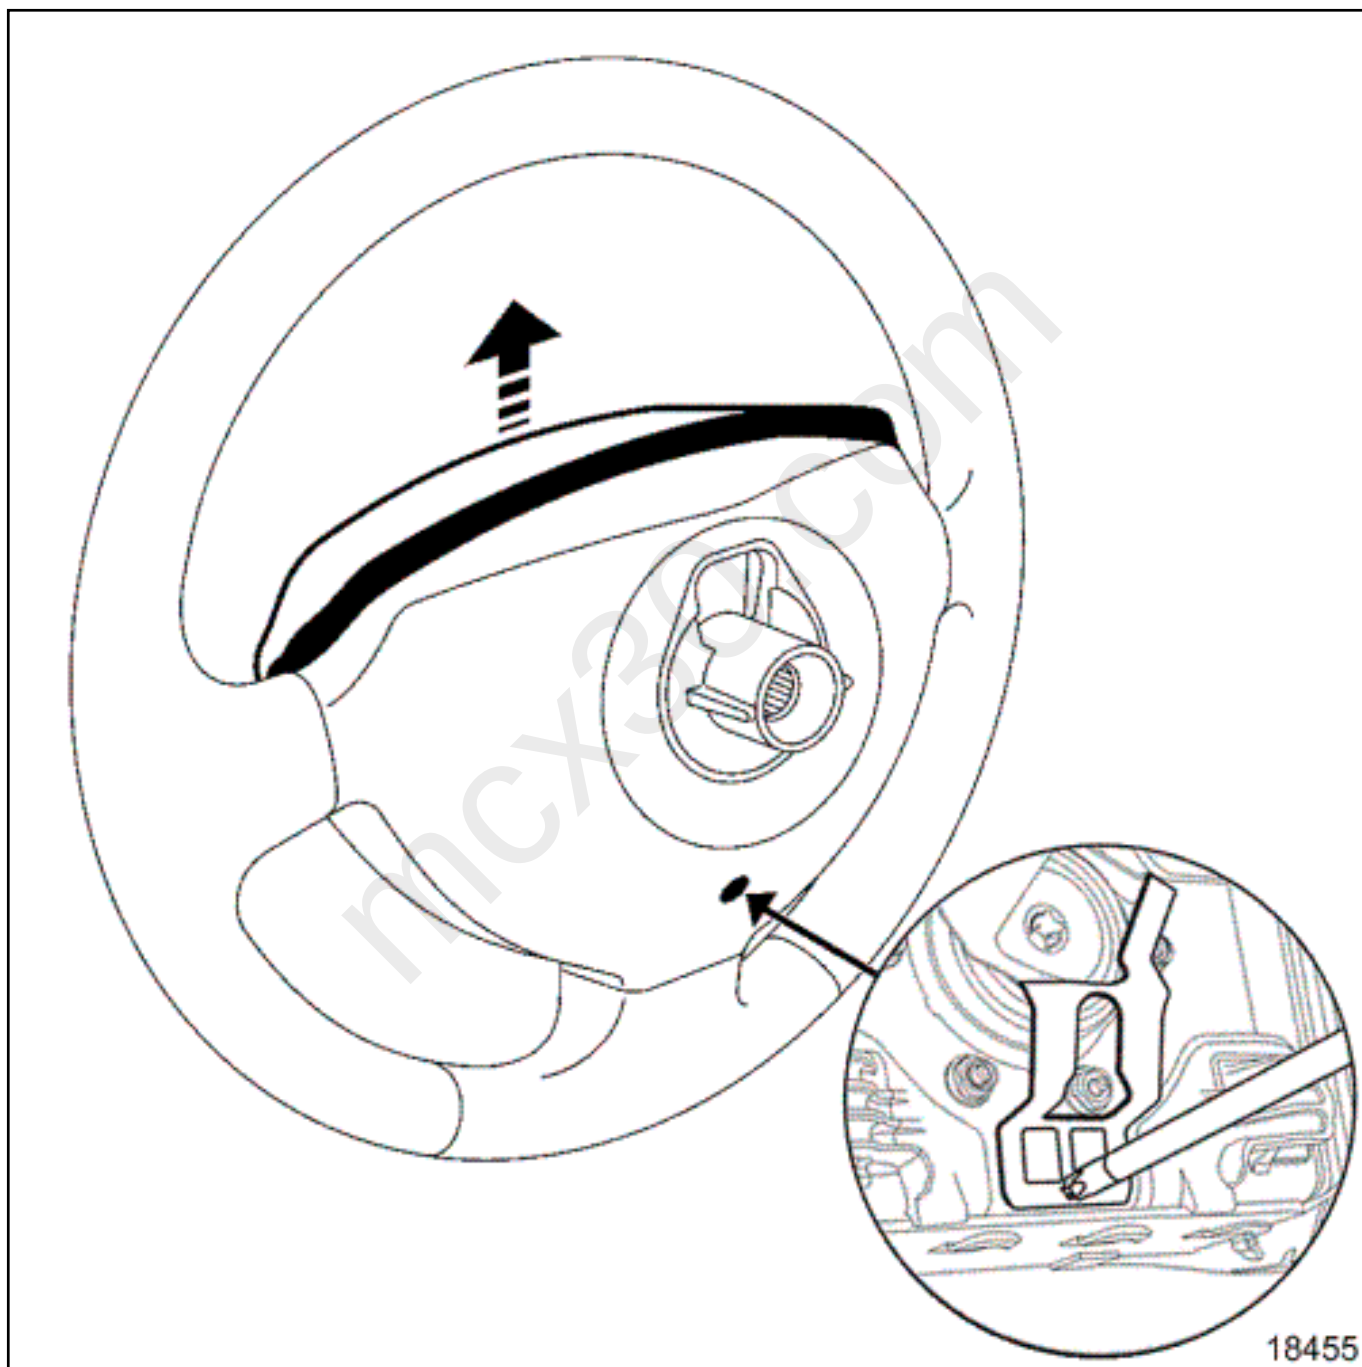
■ Insert a screwdriver (type T30) into the aperture(1) located behind the steering wheel.

■ Unclip the clip(2) by pushing the screwdriver, whilst pushing the airbag according to the direction(3) .

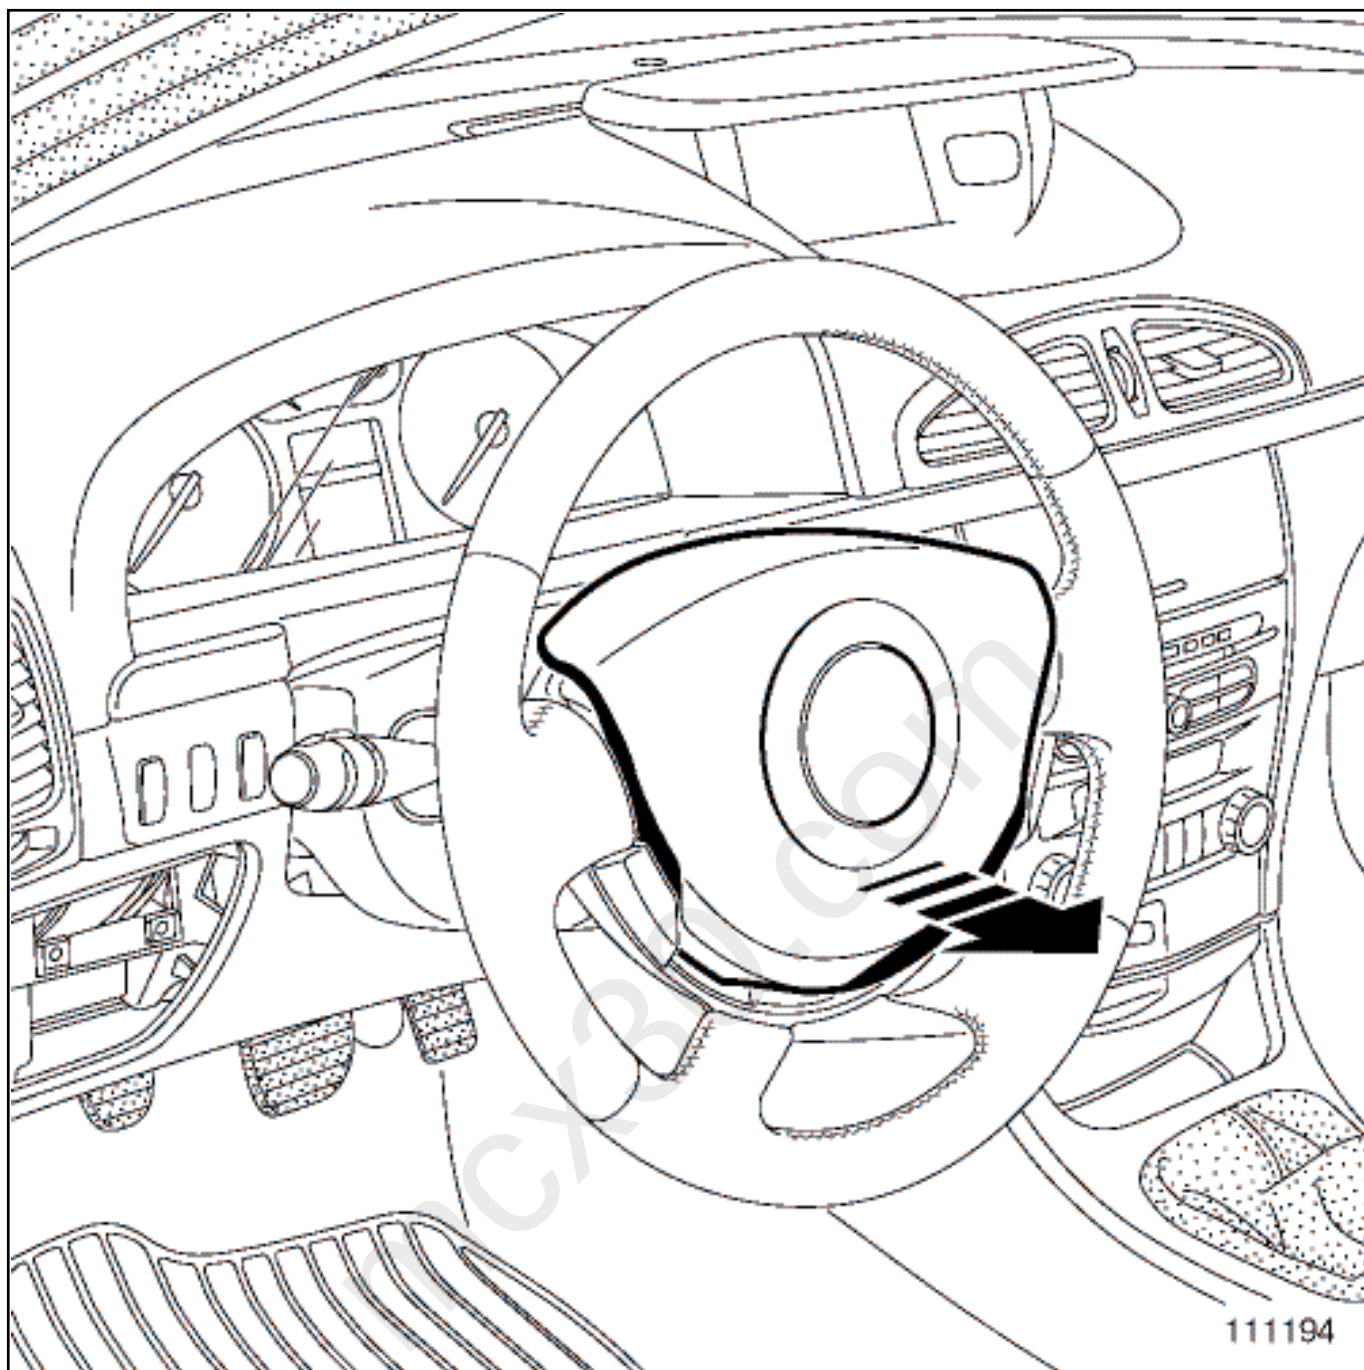
- Remove the driver's front airbag.
- Unlock the connector(s) of the driver's frontal airbag.
- Disconnect the connector(s).
