# EXTERIOR BODY FRONT TRIM ASSEMBLY: EXPLODED VIEW

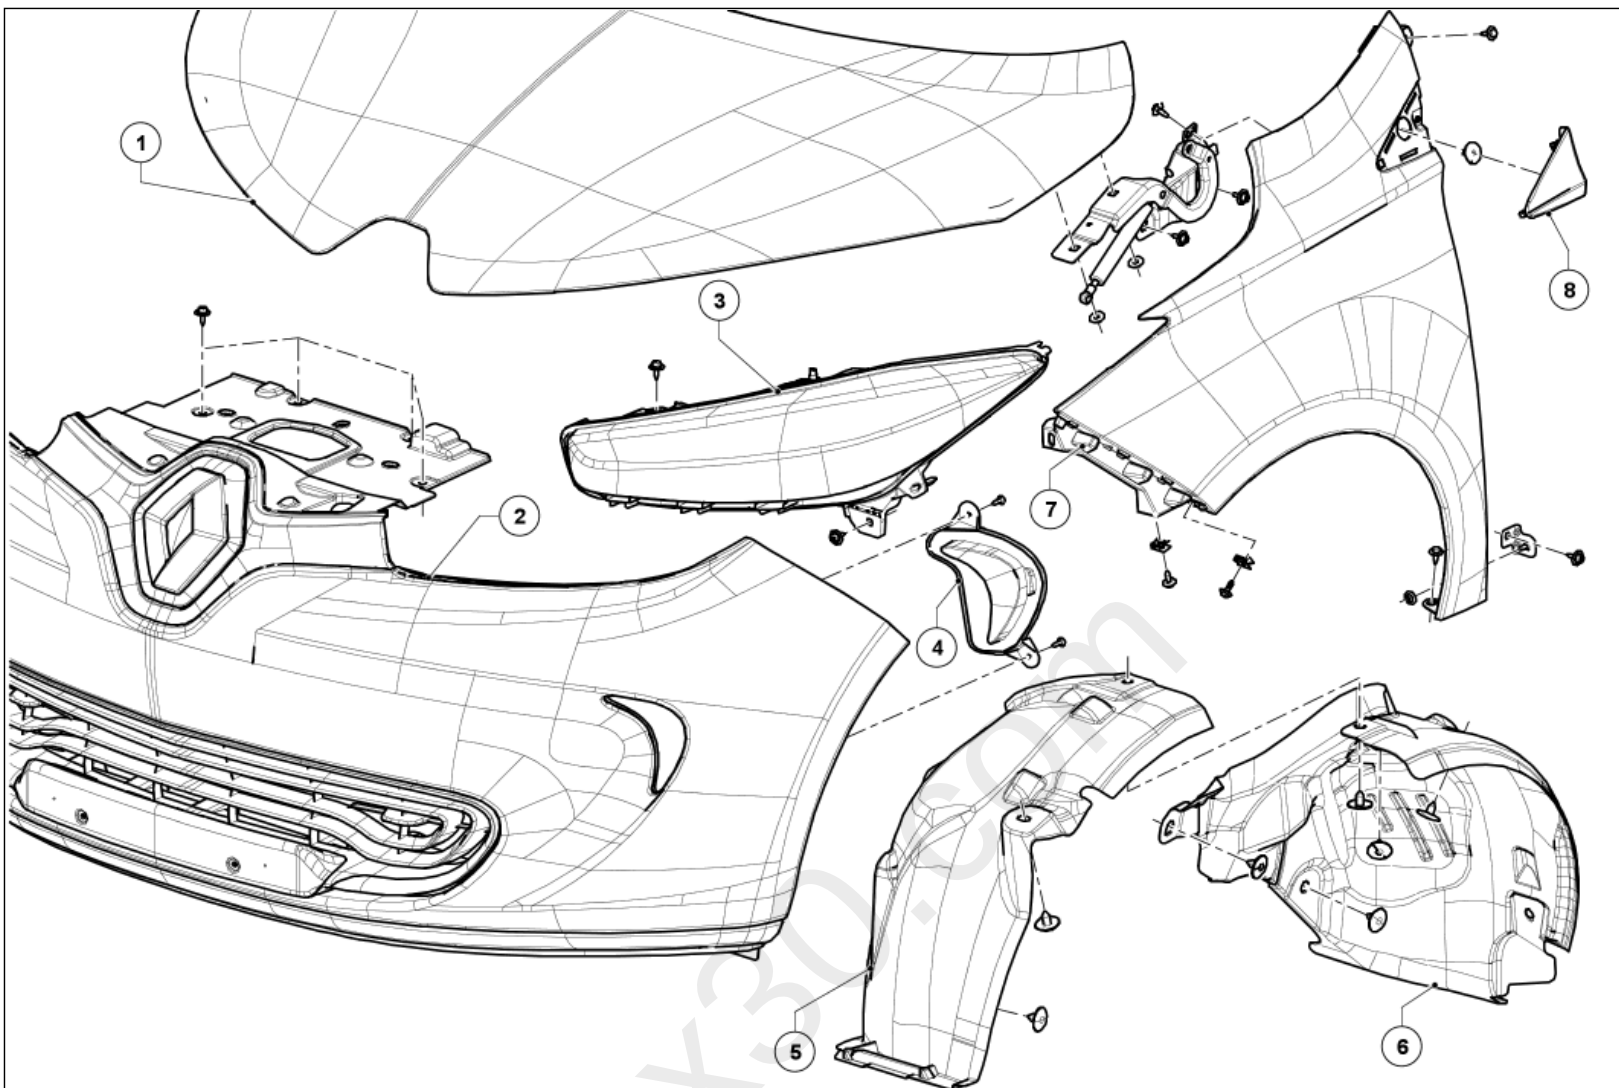
| Marks | Designations | Informations |
|---|---|---|
| 1 | Bonnet | |
| 2 | Front bumper assembly | <a href="#">(see 55A, Exterior protection, Front bumper assembly: Exploded view)</a> |
| 3 | Headlight | <a href="#">Headlight assembly: Exploded view</a> |
| 4 | Daytime running light | Daytime running light: Removal - Refitting@80,02,02,11-01,37-1 |
| 5 | Front wheel arch liner, front section | |
| 6 | Front wheel arch liner, rear section | |
| 7 | Front wing | Front wing: Removal - Refitting@40,06,02-01,37-1 |
| 8 | Front wing trim | |
