# FRONT SEAT ASSEMBLY: EXPLODED VIEW

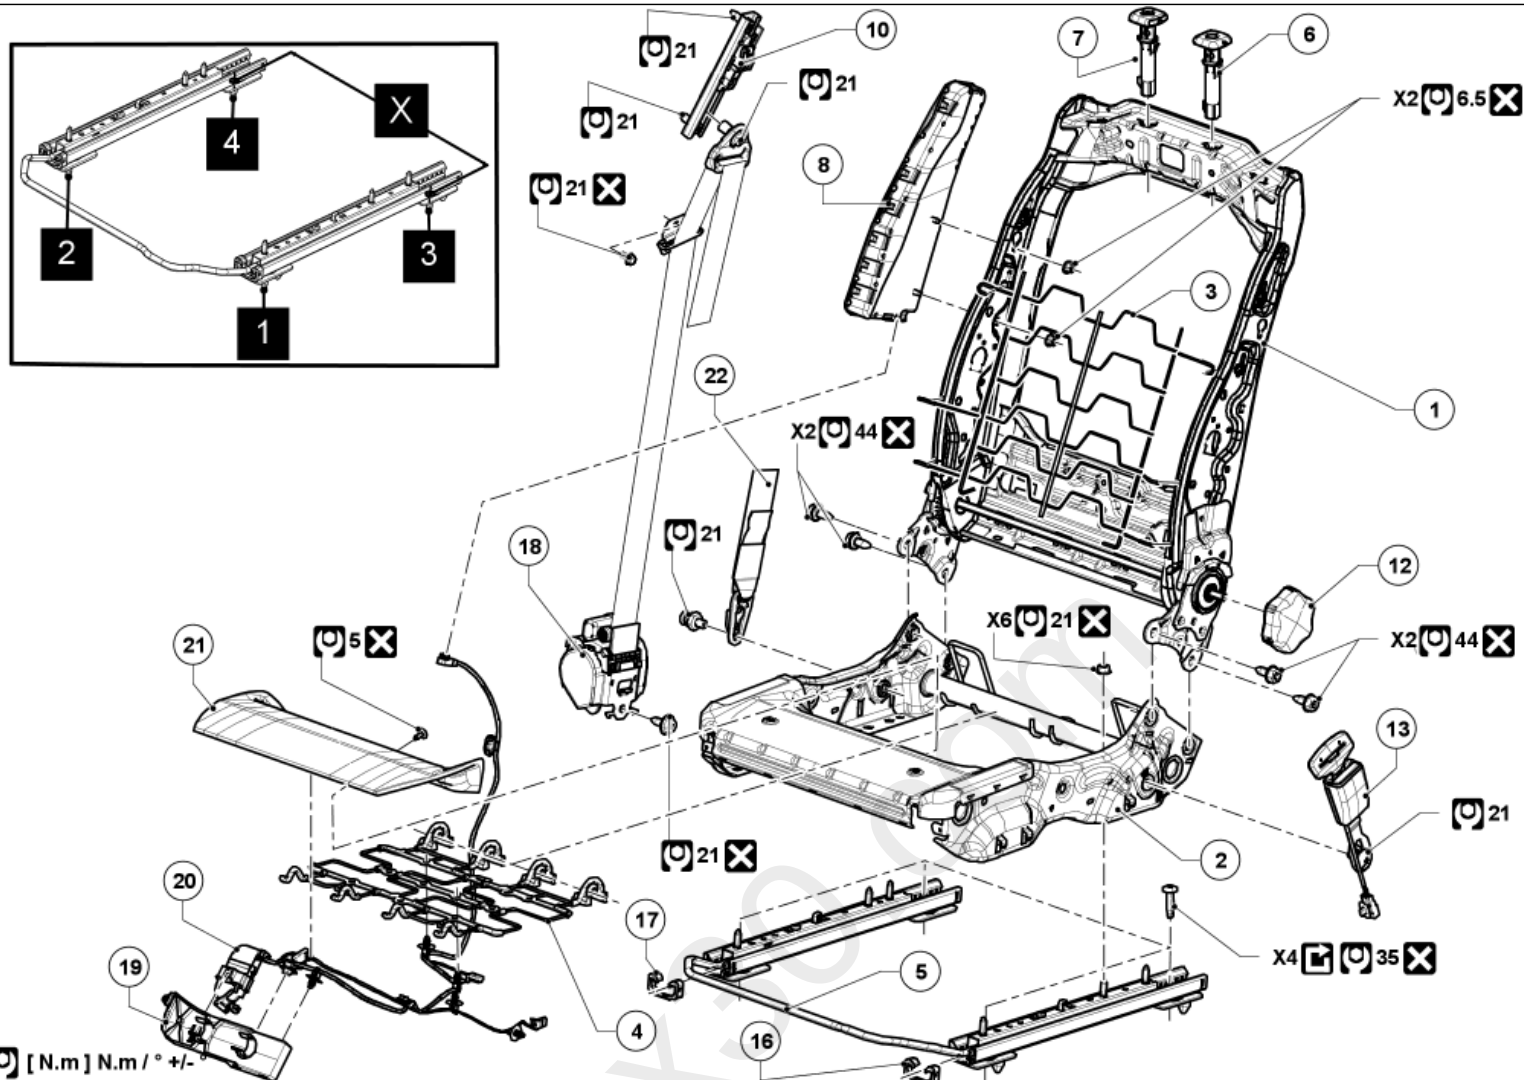
| Marks | Designations | Informations |
| 1 | Front seatback frame | |
| 2 | Front seat base frame | |
| 3 | Front seat lumbar pad | |
| 4 | Sheet of front seat cushion | |
| 5 | Front seat runner | Centre to centre distance X = 420 mm |
| 6 | Front seat headrest guide | |
| 7 | Front seat headrest guide | |
| 8 | Front seat chest-level side airbag | (see Airbag and pretensioners: Precautions for the repair) and (see Airbags and pretensioners: Recycling - Destruction)<br>Vehicle involved in an impact:(see Vehicle involved in an impact: Mechanical impact fault finding) |
| 10 | Seat belt height adjustment system | |
| 12 | Front seat backrest tilt control | |
| 13 | Front seat belt buckle | |
| 16 | Front seat runner end cover | |
| 17 | Front seat runner end cover | |
| 18 | Front seat belt | (see Airbag and pretensioners: Precautions for the repair) and (see Airbags and pretensioners: Recycling - Destruction)<br>Vehicle involved in an impact:(see Vehicle involved in an impact: Mechanical impact fault finding) |
| 19 | Front seat electrical wiring support | |
| 20 | Front seat electrical wiring | |
| 21 | Anti-submarining airbag | (see Airbag and pretensioners: Precautions for the repair) and (see Airbags and pretensioners: Recycling - Destruction)<br>Vehicle involved in an impact:(see Vehicle involved in an impact: Mechanical impact fault finding) |
| 22 | Front seat belt | (see Airbag and pretensioners: Precautions for the repair) and (see Airbags and pretensioners: Recycling - Destruction)<br>Vehicle involved in an impact:(see Vehicle involved in an impact: Mechanical impact fault finding) |

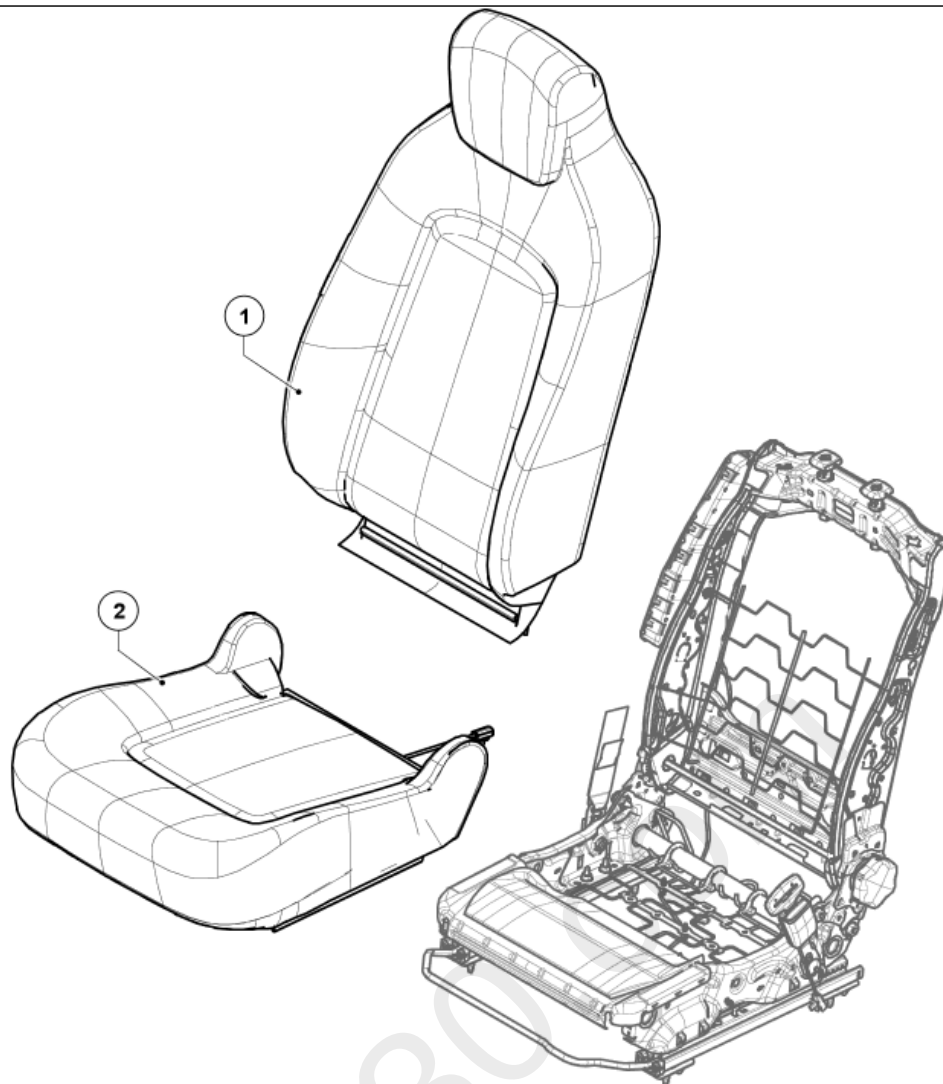
| Marks | Designations | Informations |
| 1 | Front seatback cover | (see <b>Front seatback trim: Removal - Refitting</b> ) |
| 2 | Front seat base cover | |
