# TRACTION BATTERY INTERNAL CURRENT SENSOR : REMOVAL - REFITTING

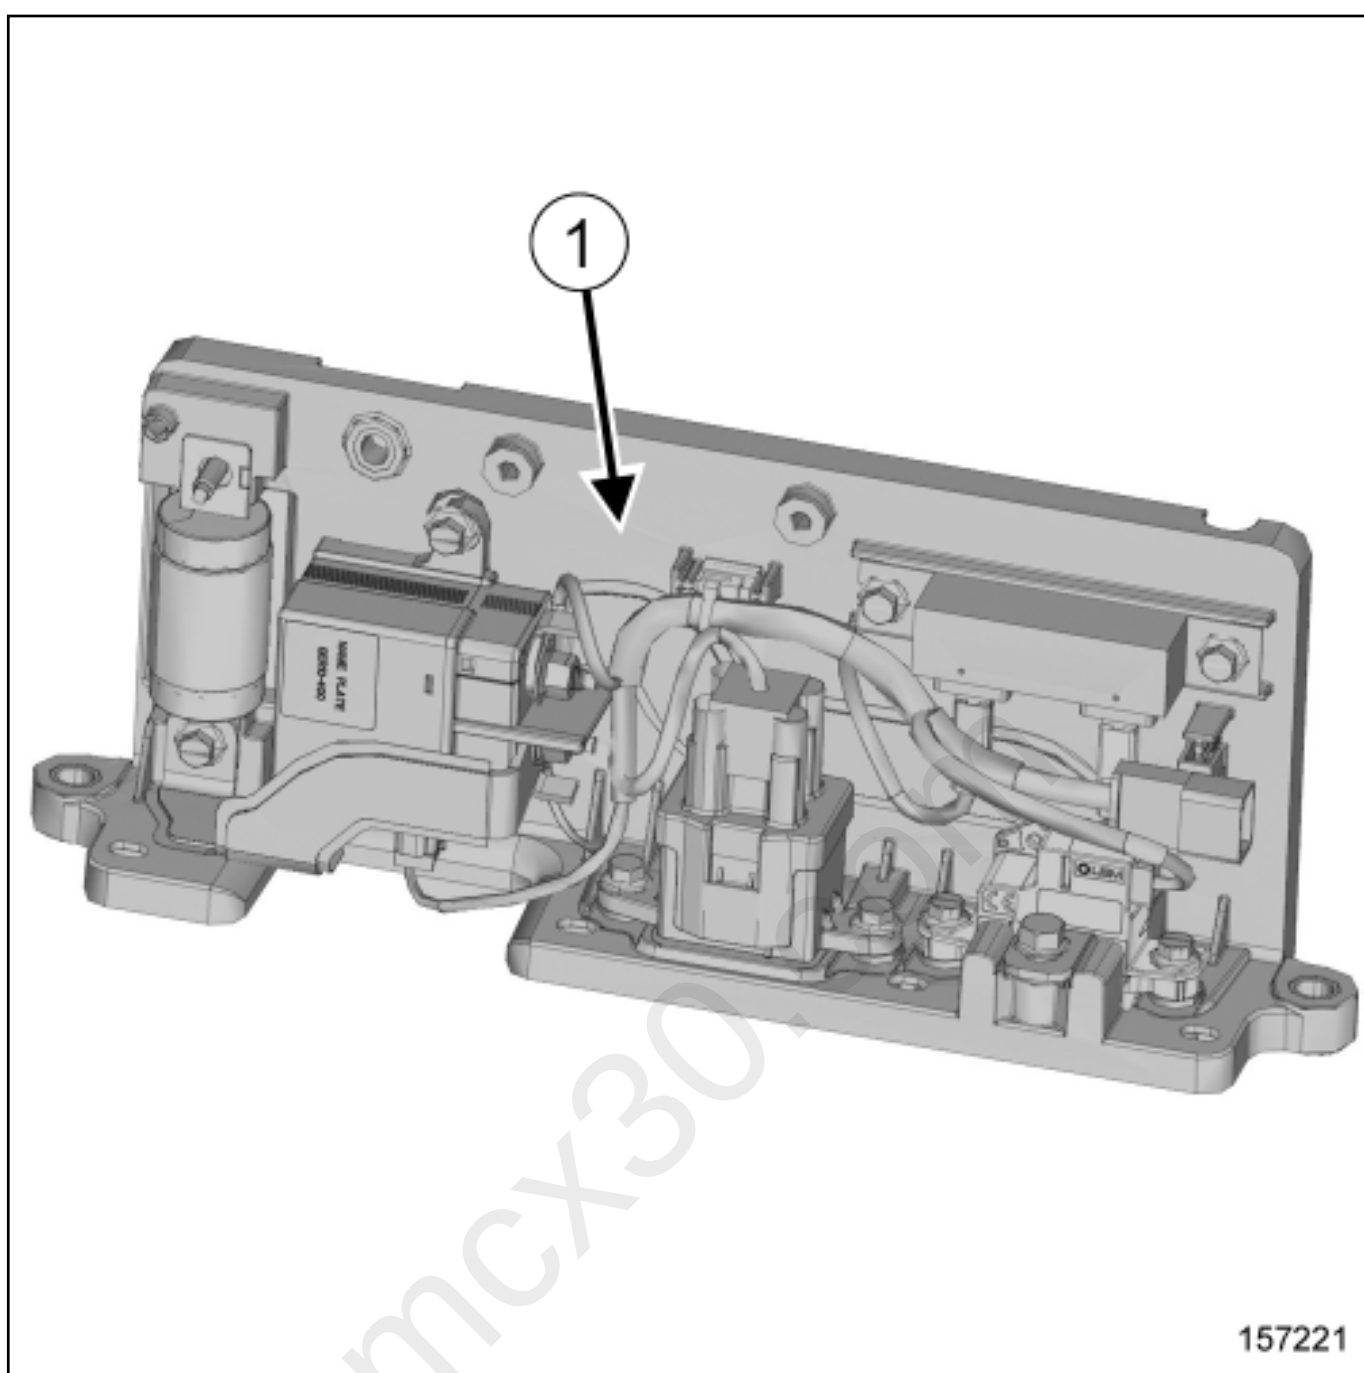
- Remove the traction battery internal junction box(1) ([see 19E, Traction battery, Traction battery module stack assembly : Exploded view](#)) .

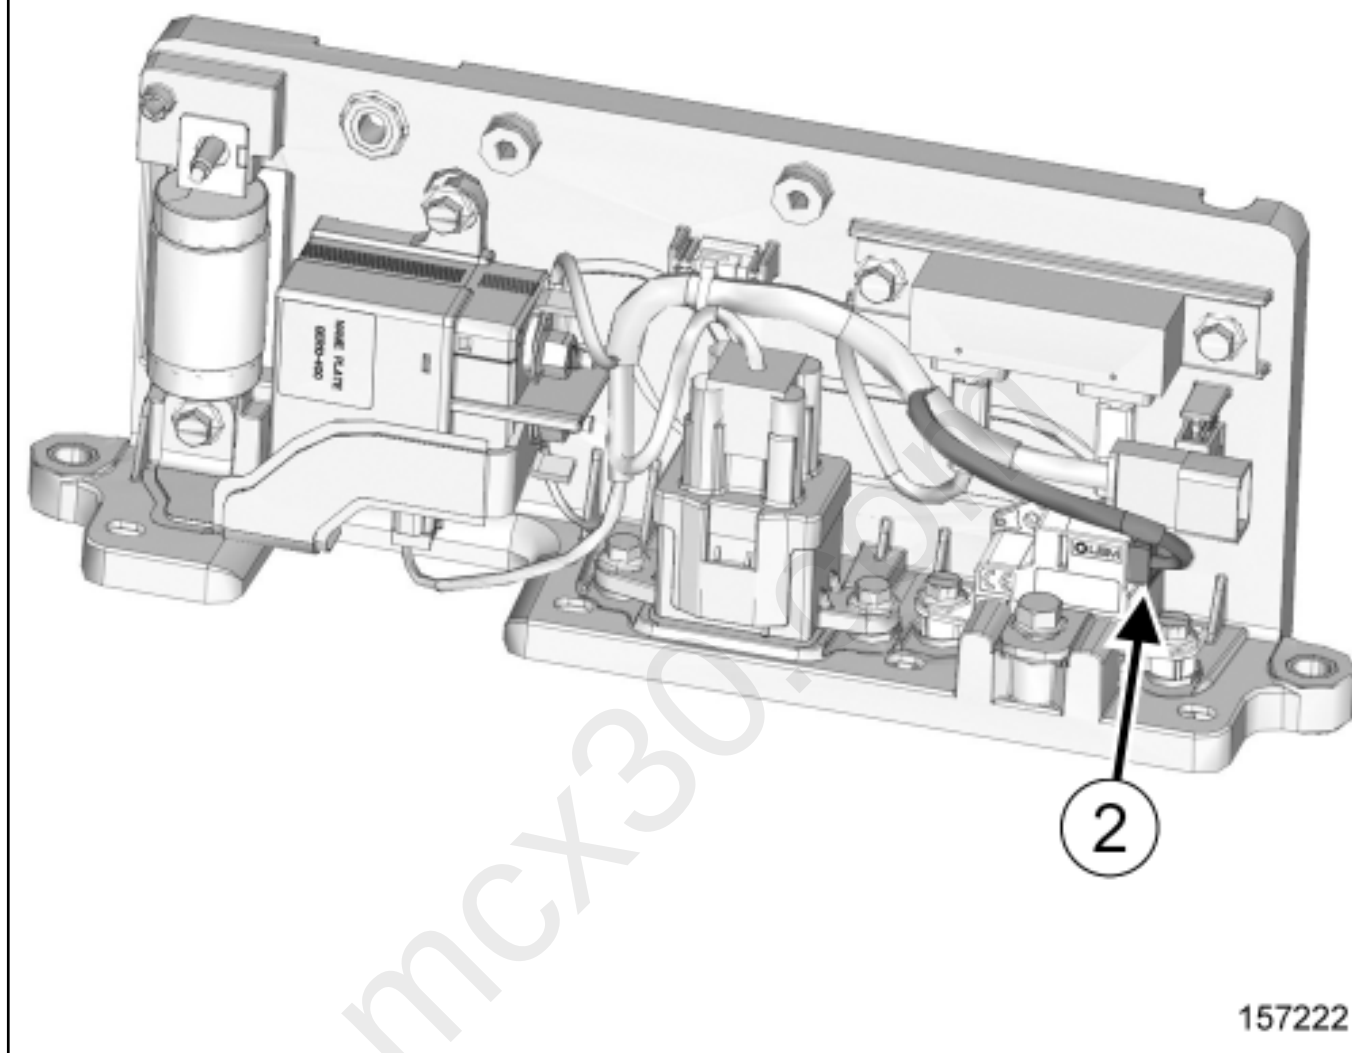
- Disconnect the current sensor plug(2) using the toolSet of trim removal levers.(Car. 1363) .
- Move the current sensor plug wire.

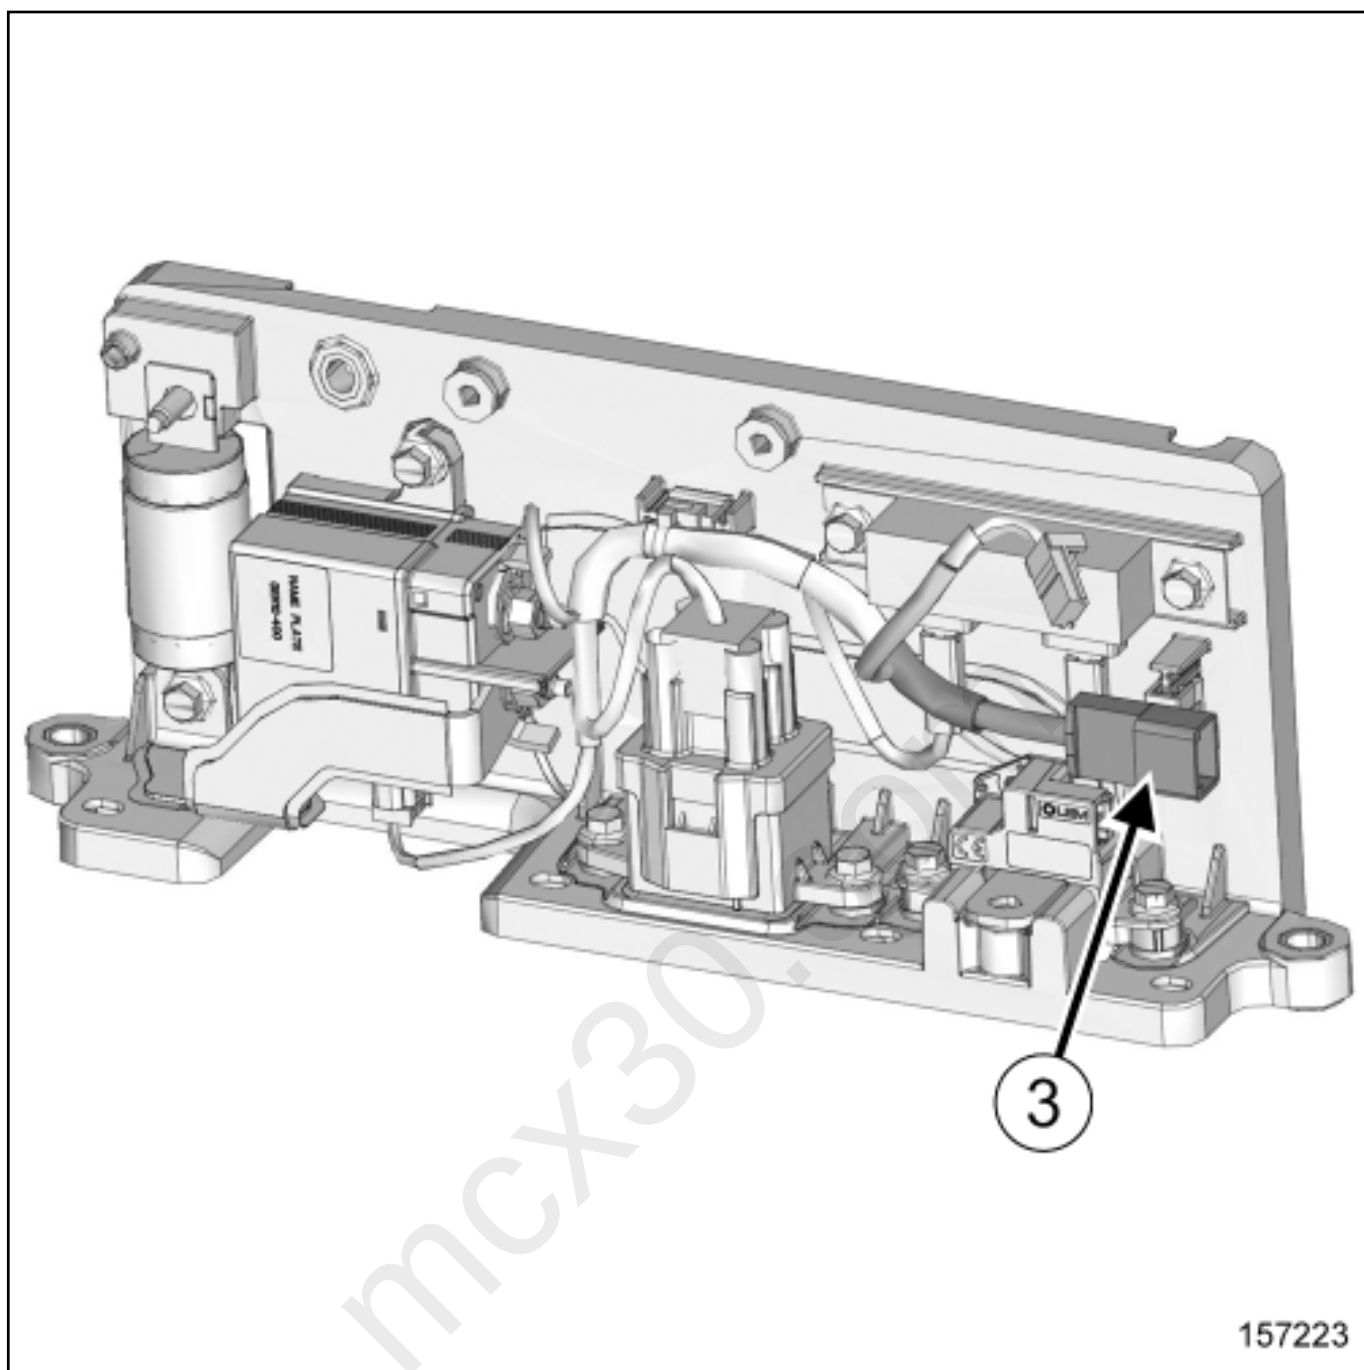
- Unclip the internal junction box wiring socket(3) using the toolSet of trim removal levers.(Car. 1363) .

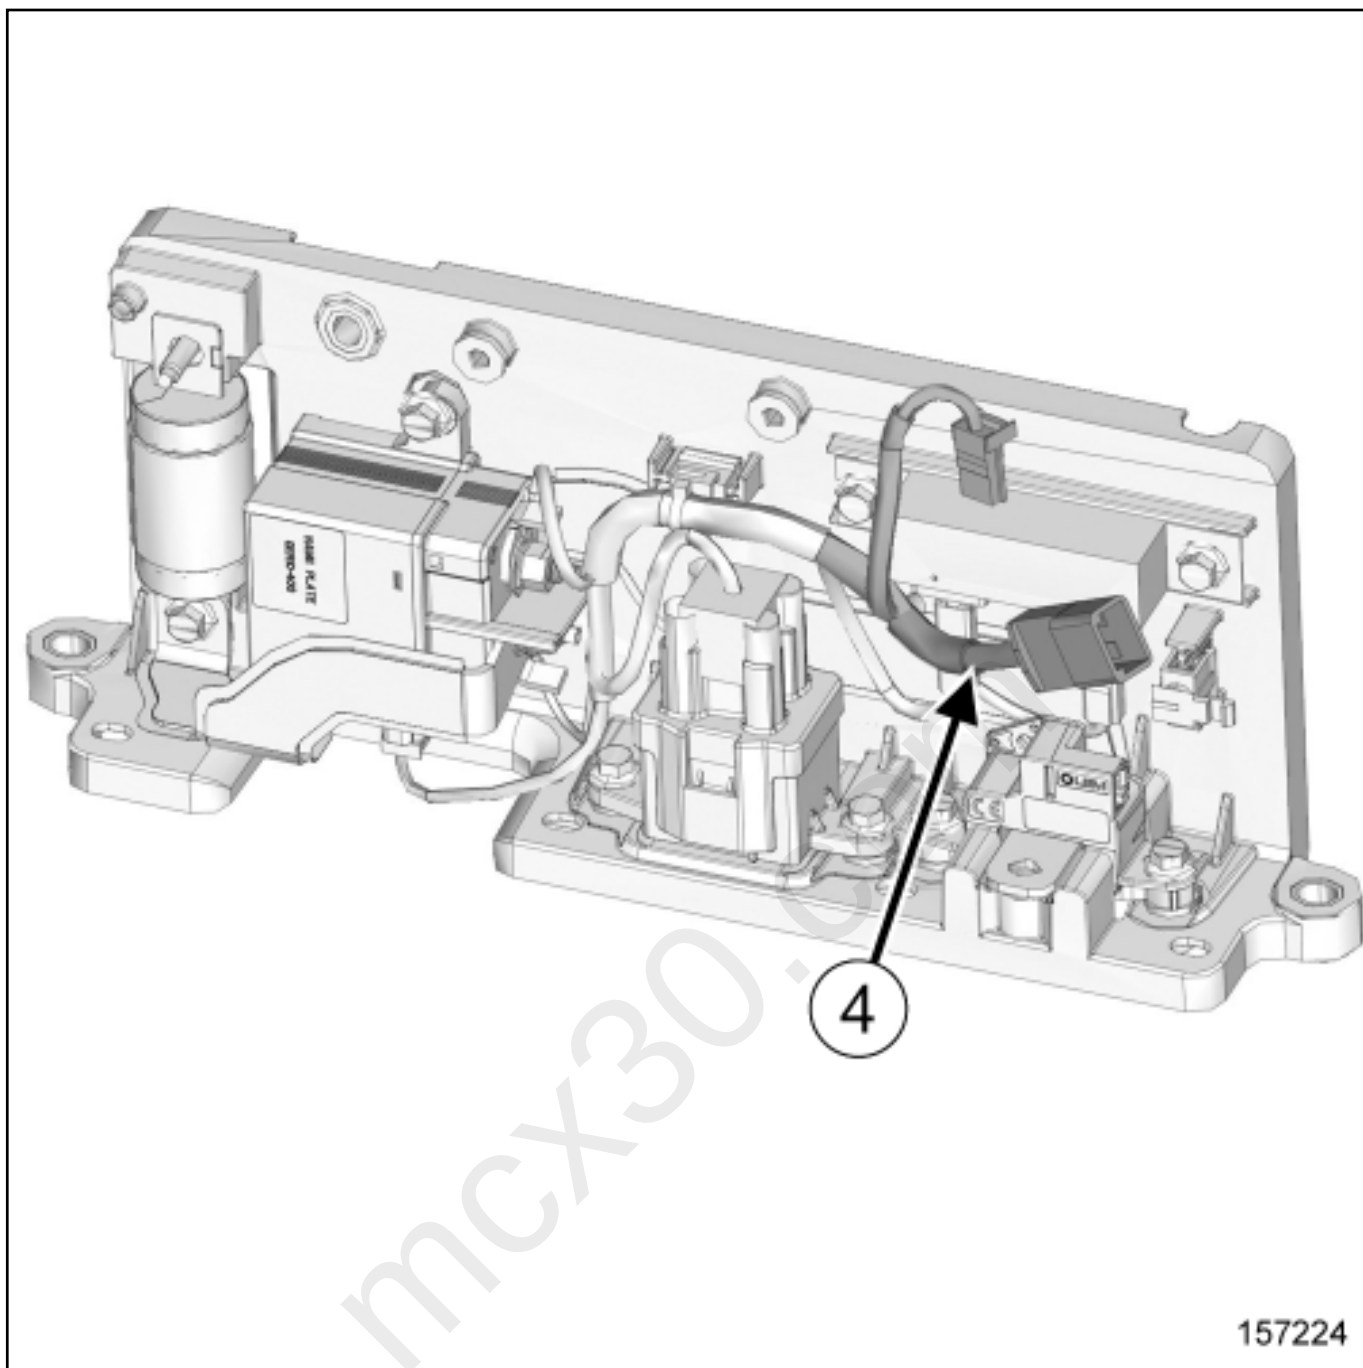
157224

- Move the socket(4) of the internal junction box wiring.

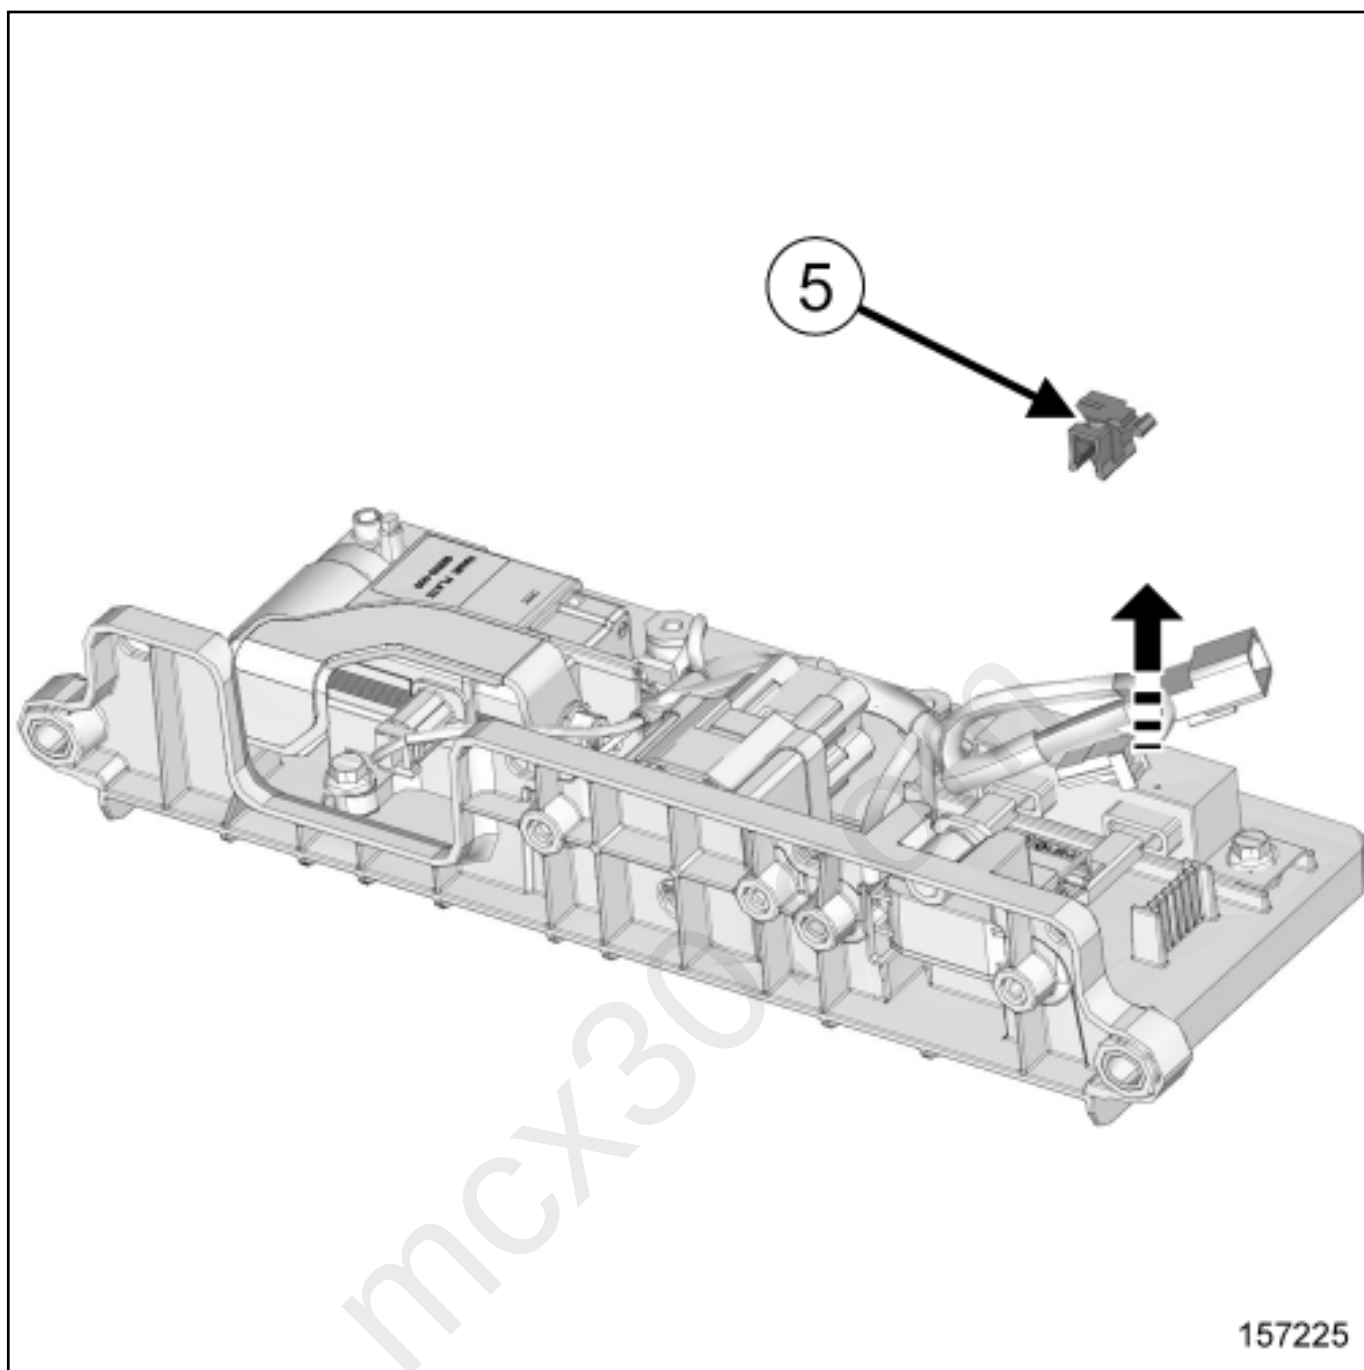
■ Unclip the clip(5) from the internal junction plate using the toolSet of trim removal levers.(Car. 1363) .

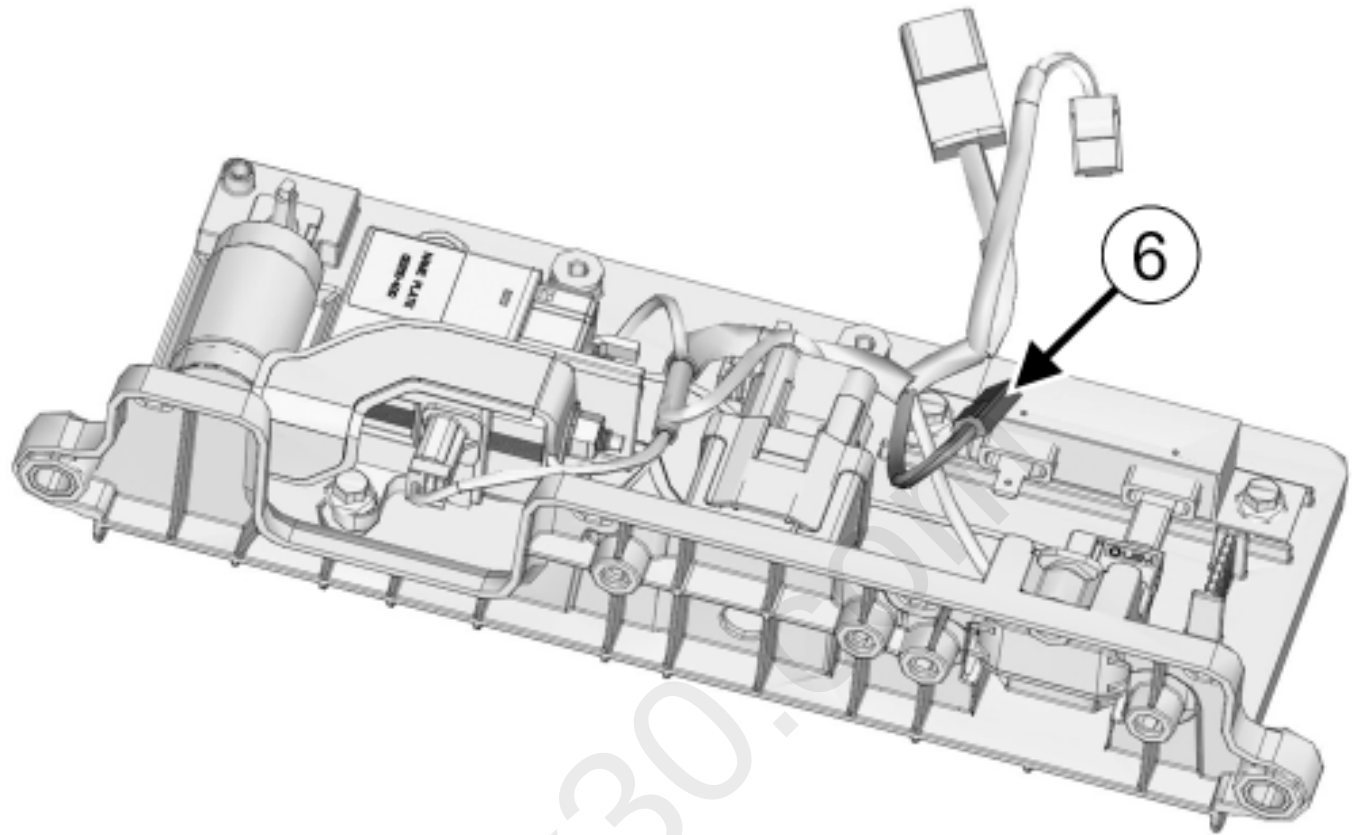
157226

- Disconnect the left side terminal(6) from the precharge resistor using the toolSet of trim removal levers. (Car. 1363) .
- Move the left terminal plug wire.

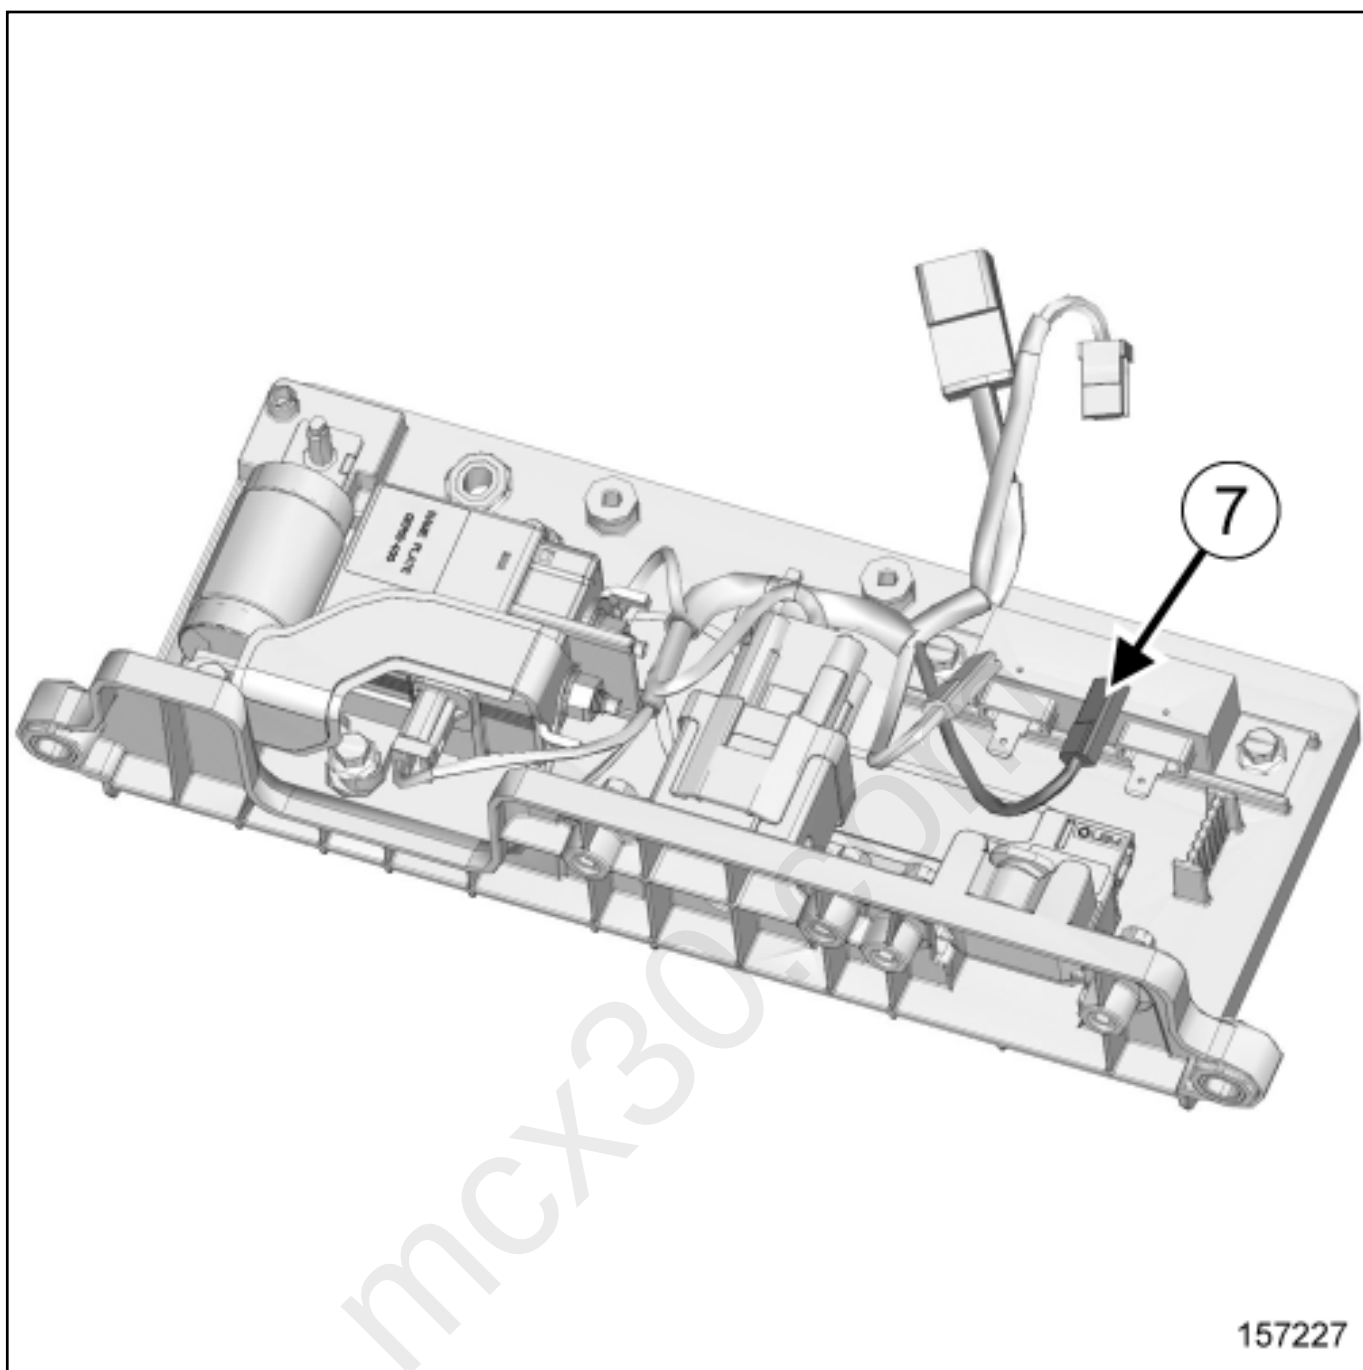
157227

- Disconnect the right side terminal(7) from the precharge resistor using the toolSet of trim removal levers. (Car. 1363) .
- Move the right side terminal wire.

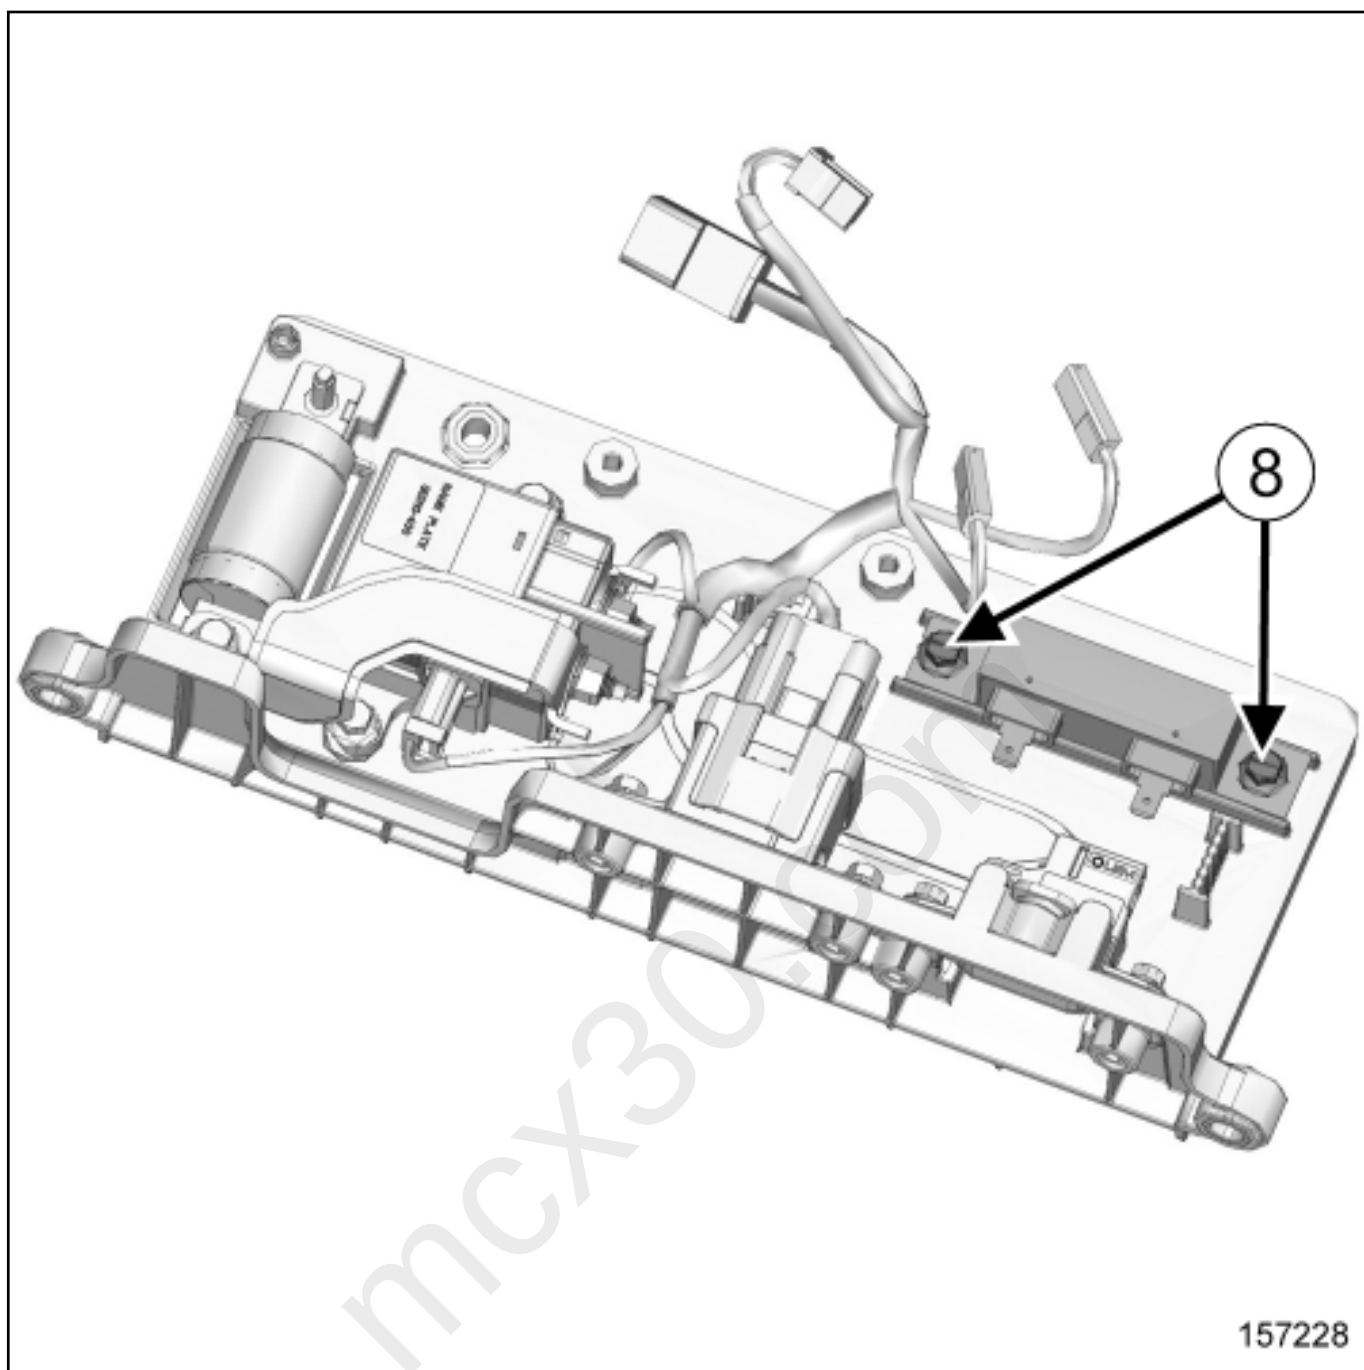
Remove the precharge resistor screws(8) using an insulated magnetic socket([see 19E, Traction battery, Traction battery module stack assembly : Exploded view](#)) .

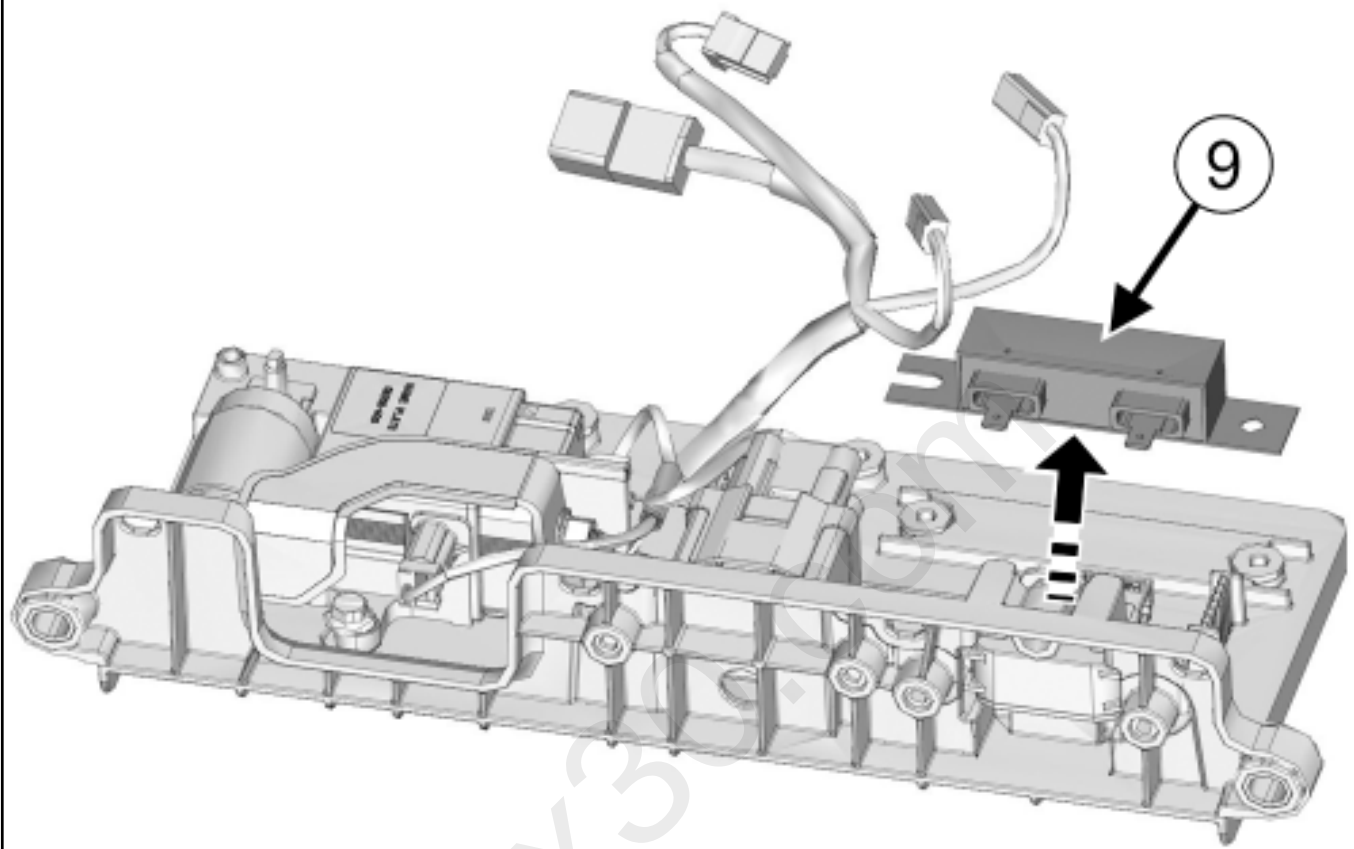
157229

Remove the precharge resistor(9) .

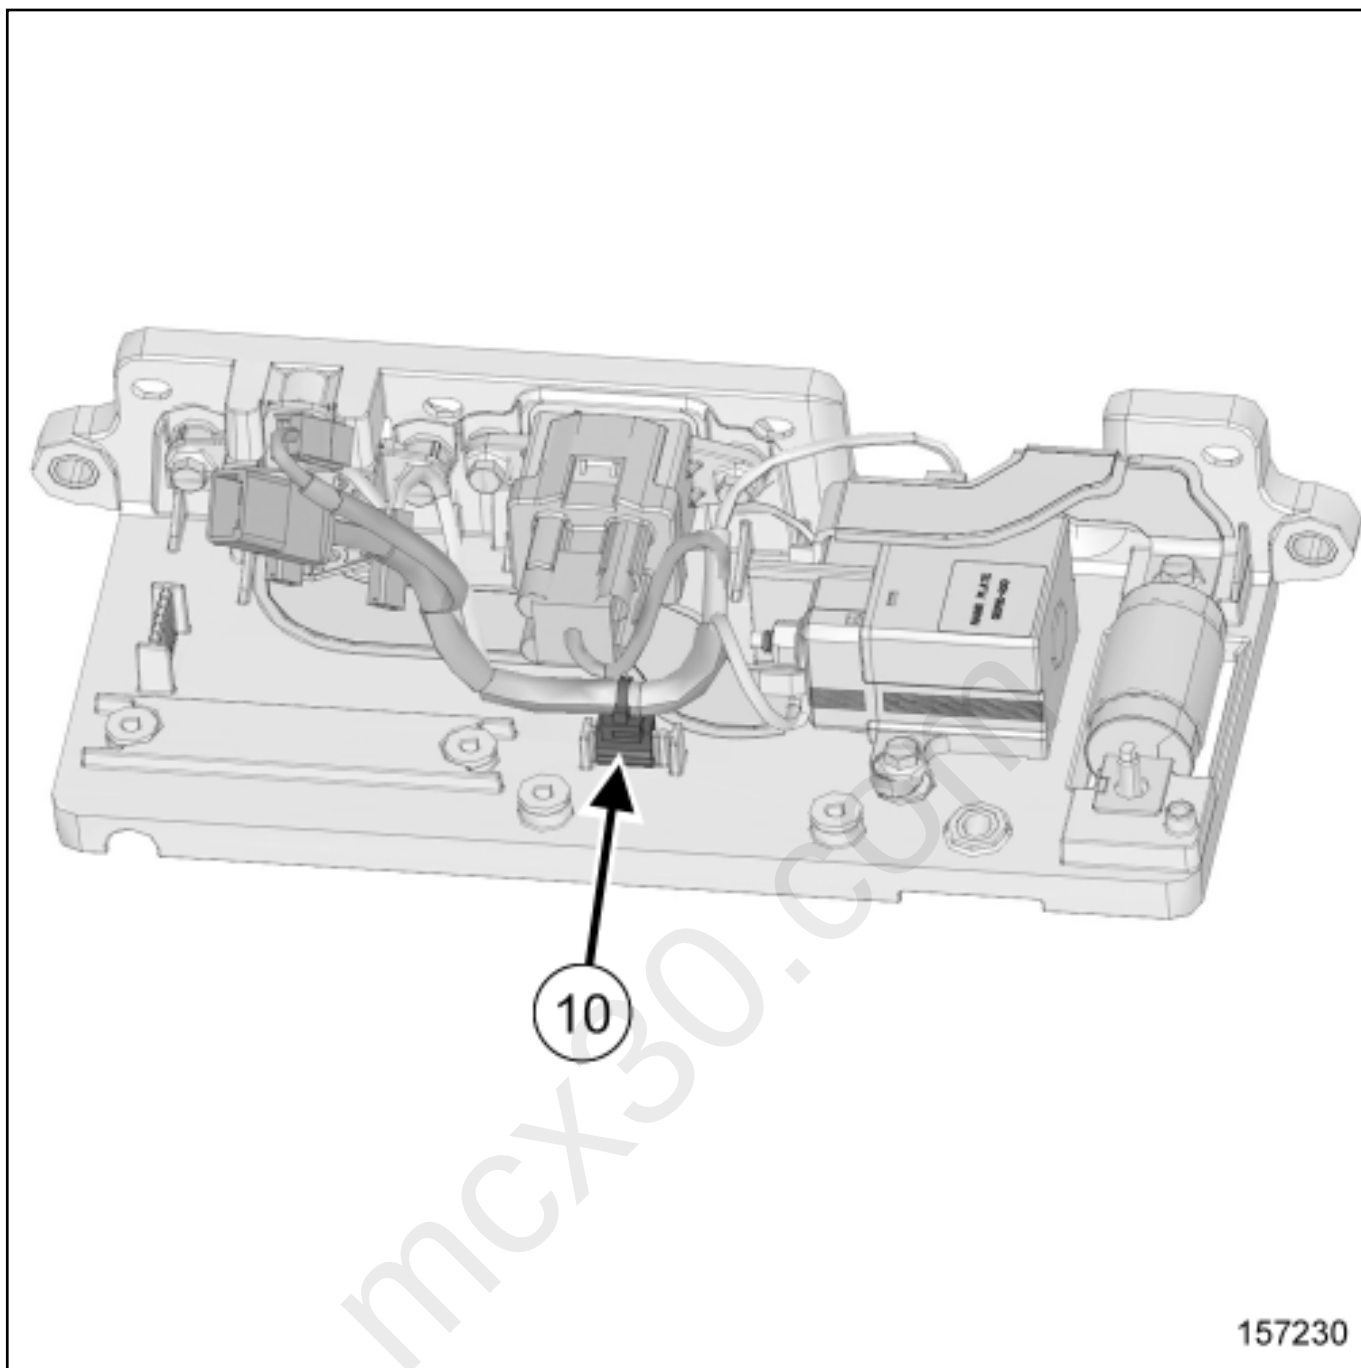
Mark the location of the clamp clip(10) on the low voltage wiring using a PAINT MARKER.

Cut the clamp clip on the low voltage wiring using insulated cutting pliers.

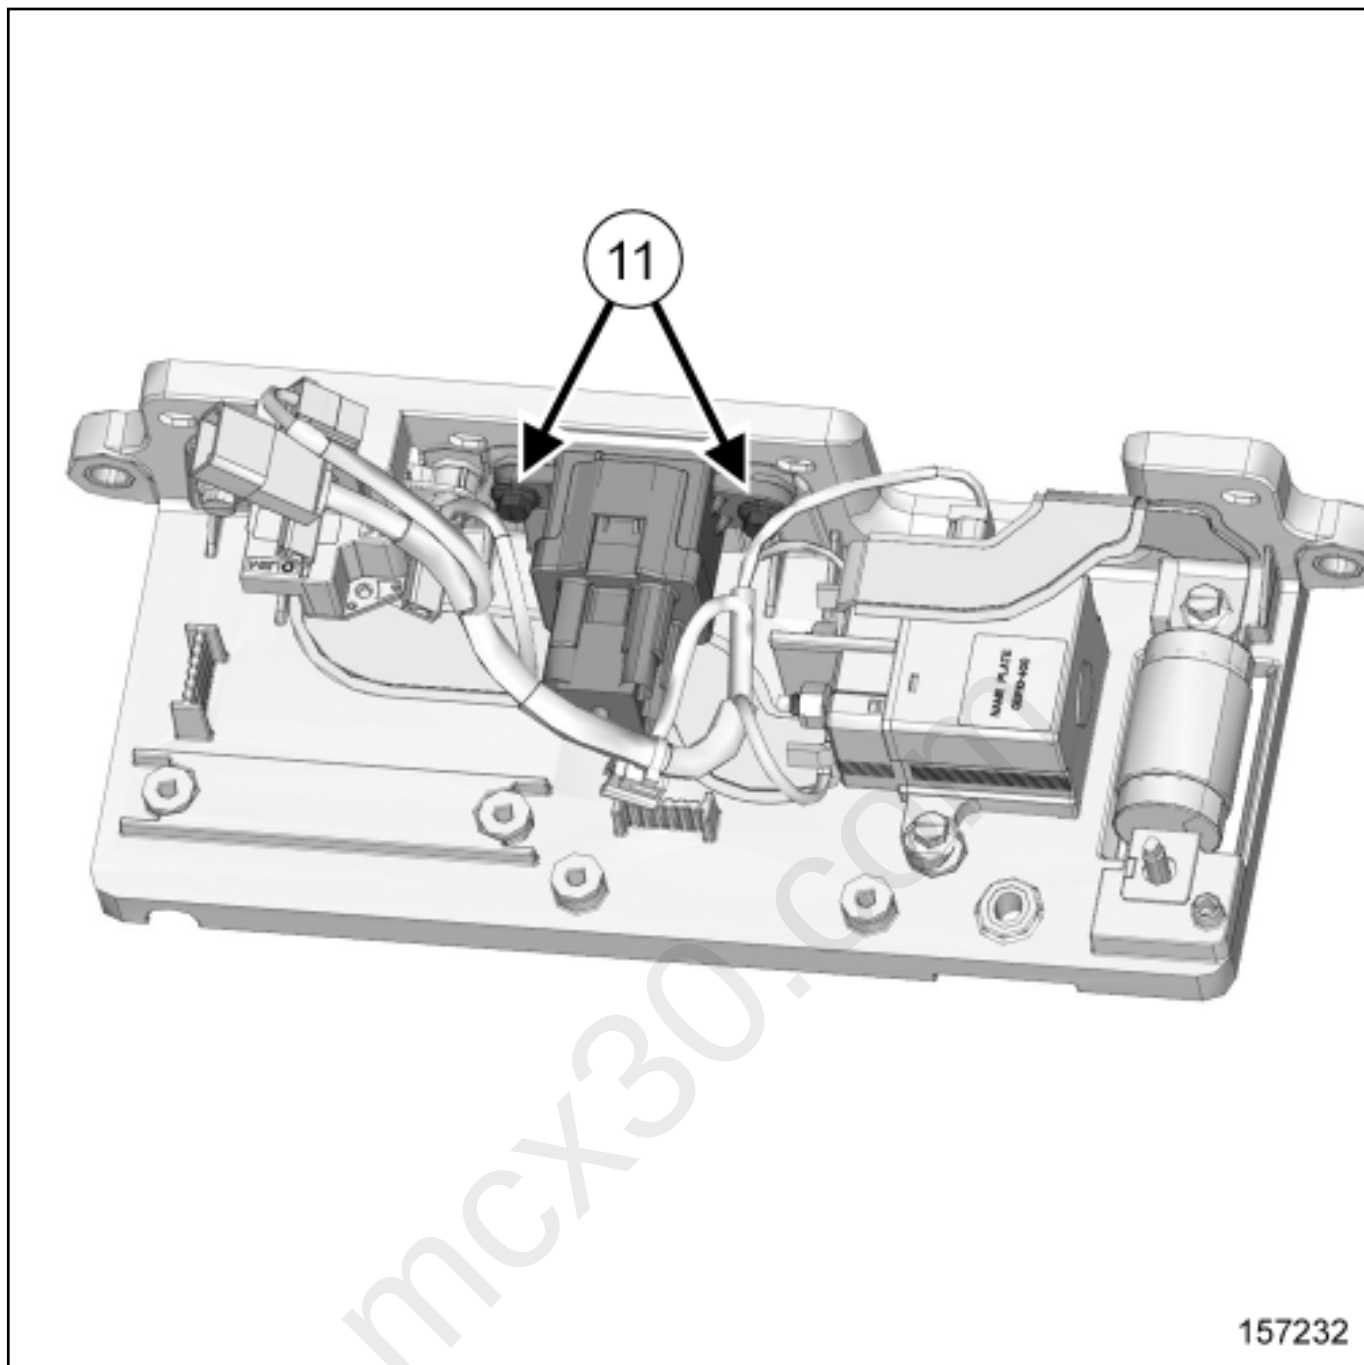
Remove the precharge relay screws(11) using an insulated magnetic socket([see 19E, Traction battery, Traction battery module stack assembly : Exploded view](#)) .

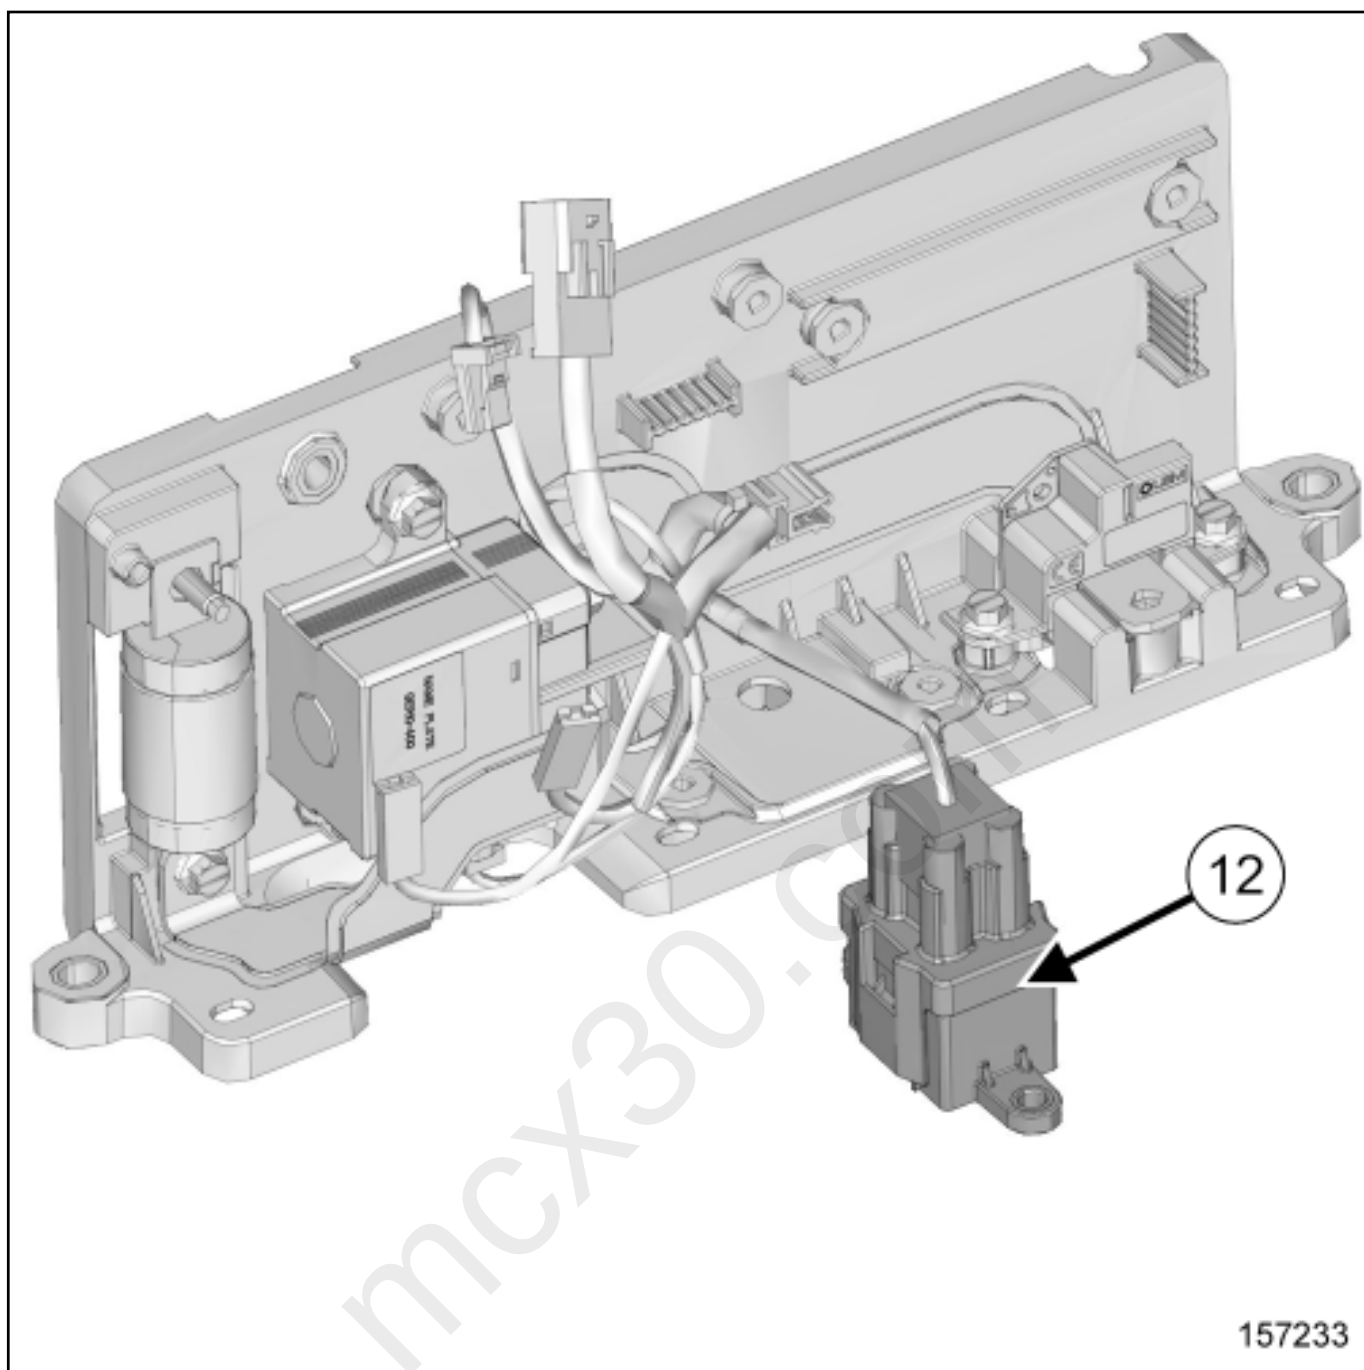
Move the wiring with the precharge relay(12) .

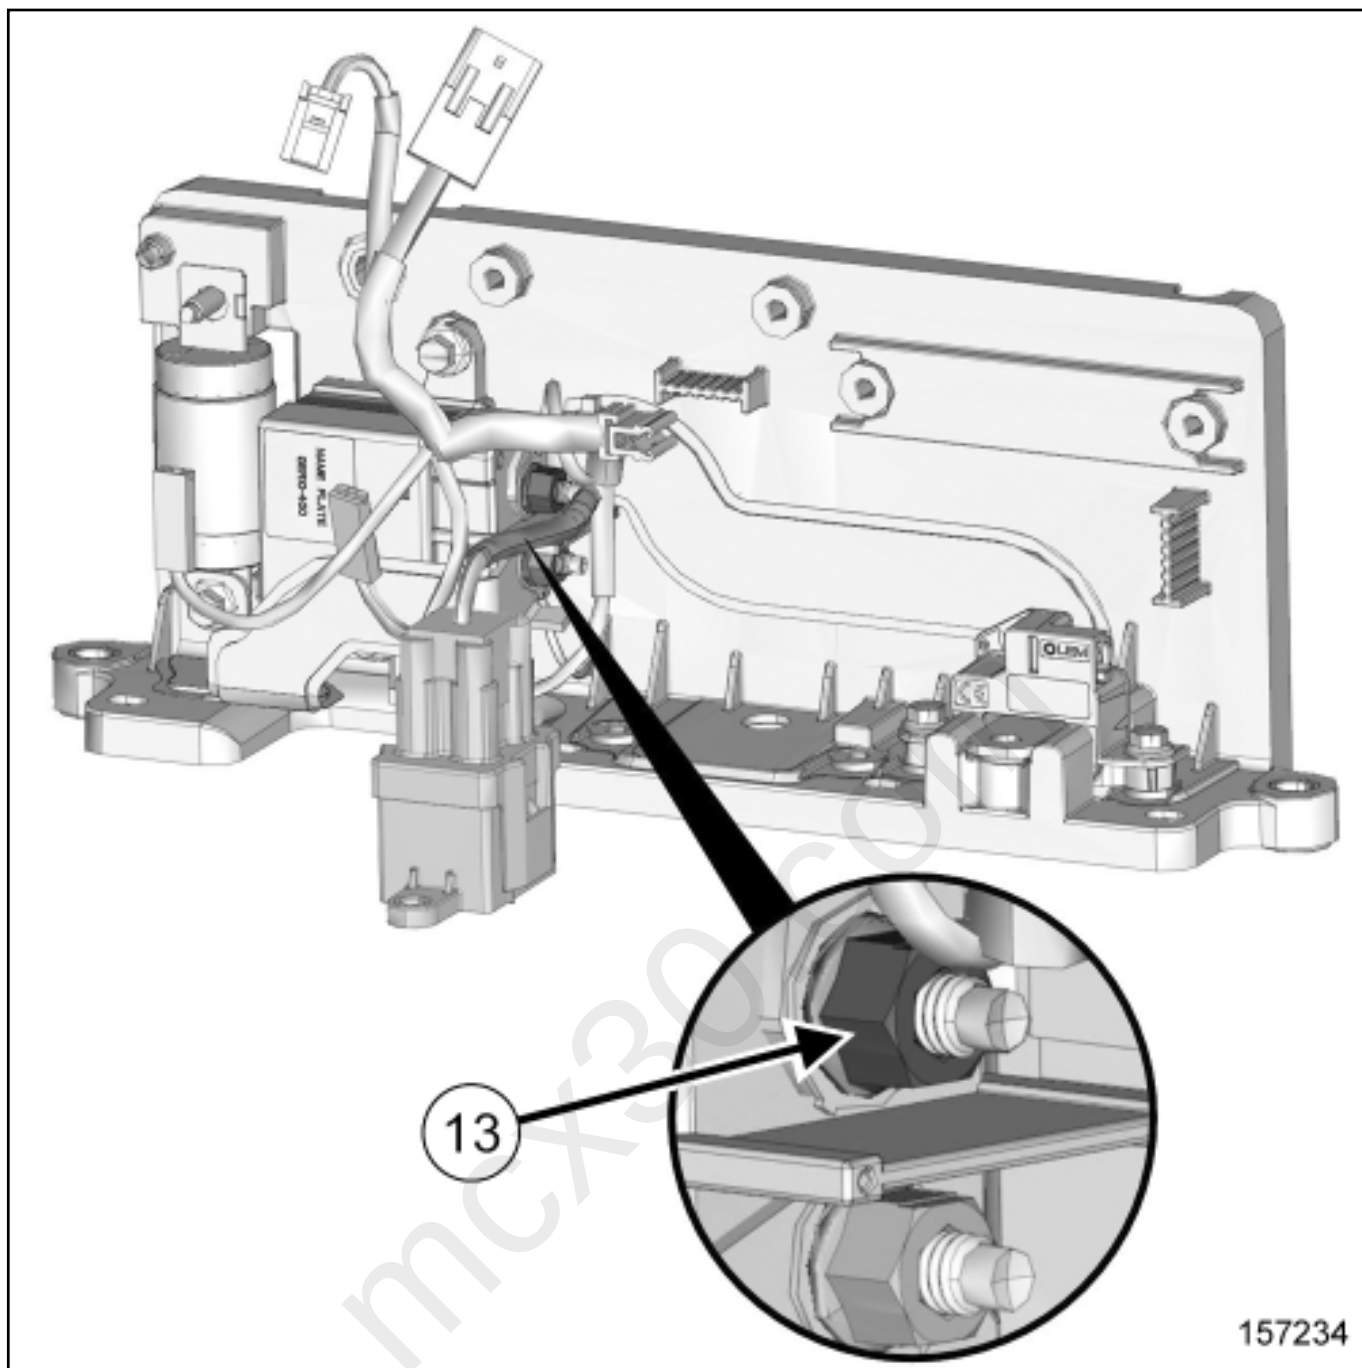
Remove the main relay electric connection upper nut(13) using an insulated magnetic socket([see 19E, Traction battery, Traction battery module stack assembly : Exploded view](#)) .
