# TRACTION BATTERY INTERNAL CURRENT SENSOR : REMOVAL - REFITTING

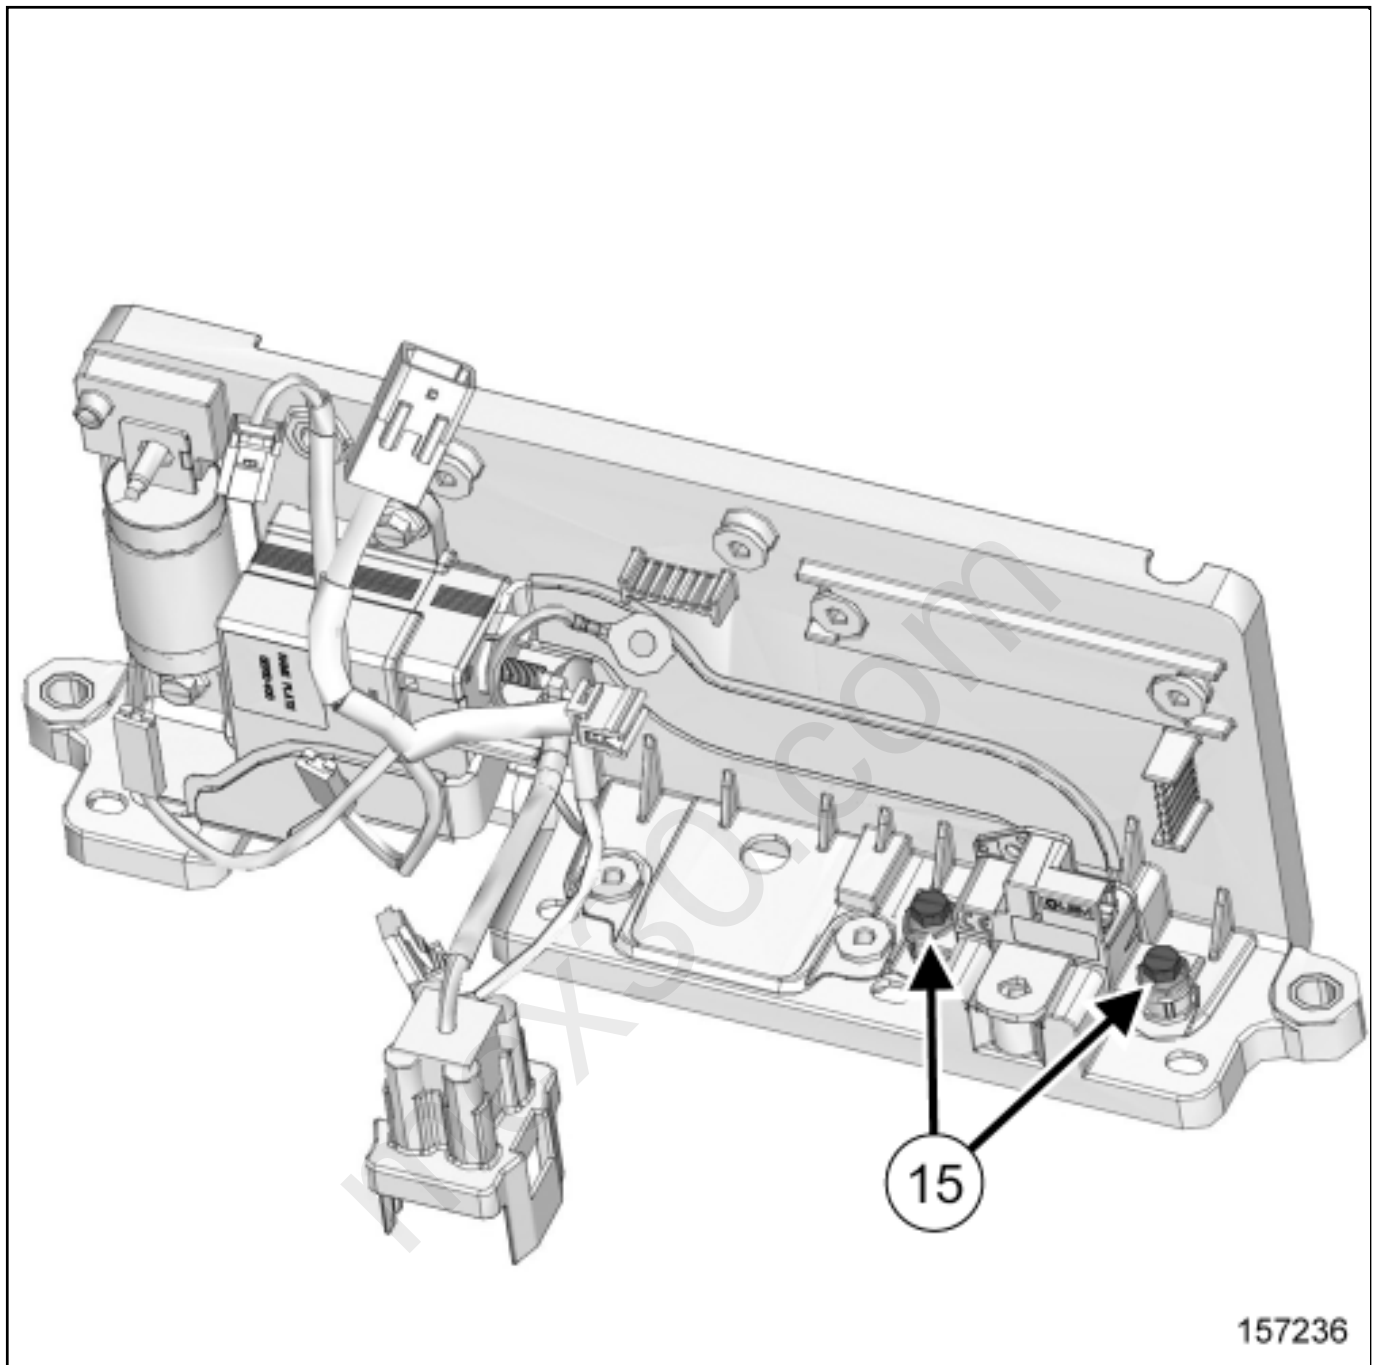
Remove the current sensor screws(15) using an insulated magnetic socket([see 19E, Traction battery, Traction battery module stack assembly : Exploded view](#)) .

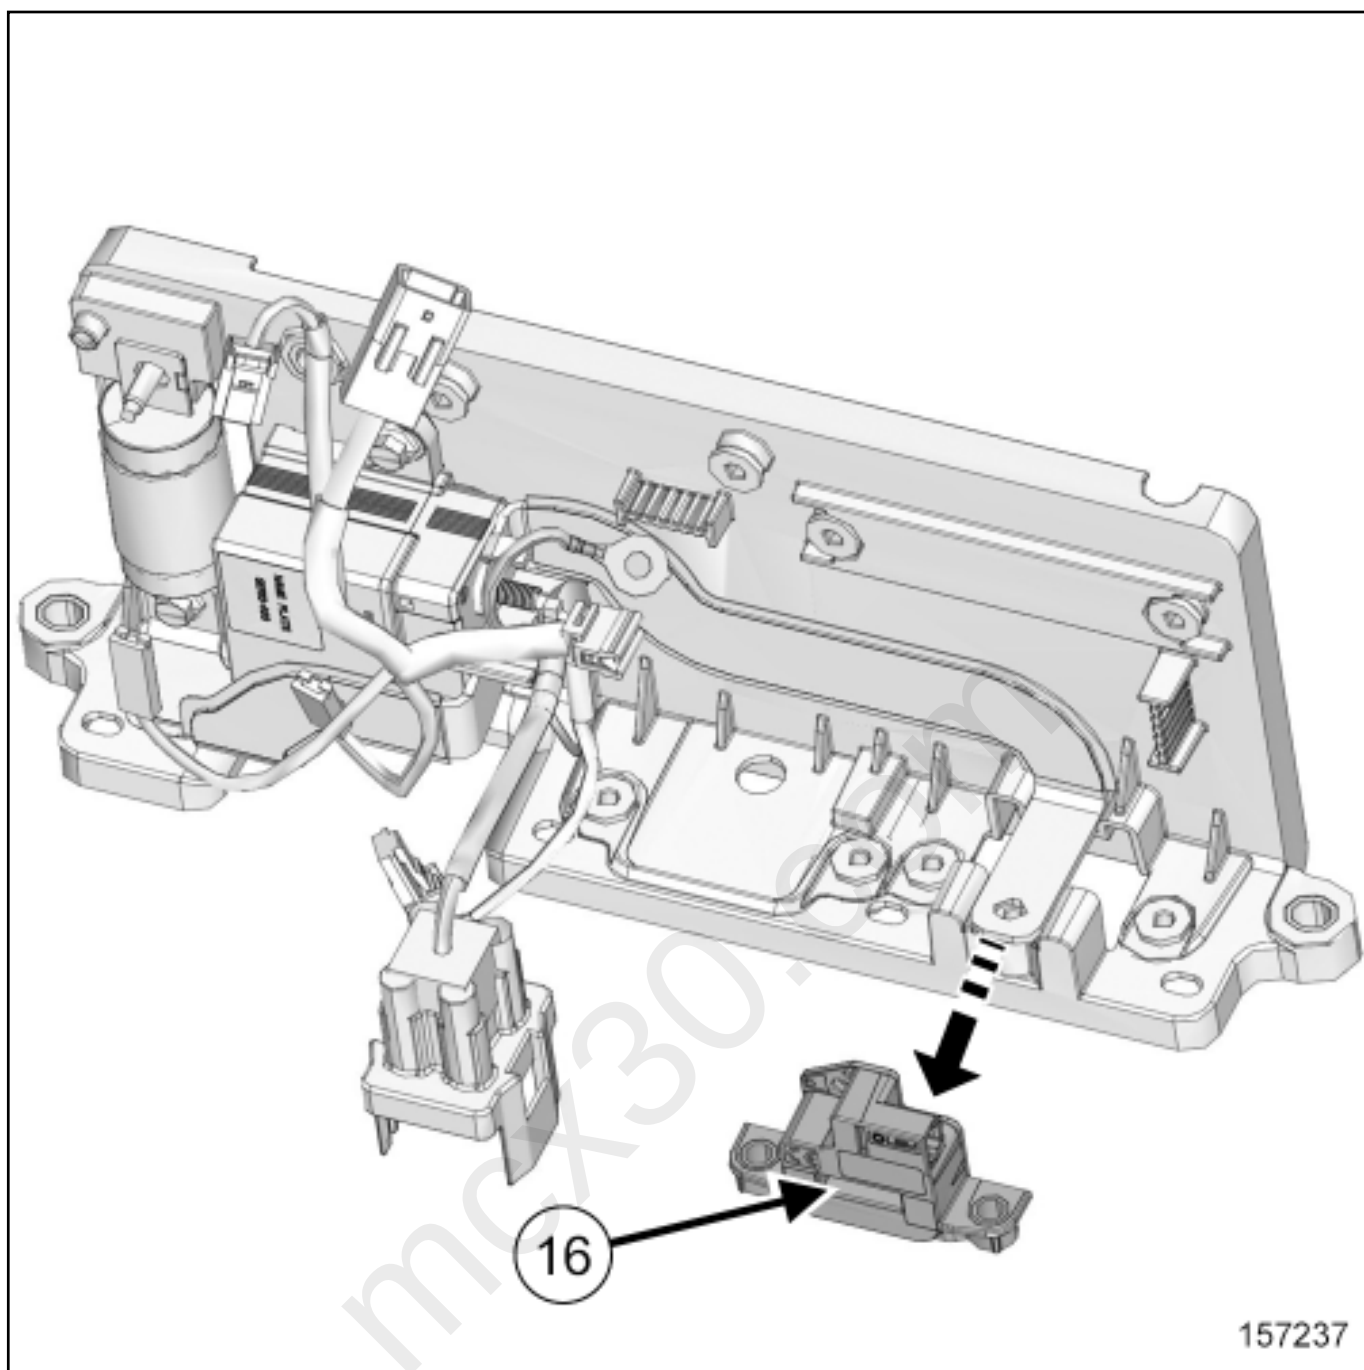
Remove the current sensor(16) .

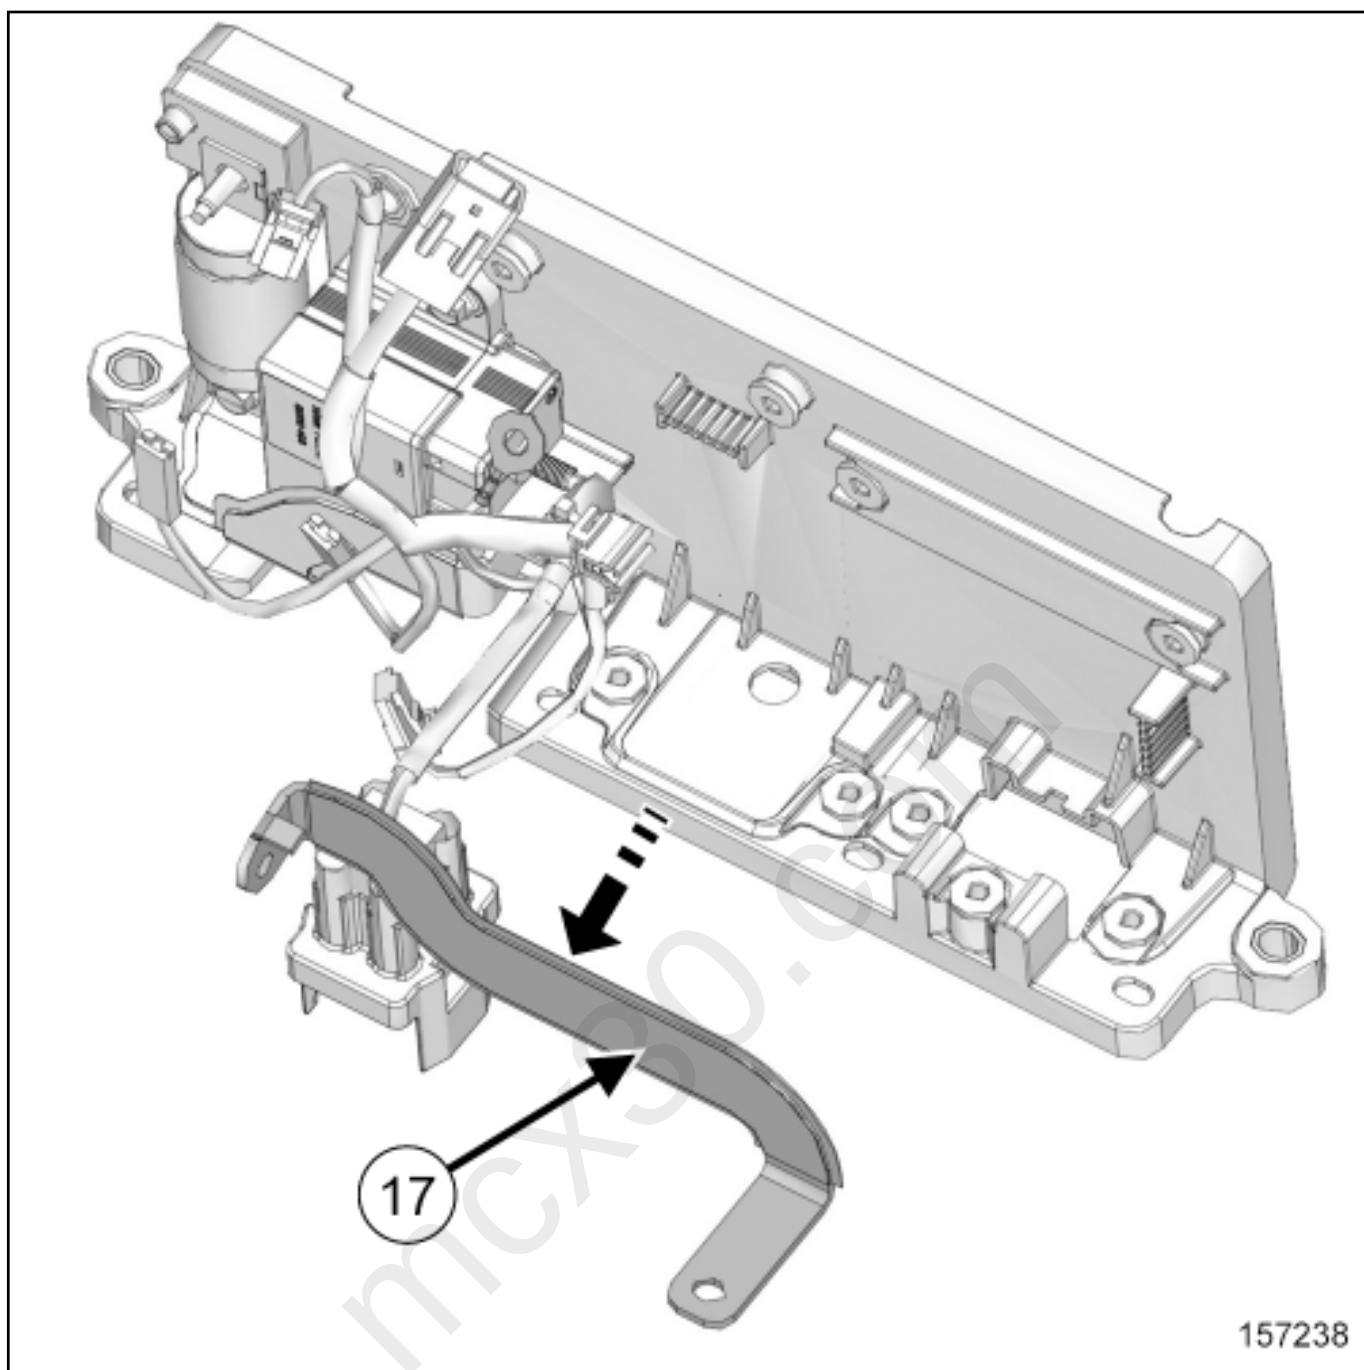
Remove the bus bar(17) .

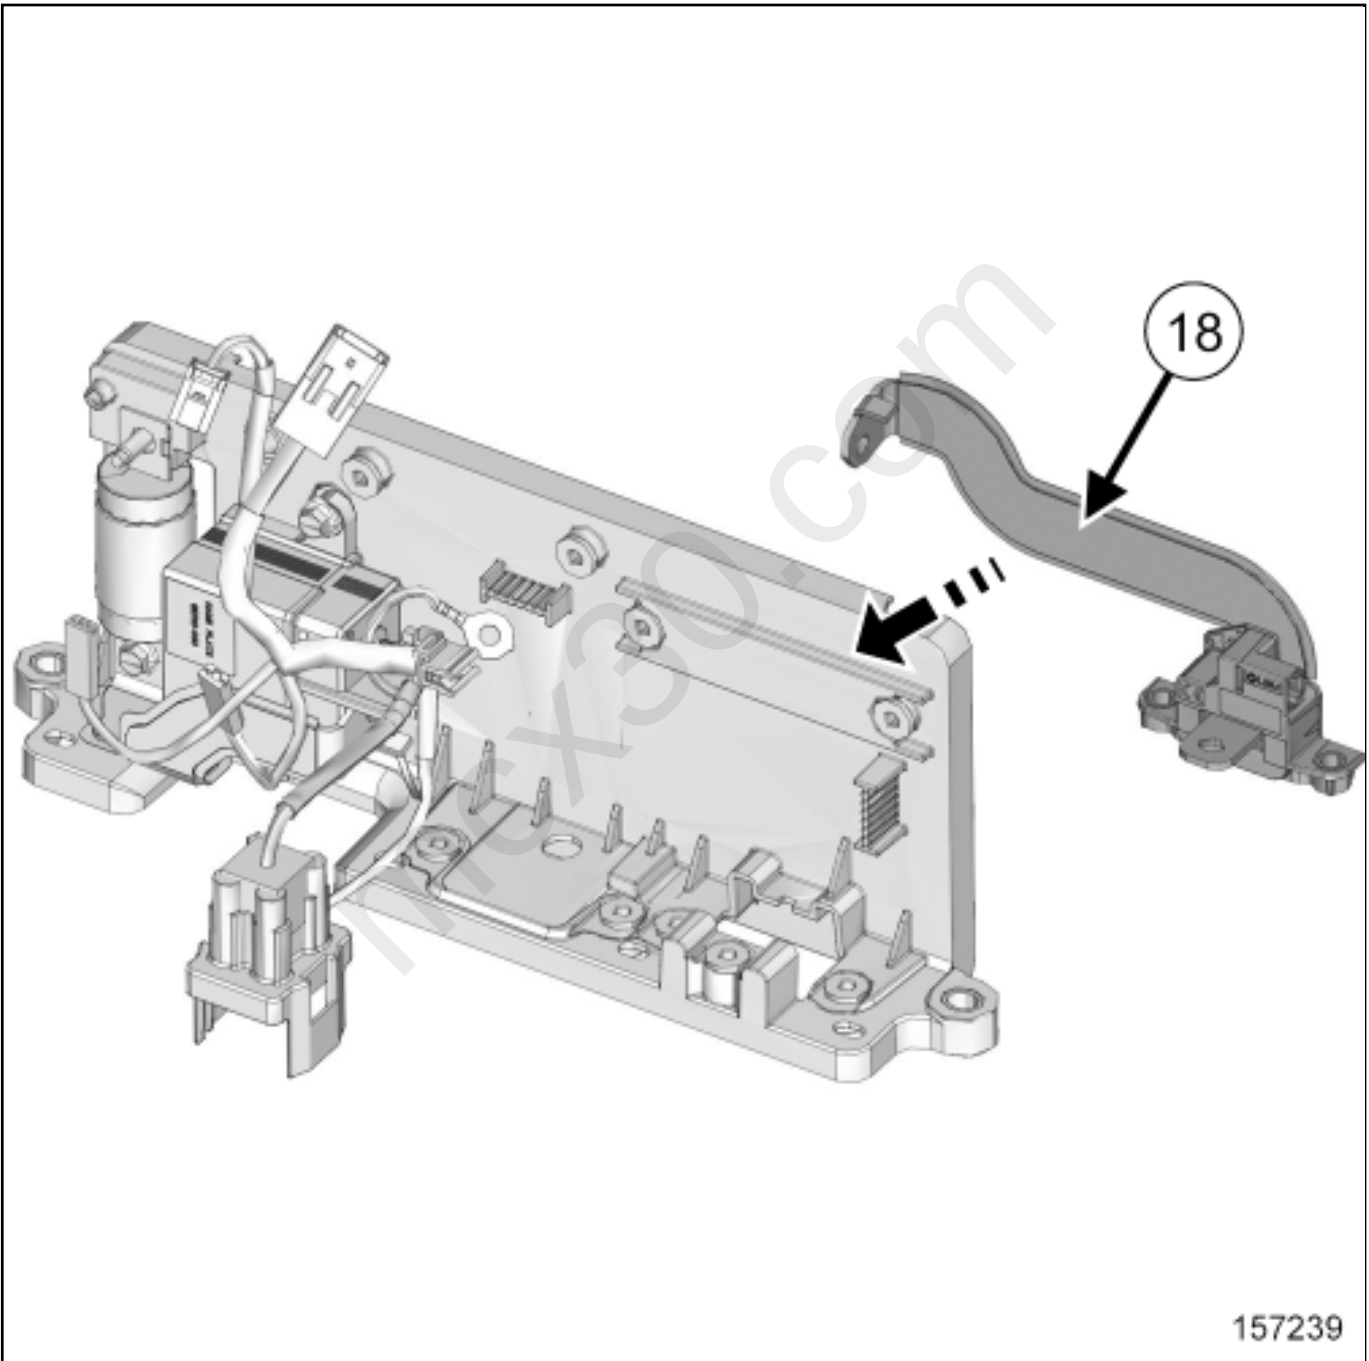
Refit the bus bar + the current sensor(18) .

Pay attention to the mechanical coding on the current sensor.

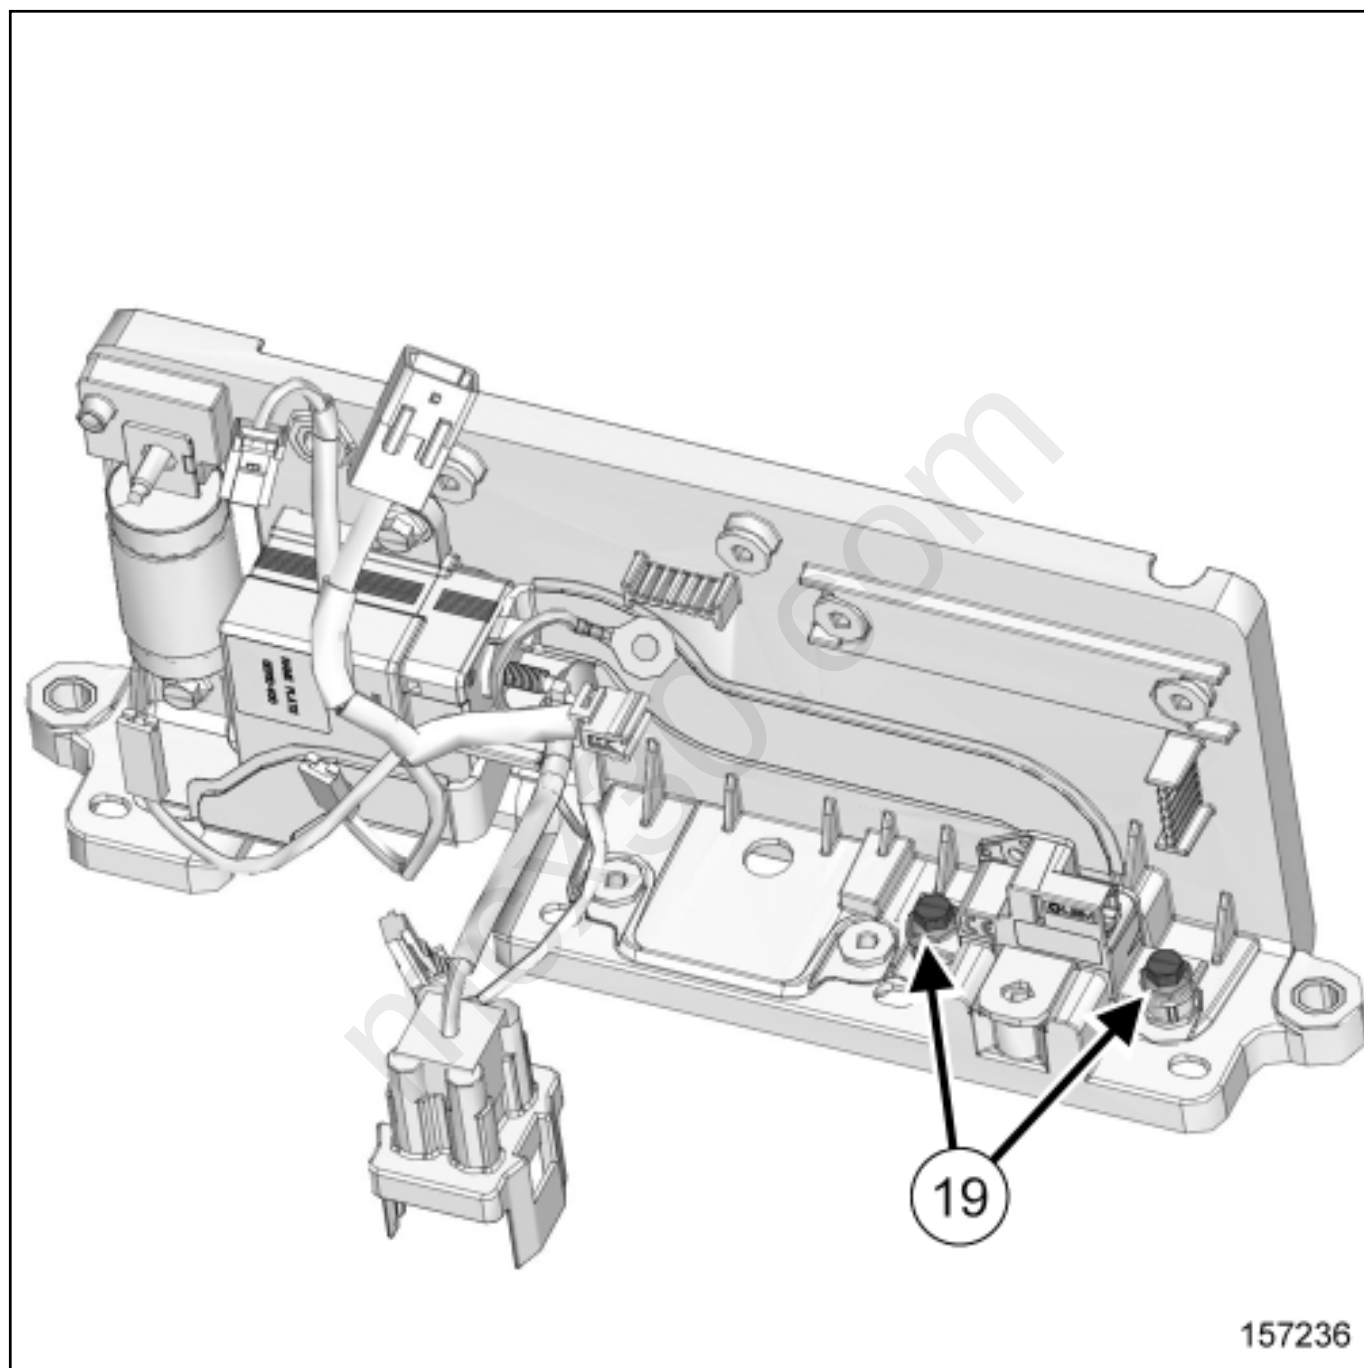
Refit the current sensor screws(19) using an insulated magnetic socket([see 19E, Traction battery, Traction battery module stack assembly : Exploded view](#)) .

Torque tighten the current sensor screws using an insulated magnetic socket([see 19E, Traction battery, Traction battery module stack assembly : Exploded view](#)) .

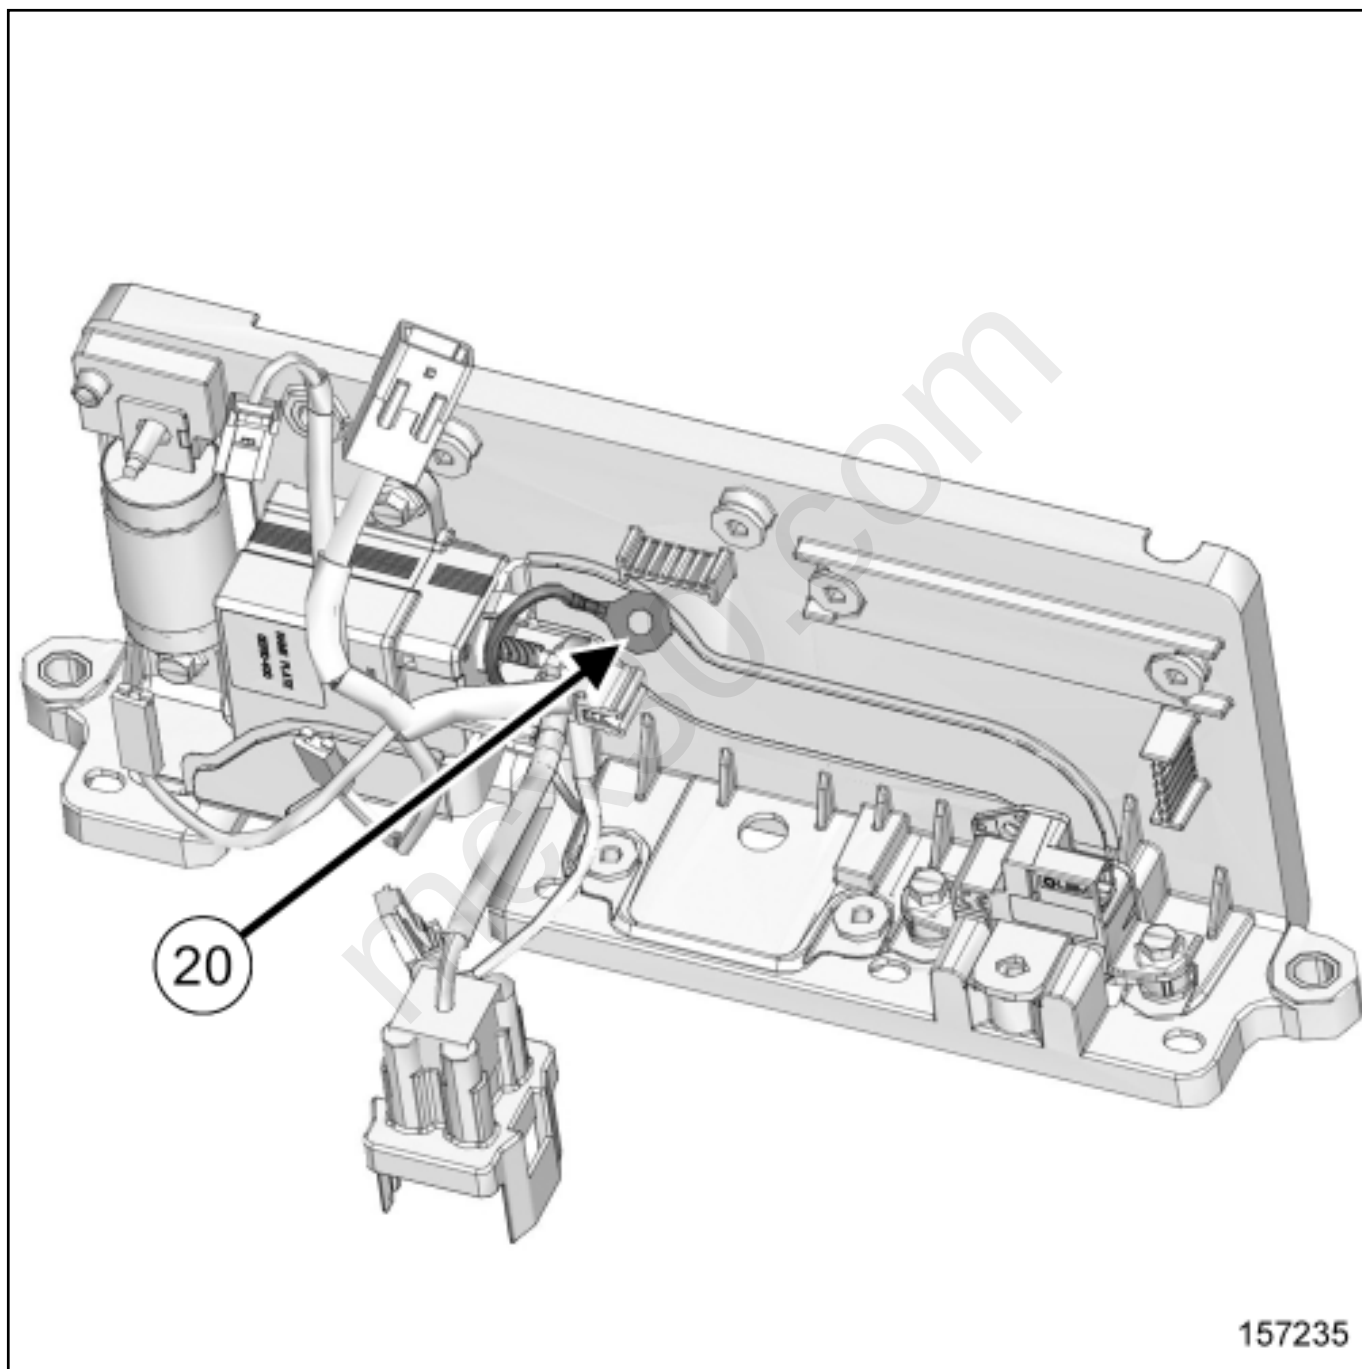
Refit the upper lug([20](#)) using the toolSet of trim removal levers.([Car. 1363](#)) .

The sleeve of the lug passes behind the anti-rotation of the bus bar.

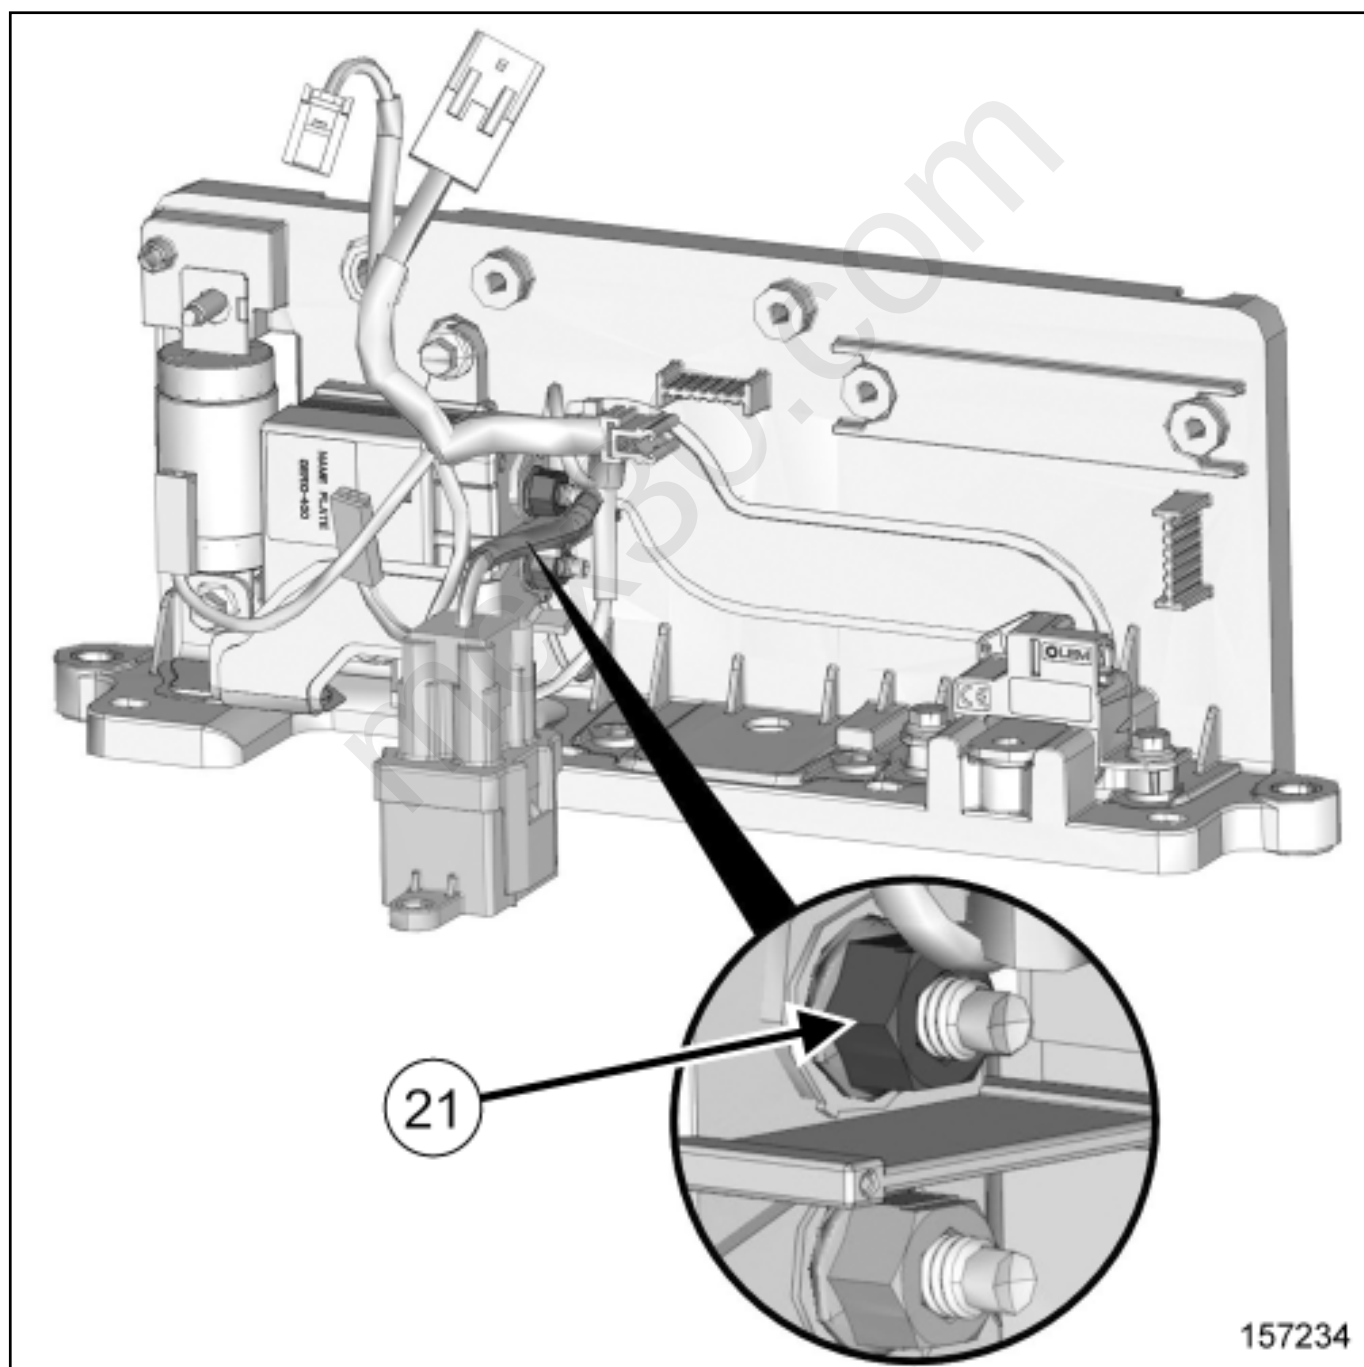
Refit the main relay electric connection upper nut(21) using an insulated magnetic socket([see 19E, Traction battery, Traction battery module stack assembly : Exploded view](#)) .

Torque tighten the main relay electric connection upper nut using an insulated magnetic socket([see 19E, Traction battery, Traction battery module stack assembly : Exploded view](#)) .

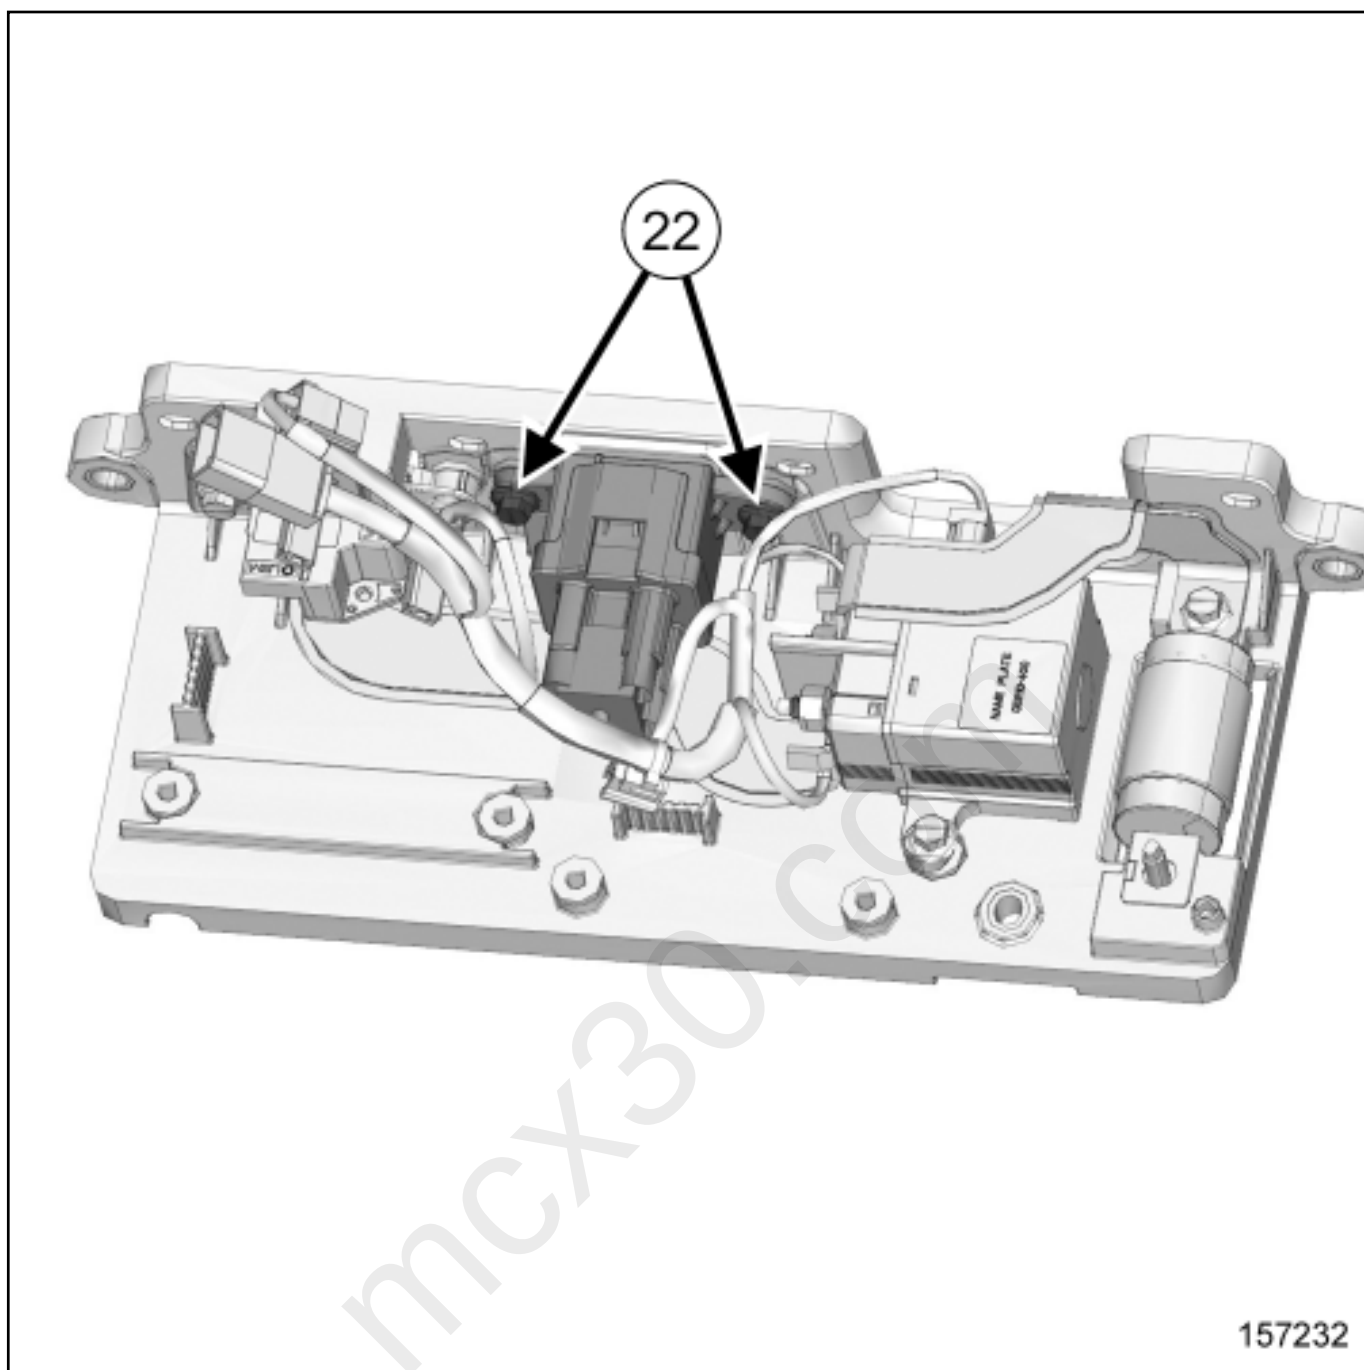
Refit the precharge relay screws(22) using an insulated magnetic socket([see 19E, Traction battery, Traction battery module stack assembly : Exploded view](#)) .

Torque tighten the precharge relay screws using an insulated magnetic socket([see 19E, Traction battery, Traction battery module stack assembly : Exploded view](#)) .

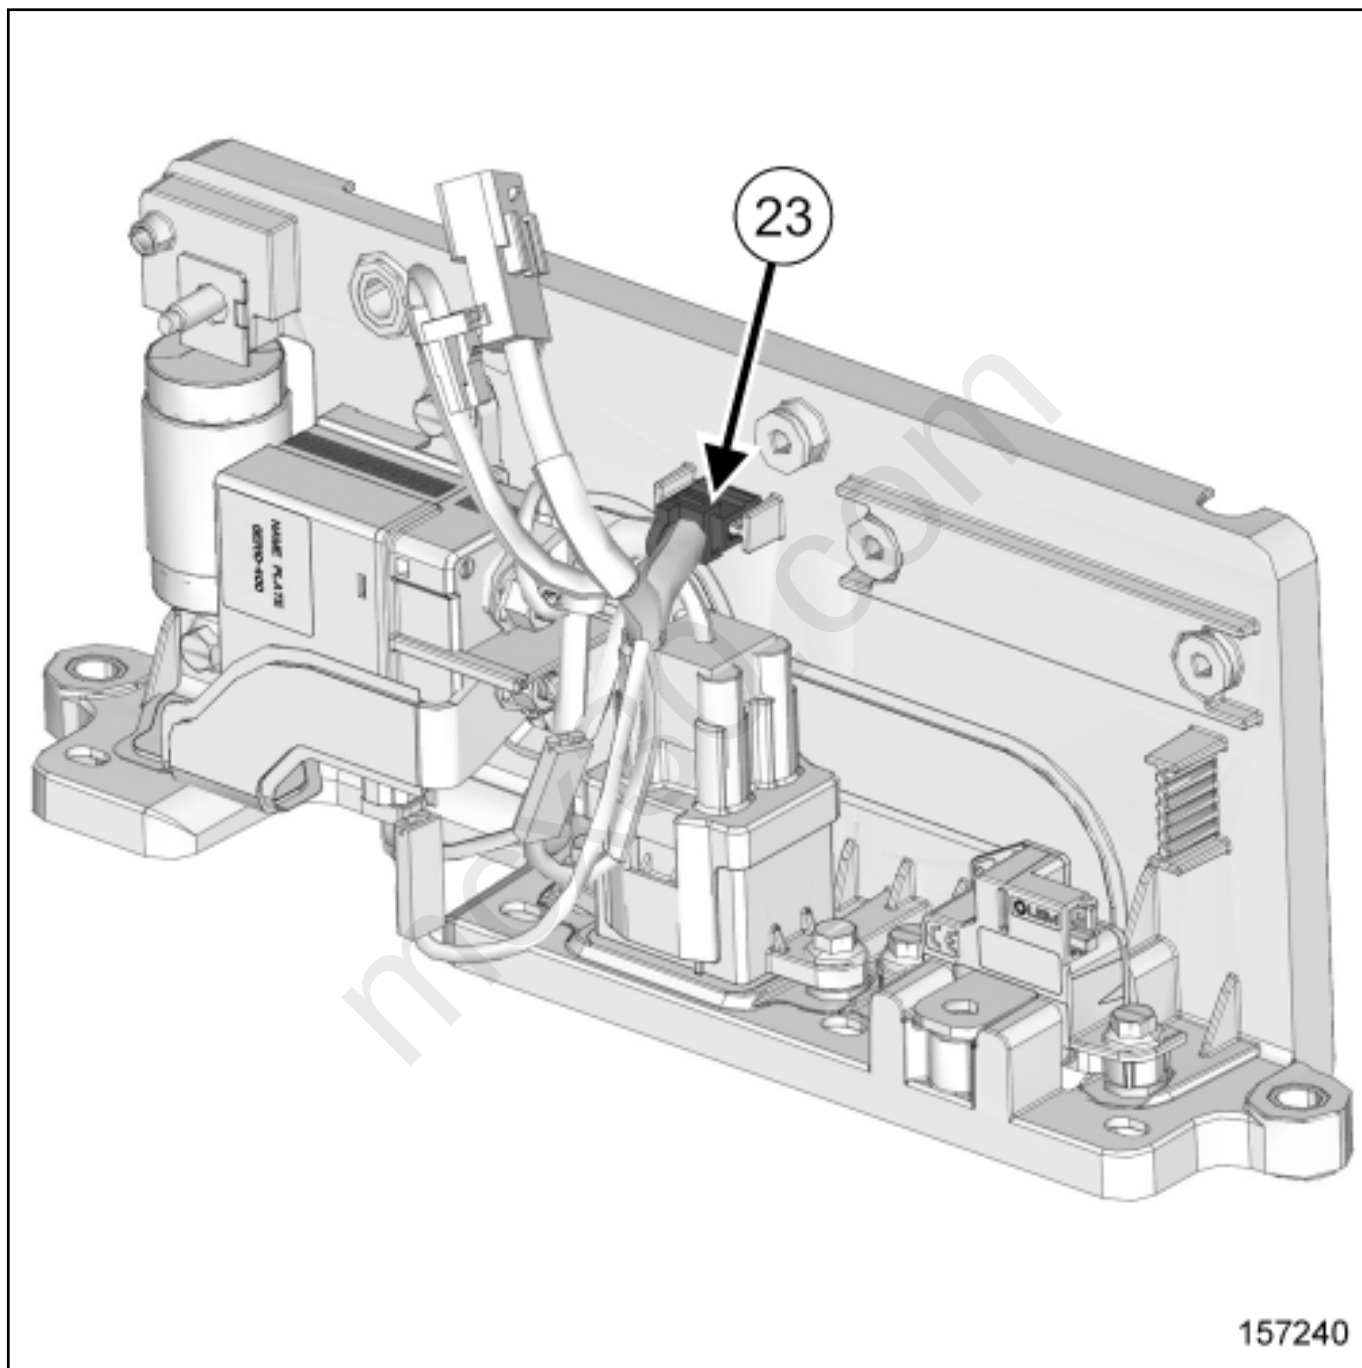
Clip the clamp clip(23) .

Cut the clip clamp using an insulated cutting pliers.

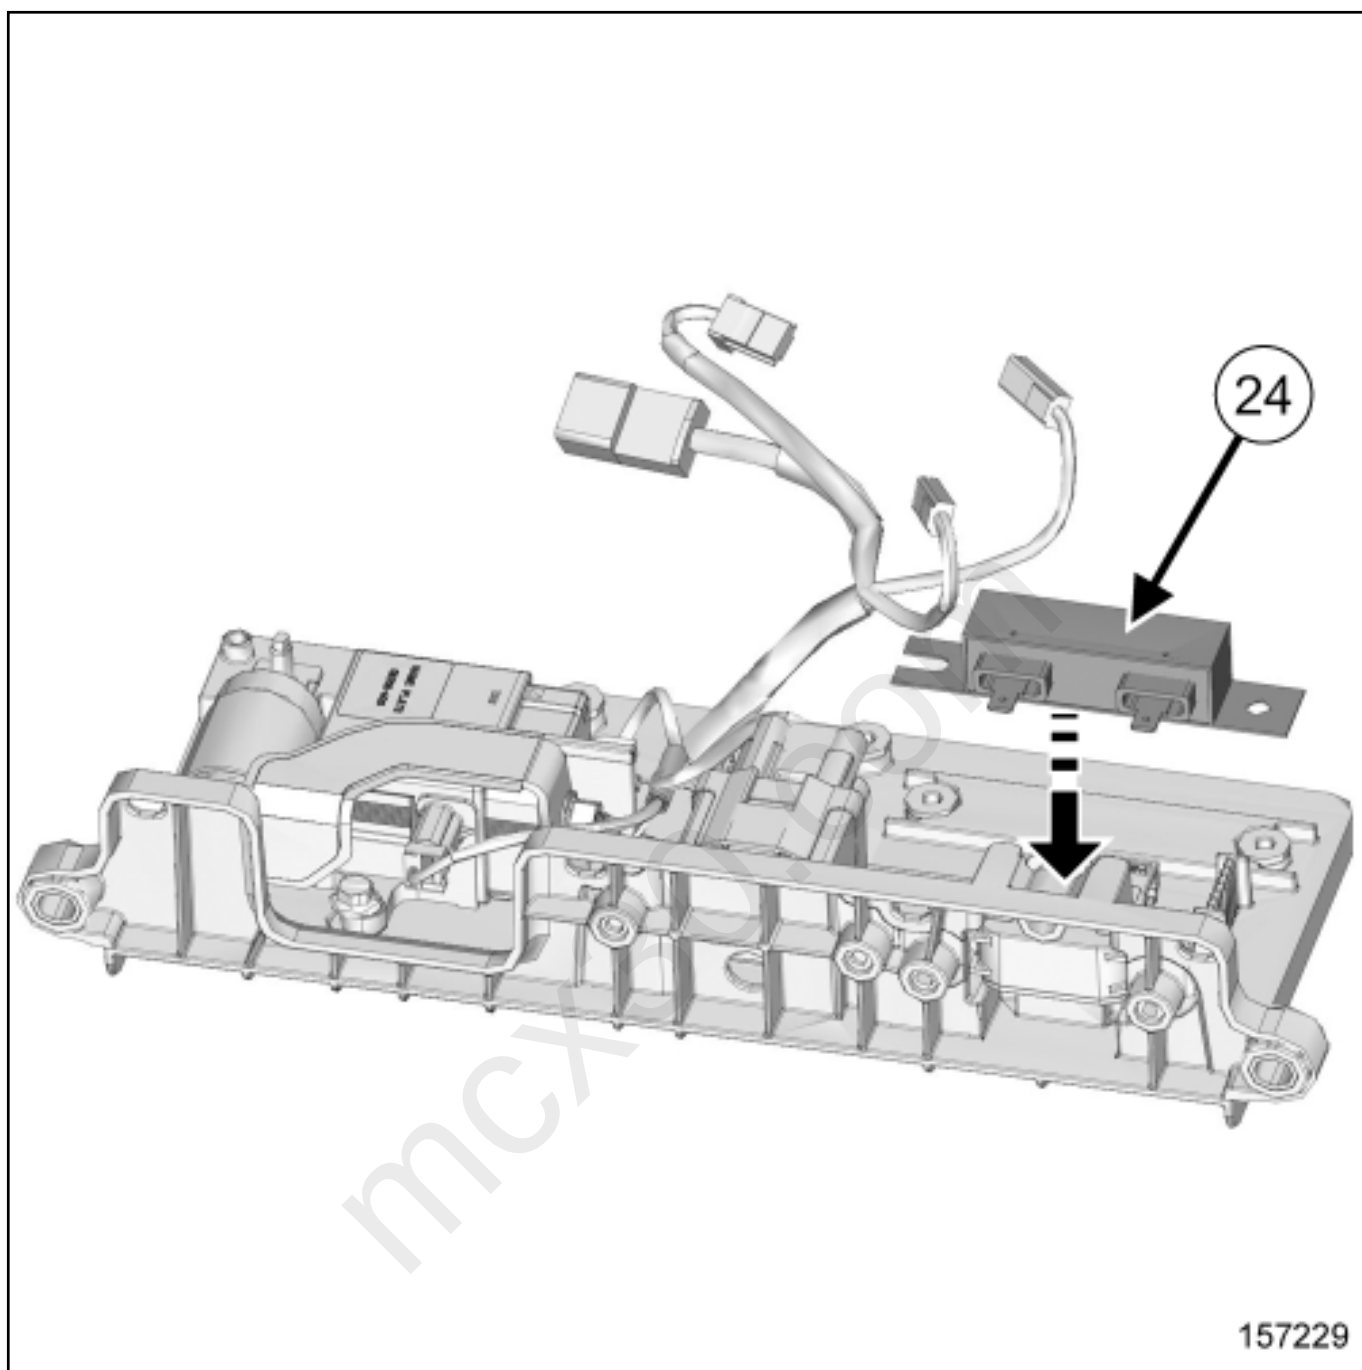
Refit the precharge resistor(24) .

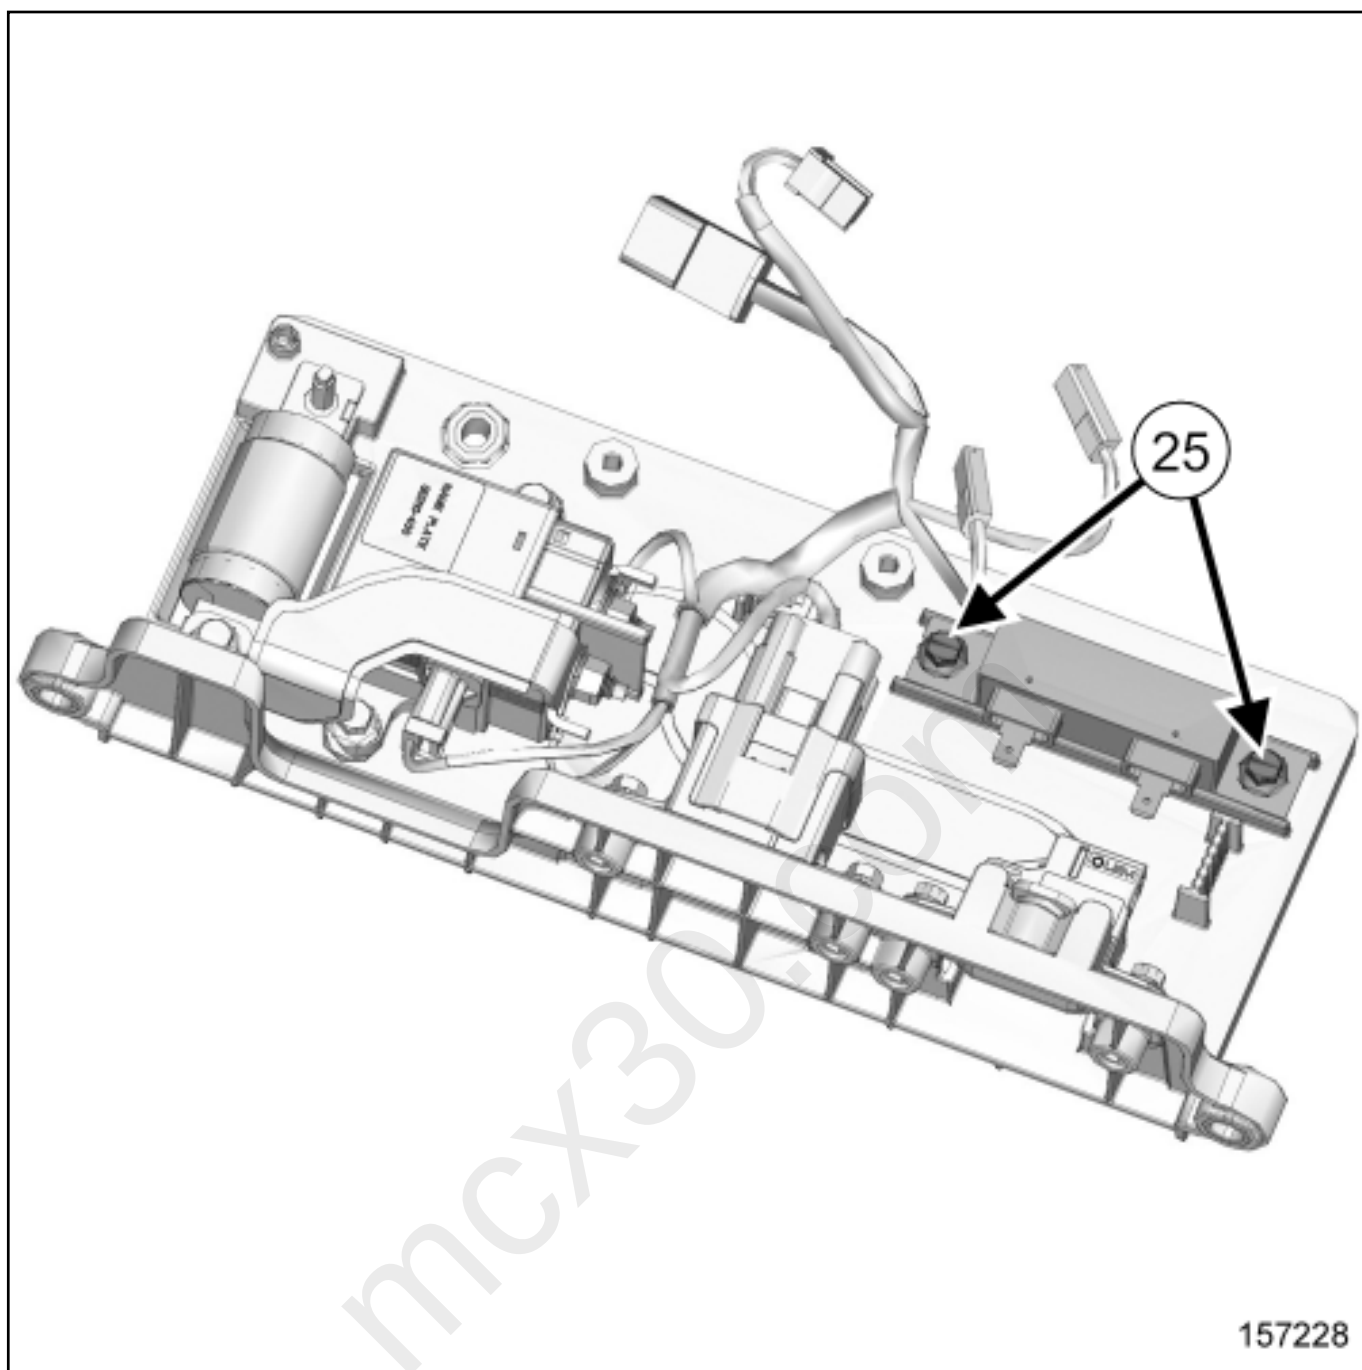
Refit the precharge resistor screws(25) using an insulated magnetic socket([see 19E, Traction battery, Traction battery module stack assembly : Exploded view](#)) .

Torque tighten the precharge resistor screws using an insulated magnetic socket([see 19E, Traction battery, Traction battery module stack assembly : Exploded view](#)) .

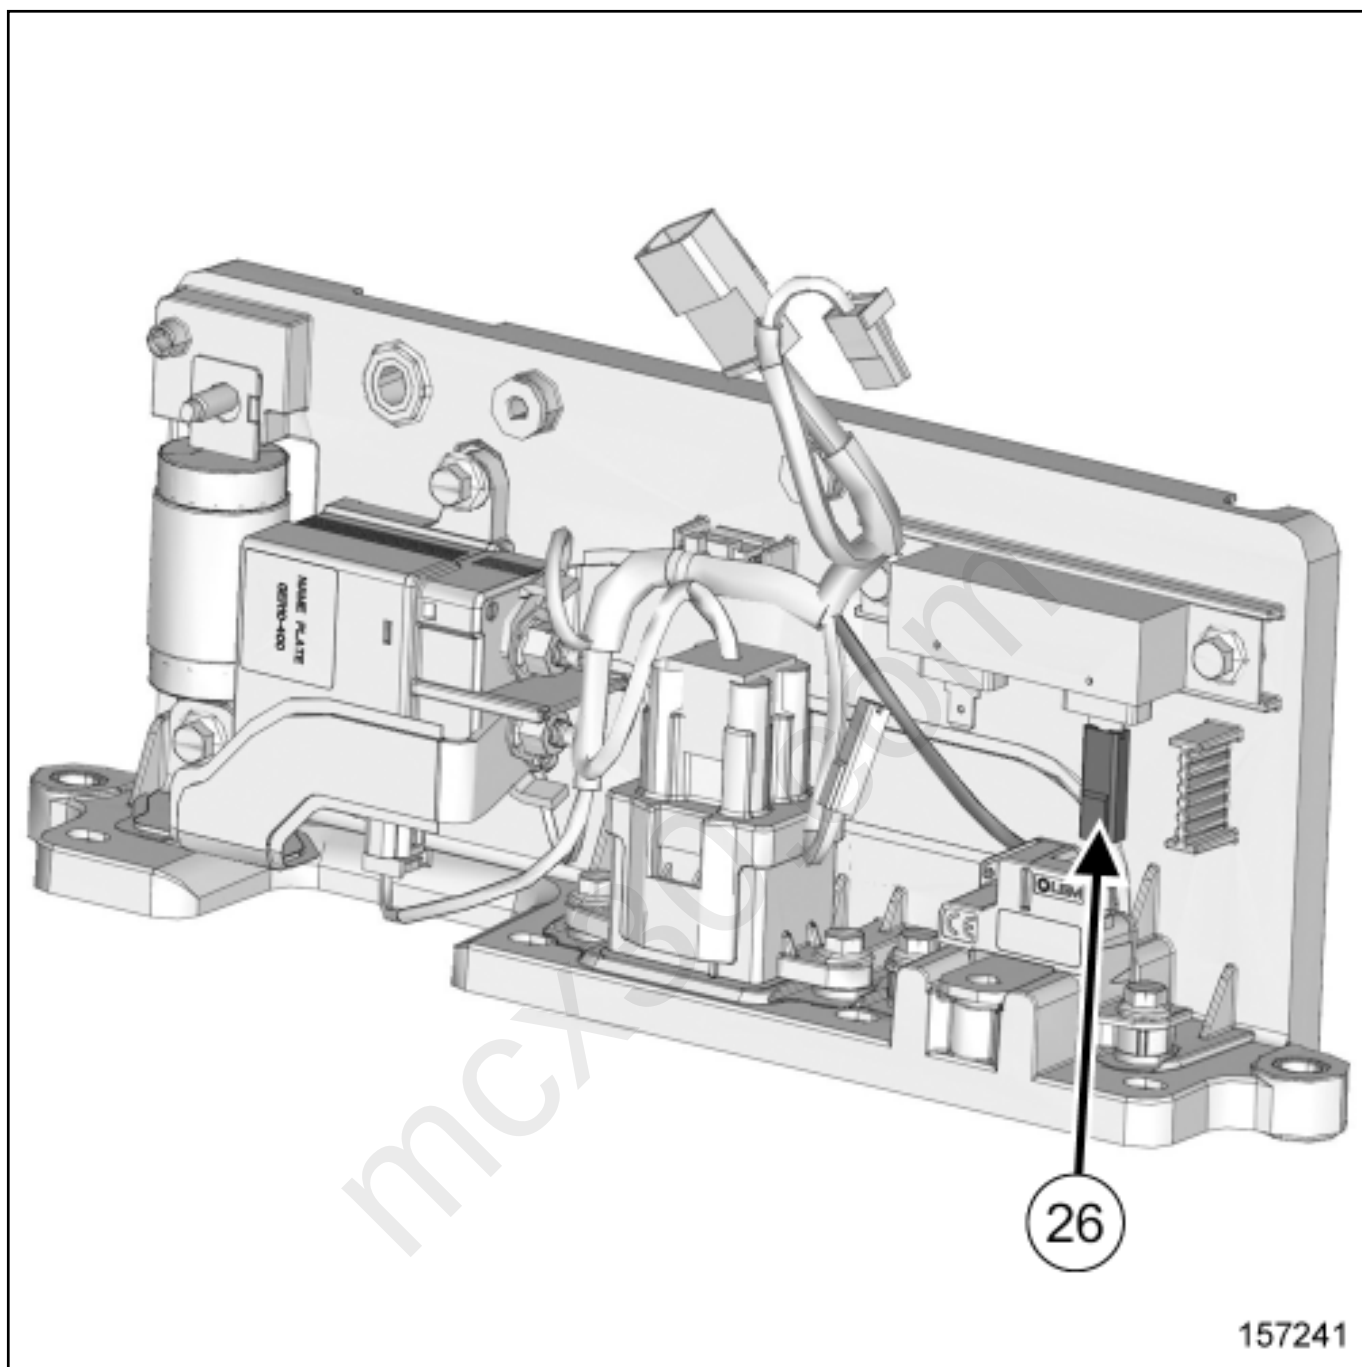
Connect the right side terminal(26) from the precharge resistor using the toolSet of trim removal levers. (Car. 1363) .

The black terminal wiring passes behind the current sensor.
