# TRACTION BATTERY INTERNAL CURRENT SENSOR : REMOVAL - REFITTING

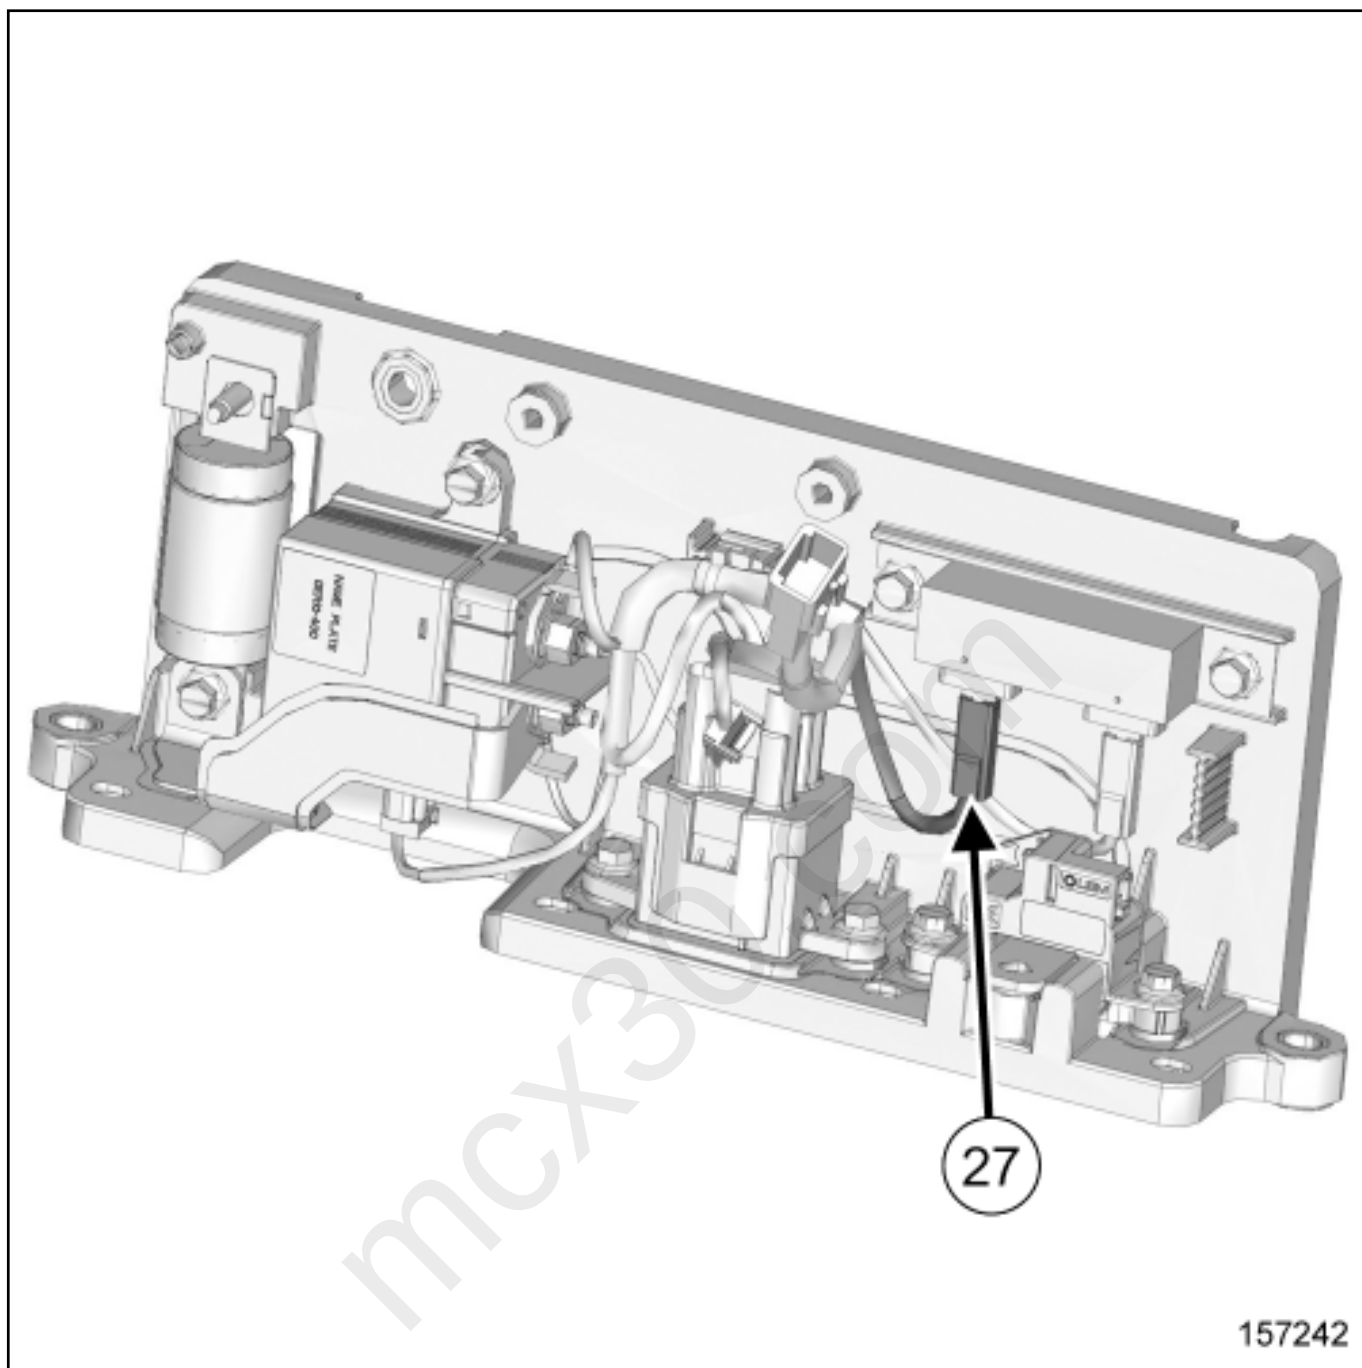
Connect the left side(27) terminal from the precharge resistor using the toolSet of trim removal levers. (Car. 1363) .

The blue terminal wiring passes over the control wiring and over the current sensor wiring.

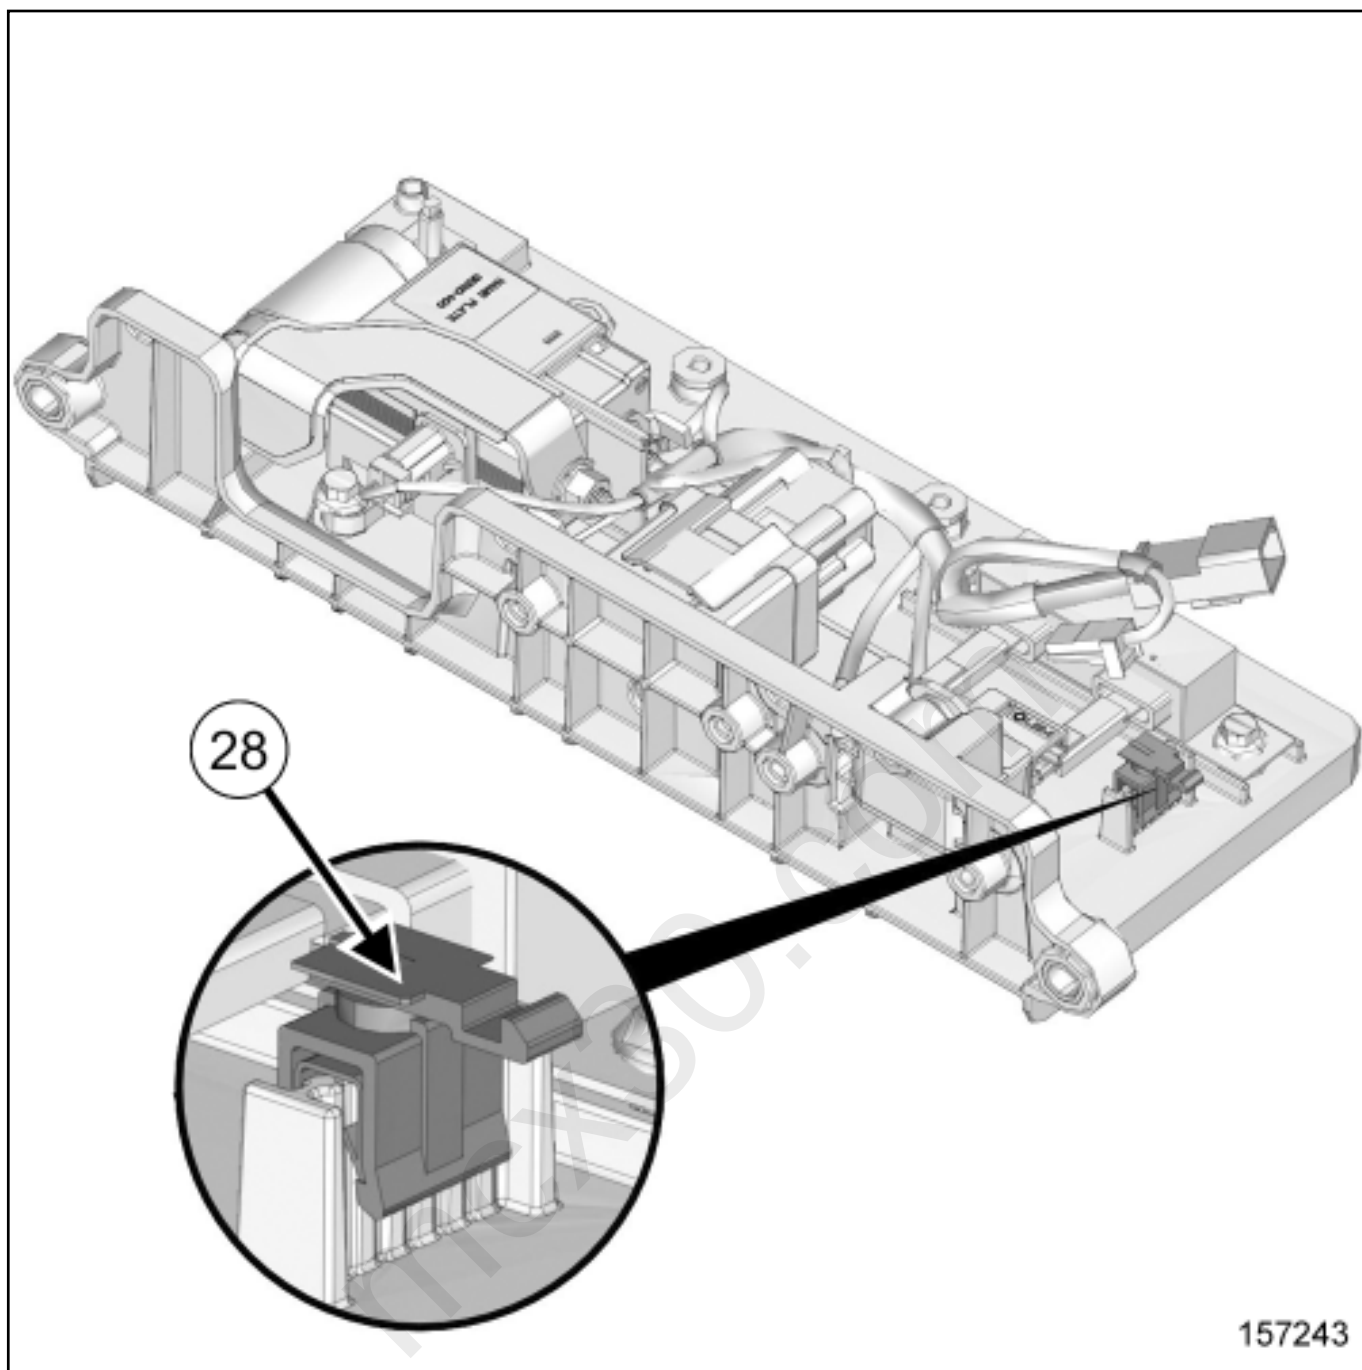
Clip the clip(28) on the internal junction plate.

The lever of the clip to the right.

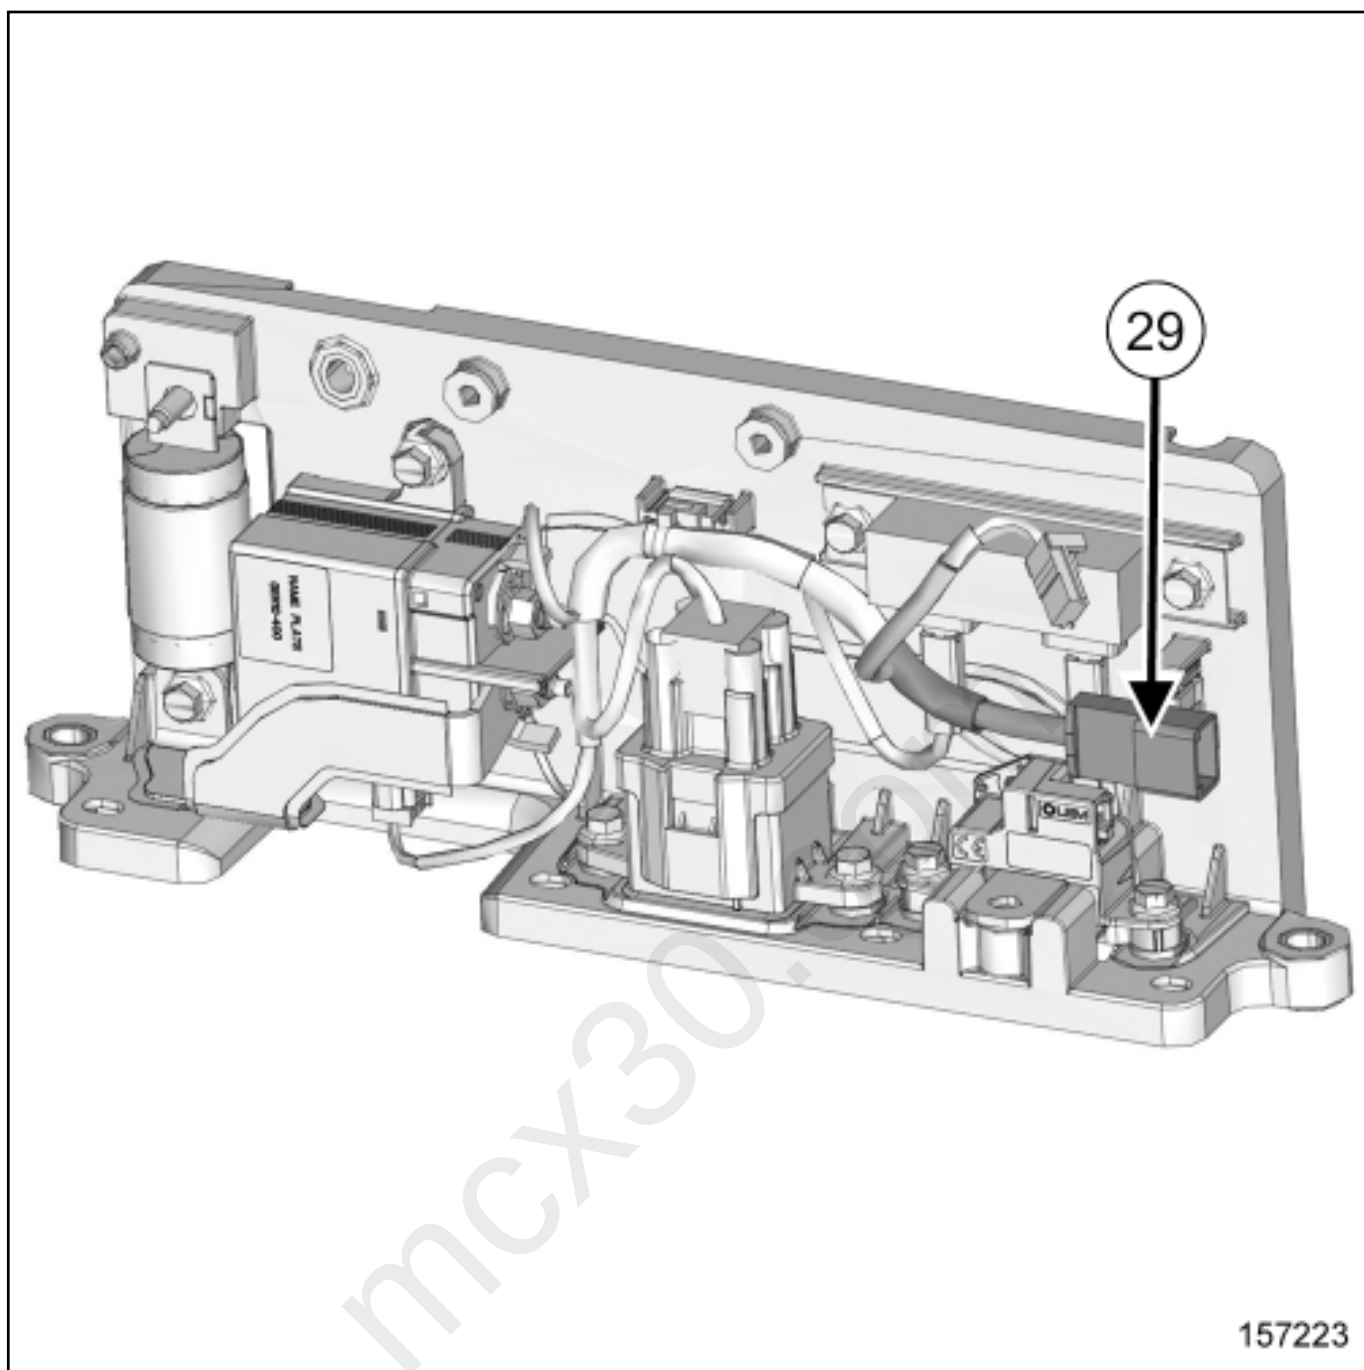
Clip the internal junction box wiring socket(29) using the toolSet of trim removal levers.(Car. 1363) .

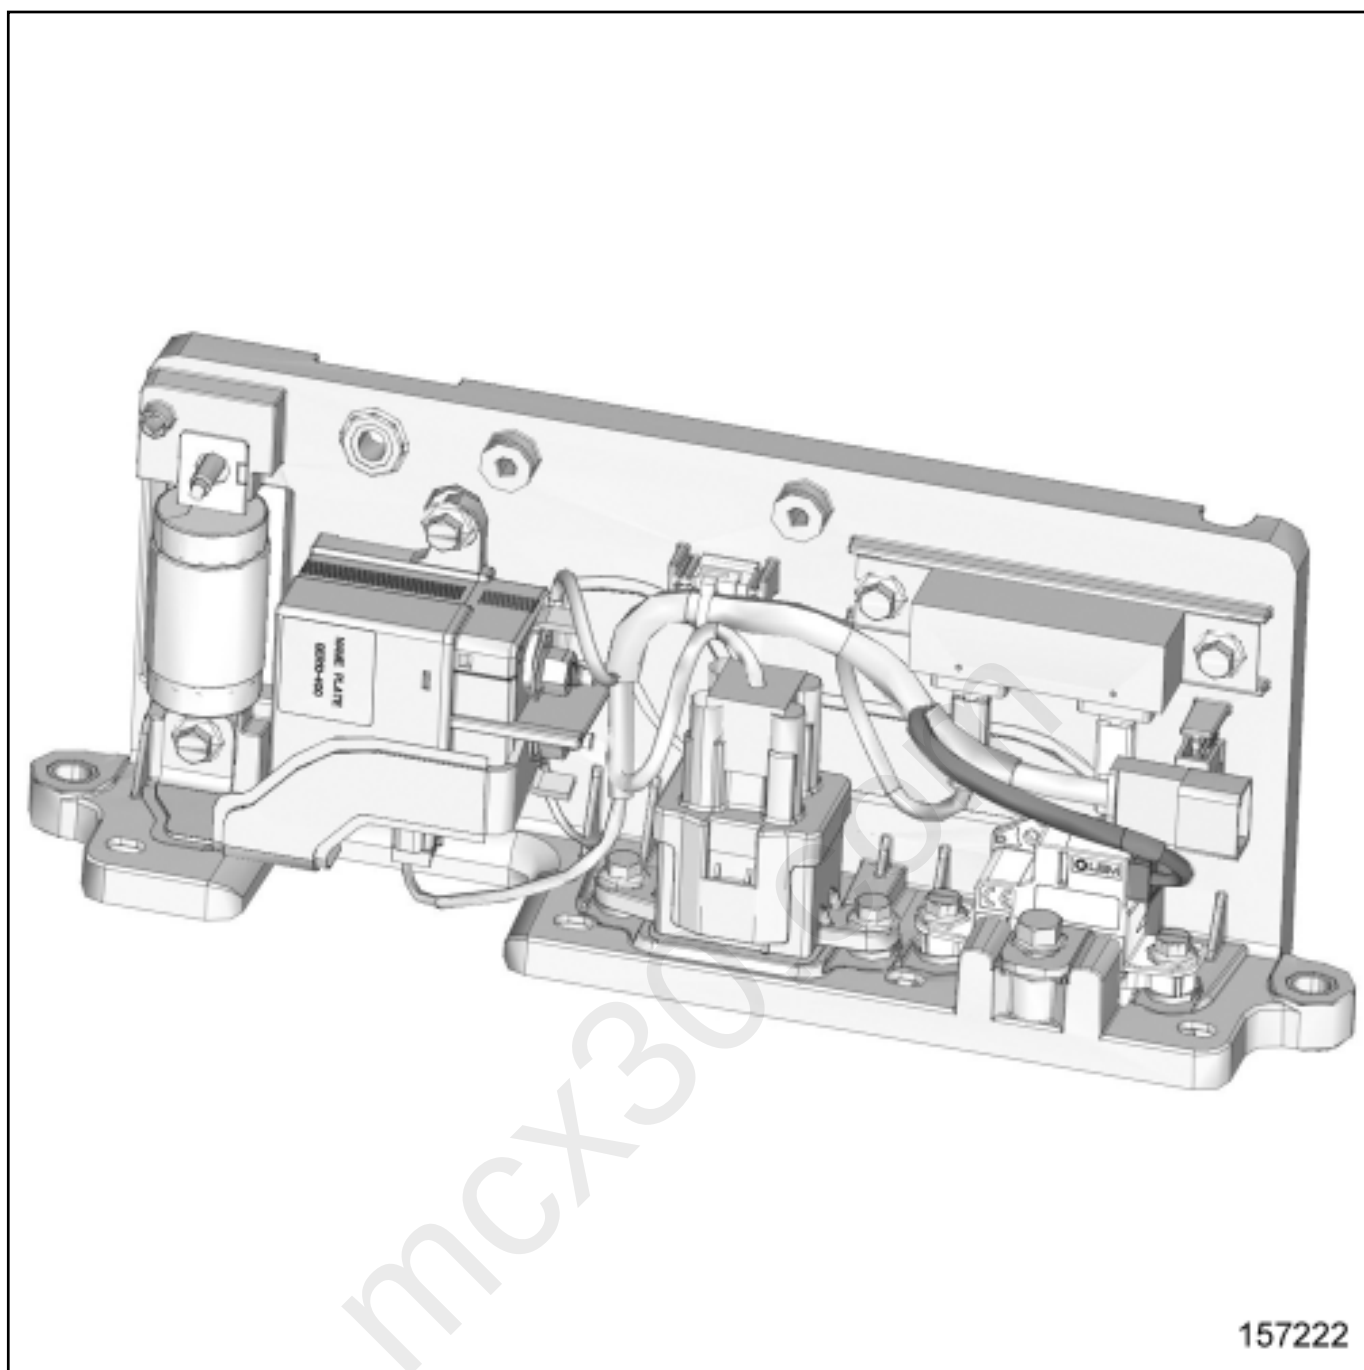
Connect the current sensor plug using the toolSet of trim removal levers.([Car. 1363](#)) .

Make a push-pull test on the connector.

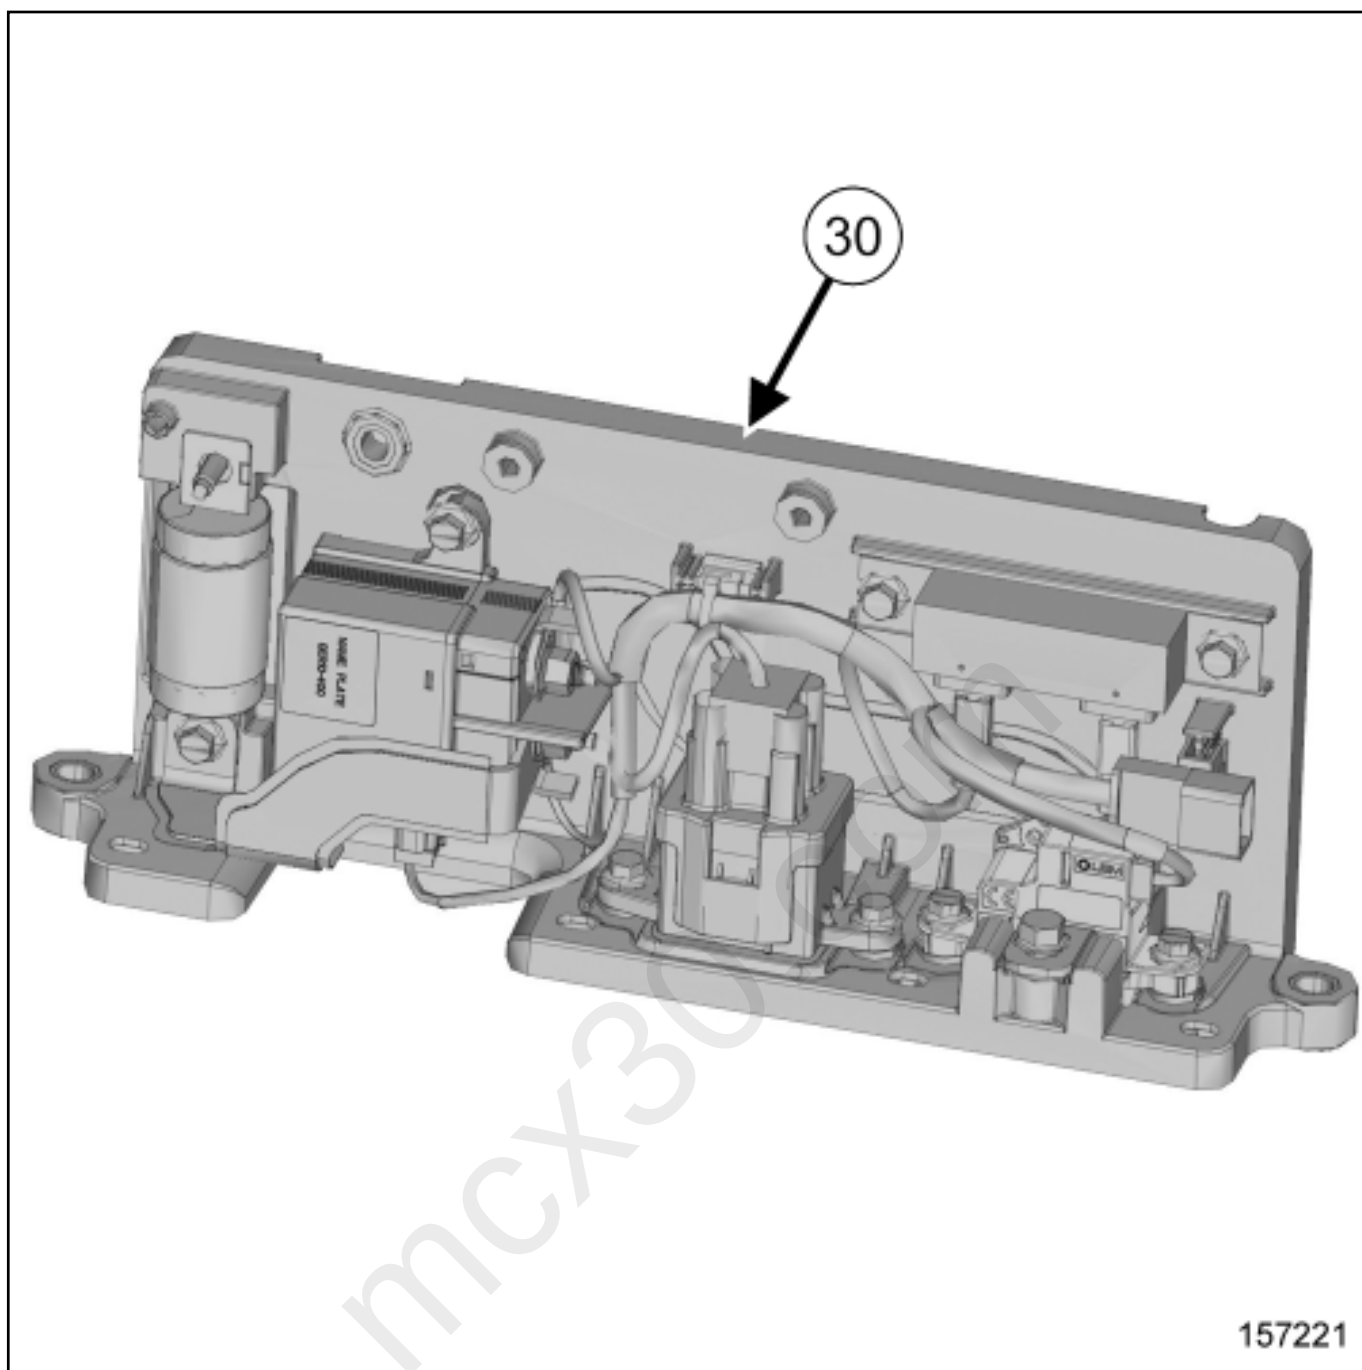
the traction battery internal junction box ([see 19E. Traction battery. Traction battery module stack assembly : Exploded view](#)) (30) ,
